# **Little River Farm Site – Stream Enhancement, Restoration, and Preservation Project Final Year 3 Monitoring Report (2012) Montgomery County, North Carolina**

**EEP Project ID #92759/EEP Contract #000623**

Data Collection Period: September 2012

Submission Date: March 2013

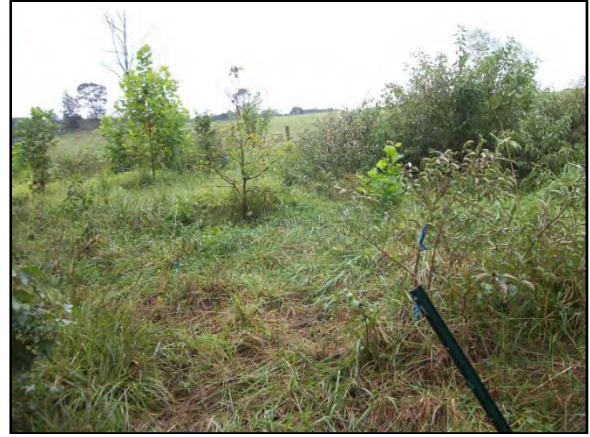
**VP-2**

Vegetation plot counts were conducted in September 2012. During this assessment, planted saplings were noted to be hand-cut in Vegetation Plot 2 and had been historically cut in Vegetation Plots 3 and 4. Observations indicate the cutting was in the area adjacent to the fence lines associated with the affected vegetation plots. Damage noted during both monitoring periods did not result in a significant

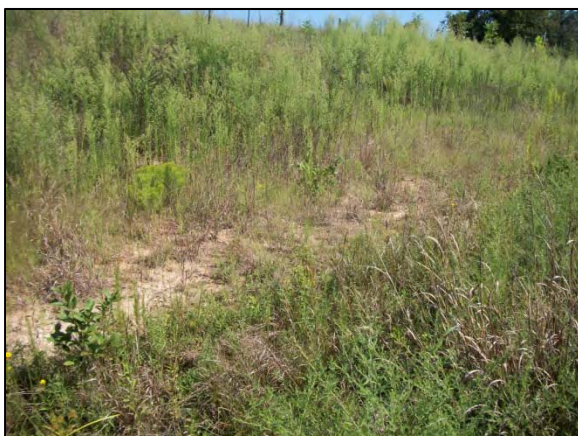
**C.6-5. Station 12+50 – 13+00**

Currently, the constructed sections of stream channel are functioning as designed and most of the rock step pool structures were noted as stable; however, areas of erosion downstream of the headwall structure at Station 12+50 are migrating upstream and are impacting the stability of the structure.
