# Little River Farm Site – Stream Enhancement, Restoration, and Preservation Project Year 4 Monitoring Report (2013) Montgomery County, North Carolina

EEP Project ID #92759/EEP Contract #000623

## Final Year 4 Monitoring Report (2013)

Michael Baker Engineering, Inc.  
NC Engineering License: F-1084

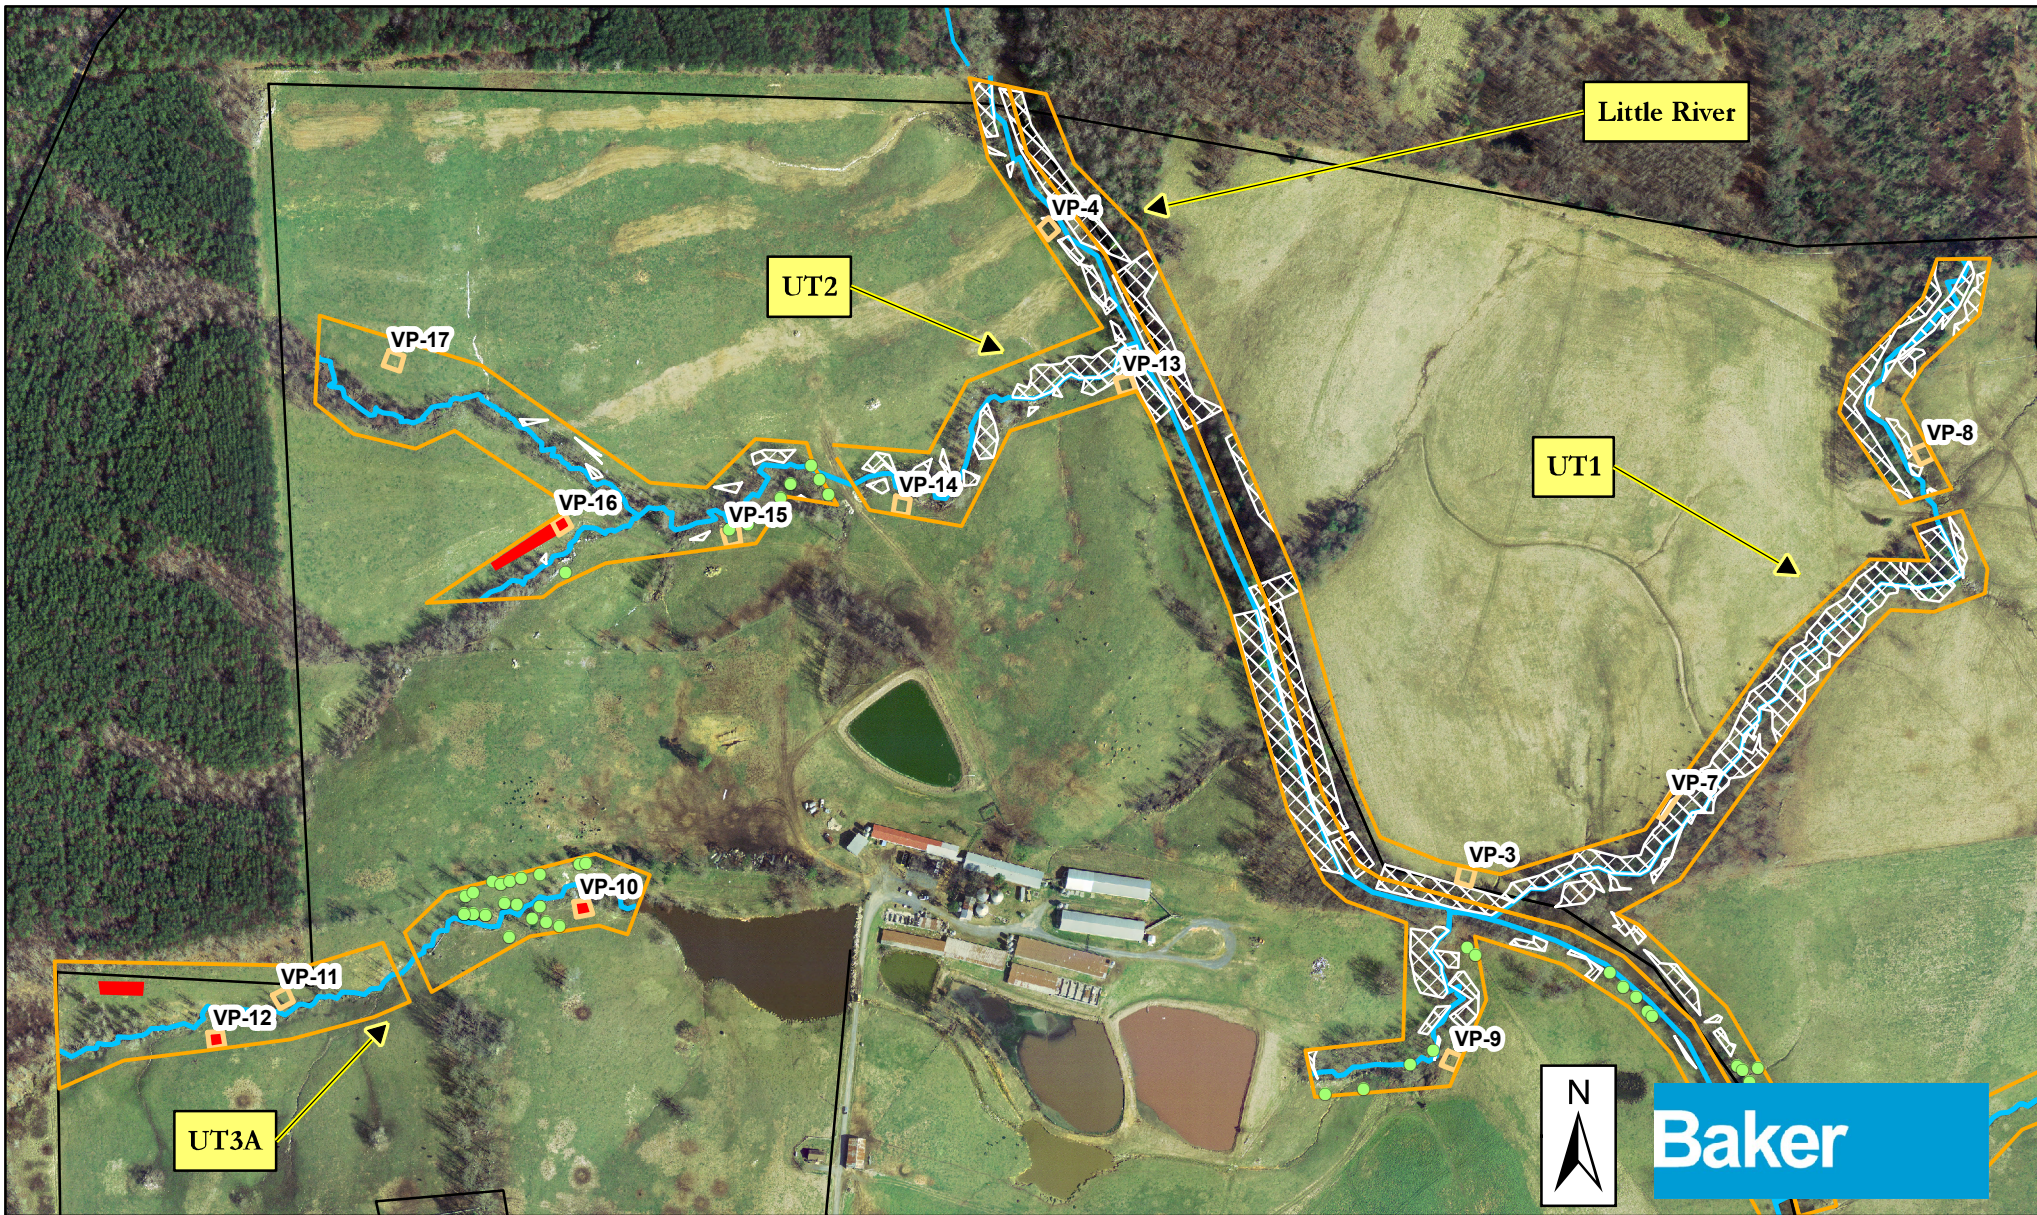
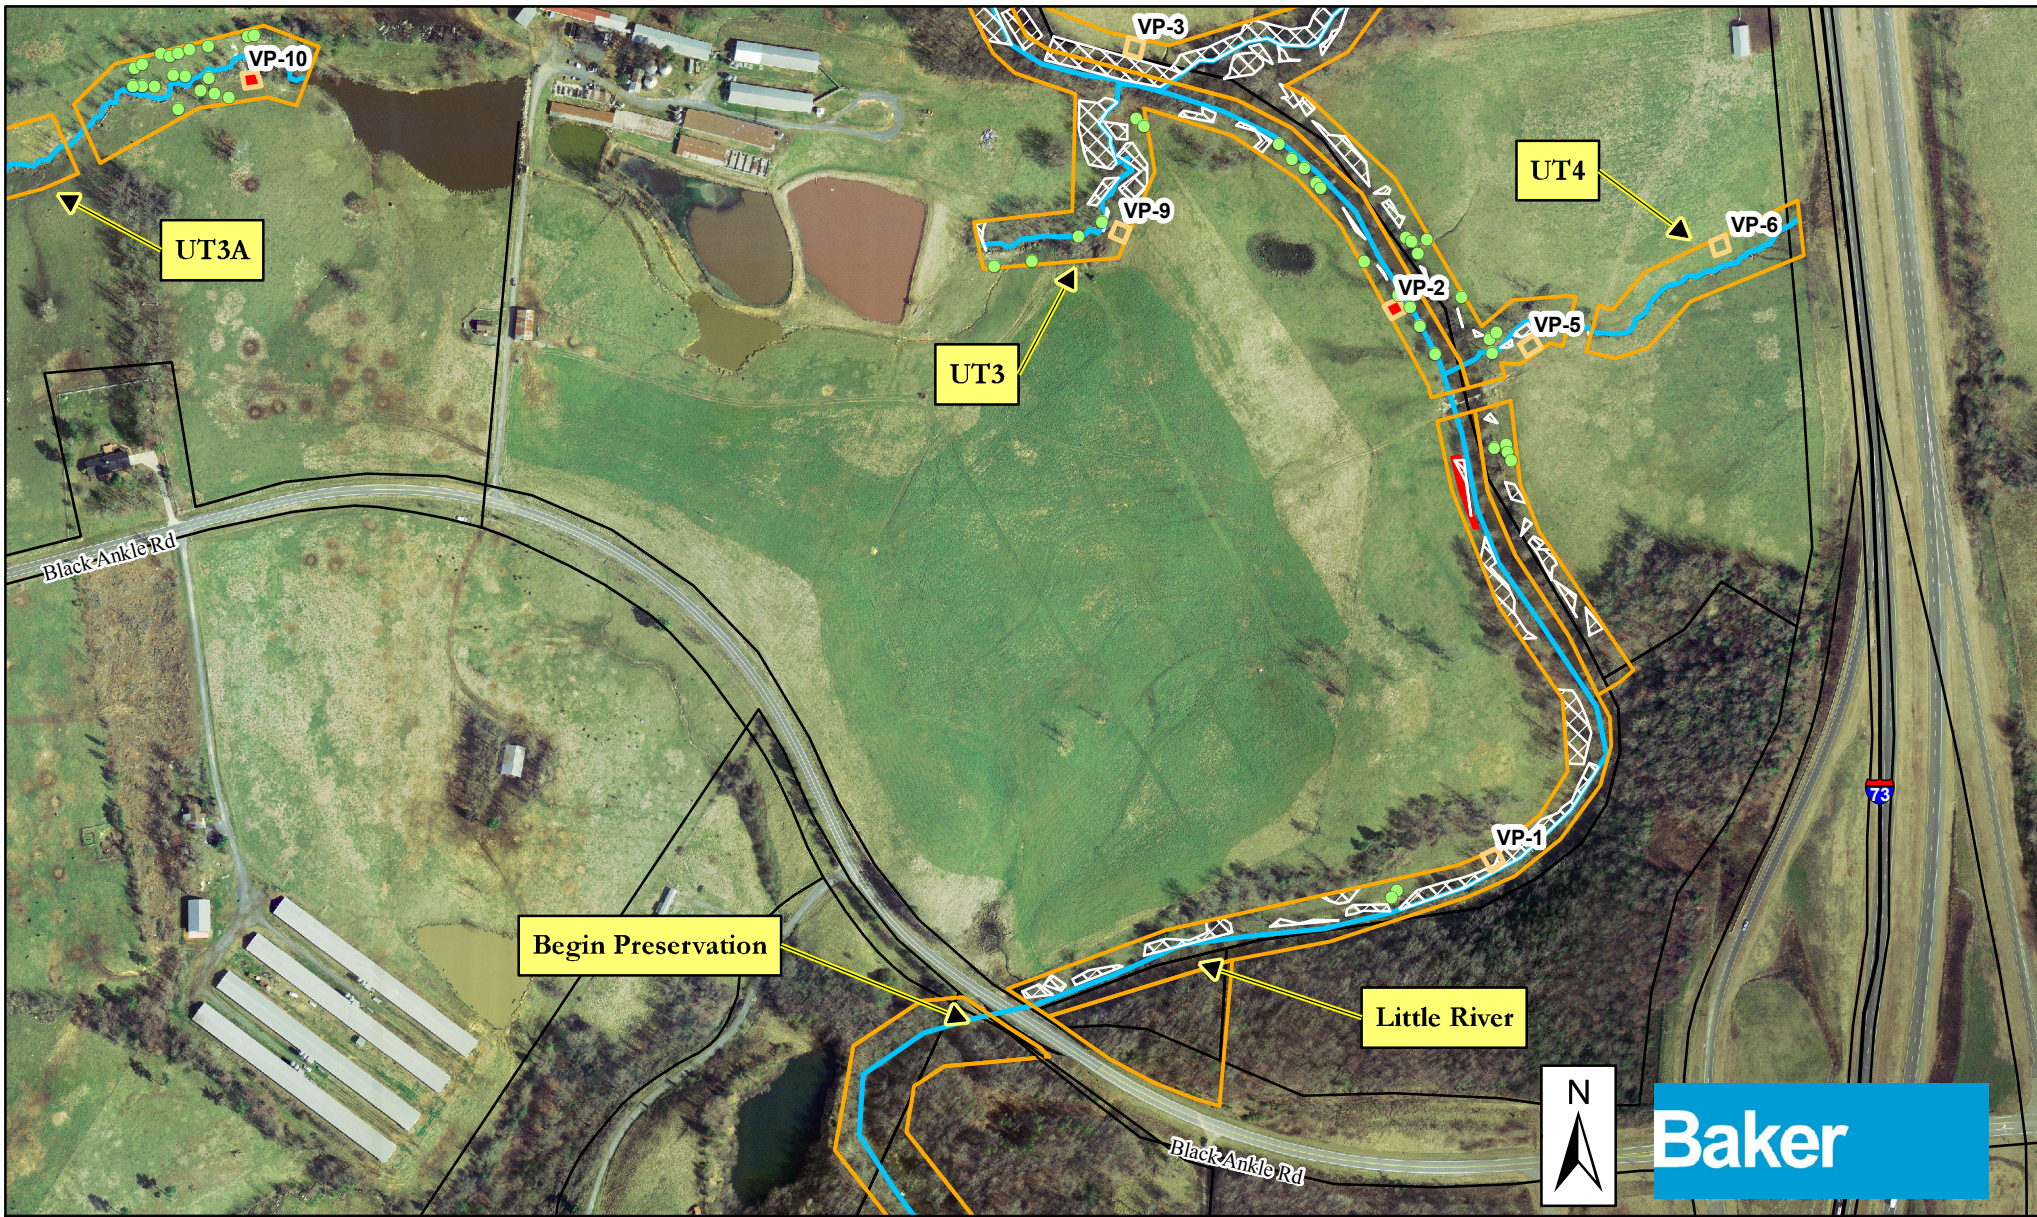
**VEGETATION PROBLEM AREAS**  
**FIGURE C1**

Vegetation plot counts were conducted in November 2013. During this assessment, planted woody stems previously noted to be hand-cut in various plots throughout the project area have been re-evaluated and indicate beaver activity. Though additional beaver activity was noted during Year 4 monitoring in vegetation plots 2, 10, 12, and 16, the damage, as in previous years, has not resulted in significant losses of vegetation. Many previously damaged stems have resprouted and are showing good indicators of growth and are likely to flourish. Areas, where invasive species were noted to be of concern in Year 3, were treated with an herbicidal spot treatment application during 2013. Additionally, in areas where Chinese privet had become established, the physical removal of invasives was used. Some regrowth of invasives in the treated areas were noted during Year 4. Therefore, in order to prevent these species from becoming reestablished, an additional herbicidal spot treatment application may be necessary in subsequent monitoring years. See Figures C1a and C1b in Appendix C for the location of the vegetation plot problem areas.
