MONITORING YEAR 5 ANNUAL REPORT

LITTLE TROUBLESOME CREEK MITIGATION SITE

Rockingham County, NC
NCDEQ Contract 003267
DMS Project Number 94640

Data Collection Period: April 2016-November 2016
Draft Submission Date: November 23, 2016
Final Submission Date: December 19, 2016

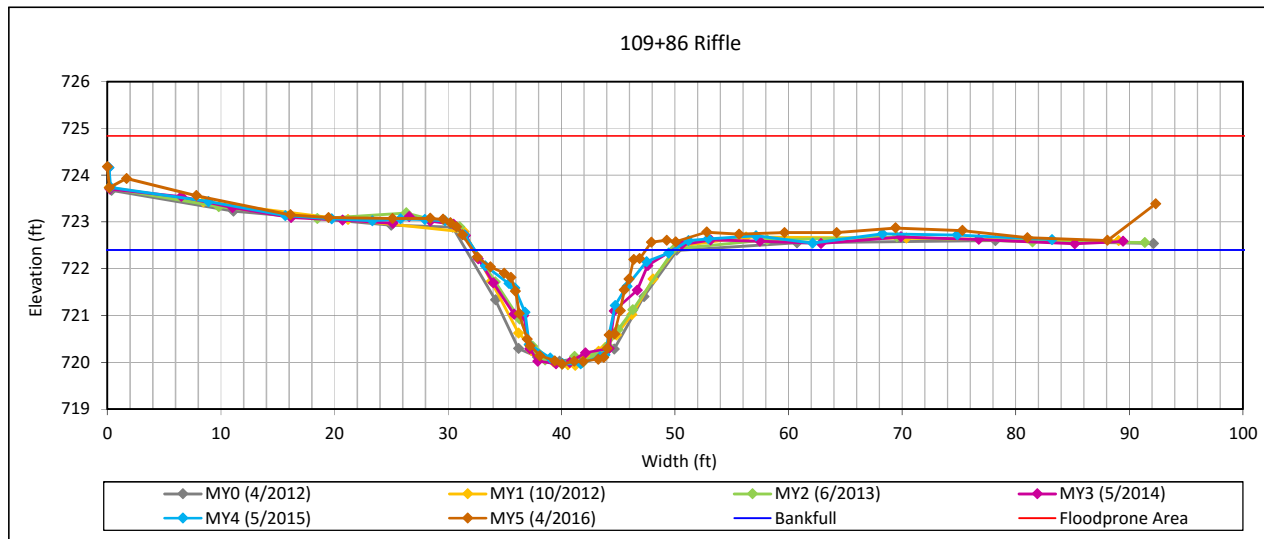
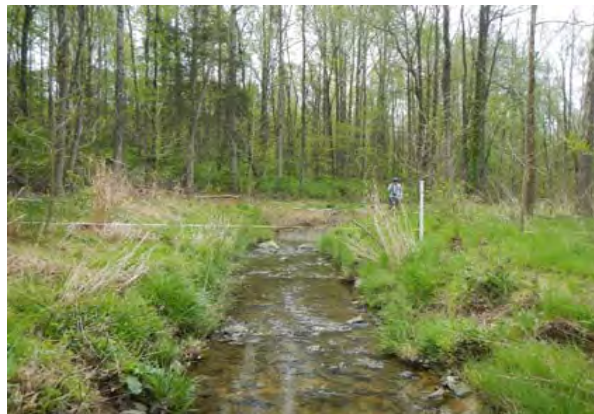
Cross Section 1 - Irvin Creek Reach 1

22.2	x-section area (ft.sq.)
15.2	width (ft)
1.5	mean depth (ft)
2.4	max depth (ft)
16.8	wetted parameter (ft)
1.3	hydraulic radius (ft)
10.4	width-depth ratio
200.0	W flood prone area (ft)
13.1	entrenchment ratio
1.2	low bank height ratio

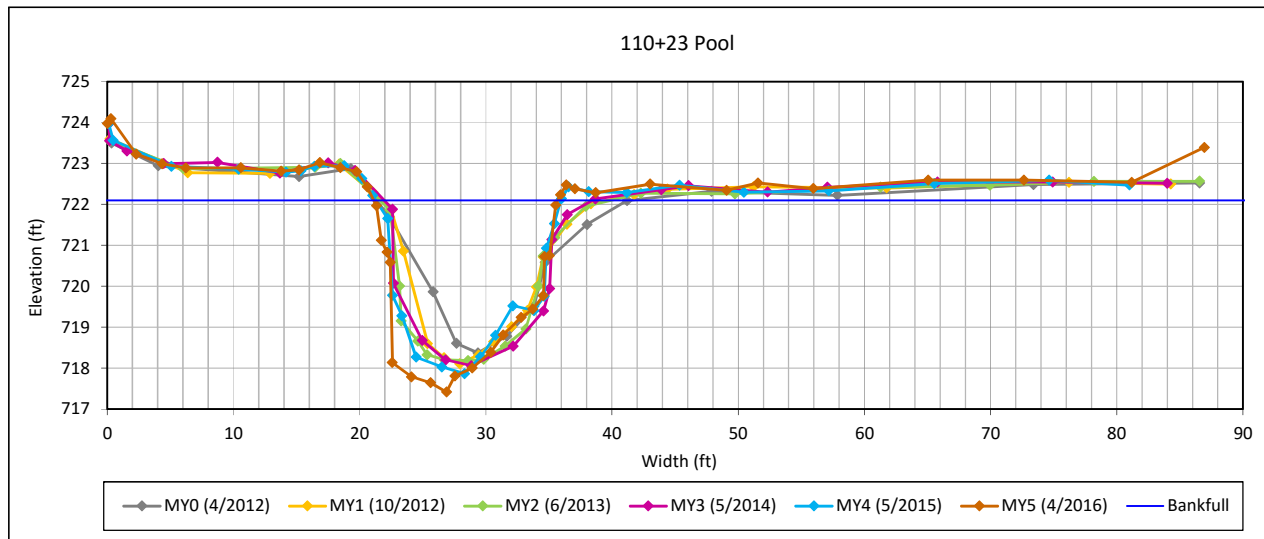
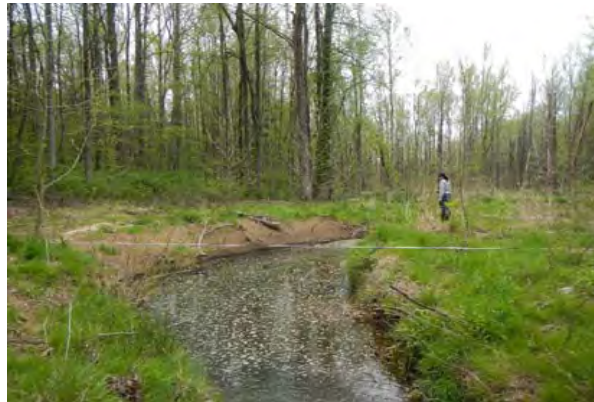
Cross Section 2 - Irvin Creek Reach 1

48.2	x-section area (ft.sq.)
14.6	width (ft)
3.3	mean depth (ft)
4.7	max depth (ft)
19.9	wetted perimeter (ft)
2.4	hydraulic radius (ft)
4.4	width-depth ratio
---	W flood prone area (ft)
---	entrenchment ratio
1.0	low bank height ratio

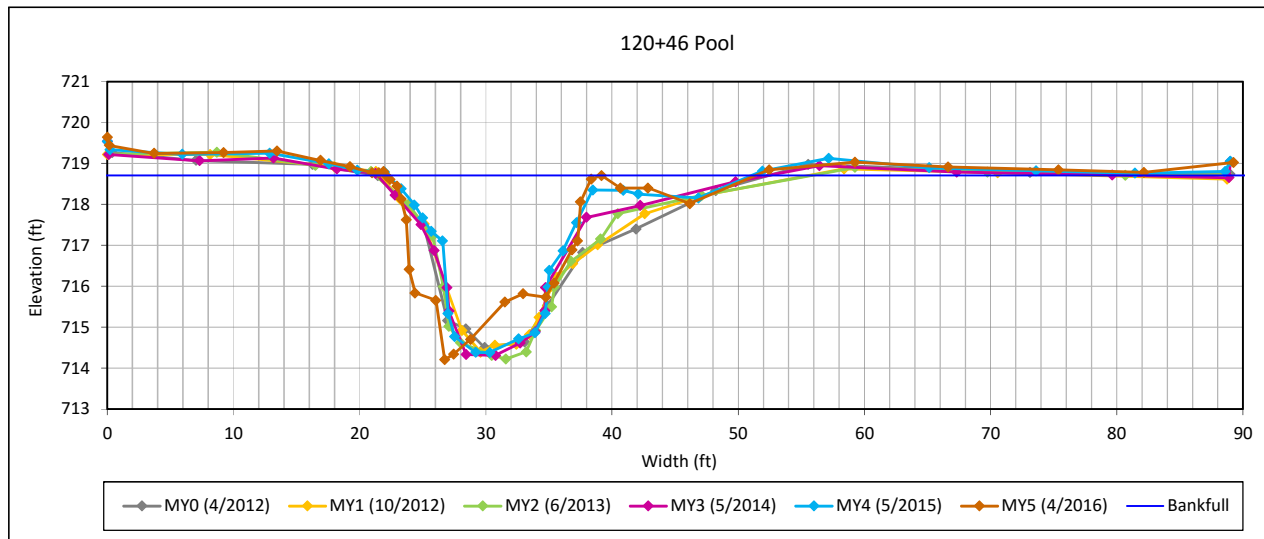
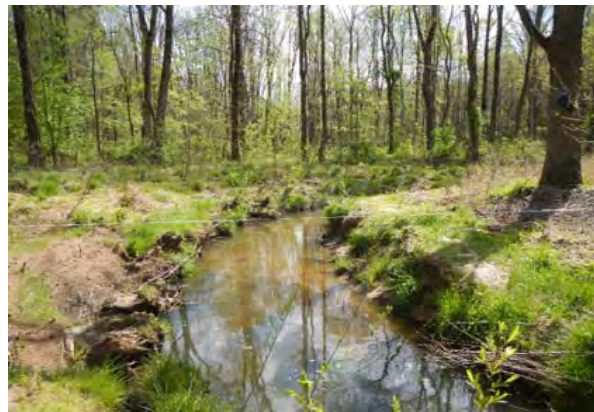
Cross Section 3 - Irvin Creek Reach 1

48.5	x-section area (ft.sq.)
29.3	width (ft)
1.7	mean depth (ft)
4.5	max depth (ft)
33.5	wetted perimeter (ft)
1.4	hydraulic radius (ft)
17.8	width-depth ratio
---	W flood prone area (ft)
---	entrenchment ratio
1.0	low bank height ratio

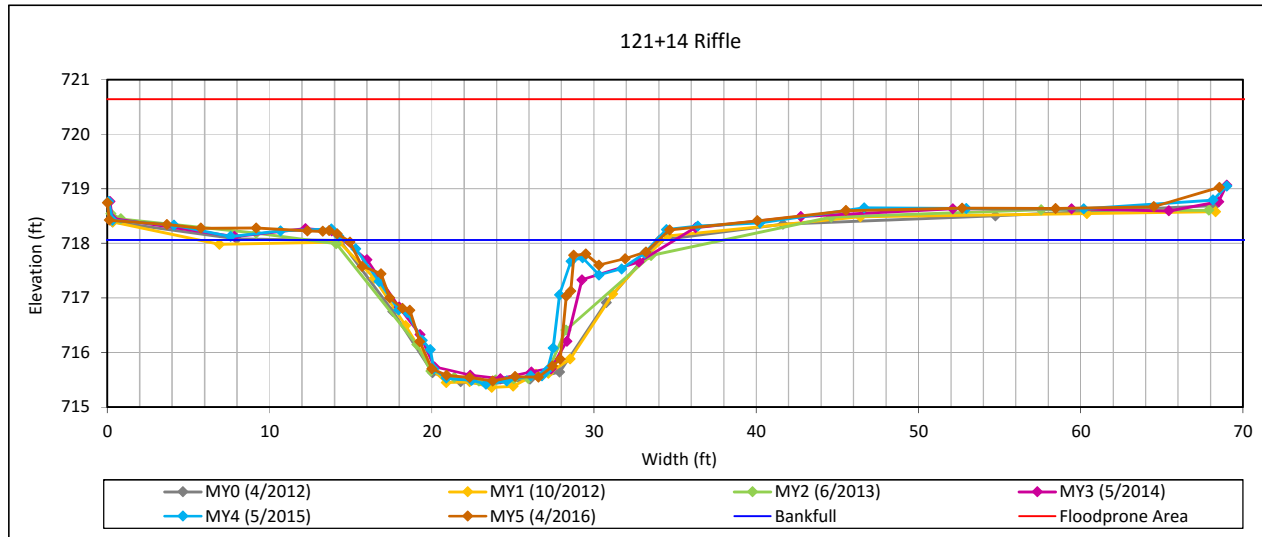
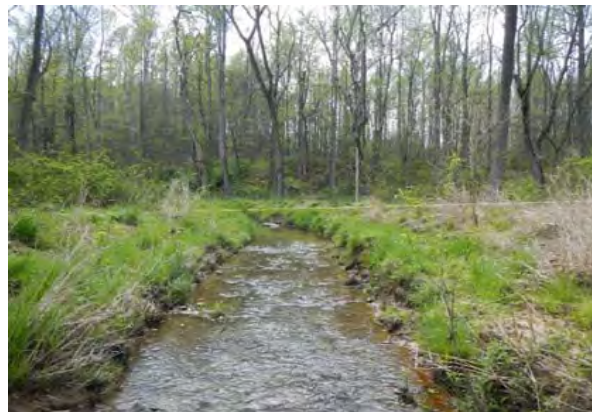
Cross Section 4 - Irvin Creek Reach 1

27.5	x-section area (ft.sq.)
19.2	width (ft)
1.4	mean depth (ft)
2.6	max depth (ft)
21.4	wetted perimeter (ft)
1.3	hydraulic radius (ft)
13.4	width-depth ratio
200.0	W flood prone area (ft)
10.4	entrenchment ratio
1.1	low bank height ratio

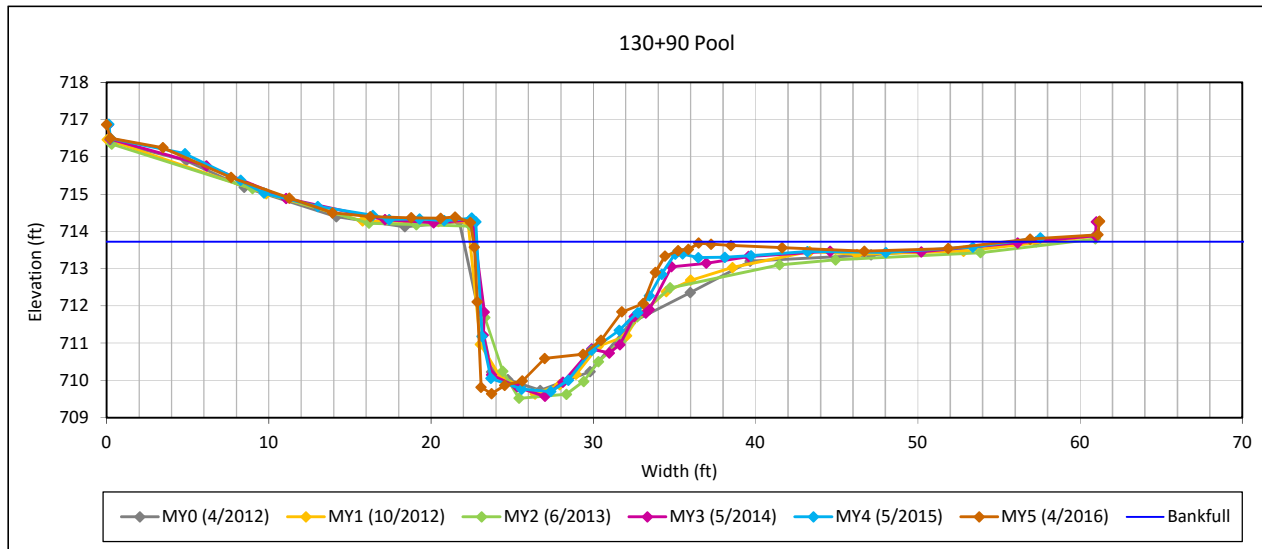
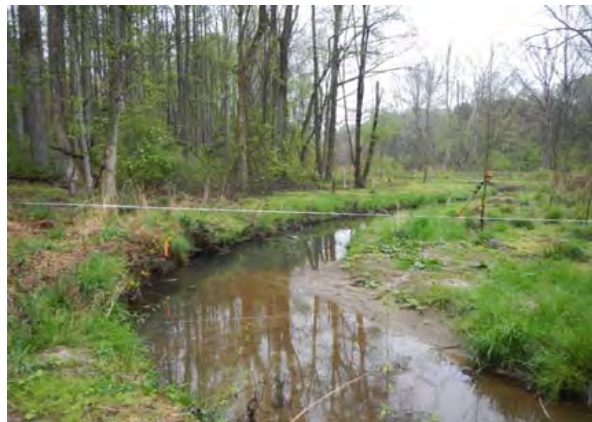
Cross Section 5 - Irvin Creek Reach 2

35.9	x-section area (ft.sq.)
32.9	width (ft)
1.1	mean depth (ft)
4.1	max depth (ft)
37.4	wetted perimeter (ft)
1.0	hydraulic radius (ft)
30.1	width-depth ratio
---	W flood prone area (ft)
---	entrenchment ratio
1.0	low bank height ratio

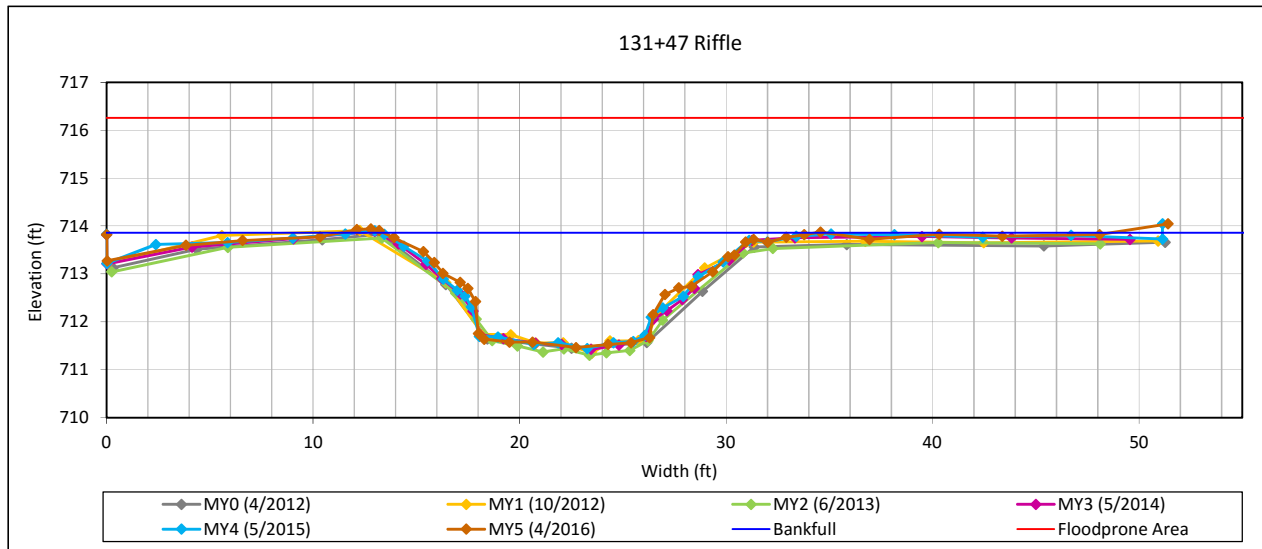
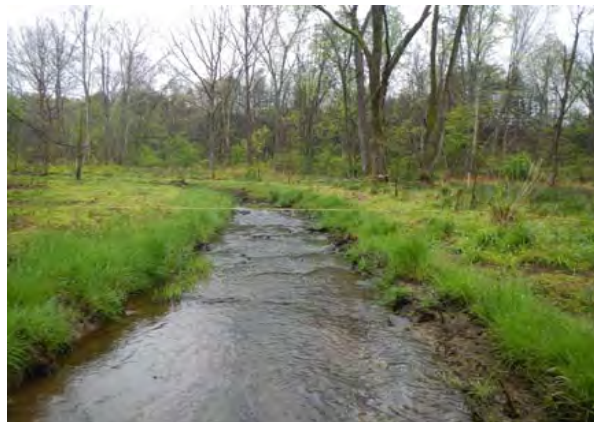
Cross Section 6 - Irvin Creek Reach 2

26.7	x-section area (ft.sq.)
18.6	width (ft)
1.4	mean depth (ft)
2.4	max depth (ft)
20.1	wetted perimeter (ft)
1.3	hydraulic radius (ft)
12.9	width-depth ratio
200.0	W flood prone area (ft)
10.8	entrenchment ratio
1.0	low bank height ratio

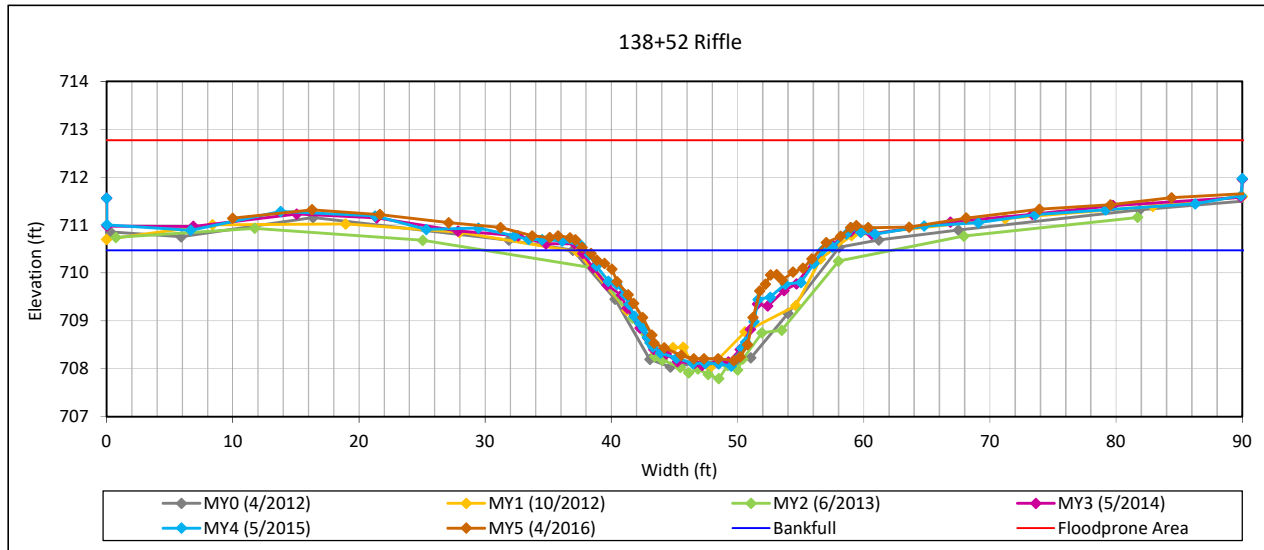
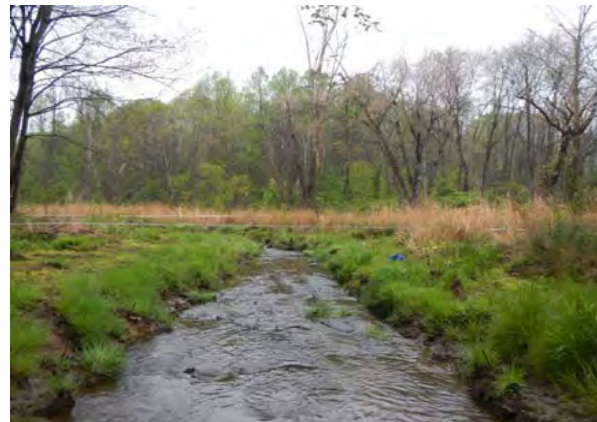
Cross Section 7 - Irvin Creek Reach 2

23.8	x-section area (ft.sq.)
18.5	width (ft)
1.3	mean depth (ft)
2.3	max depth (ft)
19.6	wetted perimeter (ft)
1.2	hydraulic radius (ft)
14.3	width-depth ratio
200.0	W flood prone area (ft)
10.8	entrenchment ratio
1.1	low bank height ratio

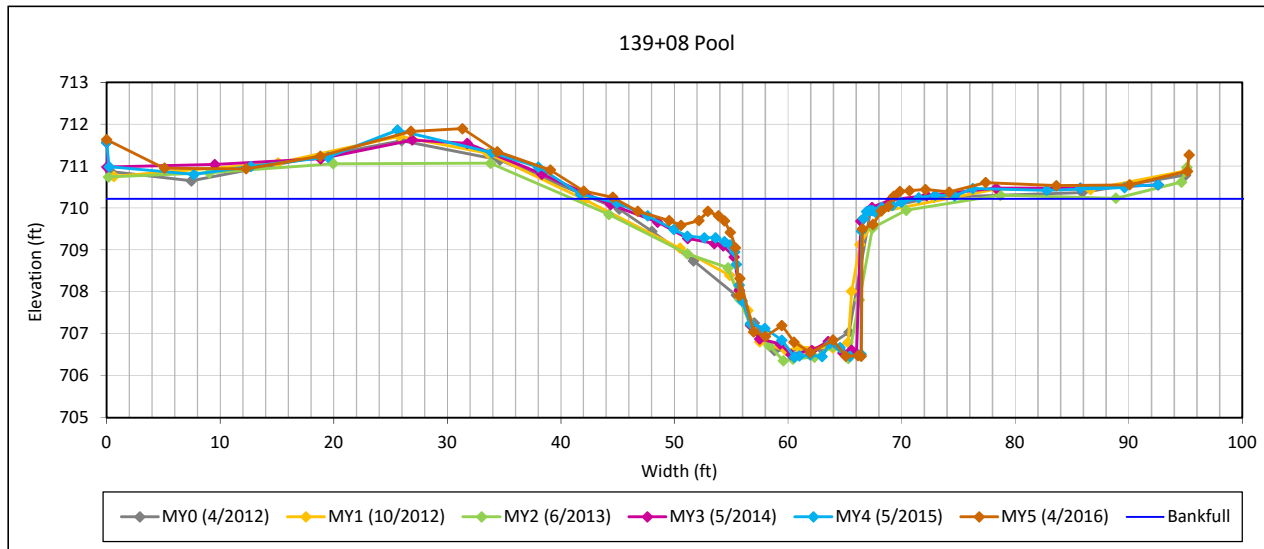
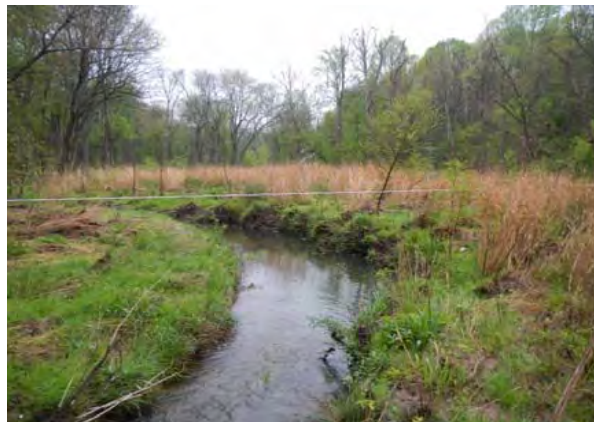
Cross Section 8 - Irvin Creek Reach 2

42.3	x-section area (ft.sq.)
24.4	width (ft)
1.7	mean depth (ft)
3.8	max depth (ft)
29.7	wetted perimeter (ft)
1.4	hydraulic radius (ft)
14.0	width-depth ratio
---	W flood prone area (ft)
---	entrenchment ratio
1.1	low bank height ratio

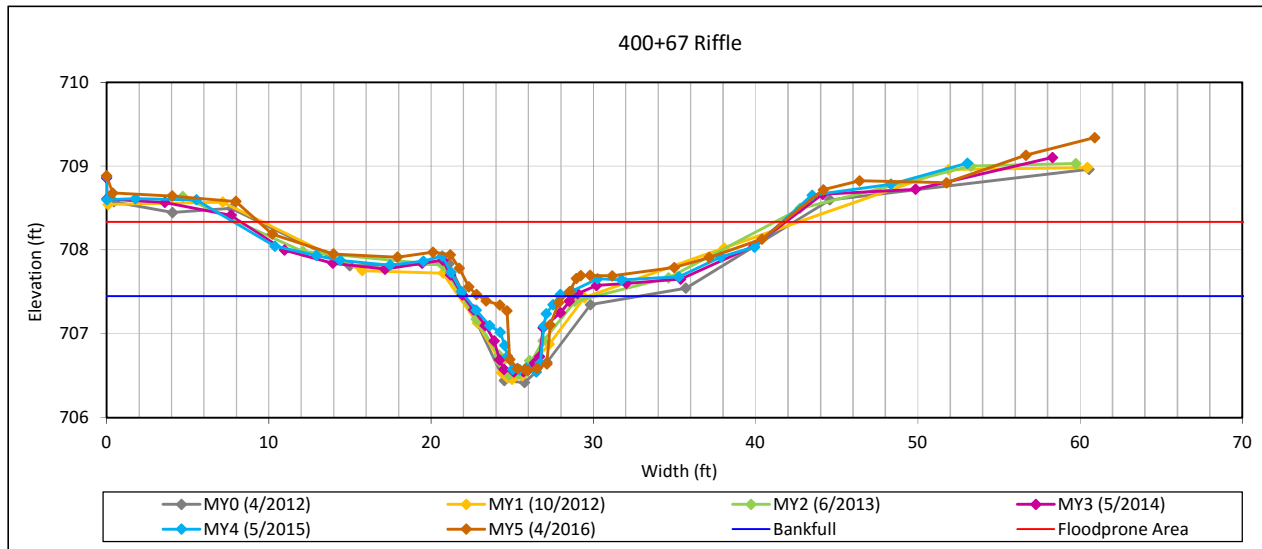
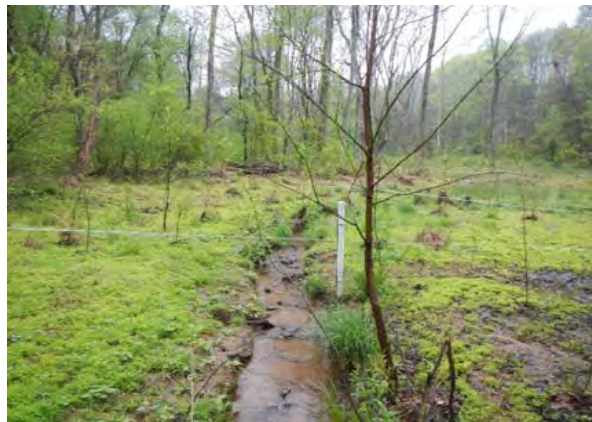
Cross Section 9 - UT1

2.4	x-section area (ft.sq.)
5.3	width (ft)
0.5	mean depth (ft)
0.9	max depth (ft)
6.2	wetted perimeter (ft)
0.4	hydraulic radius (ft)
11.7	width-depth ratio
32.4	W flood prone area (ft)
6.1	entrenchment ratio
1.2	low bank height ratio

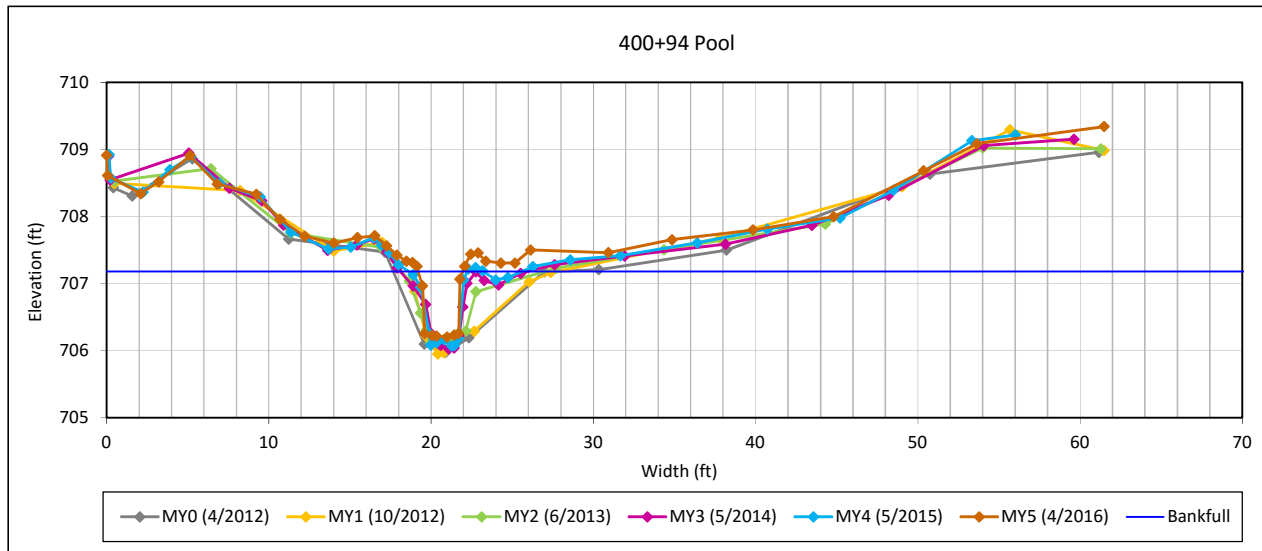
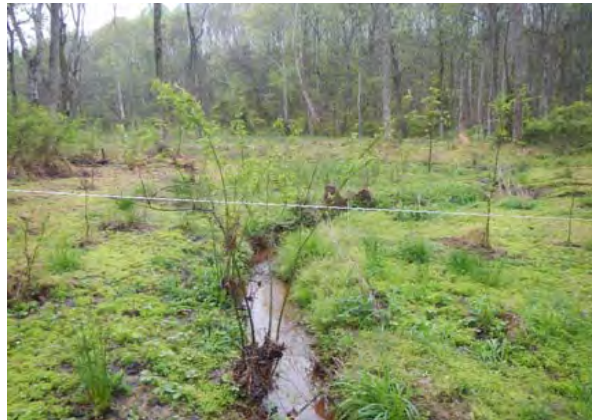
Cross Section 10 - UT1

- 2.1 x-section area (ft.sq.)
- 2.7 width (ft)
- 0.8 mean depth (ft)
- 1.0 max depth (ft)
- 4.2 wetted perimeter (ft)
- 0.5 hydraulic radius (ft)
- 3.5 width-depth ratio
- W flood prone area (ft)
- entrenchment ratio
- 1.2 low bank height ratio

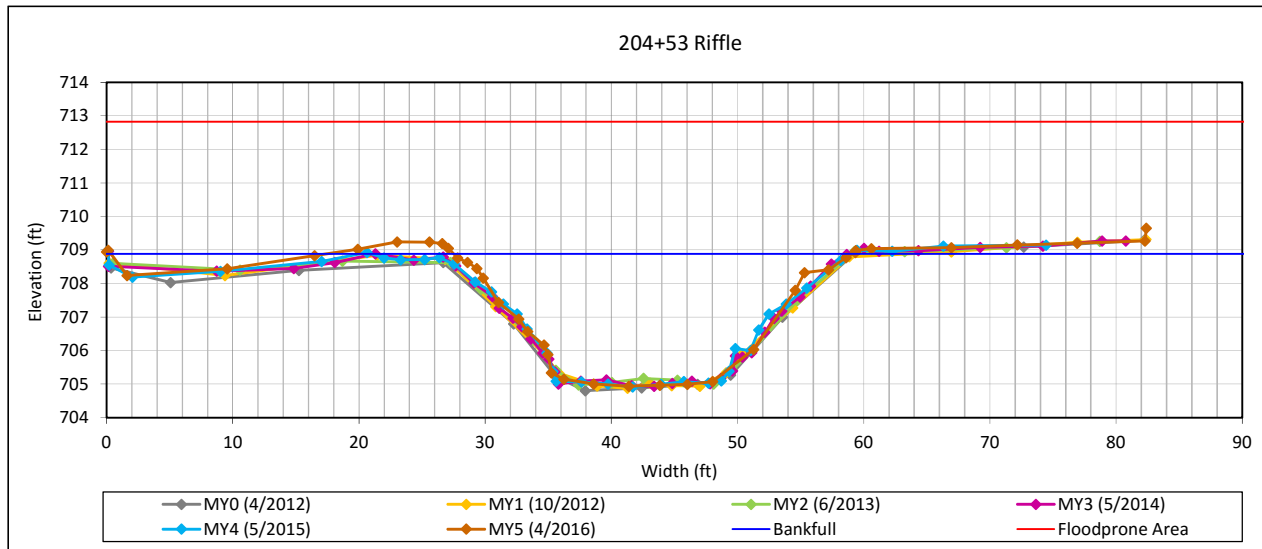
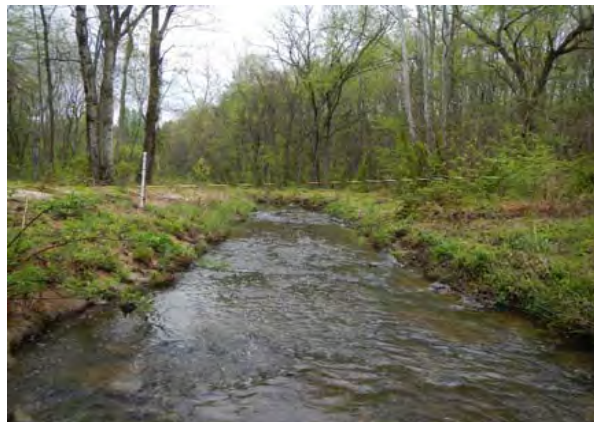
Cross Section 11 - Little Troublesome Creek

80.0	x-section area (ft.sq.)
31.6	width (ft)
2.5	mean depth (ft)
3.9	max depth (ft)
33.5	wetted perimeter (ft)
2.4	hydraulic radius (ft)
12.5	width-depth ratio
200.0	W flood prone area (ft)
6.3	entrenchment ratio
1.0	low bank height ratio

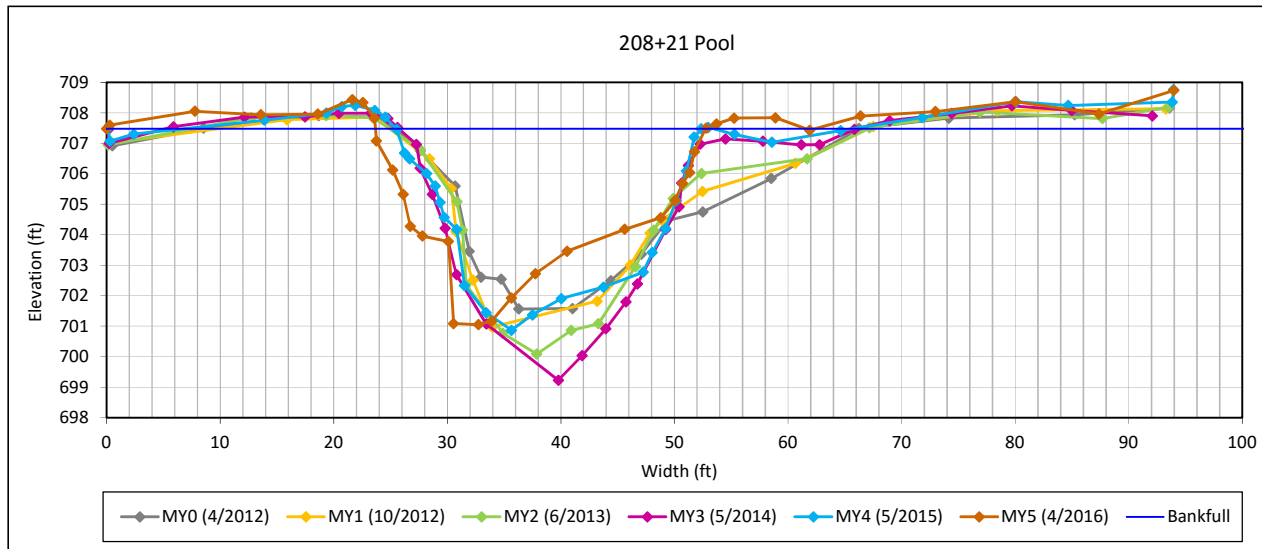
Cross Section 12 - Little Troublesome Creek

108.7	x-section area (ft.sq.)
29.1	width (ft)
3.7	mean depth (ft)
6.4	max depth (ft)
34.5	wetted perimeter (ft)
3.2	hydraulic radius (ft)
7.8	width-depth ratio
---	W flood prone area (ft)
---	entrenchment ratio
1.1	low bank height ratio

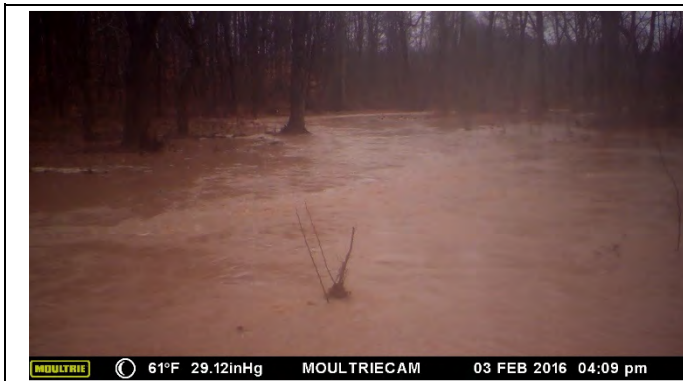
Bankfull Event 1 – Little Troublesome Creek (2/3/2016)

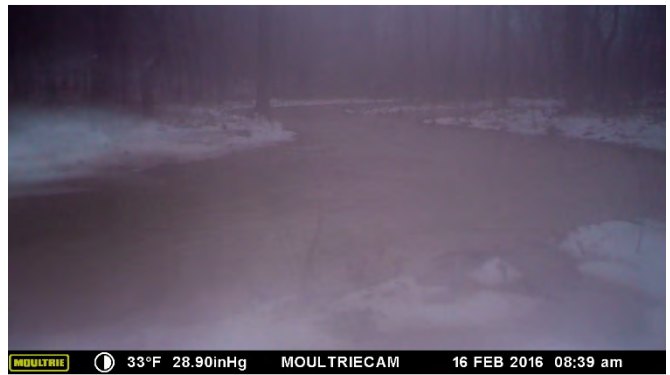
Bankfull Event 2 – Little Troublesome Creek (2/16/2016)

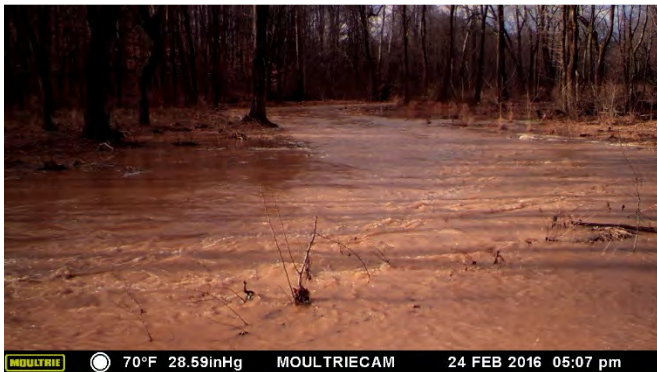
Bankfull Event 3 – Little Troublesome Creek (2/24/2016)

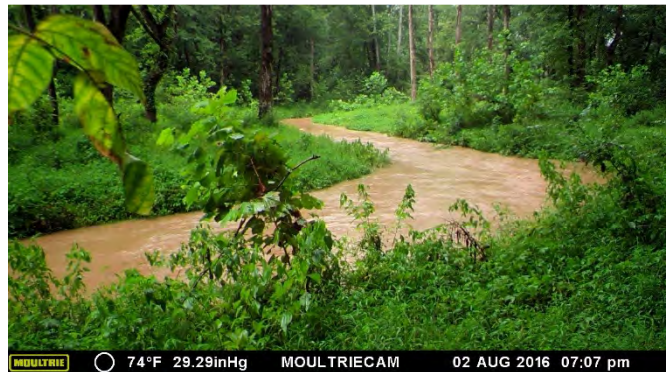
Bankfull Event 4 – Little Troublesome Creek (8/2/2016)

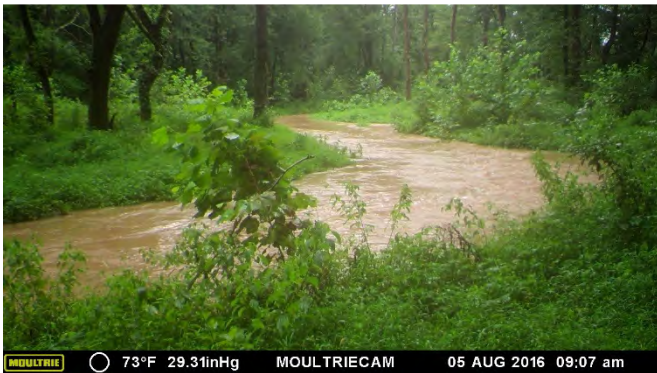
Bankfull Event 5 – Little Troublesome Creek (8/5/2016)

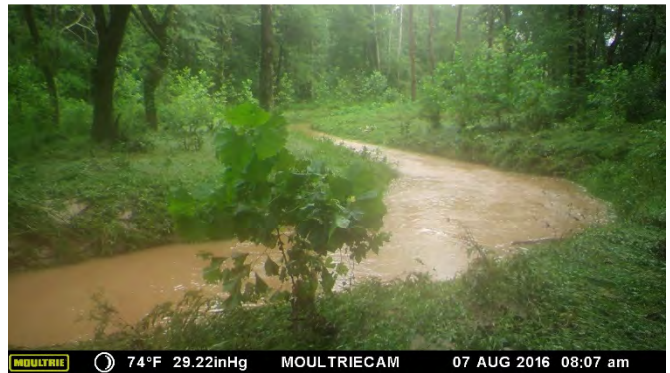
Bankfull Event 6 – Little Troublesome Creek (8/7/2016)

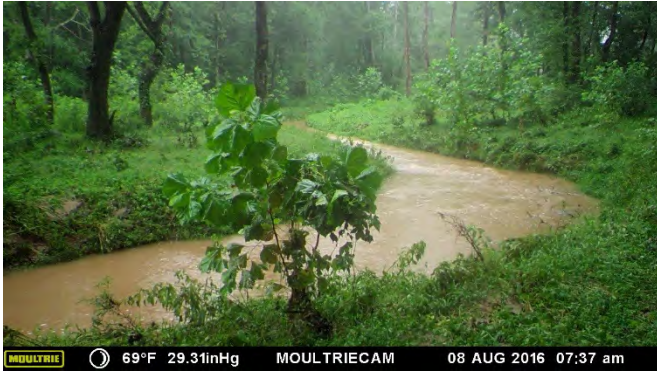
Bankfull Event 7 – Little Troublesome Creek (8/8/2016)

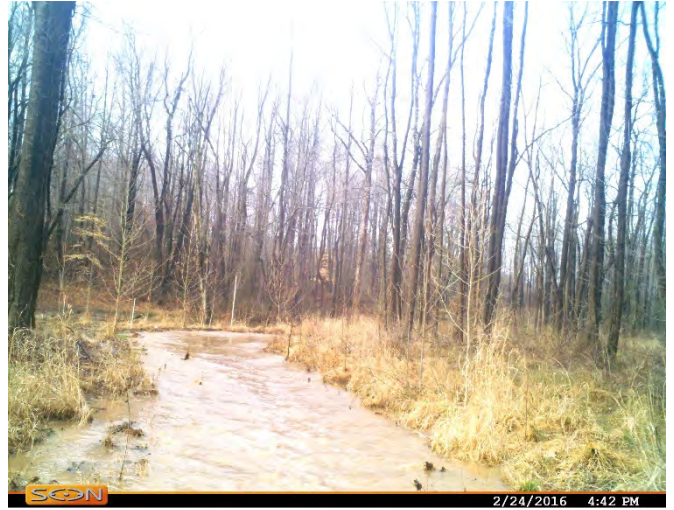
Bankfull Event 1 – Irvin Creek (2/24/2016)
