ANNUAL MONITORING REPORT

YEAR 2 (2008)

LLOYD STREAM AND WETLAND RESTORATION SITE ONslow COUNTY, NORTH CAROLINA

November 2008

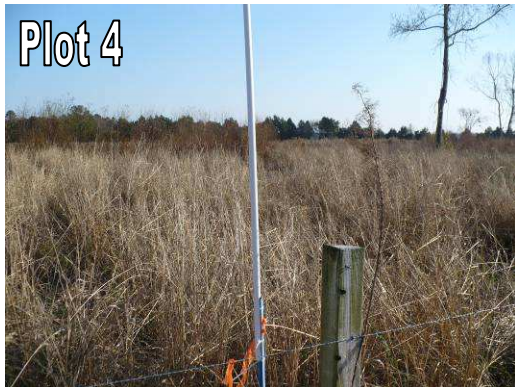
Plot 4

Vegetation sampling across the Site was above the required average density with an overall average of 599 planted stems per acre. A small area of poor vegetation growth is located near groundwater monitoring Gauge 4, most likely due to a lack of nutrients in the soil after construction. This area will continue to be monitored; however, is expected to recover naturally. In addition, four small (less than 2 feet tall) privet bushes near Station 16+00 of Tributary 1 were treated with a 2% solution of glyphosate herbicide in July. No other vegetation problem areas were noted during the Year 2 (2008) monitoring season.
