ANNUAL MONITORING REPORT

YEAR 4 (2010)

CONTRACT D06003-1

LLOYD STREAM AND WETLAND RESTORATION SITE ONSLow COUNTY, NORTH CAROLINA

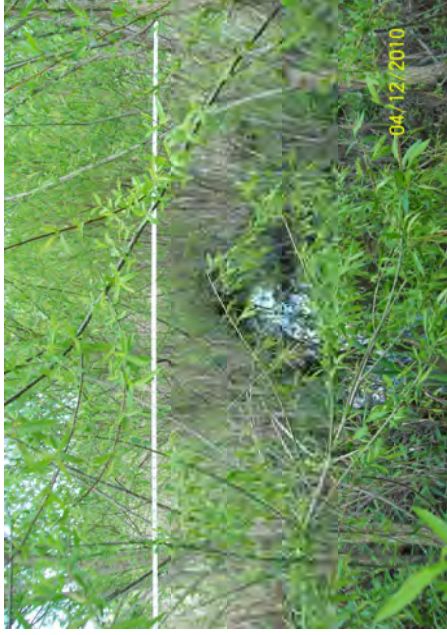
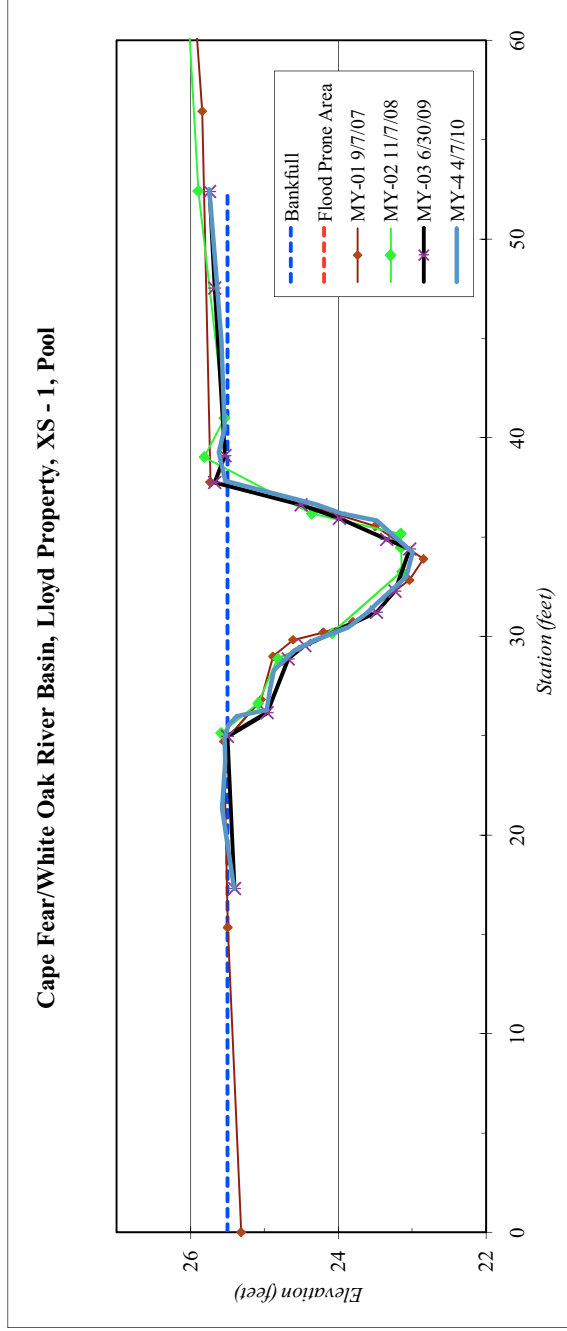
River Basin:	Cape Fear/White Oak
Watershed:	Lloyd Property
XS ID	XS - 1, Pool
Drainage Area (sq mi):	0.67
Date:	4/7/2010
Field Crew:	Dean, Perkinson

SUMMARY DATA	
Bankfull Elevation:	25.5
Bankfull Cross-Sectional Area:	17.3
Bankfull Width:	12.4
Flood Prone Area Elevation:	-
Flood Prone Width:	-
Max Depth at Bankfull:	2.5
Mean Depth at Bankfull:	1.4
W/D Ratio:	-
Entrenchment Ratio:	-
Bank Height Ratio:	-

Stream Type	E/C
-------------	-----

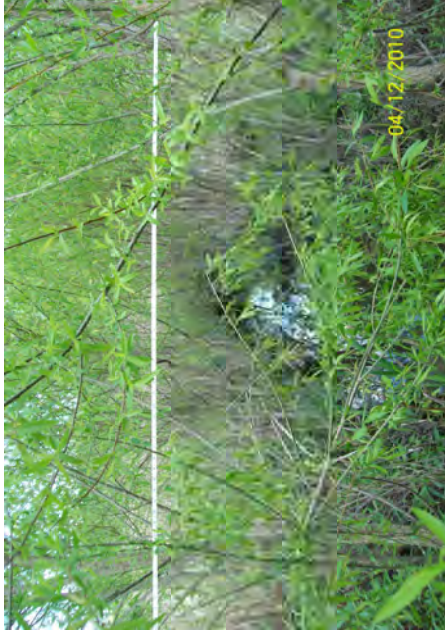
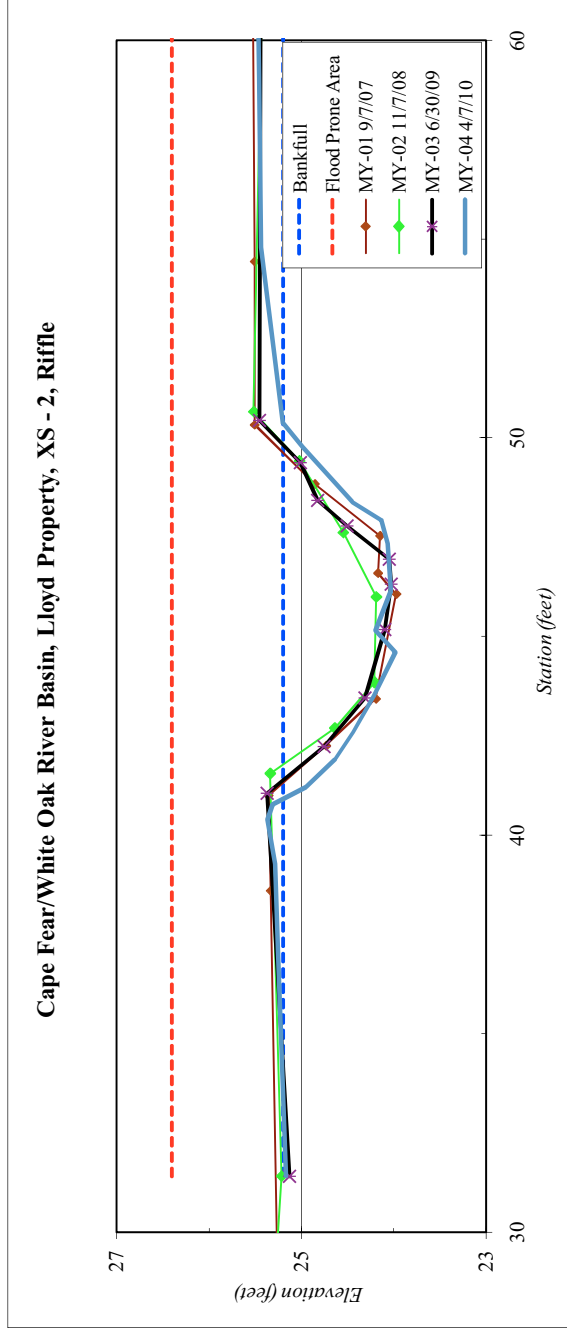
River Basin:	Cape Fear/White Oak
Watershed:	Lloyd Property
XS ID	XS - 2, Riffle
Drainage Area (sq mi):	0.67
Date:	4/7/2010
Field Crew:	Dean, Perkinson

SUMMARY DATA	
Bankfull Elevation:	25.2
Bankfull Cross-Sectional Area:	7.6
Bankfull Width:	9.5
Flood Prone Area Elevation:	26.4
Flood Prone Width:	150.0
Max Depth at Bankfull:	1.2
Mean Depth at Bankfull:	0.8
W/D Ratio:	11.9
Entrenchment Ratio:	15.8
Bank Height Ratio:	1.0

Stream Type E/C

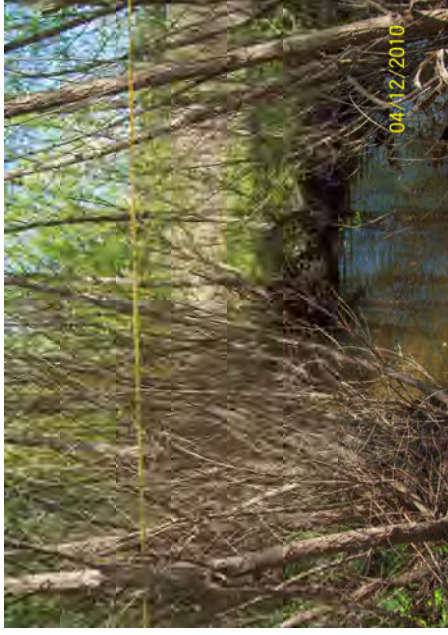
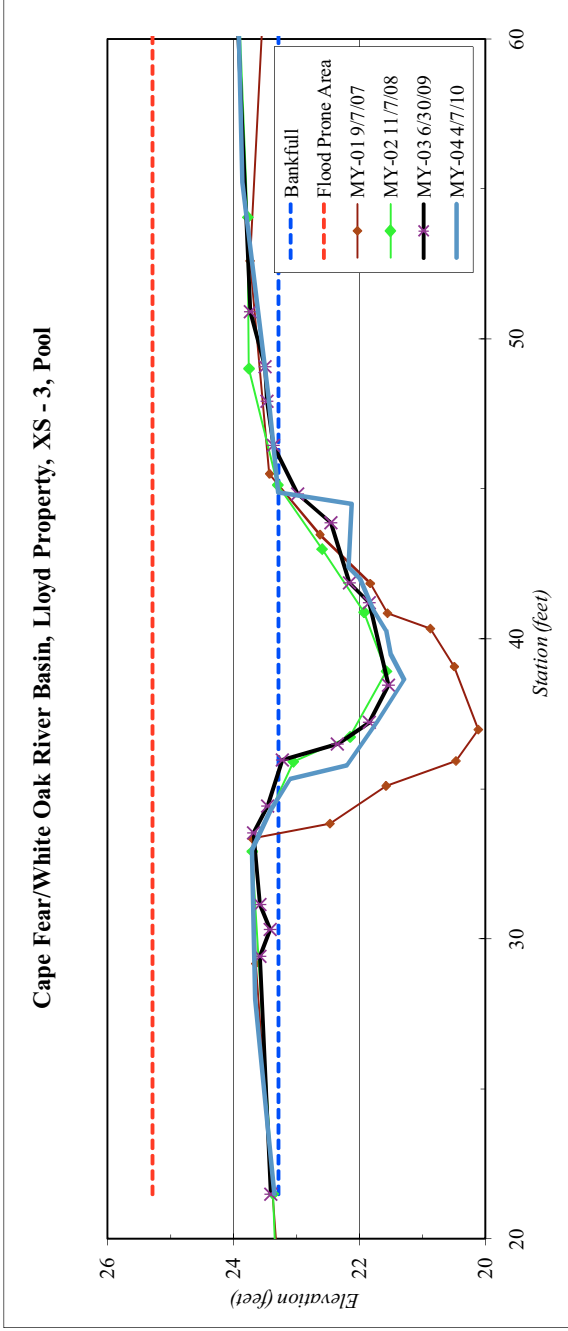
River Basin:	Cape Fear/White Oak
Watershed:	Lloyd Property
XS ID	XS - 3, Pool
Drainage Area (sq mi):	0.67
Date:	4/7/2010
Field Crew:	Dean, Perkinson

SUMMARY DATA	
Bankfull Elevation:	23.3
Bankfull Cross-Sectional Area:	13.4
Bankfull Width:	10.2
Flood Prone Area Elevation:	-
Flood Prone Width:	-
Max Depth at Bankfull:	2.0
Mean Depth at Bankfull:	1.3
W/D Ratio:	-
Entrenchment Ratio:	-
Bank Height Ratio:	-

Stream Type: C

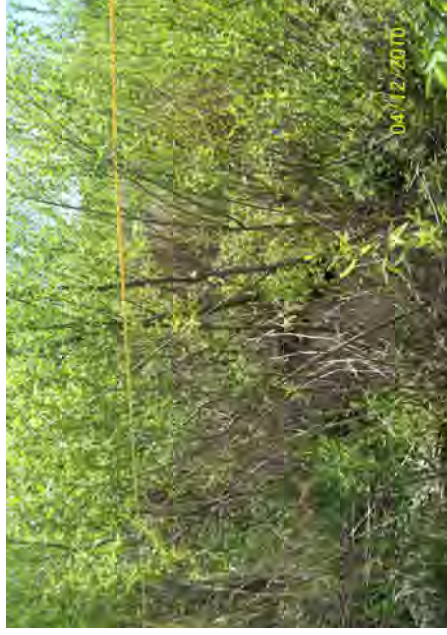
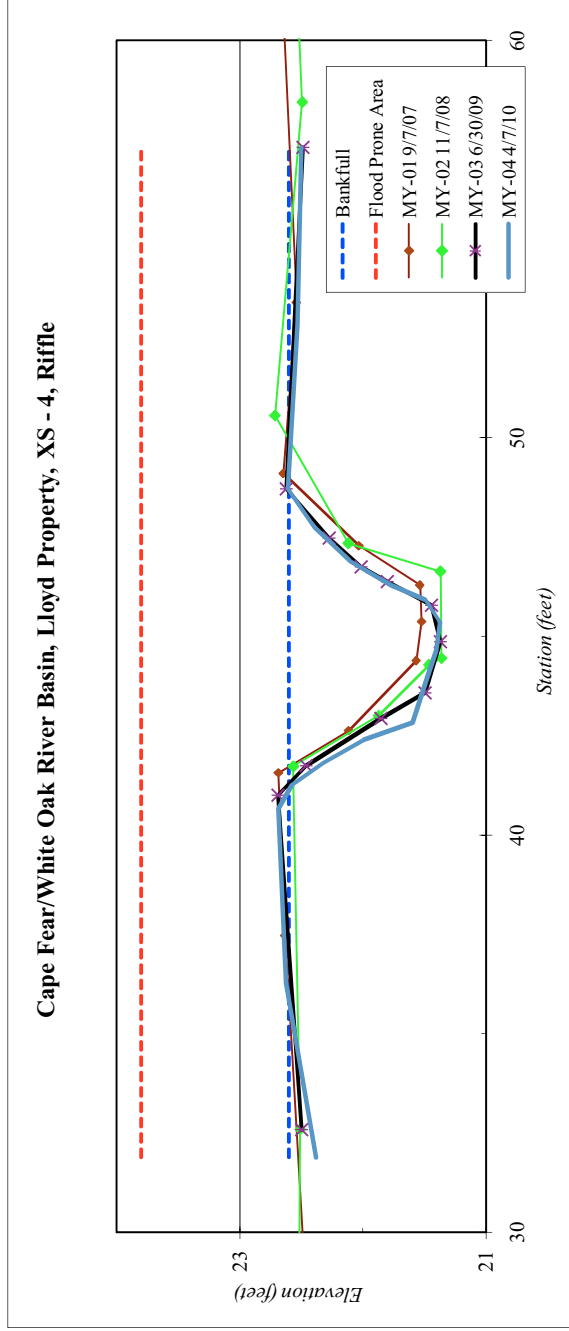
River Basin:	Cape Fear/White Oak
Watershed:	Lloyd Property
XS ID	XS - 4, Riffle
Drainage Area (sq mi):	0.67
Date:	4/7/2010
Field Crew:	Dean, Perkinson

SUMMARY DATA	
Bankfull Elevation:	22.6
Bankfull Cross-Sectional Area:	5.4
Bankfull Width:	7.5
Flood Prone Area Elevation:	23.8
Flood Prone Width:	150.0
Max Depth at Bankfull:	1.2
Mean Depth at Bankfull:	0.7
W/D Ratio:	10.4
Entrenchment Ratio:	20.0
Bank Height Ratio:	1.0

Stream Type E/C

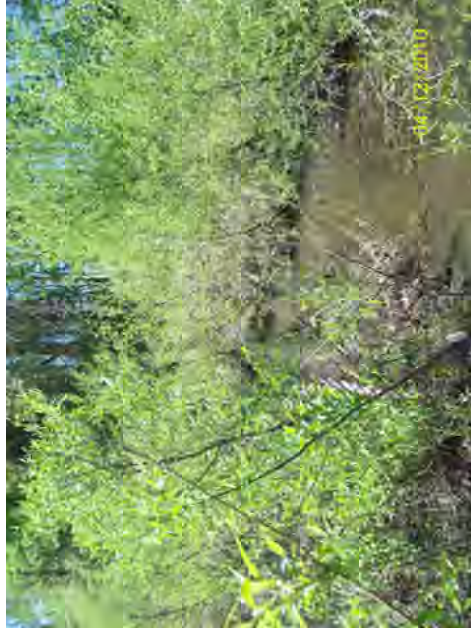
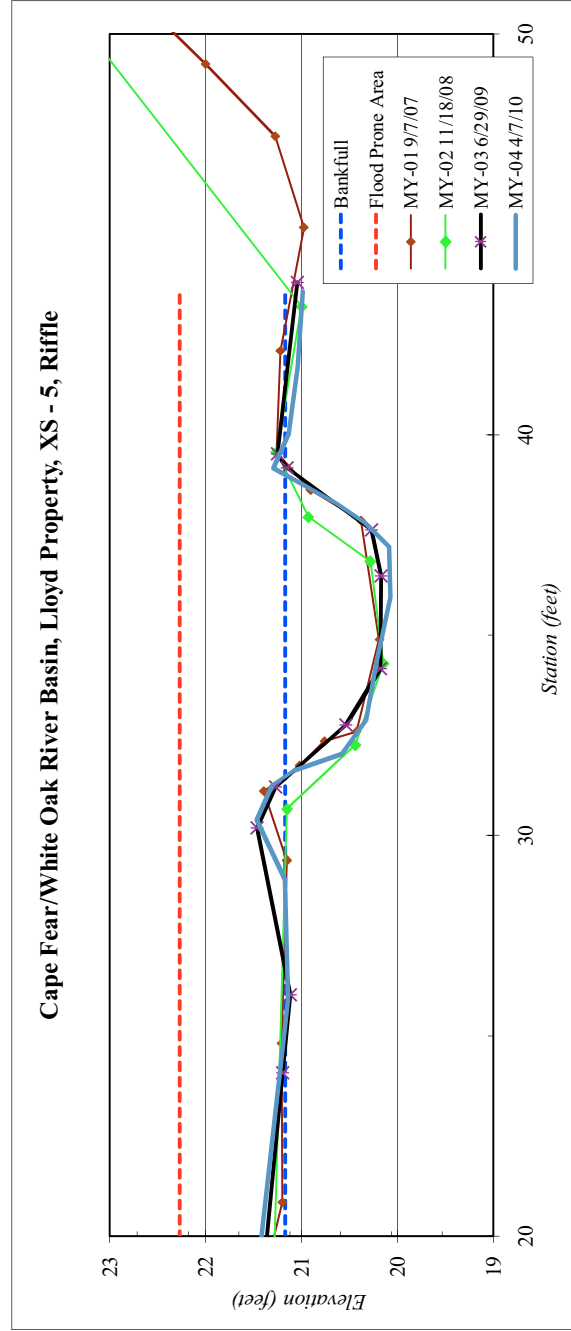
River Basin:	Cape Fear/White Oak
Watershed:	Lloyd Property
XS ID	XS - 5, Riffle
Drainage Area (sq mi):	0.55
Date:	4/7/2010
Field Crew:	Dean, Perkinson

SUMMARY DATA	
Bankfull Elevation:	21.2
Bankfull Cross-Sectional Area:	6.2
Bankfull Width:	7.6
Flood Prone Area Elevation:	22.3
Flood Prone Width:	38.0
Max Depth at Bankfull:	1.1
Mean Depth at Bankfull:	0.8
W/D Ratio:	9.3
Entrenchment Ratio:	5.0
Bank Height Ratio:	1.0

Stream Type E/C

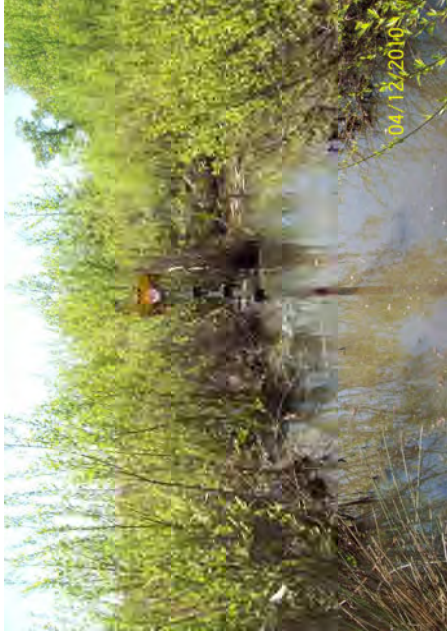
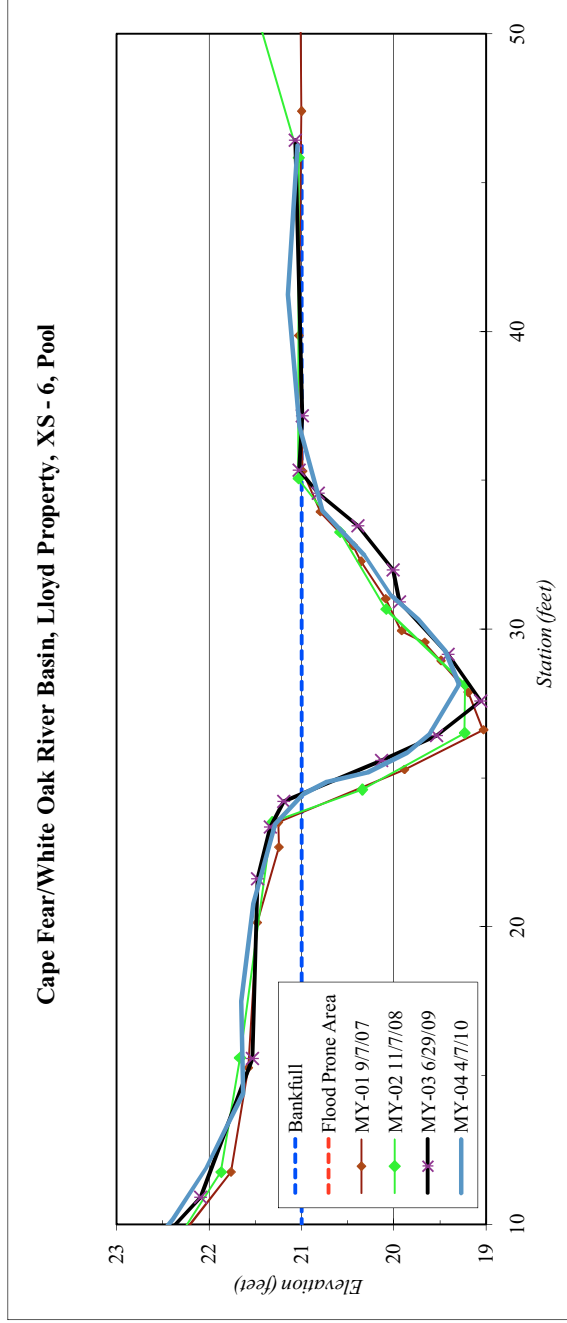
River Basin:	Cape Fear/White Oak
Watershed:	Lloyd Property
XS ID	XS - 6, Pool
Drainage Area (sq mi):	0.55
Date:	4/7/2010
Field Crew:	Dean, Perkinson

SUMMARY DATA	
Bankfull Elevation:	21.0
Bankfull Cross-Sectional Area:	10.6
Bankfull Width:	12.2
Flood Prone Area Elevation:	-
Flood Prone Width:	-
Max Depth at Bankfull:	1.7
Mean Depth at Bankfull:	0.9
W / D Ratio:	-
Entrenchment Ratio:	-
Bank Height Ratio:	-

Stream Type: C/E

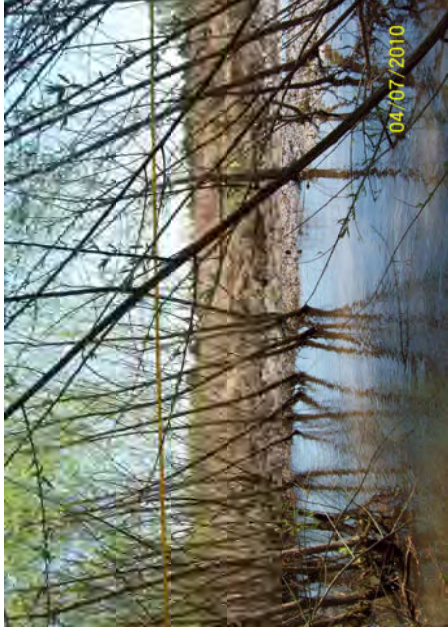
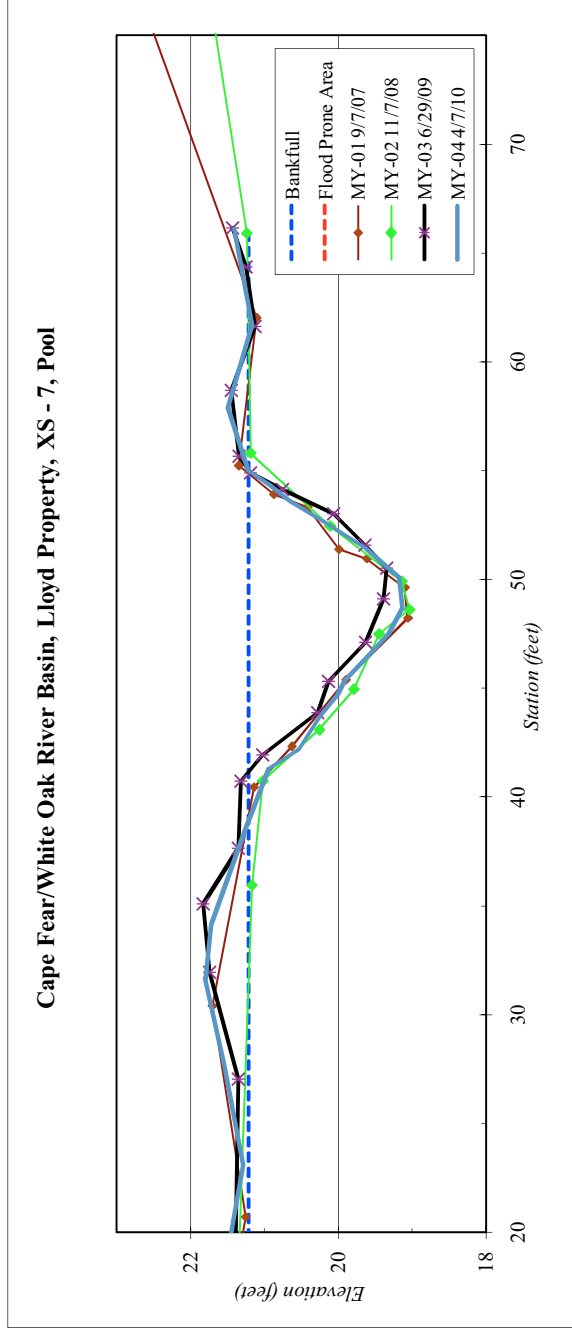
River Basin:	Cape Fear/White Oak
Watershed:	Lloyd Property
XS ID	XS - 7, Pool
Drainage Area (sq mi):	0.55
Date:	4/7/2010
Field Crew:	Dean, Perkinson

SUMMARY DATA	
Bankfull Elevation:	21.2
Bankfull Cross-Sectional Area:	17.7
Bankfull Width:	16.1
Flood Prone Area Elevation:	-
Flood Prone Width:	-
Max Depth at Bankfull:	2.1
Mean Depth at Bankfull:	1.1
W/D Ratio:	-
Entrenchment Ratio:	-
Bank Height Ratio:	-

Stream Type: E/C

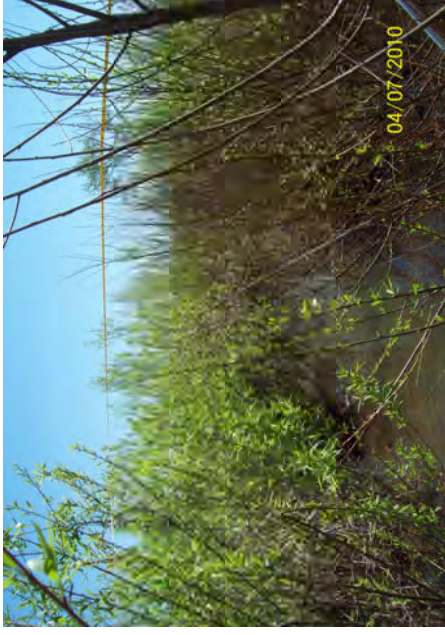
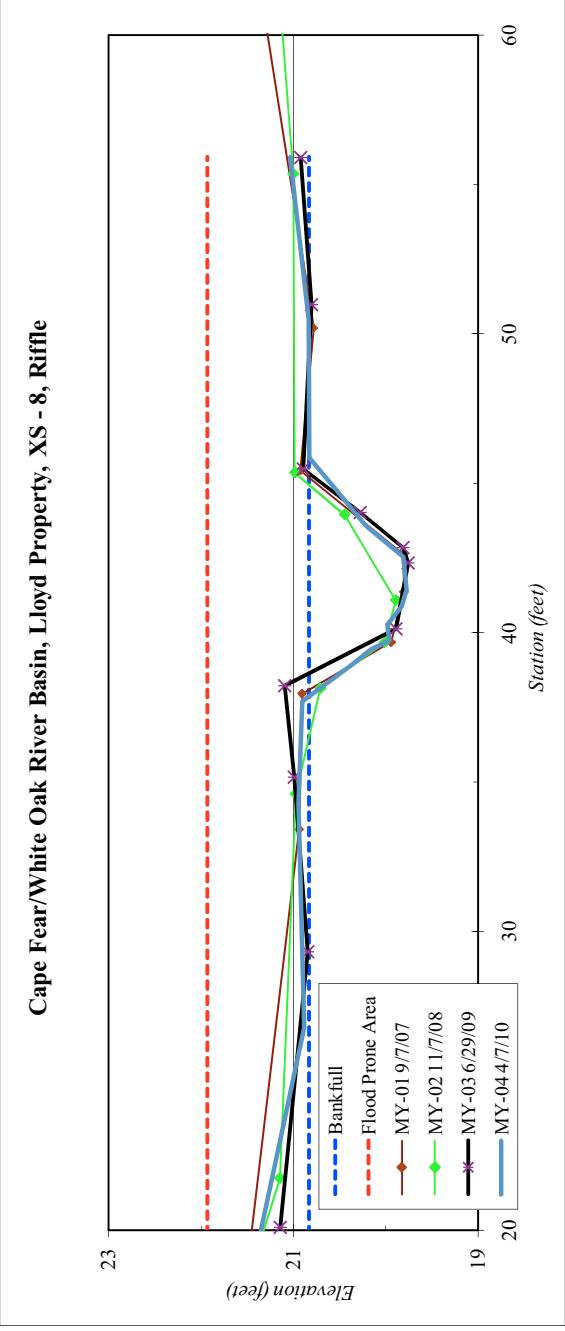
River Basin:	Cape Fear/White Oak
Watershed:	Lloyd Property
XS ID	XS - 8, Riffle
Drainage Area (sq mi):	0.55
Date:	4/7/2010
Field Crew:	Dean, Perkinson

SUMMARY DATA	
Bankfull Elevation:	20.8
Bankfull Cross-Sectional Area:	5.1
Bankfull Width:	8.0
Flood Prone Area Elevation:	21.9
Flood Prone Width:	80.0
Max Depth at Bankfull:	1.1
Mean Depth at Bankfull:	0.6
W/D Ratio:	12.5
Entrenchment Ratio:	10.0
Bank Height Ratio:	1.0

Stream Type E

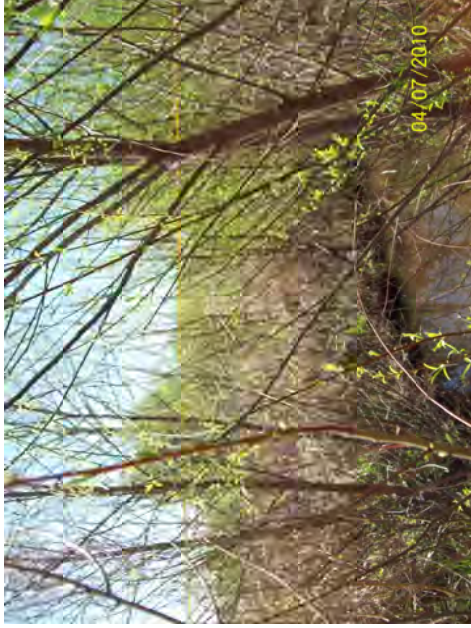
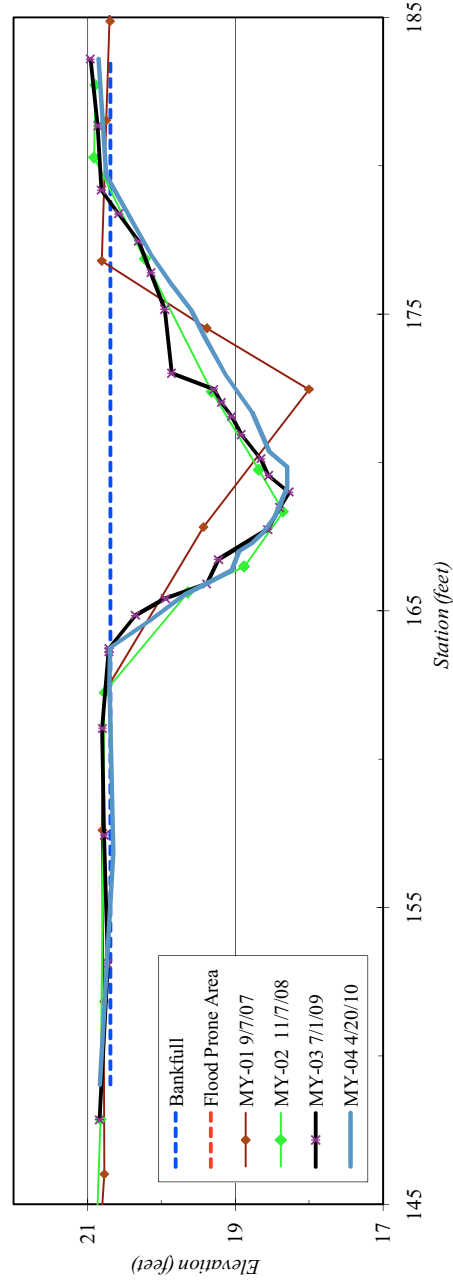
River Basin:	Cape Fear/White Oak
Watershed:	Lloyd Property
XS ID	XS - 9, Pool
Drainage Area (sq mi):	1.2
Date:	4/7/2010
Field Crew:	Dean, Perkinson

SUMMARY DATA	
Bankfull Elevation:	20.7
Bankfull Cross-Sectional Area:	20.5
Bankfull Width:	15.7
Flood Prone Area Elevation:	-
Flood Prone Width:	-
Max Depth at Bankfull:	2.4
Mean Depth at Bankfull:	1.3
W/D Ratio:	-
Entrenchment Ratio:	-
Bank Height Ratio:	-

Stream Type: E/C

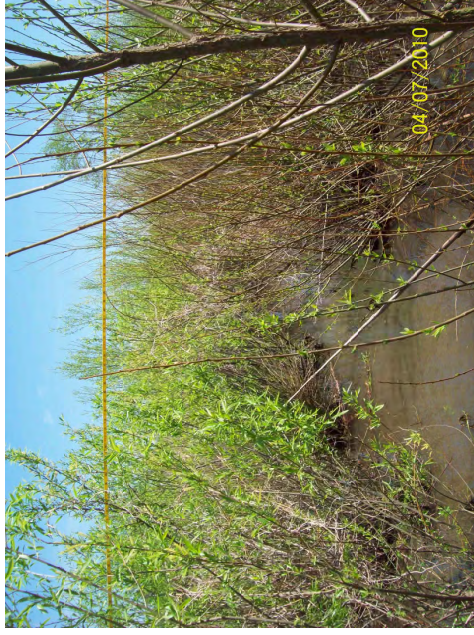
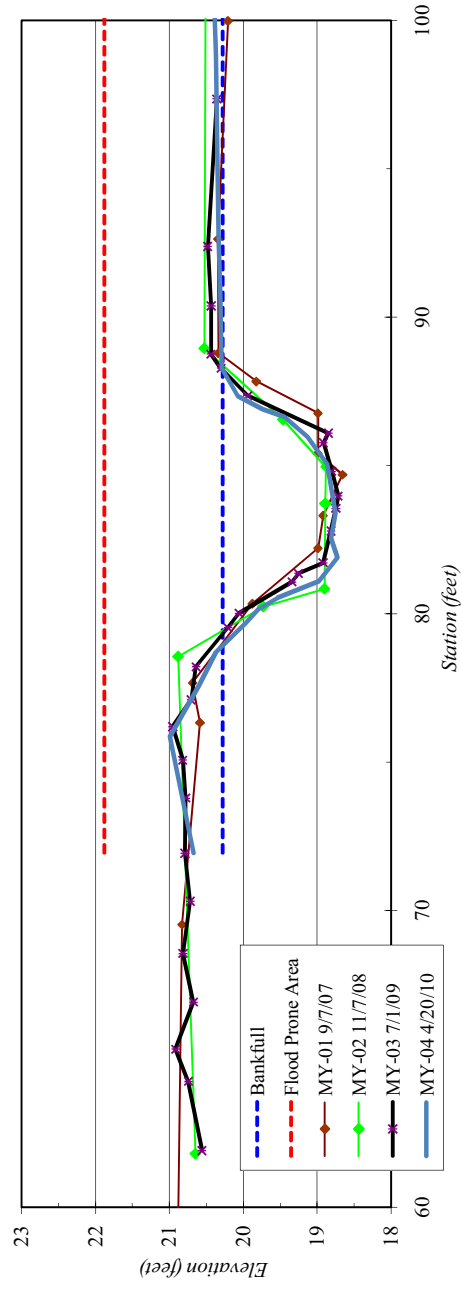
River Basin:	Cape Fear/White Oak
Watershed:	Lloyd Property
XS ID	XS - 10, Riffle
Drainage Area (sq mi):	1.2
Date:	4/7/2010
Field Crew:	Dean, Perkinson

SUMMARY DATA	
Bankfull Elevation:	20.3
Bankfull Cross-Sectional Area:	9.2
Bankfull Width:	9.3
Flood Prone Area Elevation:	21.9
Flood Prone Width:	150.0
Max Depth at Bankfull:	1.6
Mean Depth at Bankfull:	1.0
W / D Ratio:	9.4
Entrenchment Ratio:	16.1
Bank Height Ratio:	1.0

Stream Type E/C

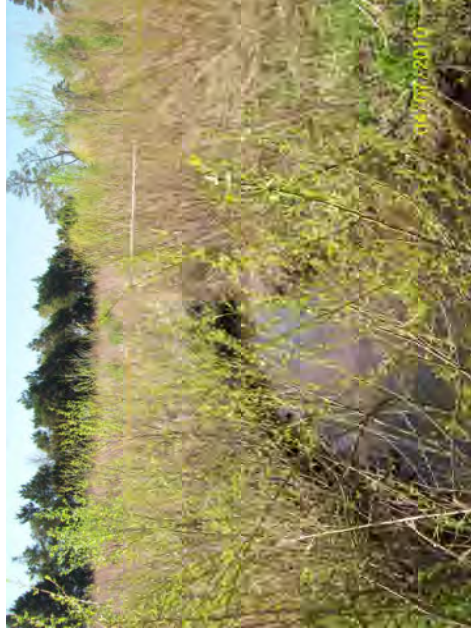
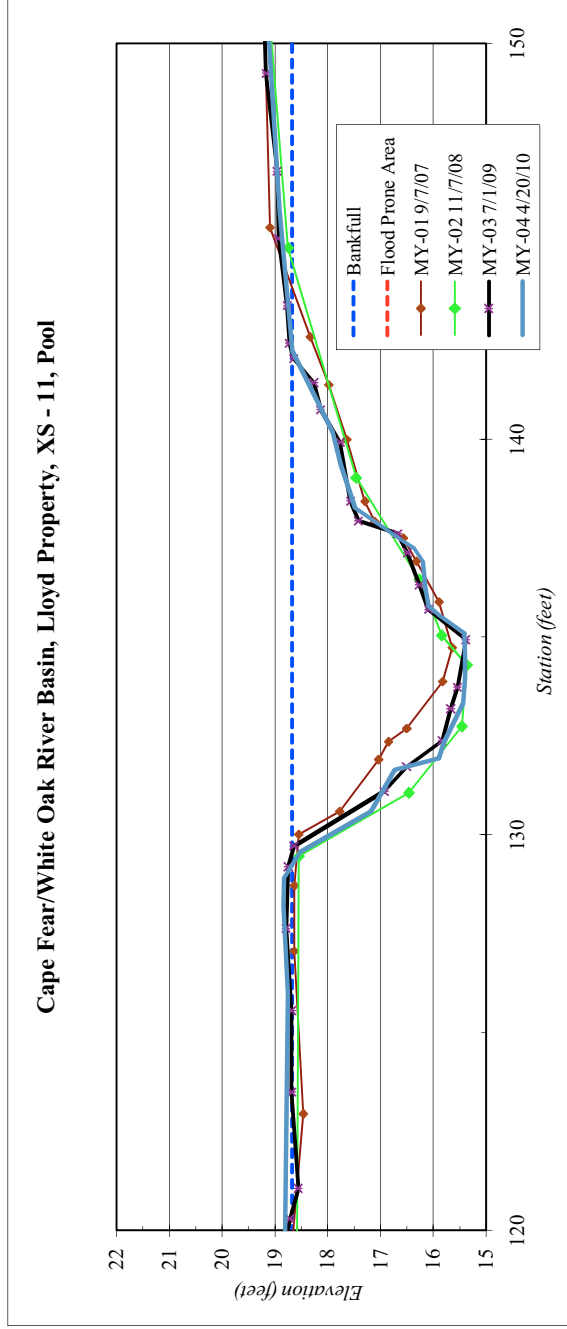
River Basin:	Cape Fear/White Oak
Watershed:	Lloyd Property
XS ID	XS - 11, Pool
Drainage Area (sq mi):	1.2
Date:	4/7/2010
Field Crew:	Dean, Perkinson

Stream Type: E/C

SUMMARY DATA	
Bankfull Elevation:	18.7
Bankfull Cross-Sectional Area:	23.3
Bankfull Width:	13.0
Flood Prone Area Elevation:	-
Flood Prone Width:	-
Max Depth at Bankfull:	3.3
Mean Depth at Bankfull:	1.8
W/D Ratio:	-
Entrenchment Ratio:	-
Bank Height Ratio:	-

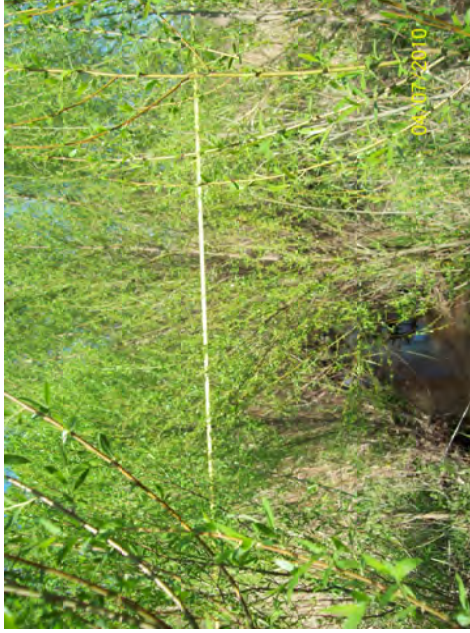
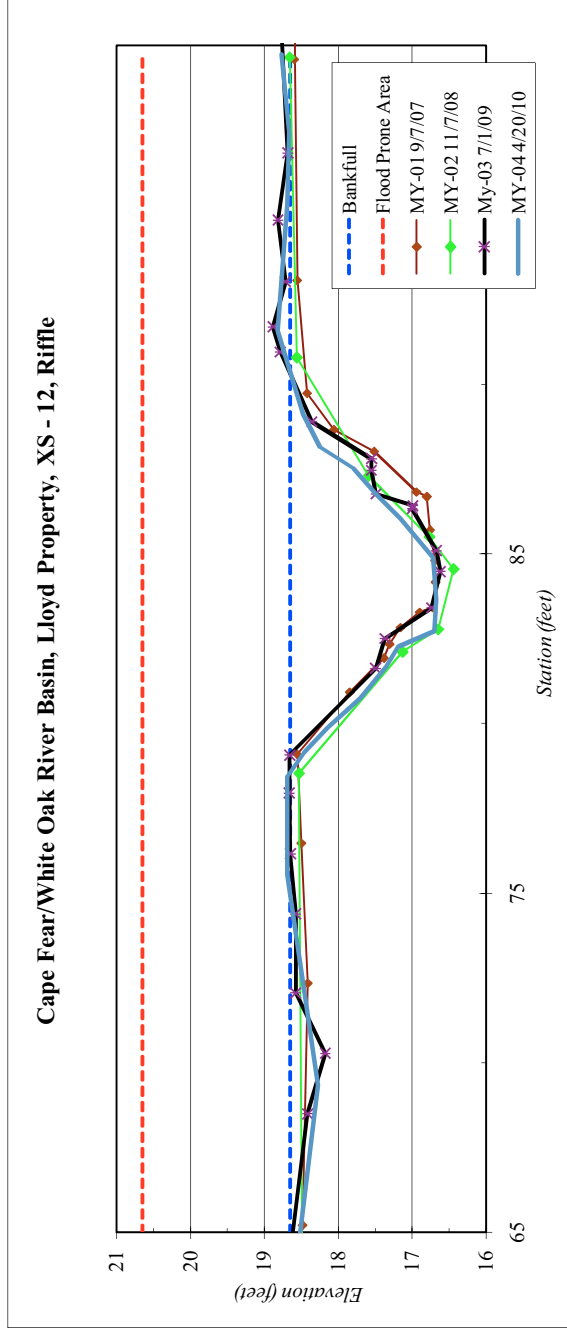
River Basin:	Cape Fear/White Oak
Watershed:	Lloyd Property
XS ID	XS - 12, Riffle
Drainage Area (sq mi):	1.2
Date:	4/7/2010
Field Crew:	Dean, Perkinson

SUMMARY DATA	
Bankfull Elevation:	18.7
Bankfull Cross-Sectional Area:	12.3
Bankfull Width:	11.8
Flood Prone Area Elevation:	20.7
Flood Prone Width:	150.0
Max Depth at Bankfull:	2.0
Mean Depth at Bankfull:	1.0
W/D Ratio:	11.3
Entrenchment Ratio:	12.7
Bank Height Ratio:	1.0

Stream Type: E/C
