ANNUAL MONITORING REPORT

YEAR 4 (2010)

CONTRACT D06003-1

LLOYD STREAM AND WETLAND RESTORATION SITE ONSLow COUNTY, NORTH CAROLINA

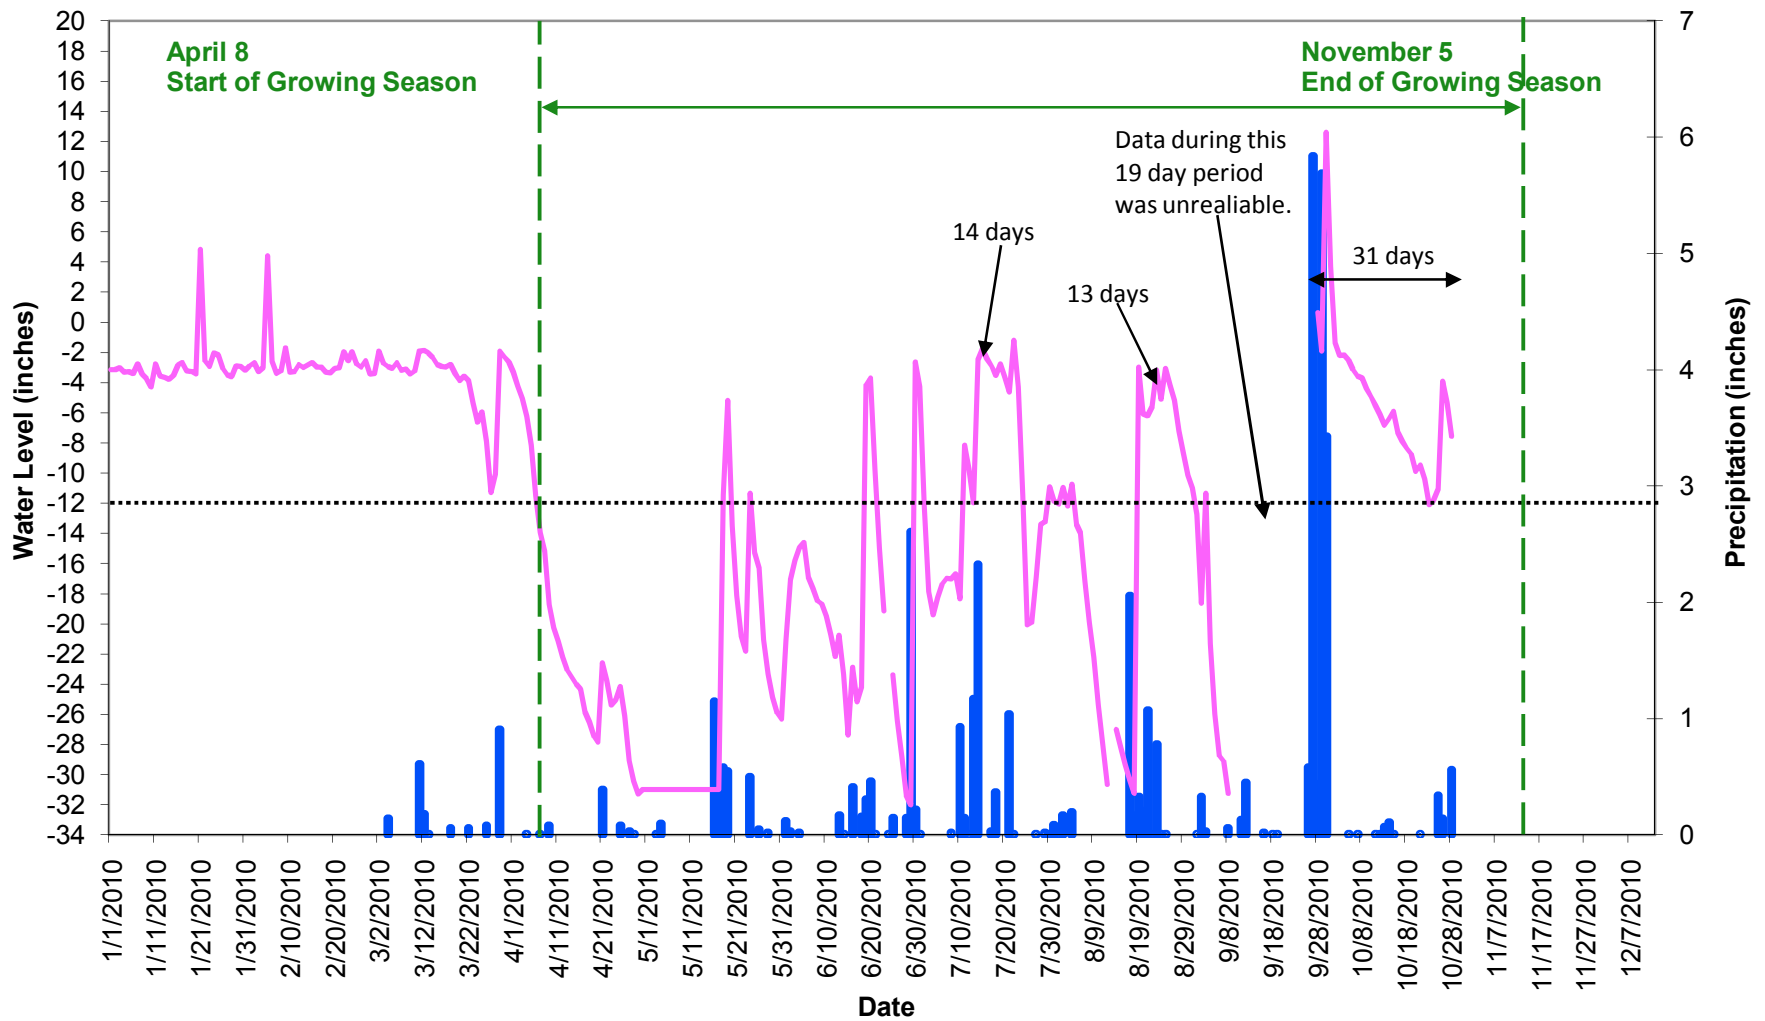
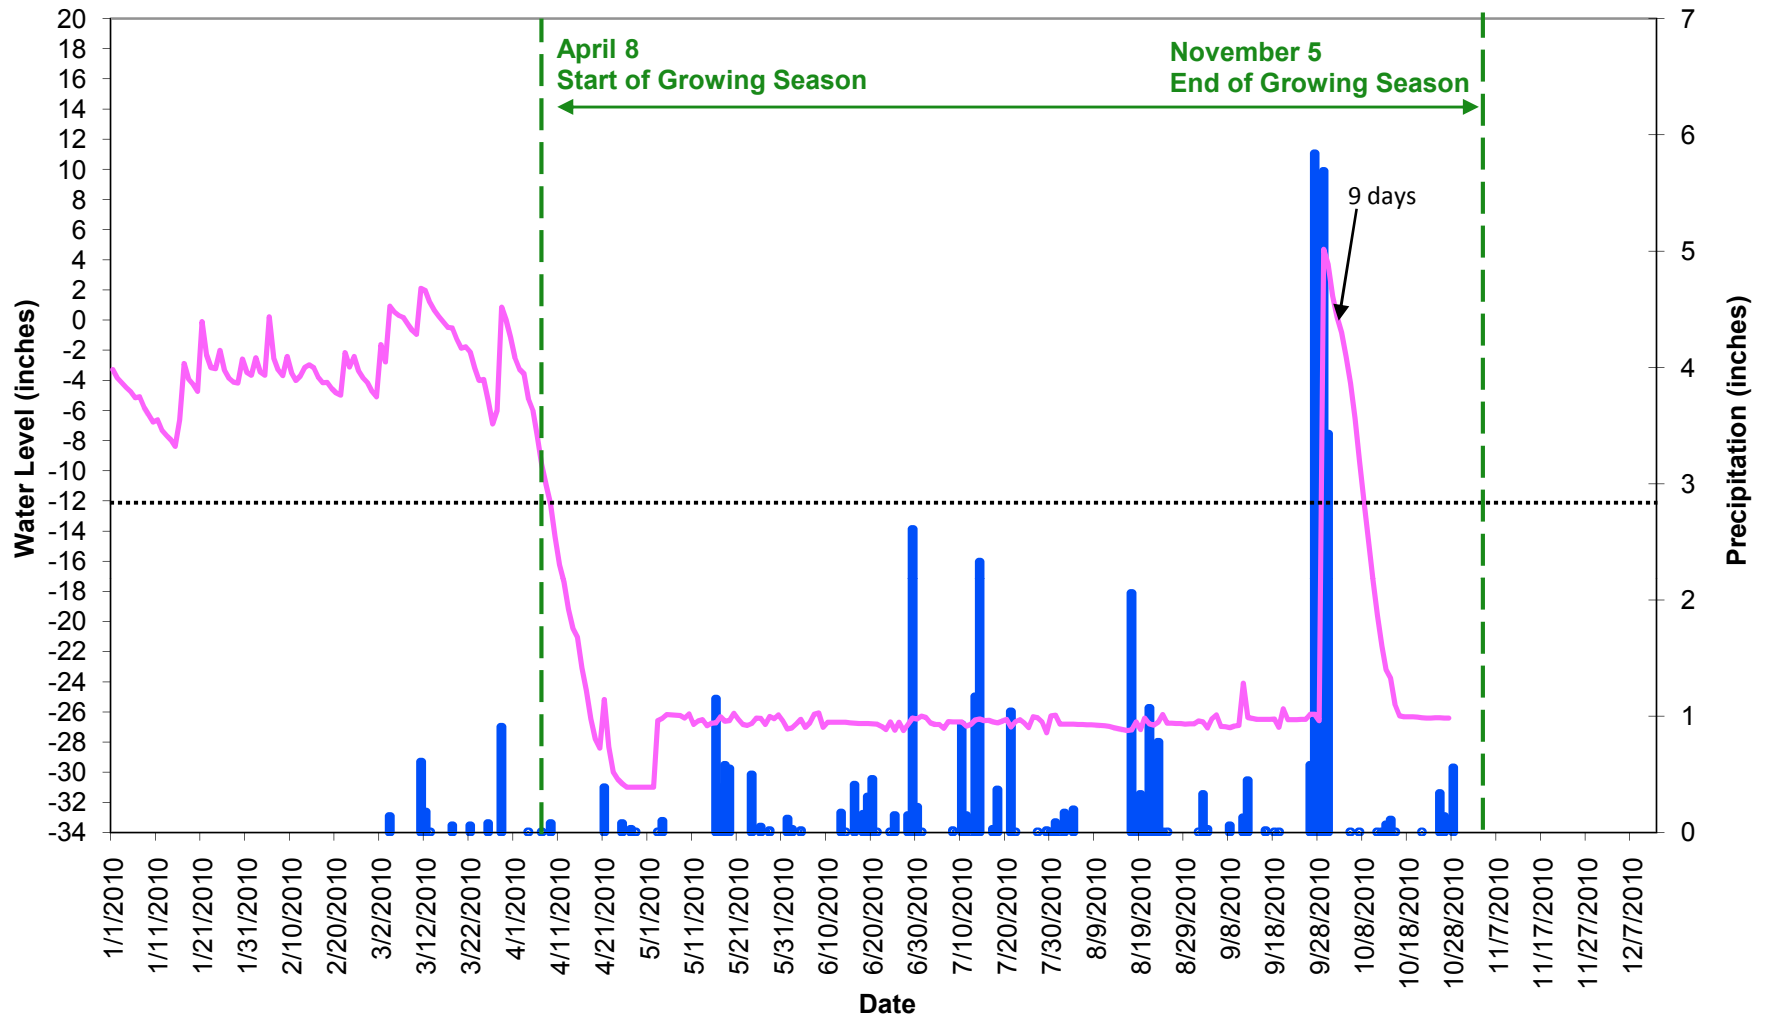
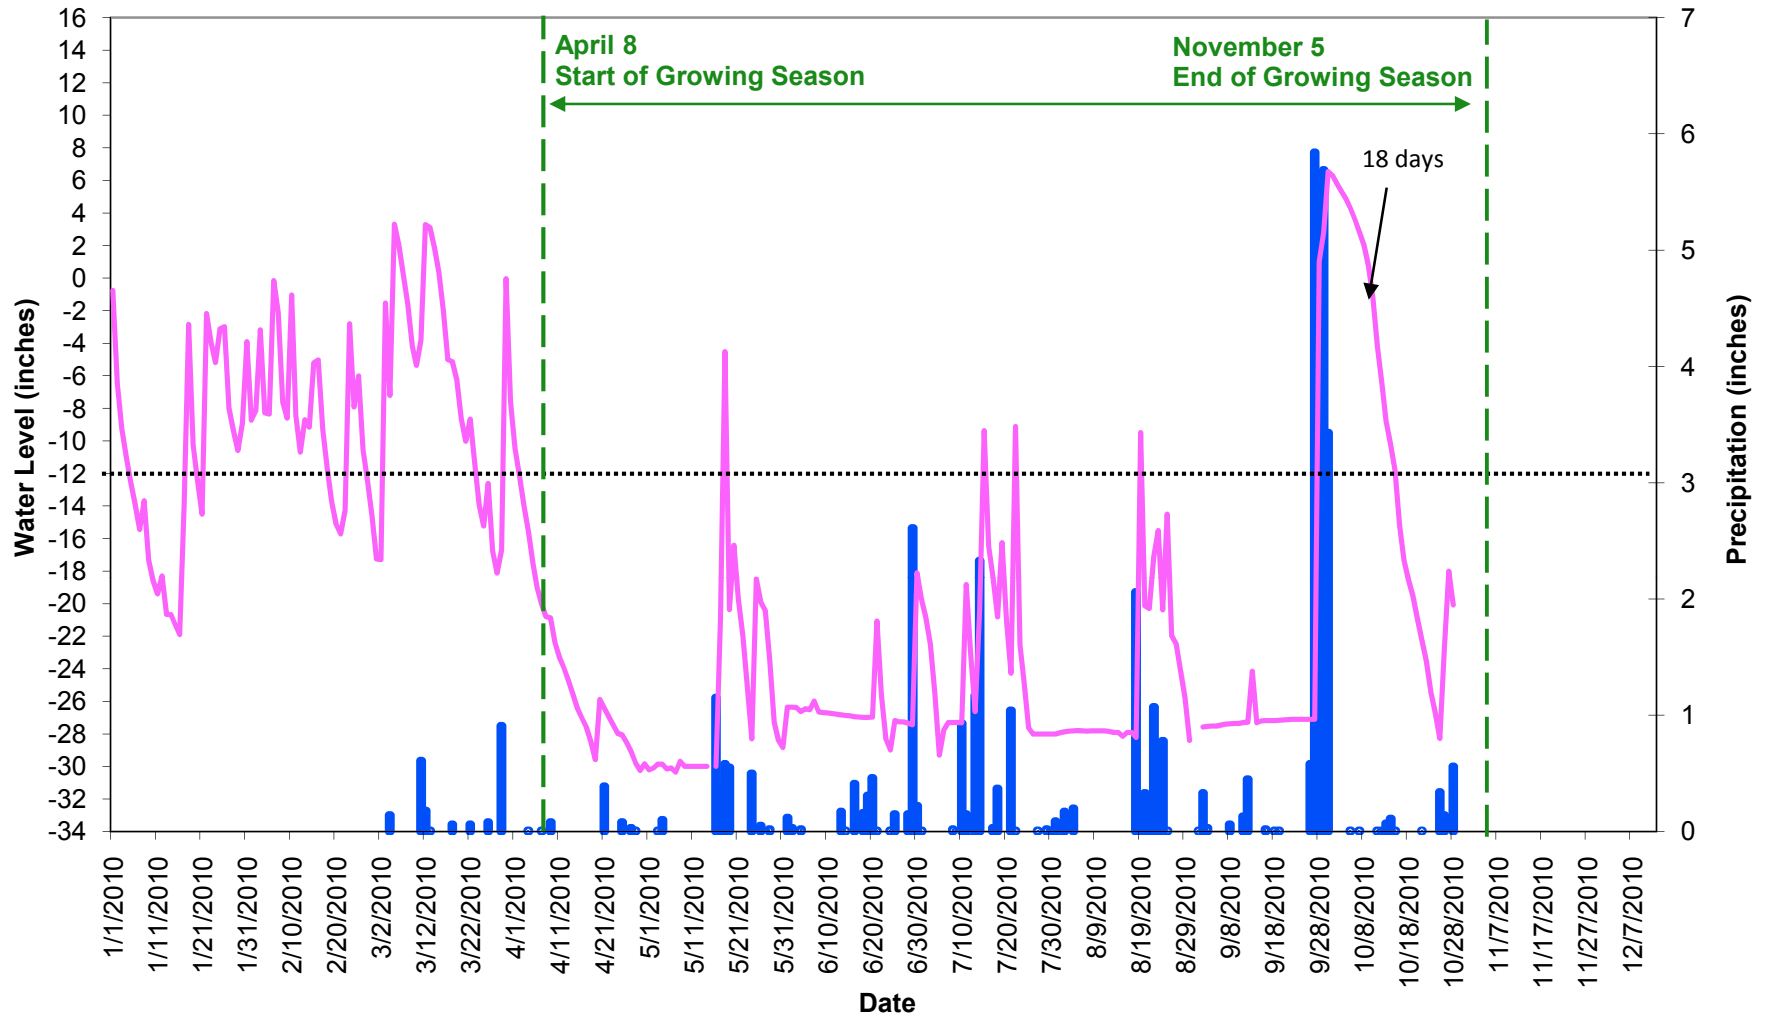
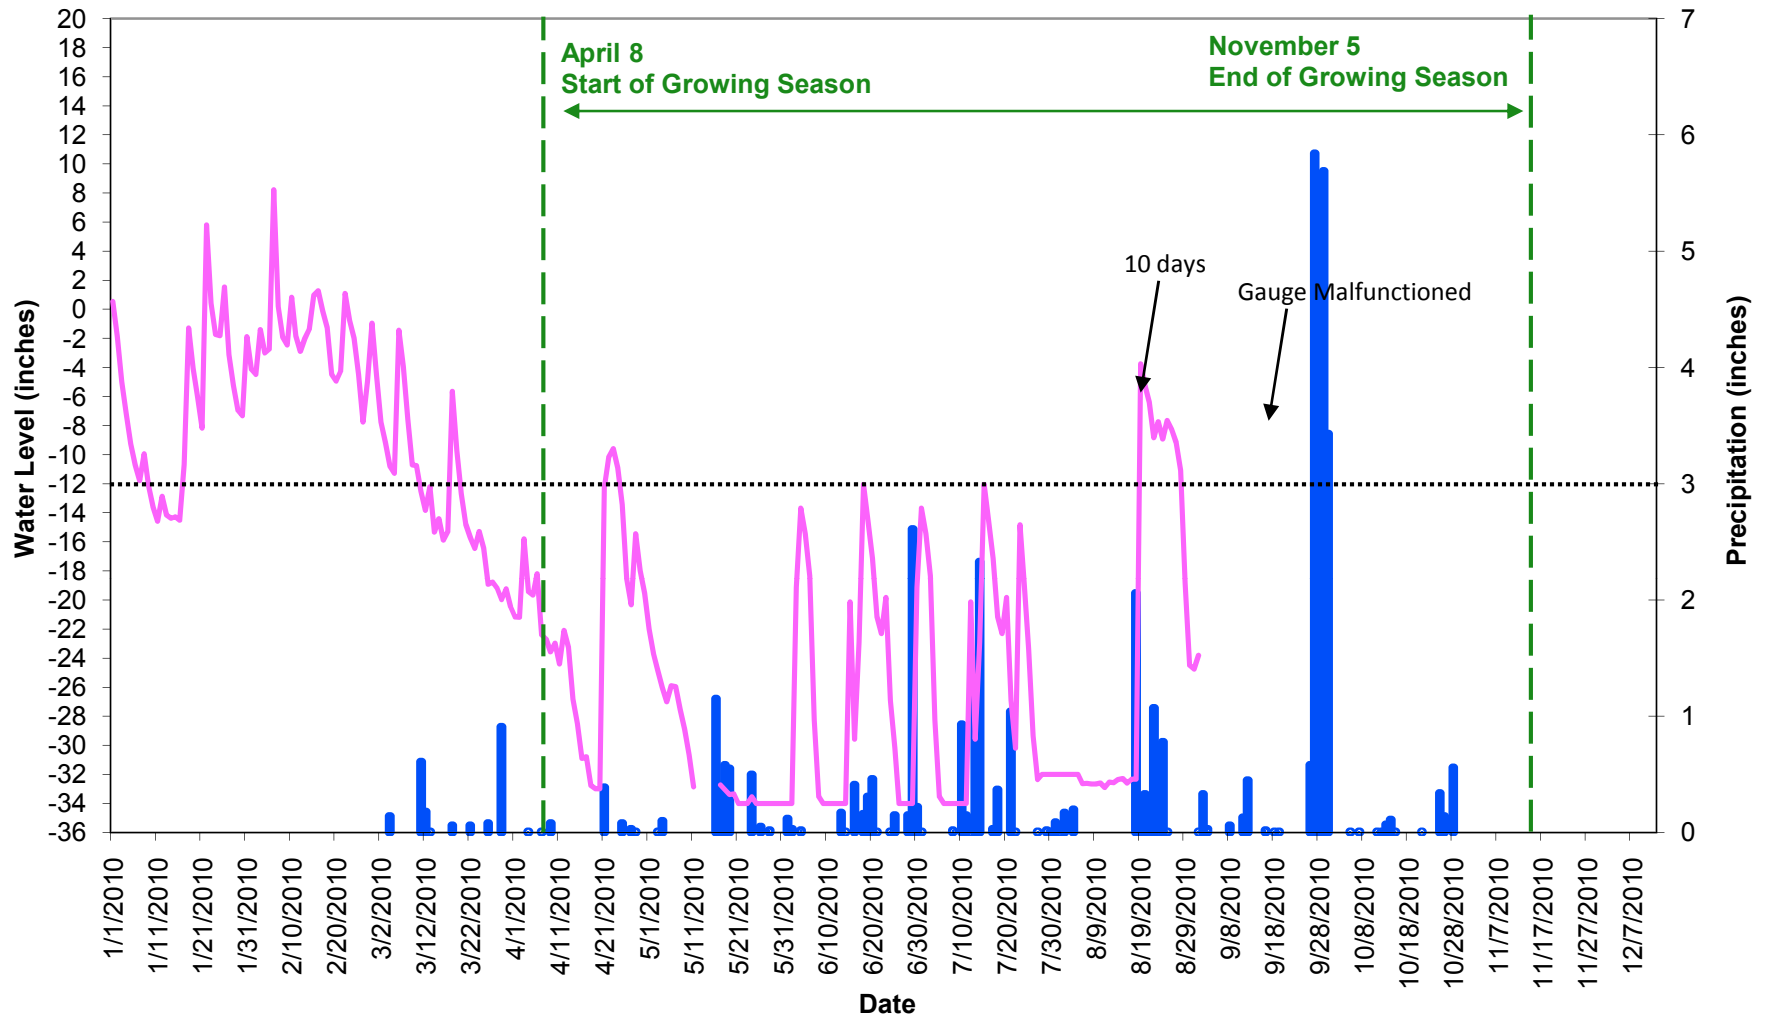
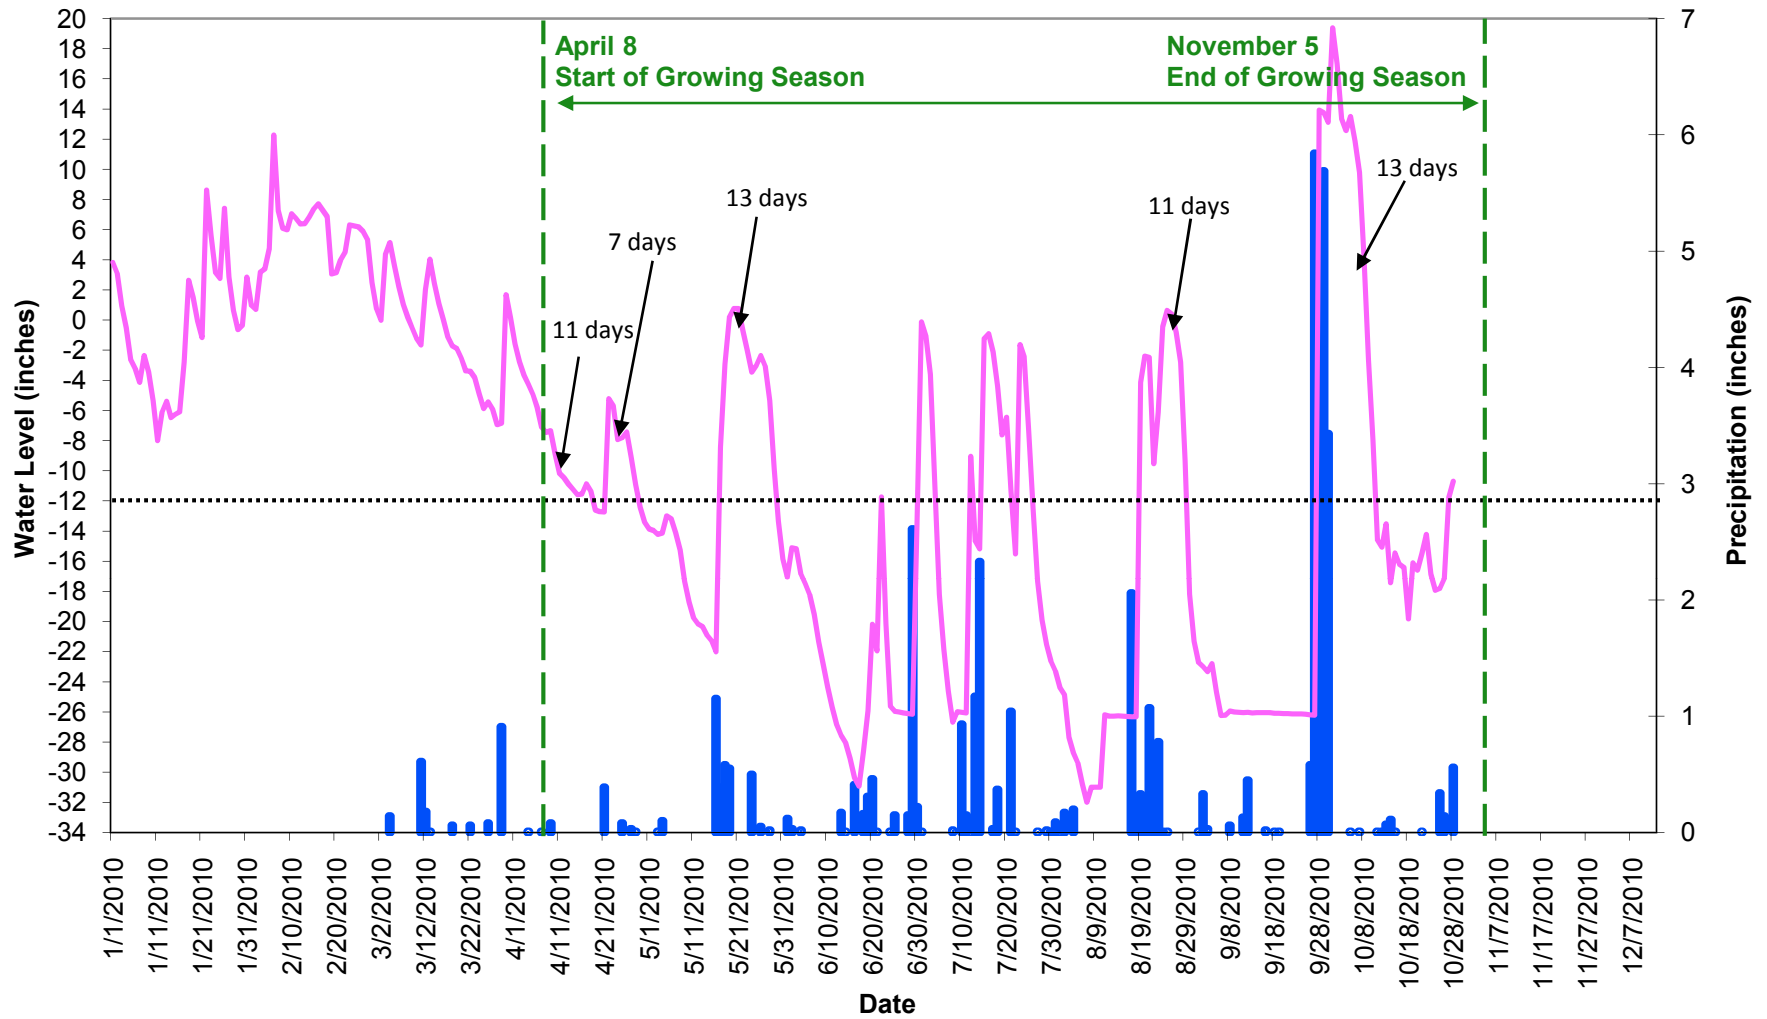
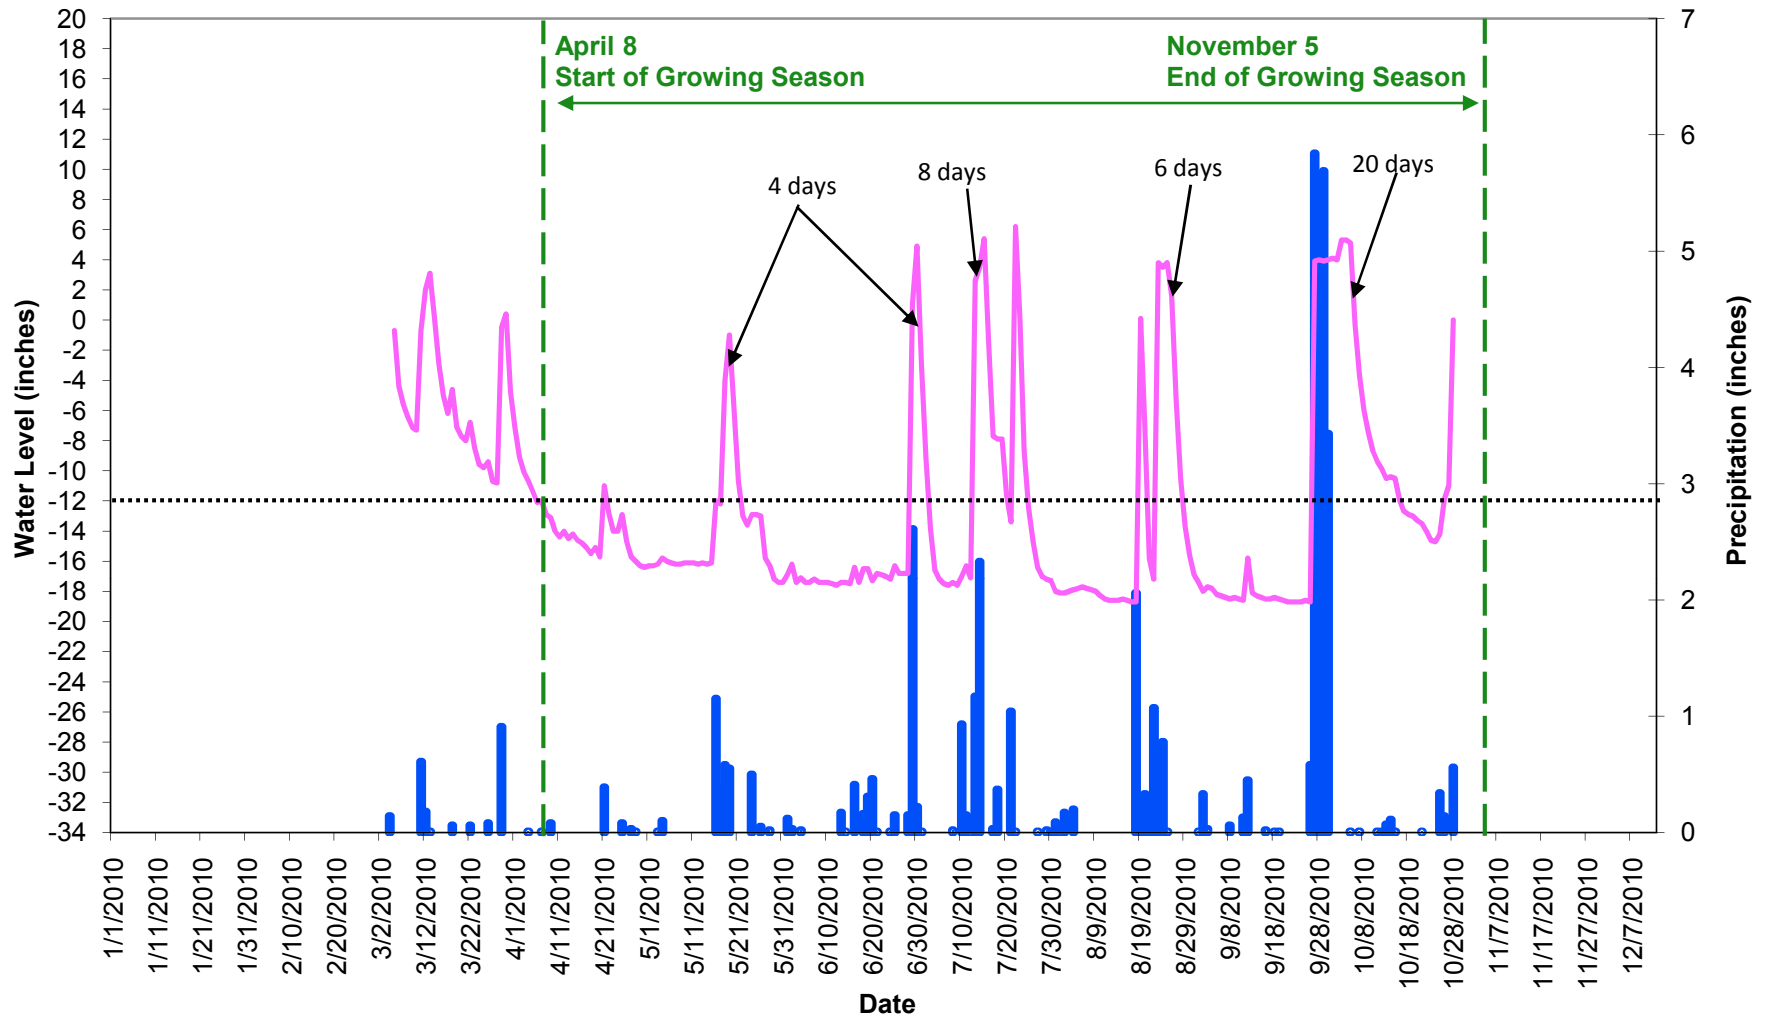
Success criteria of restoration gauges are based on comparisons to reference gauge data and all gauges should be considered successful for Year 4 (2010). Hydrographs containing groundwater and precipitation data for each gauge can be found in Appendix C. A summary of groundwater gauge data is included in Table 11. All vegetation plots across the Site were above the required 320 stems per acre with an average of 656 tree stems per acre in the Fourth Monitoring Year (Year 2010) (Table 12).
