# Lochill Farm Stream Mitigation Project Year 1 (2019) Monitoring Report Final

DMS Project ID No. 97083, DEQ Contract No. 6828  
USACE Action ID No. SAW-2016-00881, DWR# 16-0370  
Orange County, North Carolina, Neuse River Basin: 03020201-030030  
MY1 Data Collection Period: October 2019

**Subject:** Response to DMS Comments for DRAFT MY1 Report  
Lochill Farm Stream Mitigation Project, Orange County  
DMS Project # 97083, DEQ Contract #6828, Neuse-01 River Basin

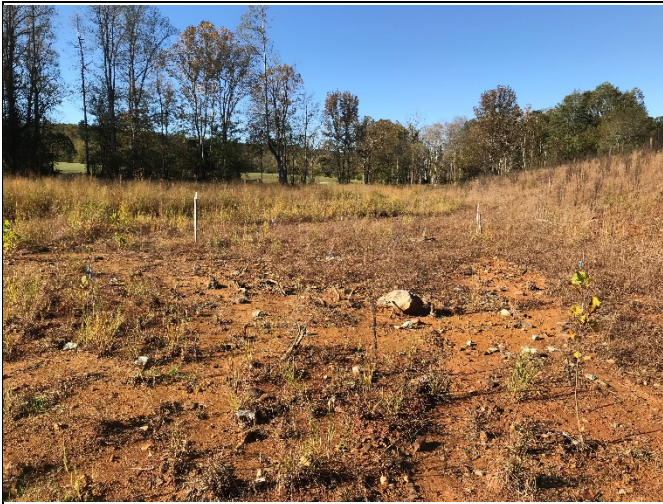
Thin herbaceous vegetation establishment in floodplain on R1 at Station 13+50

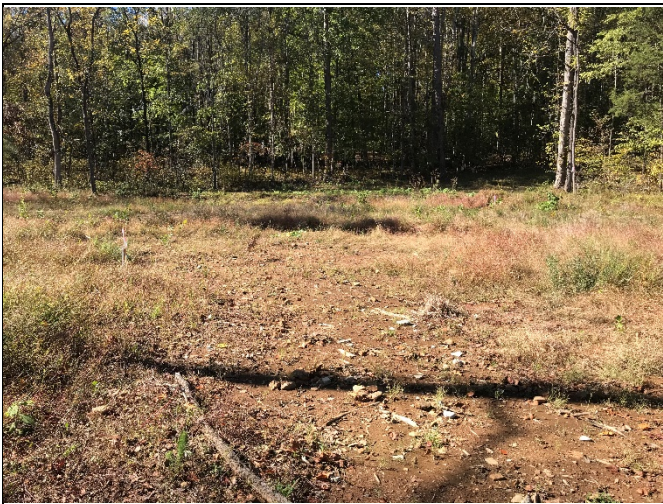
Thin herbaceous vegetation establishment in floodplain on R1 at Station 37+50

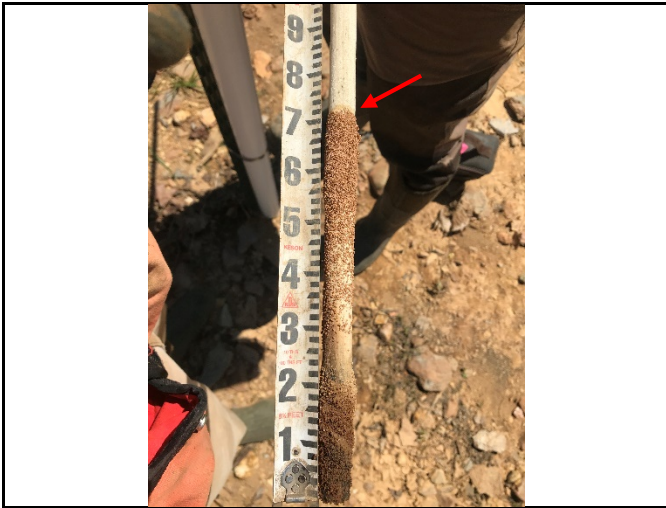
Manual crest gauge on upper R1 reading 0.71 ft  
(photo: 4/18/19)

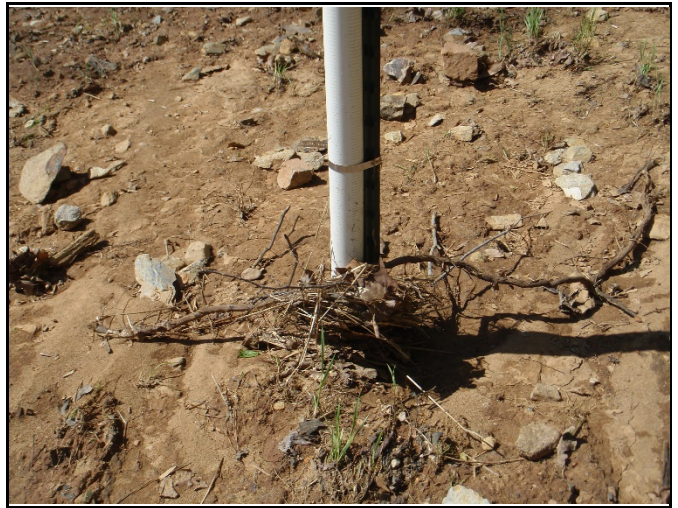
Debris jam by manual crest gauge on upper R1  
(photo: 4/18/19)

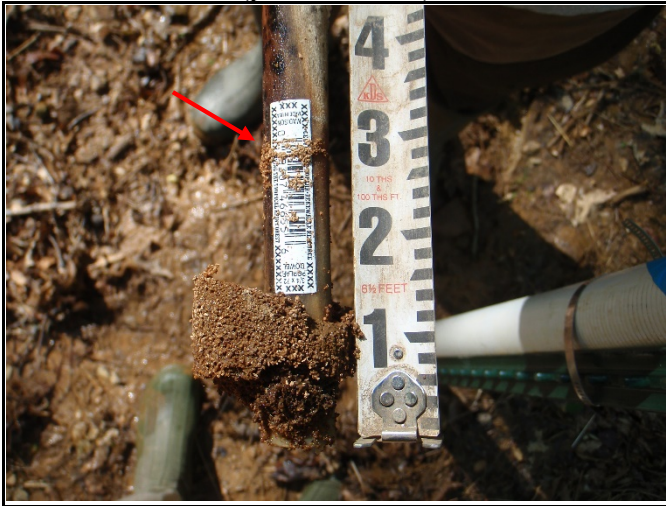
Manual crest gauge on upper R3 reading 0.30 ft  
(photo: 4/18/19)

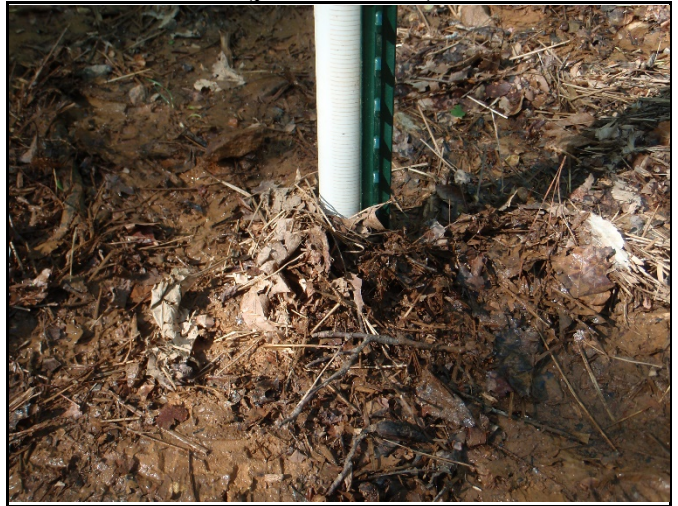
Debris jam by manual crest gauge on upper R3  
(photo: 4/18/19)

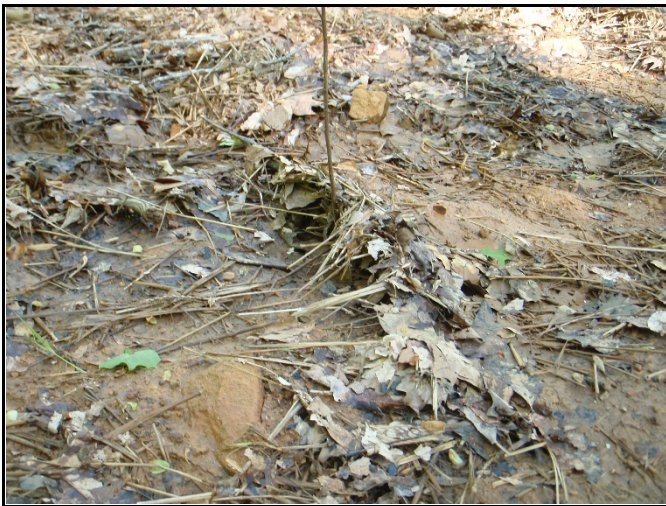
Debris jam on tree stem in floodplain of upper R3  
(photo: 4/18/19)

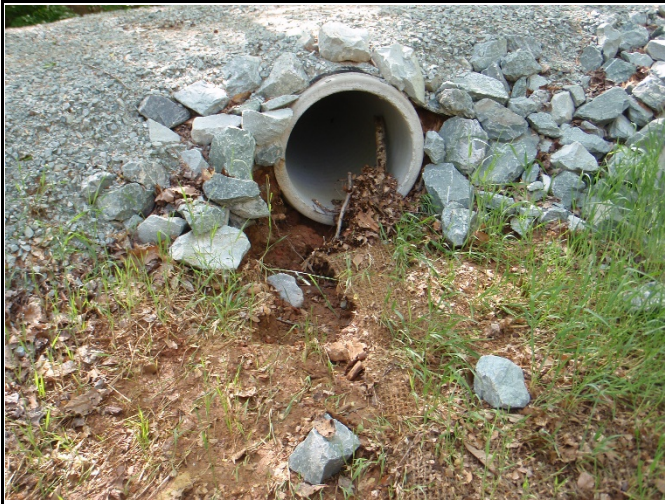
Evidence of scour and debris deposition in floodplain overflow pipe at crossing in upper R3 (photo: 4/18/19)

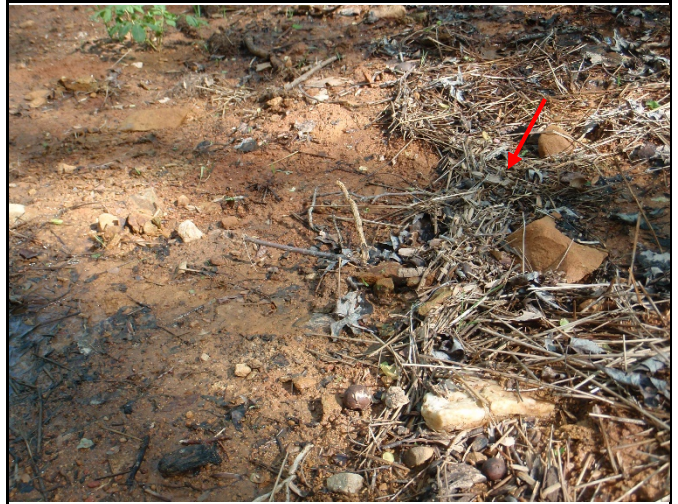
Wrack line of straw/debris in floodplain of upper R3 (photo: 4/18/19)

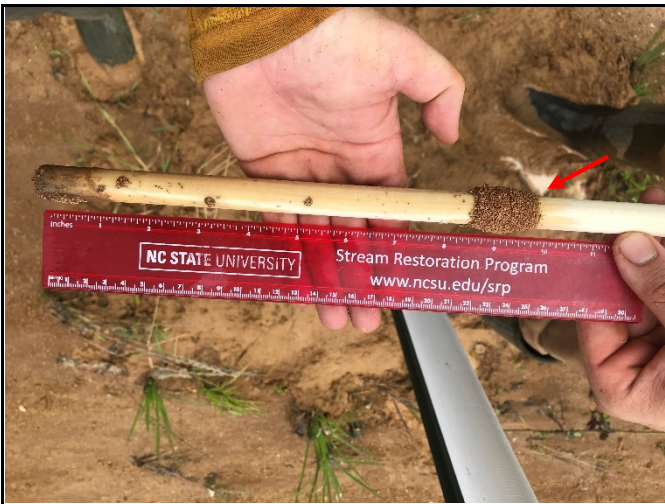
Manual crest gauge on upper R1 reading 0.81 ft (photo: 6/19/19)

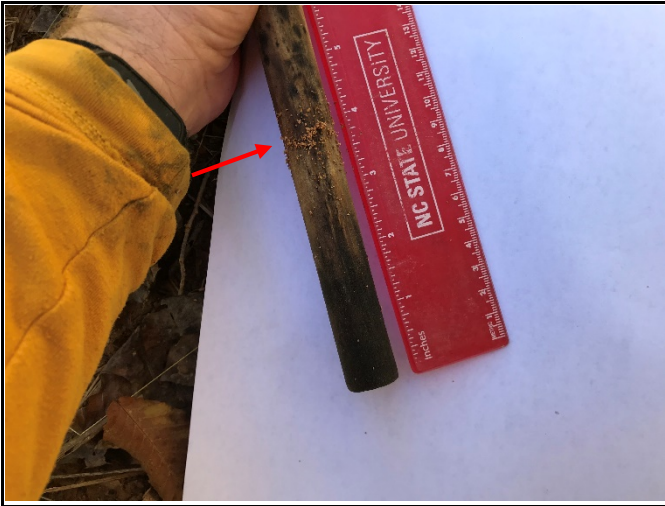
Manual crest gauge on upper R3 reading 0.29 ft (photo: 6/19/19)

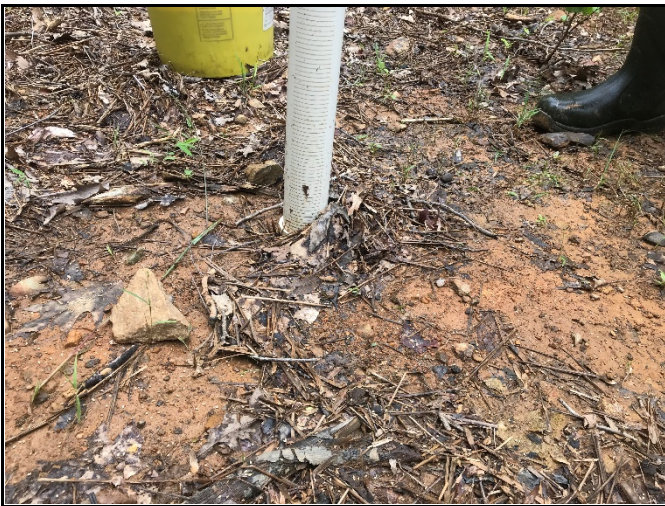
Debris jam by manual crest gauge on upper R3 (photo: 6/19/19)

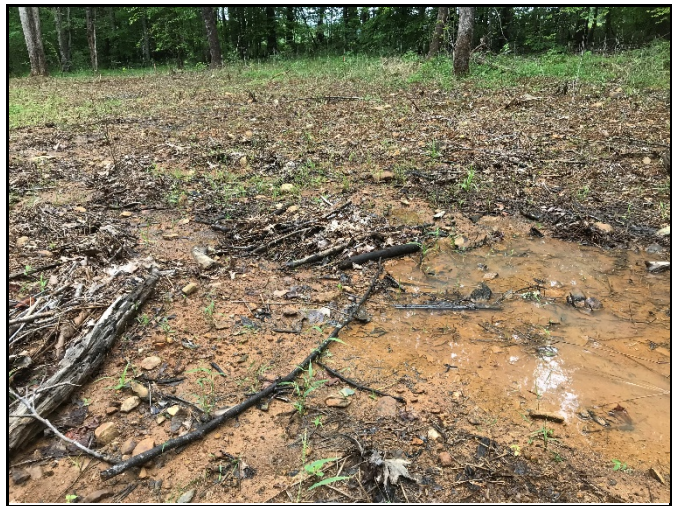
Scour flow paths and debris in floodplain of upper R3 (photo: 6/19/19)
