# Lochill Farm Stream Mitigation Project Year 2 (2020) Monitoring Report Final

DMS Project ID No. 97083, DEQ Contract No. 6828  
USACE Action ID No. SAW-2016-00881, DWR# 16-0370  
Orange County, North Carolina, Neuse River Basin: 03020201-030030  
MY2 Data Collection Period: October 2020

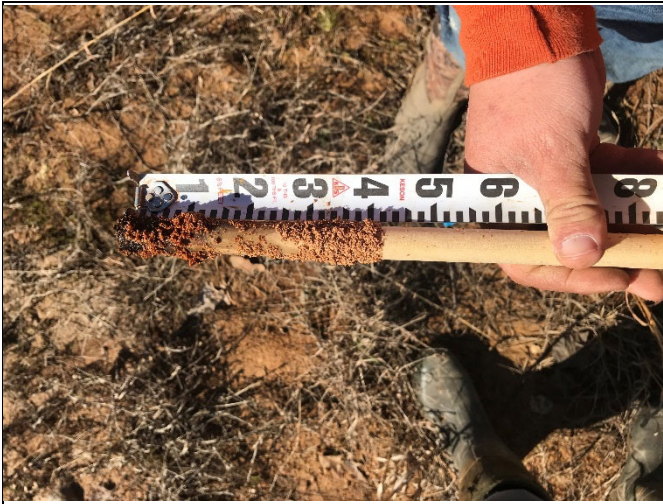
Manual crest gauge reading of 0.41 ft on upper R1 (photo from 2/27/20, storm on 2/27/20)

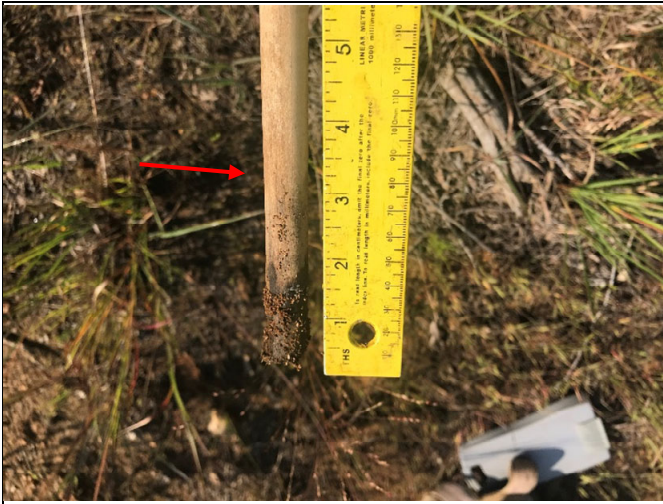
Manual crest gauge reading of 0.23 ft on upper R1 (photo from 5/8/20, storm on 3/25/20)

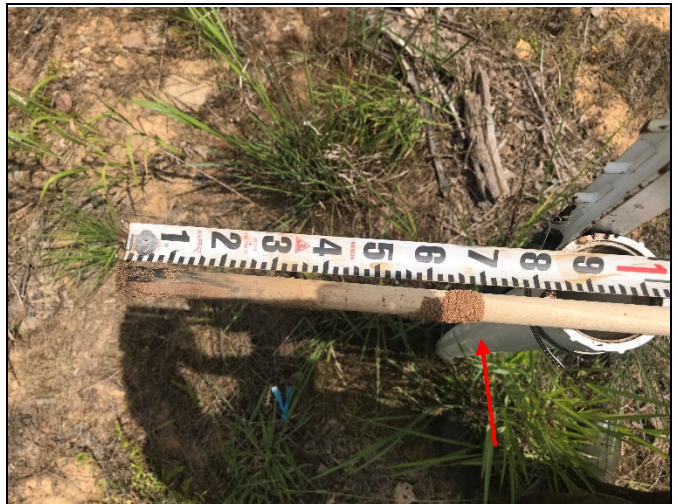
Manual crest gauge reading of 0.69 ft on upper R1 (photo from 7/10/20, storm on 5/20/20)

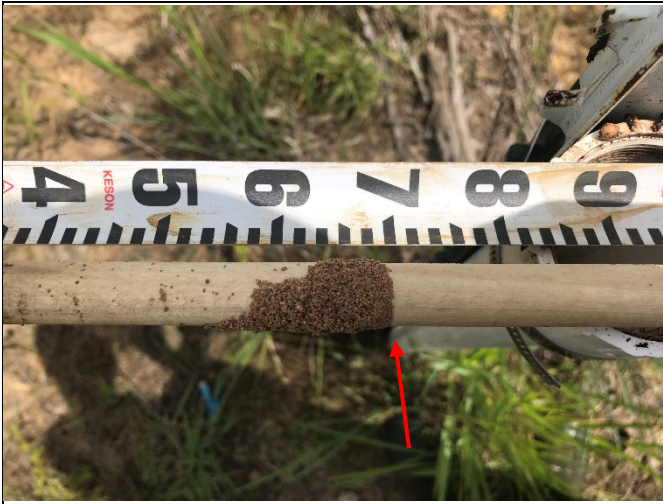
Close-up of manual crest gauge reading of 0.69 ft on upper R1 (photo from 7/10/20, storm on 5/20/20)

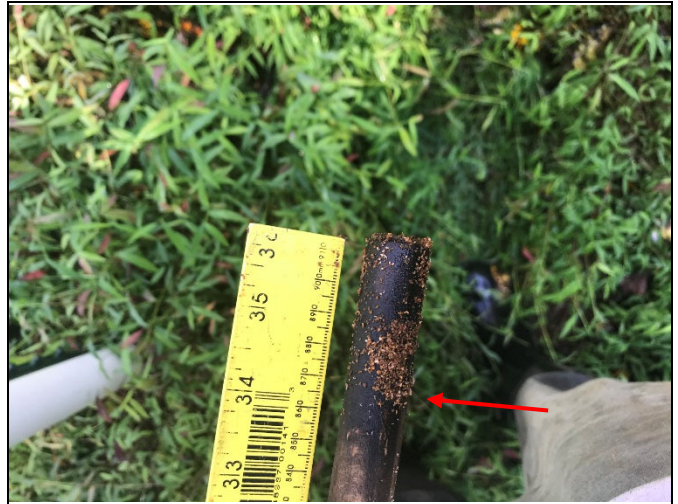
Manual crest gauge reading of 0.16 ft on upper R3 (photo from 7/10/20, storm on 5/20/20)

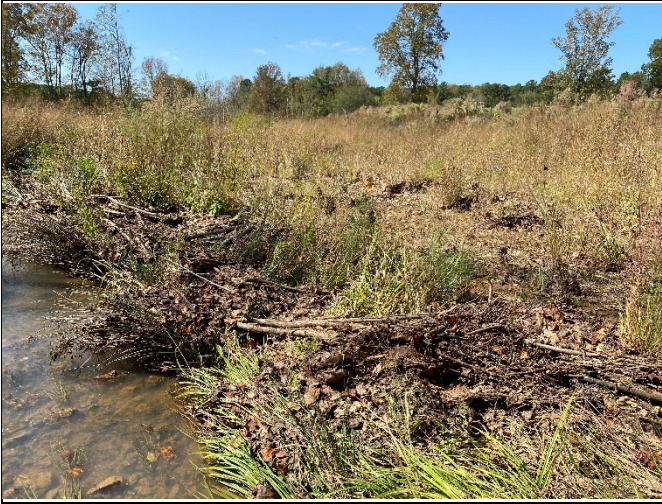
Debris lines along banks of upper R1 (10/14/20)

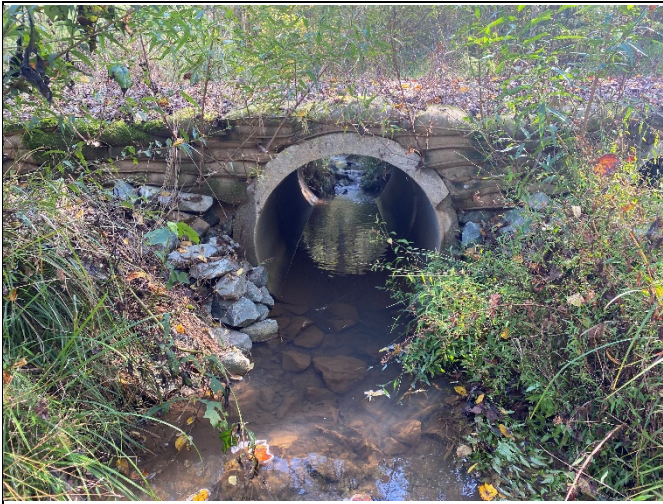
Pipe at crossing on R3 at Station ~16+30 (10/13/20)

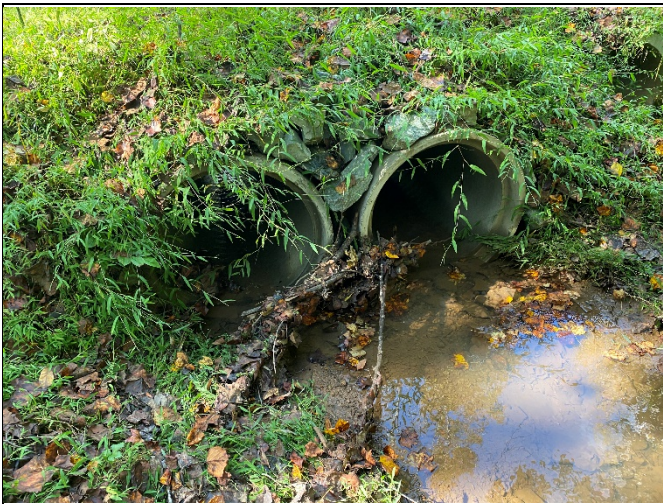
Pipes at crossing at top of R3 at Station 10+00 (10/13/20)

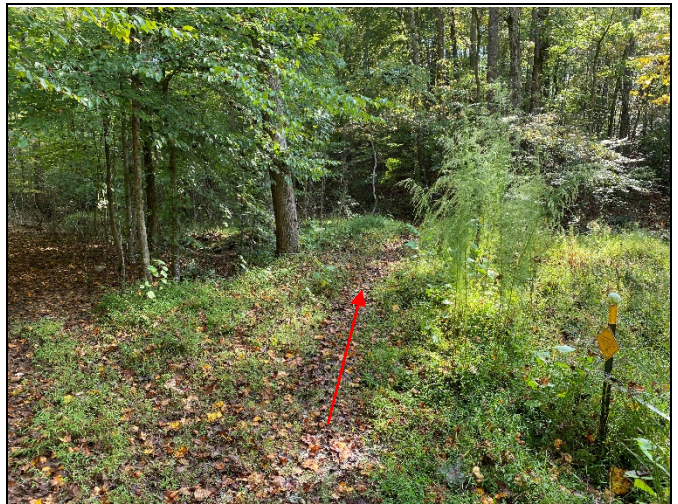
Crossing over pipes at top of R3 at Station 10+00 (path shown by arrow, 10/13/20)
