Lochill Farm Stream Mitigation Project Year 3 (2021) Monitoring Report FINAL

DMS Project ID No. 97083, DEQ Contract No. 6828

Orange County, North Carolina, Neuse River Basin: 03020201-030030

MY3 Data Collection Period: September 2021

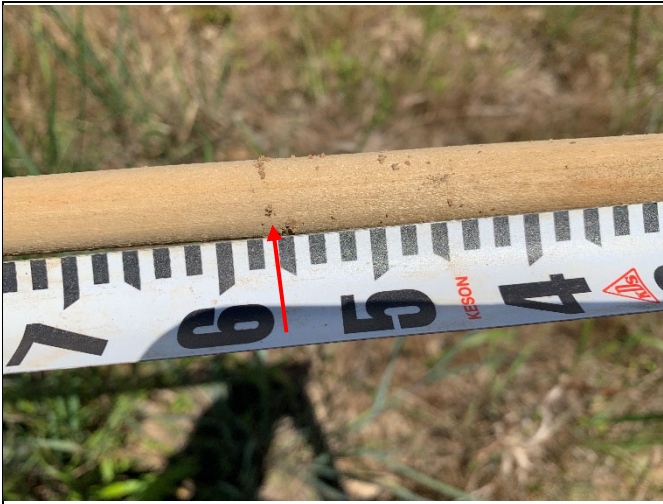
Manual crest gauge reading of 0.57 ft on upper R1 (photo from 6/24/21, storm on 4/9/21)

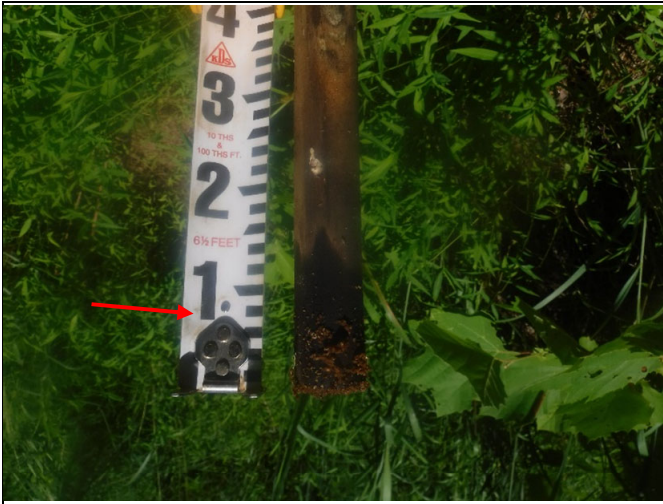
Manual crest gauge reading of N/A on R3 (photo from 6/24/21)

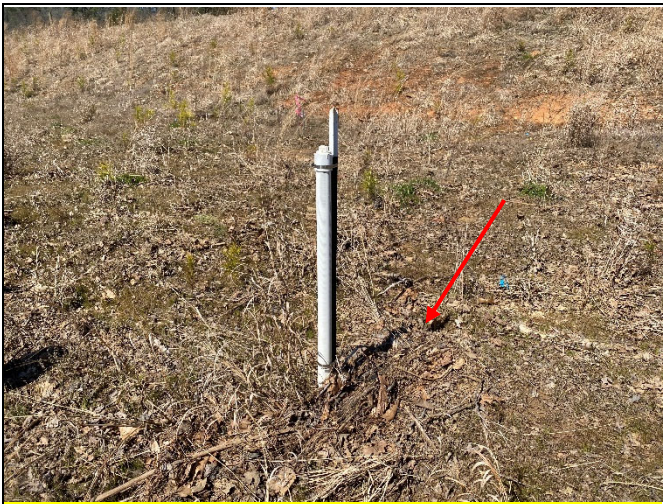
Debris jams around base of crest gauge on upper R1 (photo from 3/11/21)

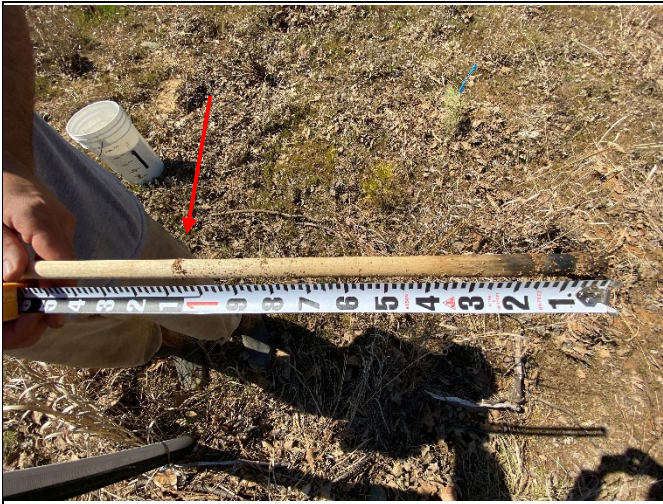
Manual crest gauge reading of 1.01 ft on upper R1 (photo from 3/11/21, storm on 2/16/21)

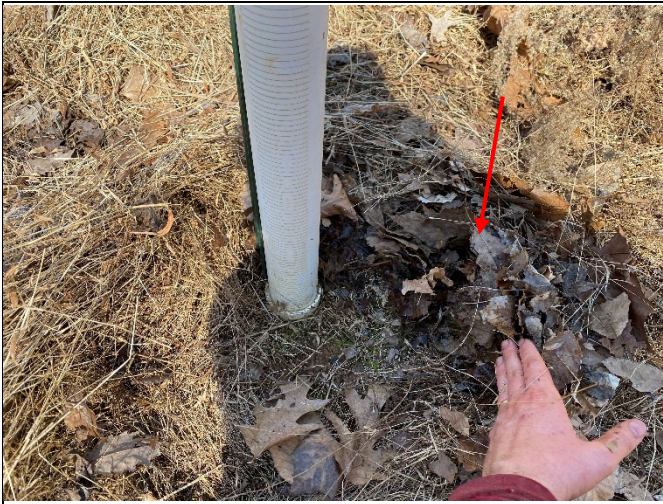
Debris jammed up against crest gauge base (pushed back for photo) on upper R3 (photo from 3/11/21)

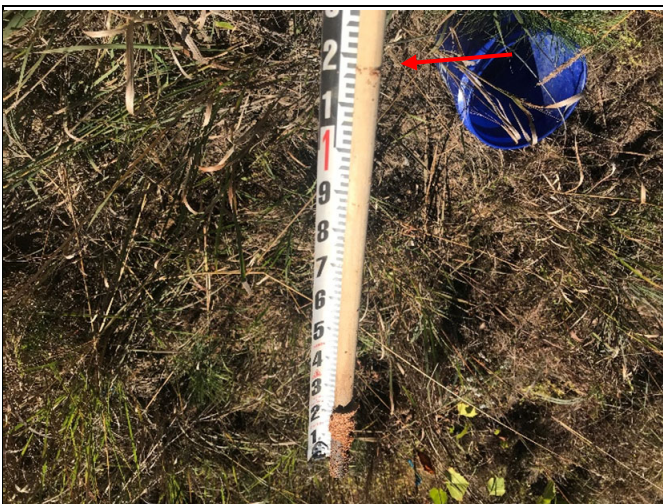
Manual crest gauge reading of 1.17 ft on upper R1 (photo from 10/20/21, storm from 7/19/21)

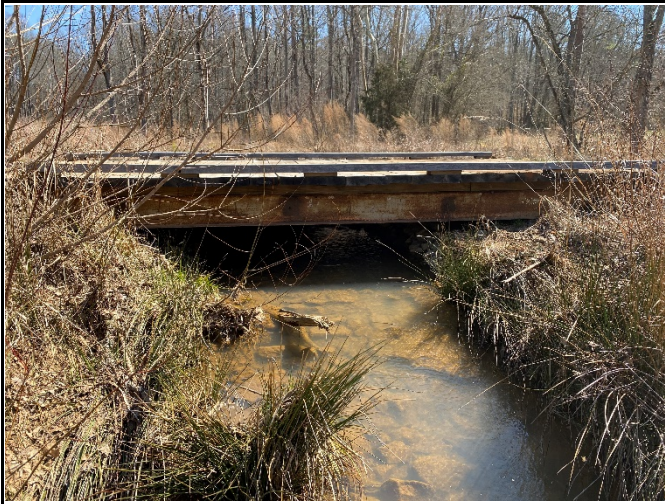
Bridge on R1 at Station ~18+20 (3/11/21)

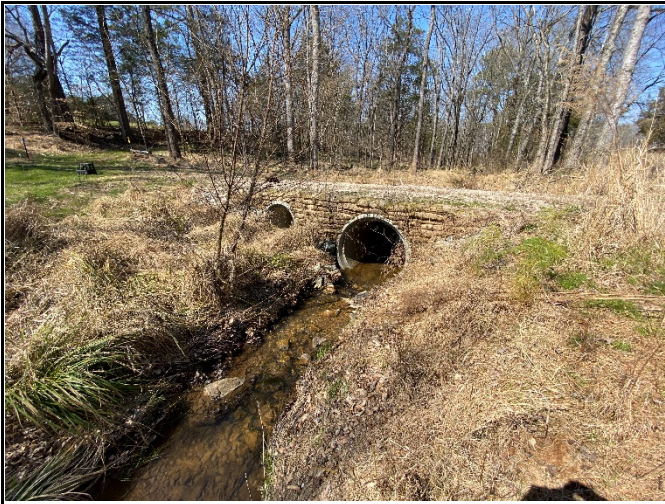
Pipe crossing on R3 at Station ~16+30 (3/11/21)

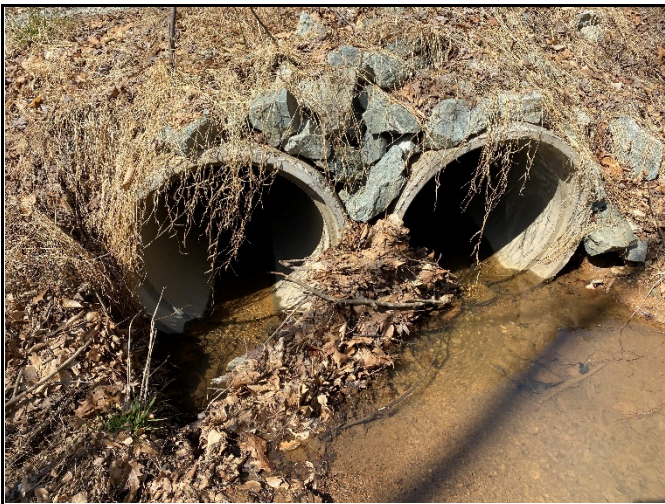
Pipes at crossing at top of R3 at Station 10+00 (3/11/21)

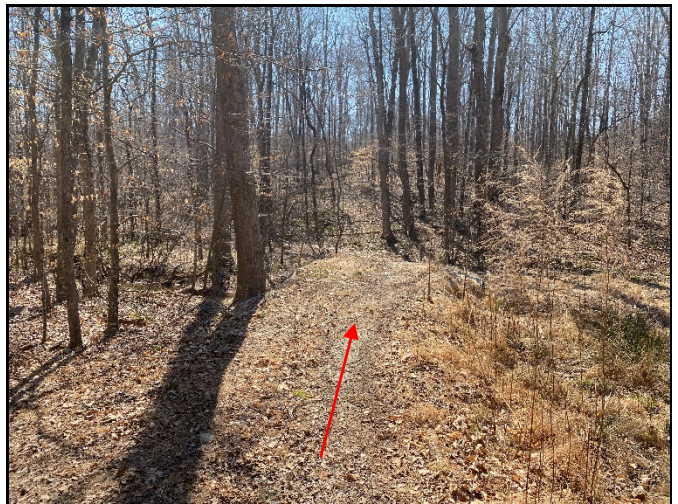
Crossing over pipes at top of R3 at Station 10+00 (path shown by arrow, 3/11/21)
