Lochill Farm Stream Mitigation Project Year 4 (2022) Monitoring Report FINAL

DMS Project ID No. 97083, DEQ Contract No. 6828
USACE Action ID No. SAW-2016-00881, DWR# 16-0370
Orange County, North Carolina, Neuse River Basin: 03020201-030030
MY4 Data Collection Period: November 2022

Lochill Farm: MY4 Stream Station Photo-Points (taken 3/15/22)

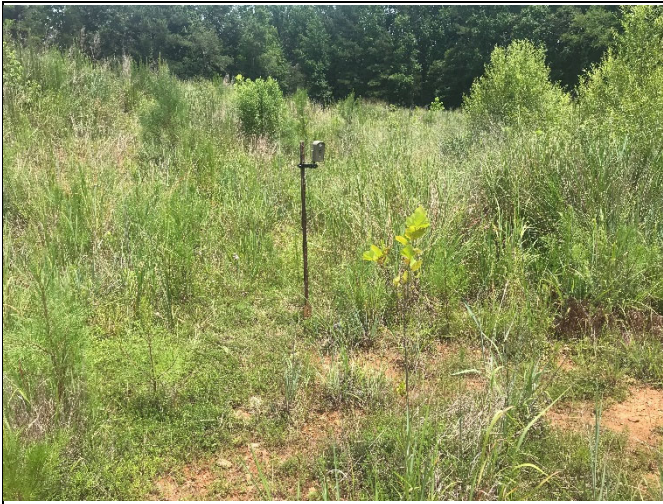
Overbank camera moved to R1 Station 13+30 (7/14/22)

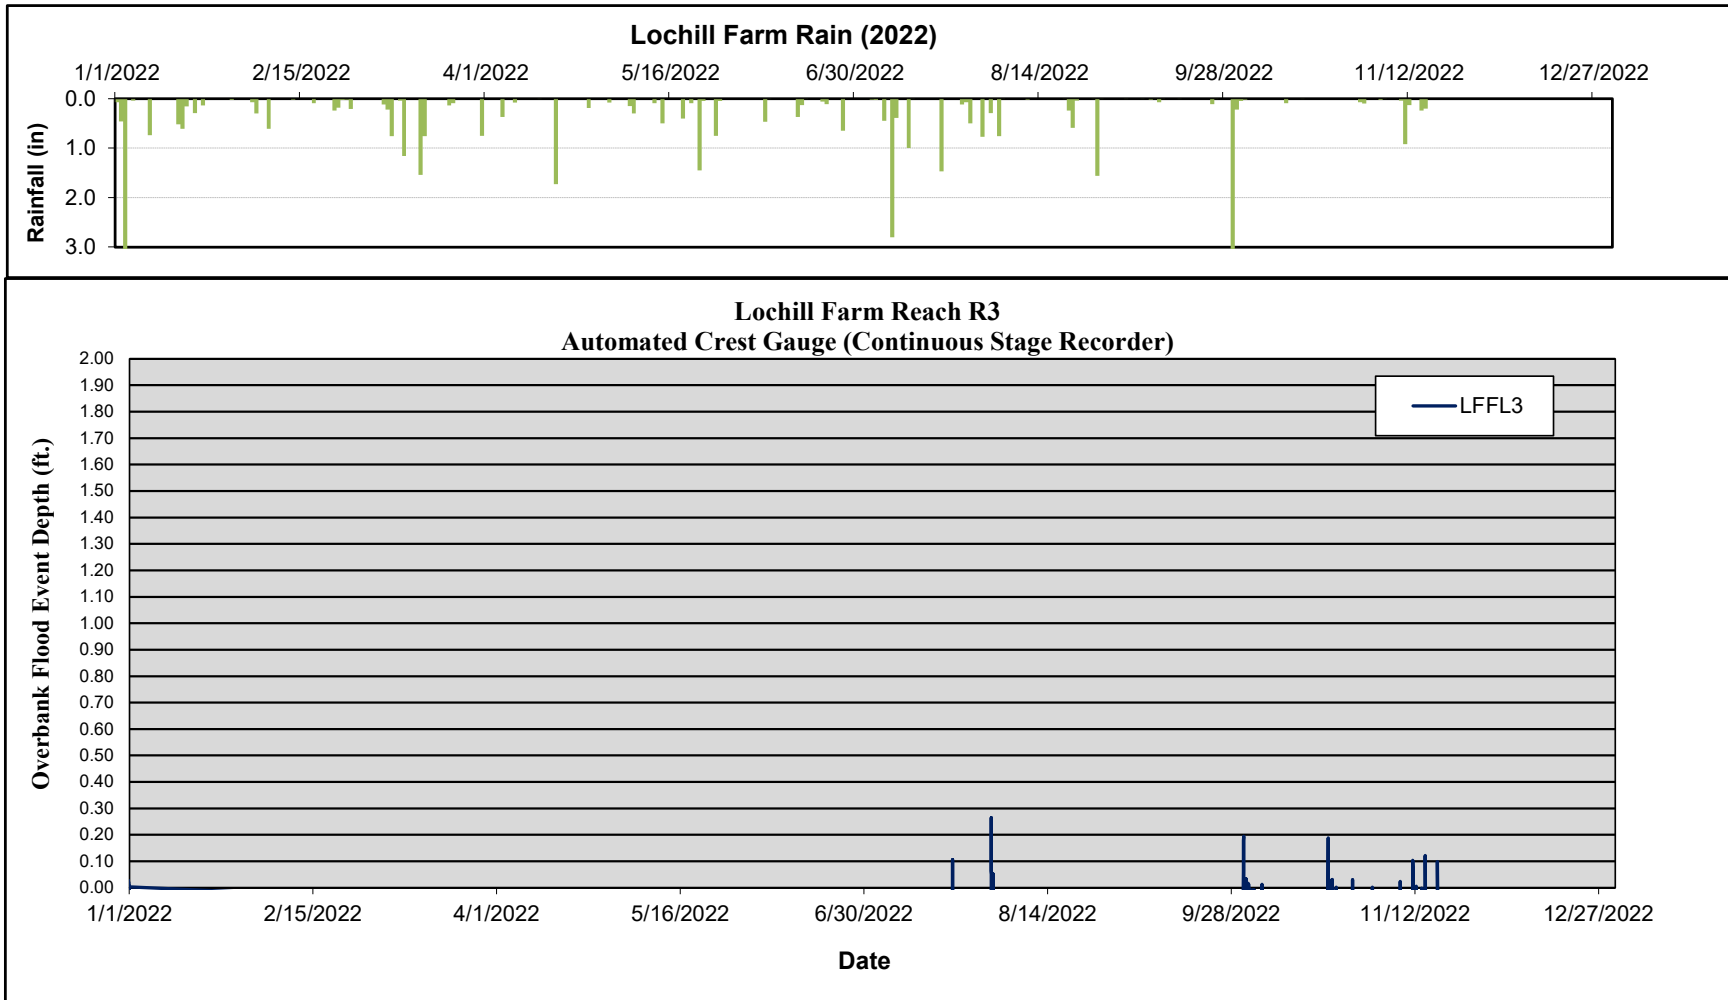
Figure 5. Automated Crest Gauge (Continuous Stage Recorder) Graph

During Year 4 monitoring, two separate post-construction bankfull events were documented (see Table 10 and Figure 5 in Appendix E and the Overbank Event Photographs in Appendix B). They were documented primarily through the use of an automated crest gauge, but also through manual cork crest gauge readings, and post-flood event site inspection photographs. Crest gauge 3 was changed to an automated in-stream crest gauge to better show overbank events due to the thick vegetation surrounding the gauge. It was noticed during site visits that overbank events happened on R3 but never captured by the original cork gauge.

Only the largest overbank event is called out here and in the report. However, several smaller overbank events also appear to have occurred as shown in the graph above.

Crest Gauge installed 7/15/2022

Note: Data presented here is from 7/15/22 thru 11/21/22

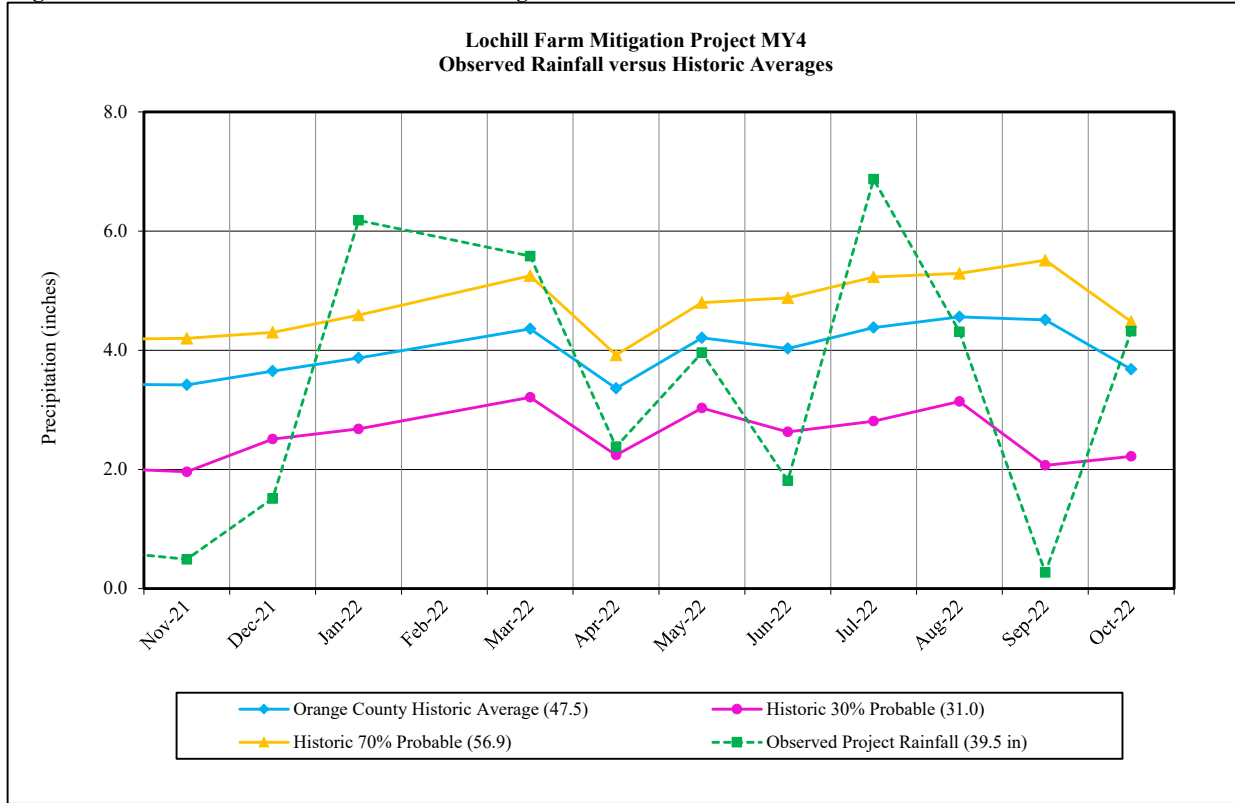
Figure 7. Observed Rainfall Versus Historic Averages

As the observed monthly rainfall data for the project presented in Figure 7 in Appendix E demonstrates, the past 12 months have seen wide variability as compared to historic average precipitation, with three months exceeding the 70% probable average and four months below the 30% probable average. It was considerably wetter in the winter and spring of 2022 but was a very dry fall of 2022. A total of 39.5 inches of rainfall was observed for the site, a deficit of 8 inches in comparison with Orange County historic average of 47.5 inches.

Note: Historic average annual rainfall for Orange County is 47.5", while the observed project rainfall recorded a total of 39.5" over the previous 12 months (from 11/1/2021 to 10/31/2022). Project rainfall was collected from the nearest NC-CRONOS station.
