# **Lochill Farm Stream Mitigation Project Year 5 (2023) Monitoring Report FINAL**

DMS Project ID No. 97083, DEQ Contract No. 6828  
USACE Action ID No. SAW-2016-00881, DWR# 16-0370  
Orange County, North Carolina, Neuse River Basin: 03020201-030030  
MY5 Data Collection Period: November 2023

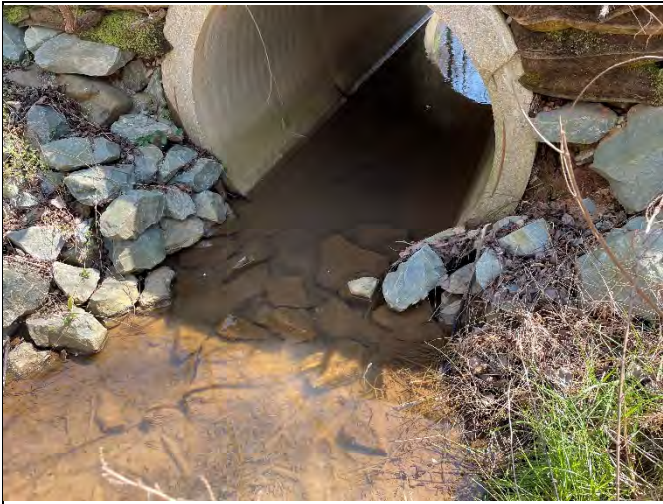
Stable pipe crossing on R3 at Station ~16+30 (10/5/23)

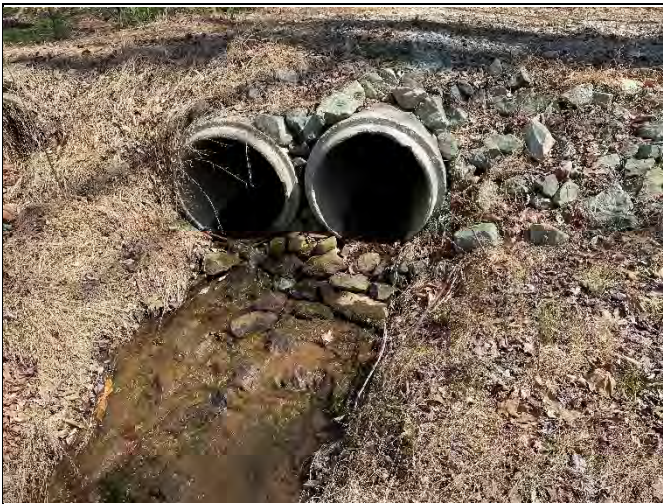
Pipe crossing on R3 at Station ~16+30 (3/23/23)

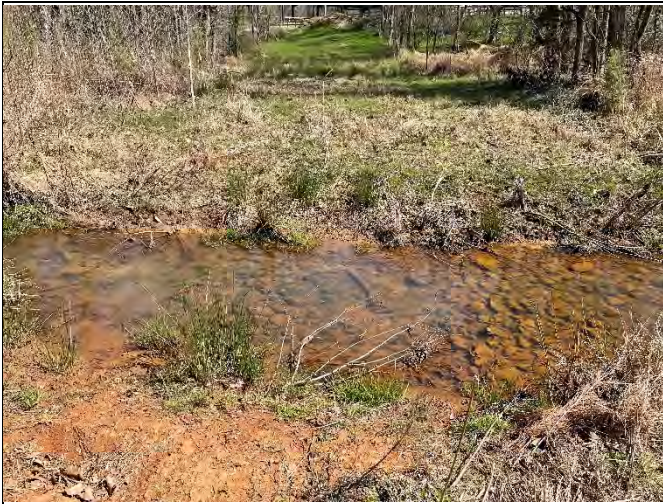
First kudzu treatment results (10/5/23)

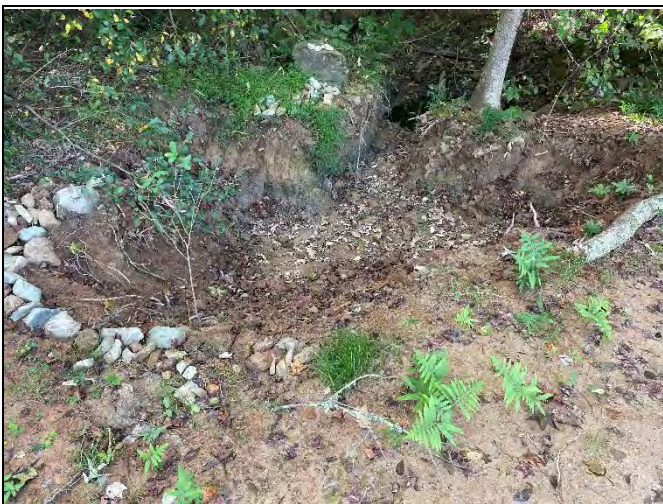
During the September 13<sup>th</sup> site visit, the landowner informed Michael Baker that there was a misguidance between he and his son resulting in an encroachment to the conservation easement at the head of Reach 2. A hole approximately 5ft by 10ft and 3ft deep was dug out in the easement and the excess spoil pile was spread into the floodplain. The total encroachment area is approximately 530 square feet. Michael Baker has discussed the violation with the landowner and developed a plan to resolve the issue. The landowner

Encroachment area at the head of R2. The white tape is the easement boundary (8/5/2023)

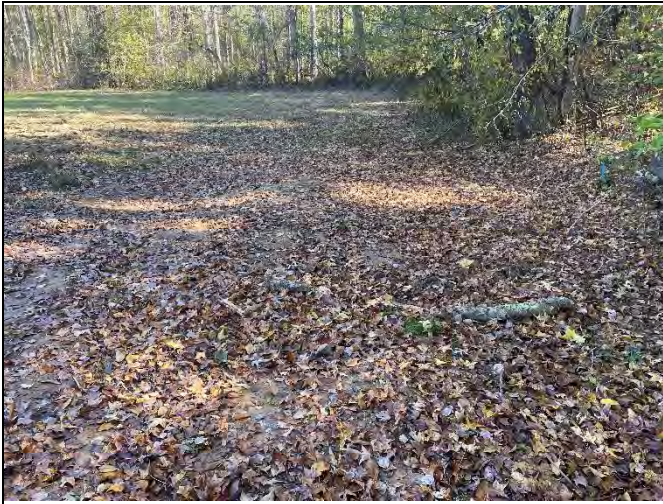
Encroachment area filled back in and graded out (photo from (11/1/23))
