# **Logan Creek Stream Restoration Project Year 1 Monitoring Report**

**Jackson County, North Carolina**

**NCDMS Project ID No. 92515; Contract No. D06046-A**

**Project Info:** Monitoring Year: 1 of 5  
Year of Data Collection: November 2015  
Year of Completed Construction: May 2015  
Submission Date: May 2016

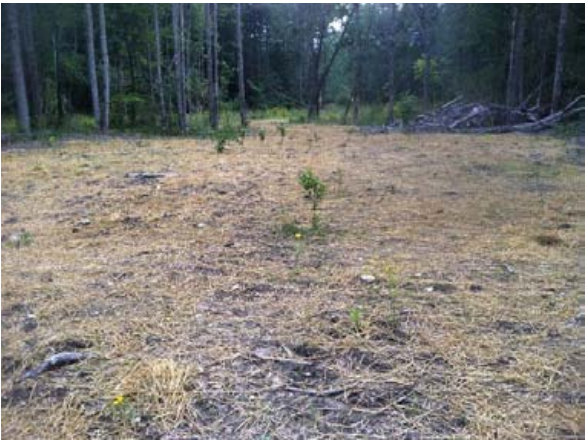
| Table 8. Vegetative Problem Areas | | | |
|---|---|--|---|
| Bare Flood Plain | Near Station 4+00, most of the area is outside of the easement. | This area was the soil stockpile area during construction. It has been seeded multiple times. Good coverage of trees but lacking in herbaceous vegetation. Had begun to grow some going into fall. | 1 and 2 |

Photo 1. VPA 1 - Area near station 4+00 showing bare area of former construction entrance and soil stockpile area. Notice multiple trees.

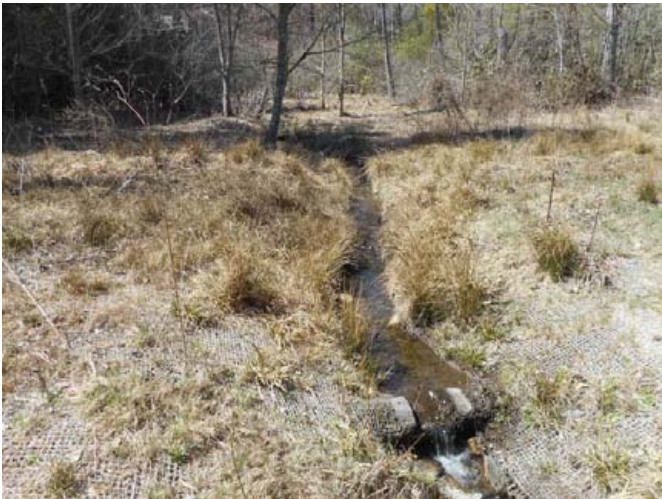
Photo 56. UT8, Photo Point 28 – Station 1+10 (March 2016) upstream view from right bank and confluence.

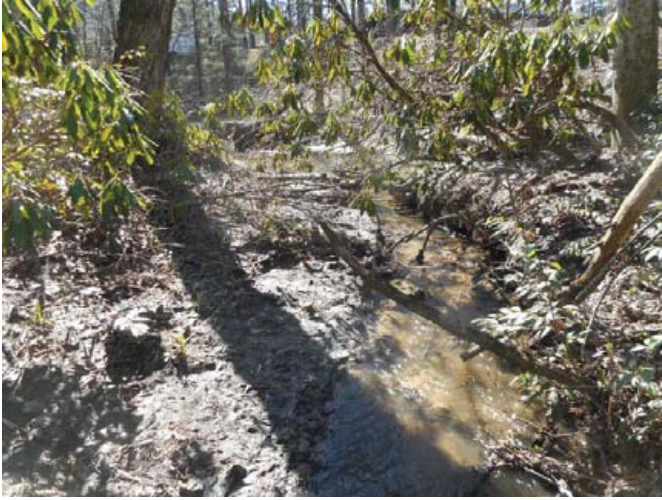
Photo 60. UT5 - Preservation, Photo Point 31 – Station 1+80 (March 2016) downstream view from mid-channel to confluence.

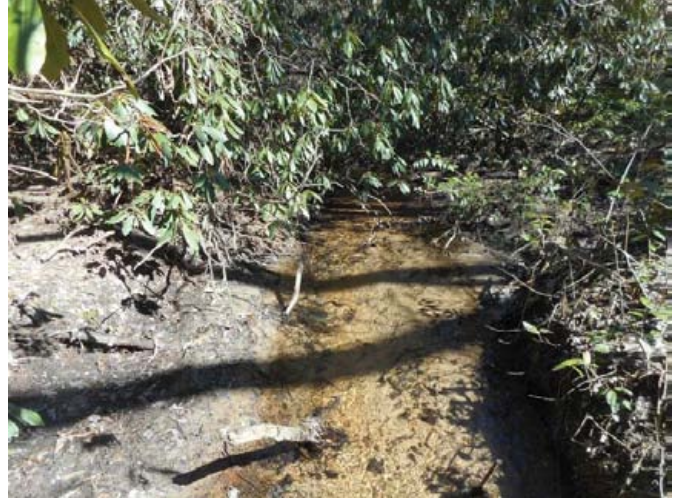
Photo 61. UT5 - Preservation, Photo Point 31 – Station 1+80 (March 2016) upstream view from mid-channel to confluence.

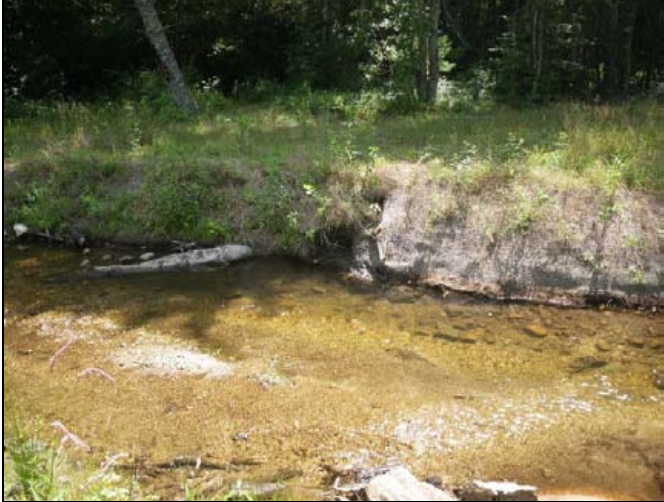
| Table 14. Stream Problem Areas and Photos<br>Logan Creek Stream Restoration Project, Number #92515 | | | |
|--|---|---|---|
| Bank Scour | Station 2+80 | High flows caused a soft place in the clay bank material to scour. (CPA-1 on CCPV) | 1 |

Photo 1. Bank Scour – Station 2+80, Small area of bank scour due to soft place in bank eroding on high flow.

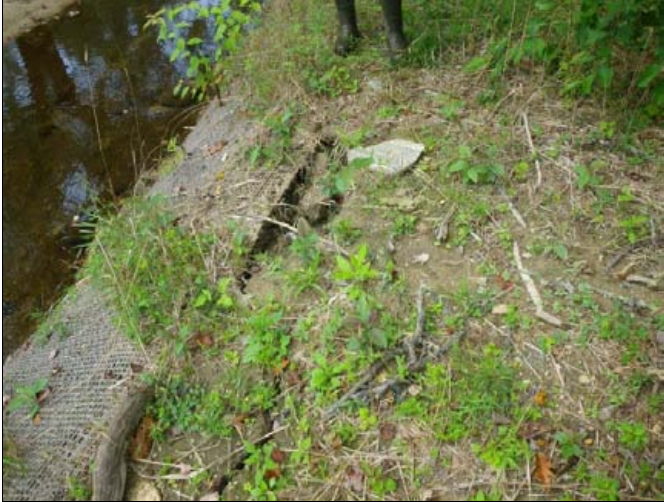
| Table 14. Stream Problem Areas and Photos<br>Logan Creek Stream Restoration Project, Number #92515 | | | |
|--|---|---|---|
| | Station 24+90 | Overland flow from pipe encroachment (see below) caused saturation of bank and bank erosion. (CPA-2 on CCPV) | 2 |

Photo 2. Bank Scour – Station 24+90, Small hole on the floodplain developed from water standing over woody debris of geolift.

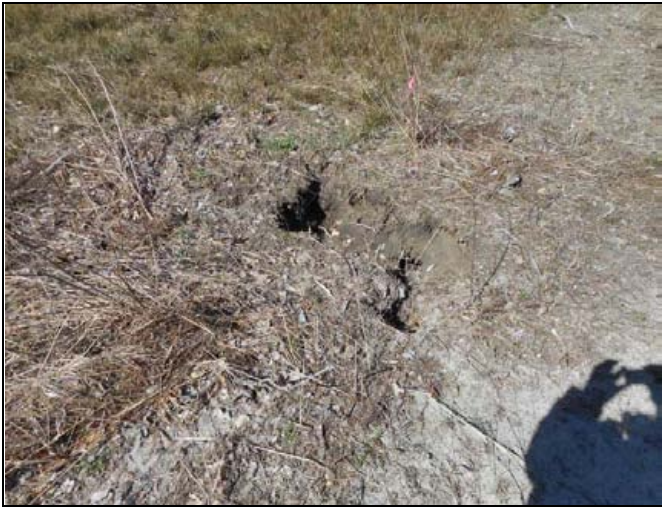
Photo 3. Bank Scour – Station 28+00, Small hole on the floodplain developed from water standing over woody debris of geolift.

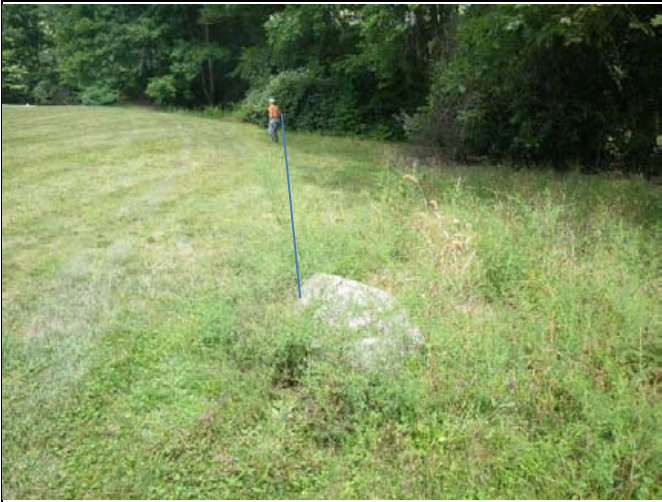
Photo 4. Encroachment – Maintenance workers mowed beyond easement line into buffer.
