Logan Creek Stream Restoration Project Year 2 Monitoring Report

NCDMS Project ID No. 92515; Contract No. D06046-A

Project Info: Monitoring Year: 2 of 5
Year of Data Collection: 2016
Year of Completed Construction: May 2015
Submission Date: December 2016

Report Prepared and Submitted by Michael Baker Engineering, Inc.
797 Haywood Road, Suite 201
Asheville, NC 28806

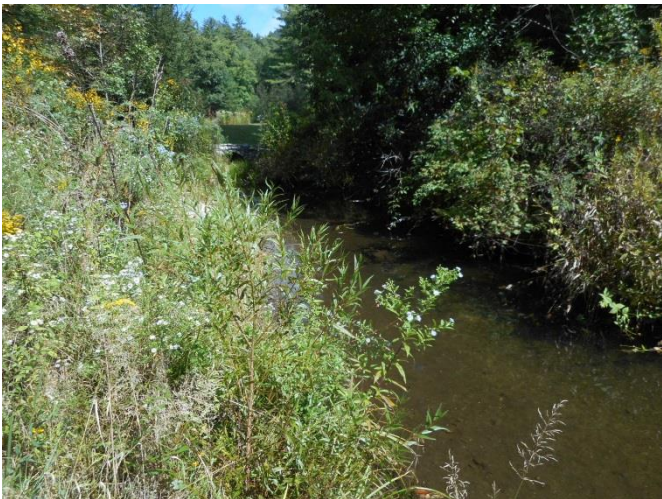
Photo 58. Logan Creek, Photo Point 30 – Station 0+50 (September 2016) upstream view from right bank.

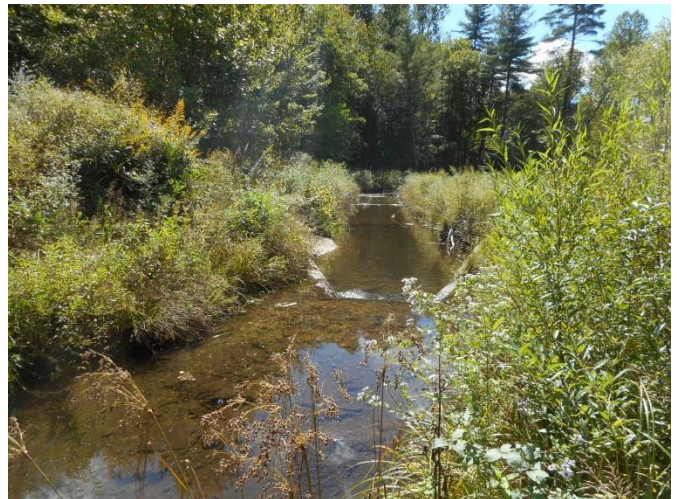
Photo 59. Logan Creek, Photo Point 30 – Station 0+50 (September 2016) downstream view from right bank.

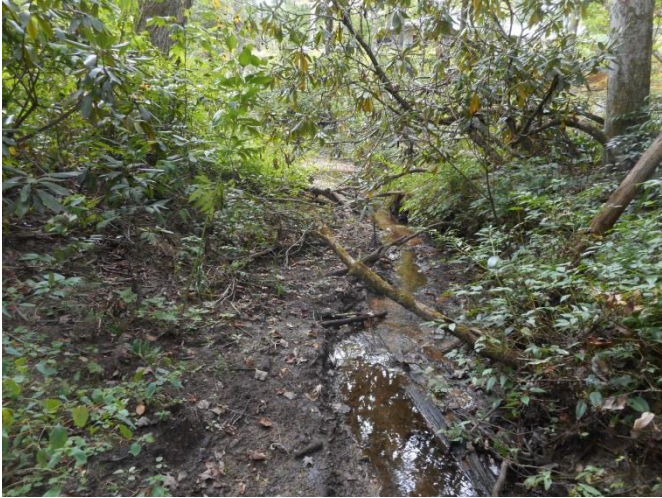
Photo 60. UT5 - Preservation, Photo Point 31 – Station 1+80 (September 2016) downstream view from mid-channel to confluence.

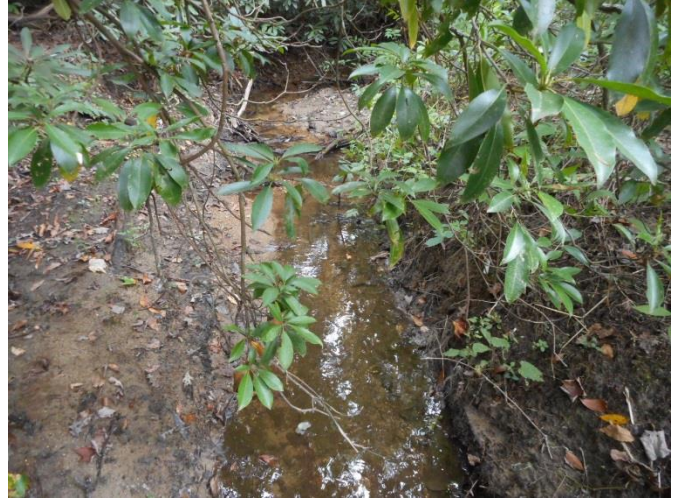
Photo 61. UT5 - Preservation, Photo Point 31 – Station 1+80 (September 2016) upstream view from mid-channel to confluence.

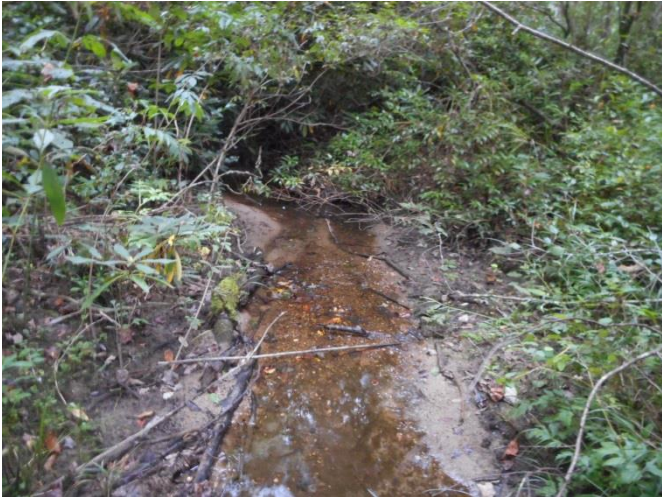
Photo 62. UT5 - Preservation, Photo Point 32 – (September 2016) downstream view from right bank.

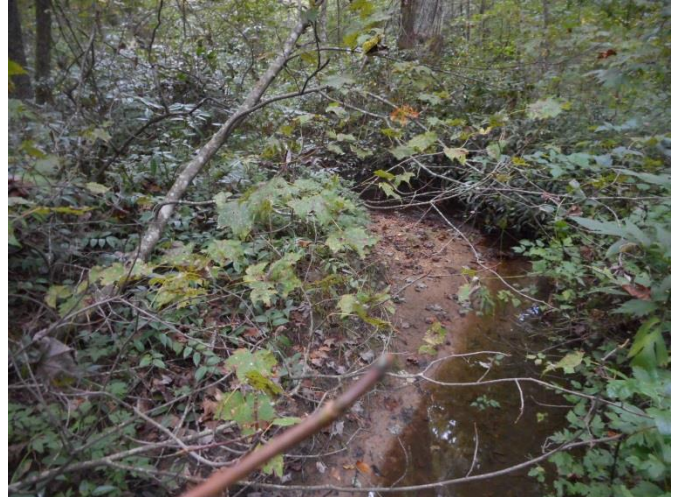
Photo 63. UT5 - Preservation, Photo Point 32 – (September 2016) upstream view from right bank.

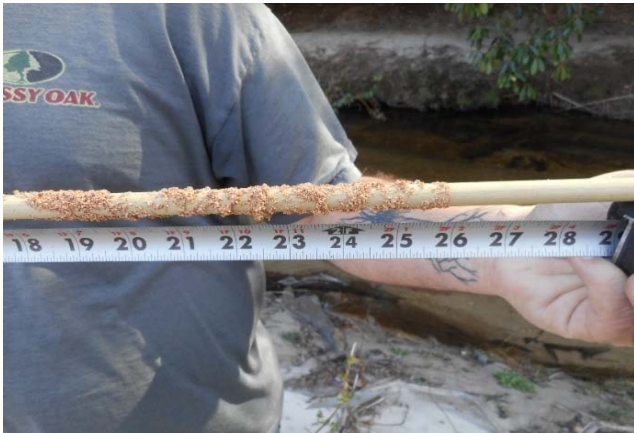
Table ; . Verification of Bankfull or Greater than Bankfull Events			
Logan Creek Stream Restoration Project: DMS Project ID No. 92515			
Date of Data Collection	Date of Event	Method of Data Collection	Gauge Watermark Height (inches)*
			Logan Creek Station 30+00
3/18/2016	2 events: 1 in Dec-15 and 1 in Jan-16.	Crest Gauge	25.75 inches
8/17/2016	undetermined	Crest Gauge	1.56 inches

Crest Gauge reading taken on 3/18/16 shows highest water level recorded during high water events that occurred during December 2015 and January 2016.

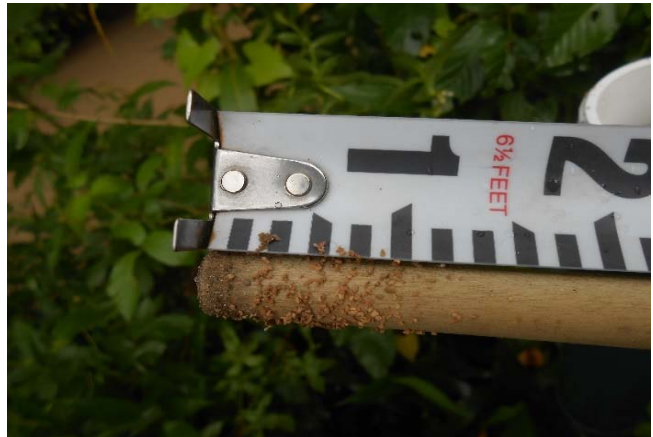
Crest Gauge reading taken on 8/17/16 shows minimal water level rise between 3/18/16 and 8/17/16.

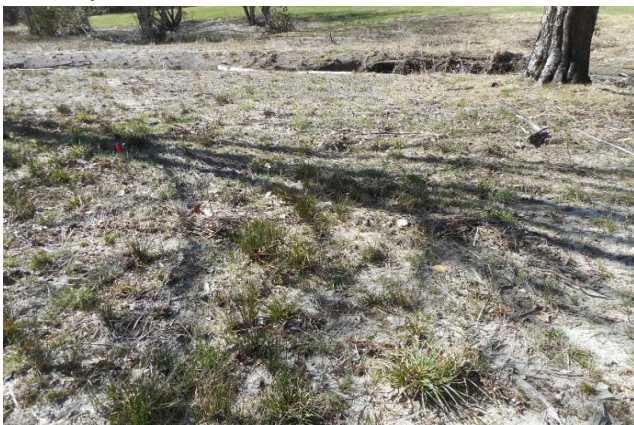
Wreck lines well back from the stream, indicating wide flooding of the floodplain during storms of late December 2015 and early February 2016.

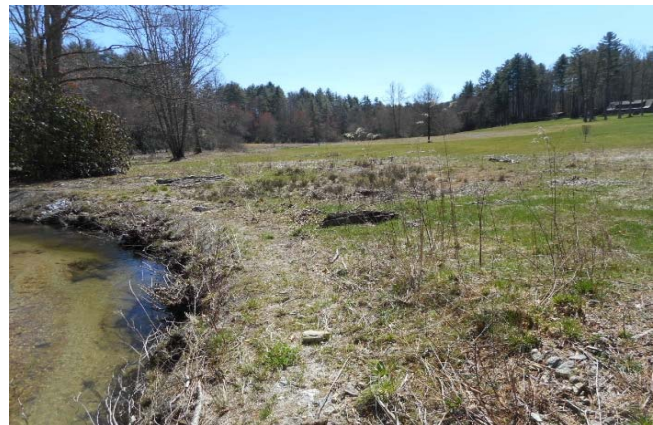
Large debris scattered across the floodplain indicating the significant flooding during storms of late December 2015 and early February 2016.

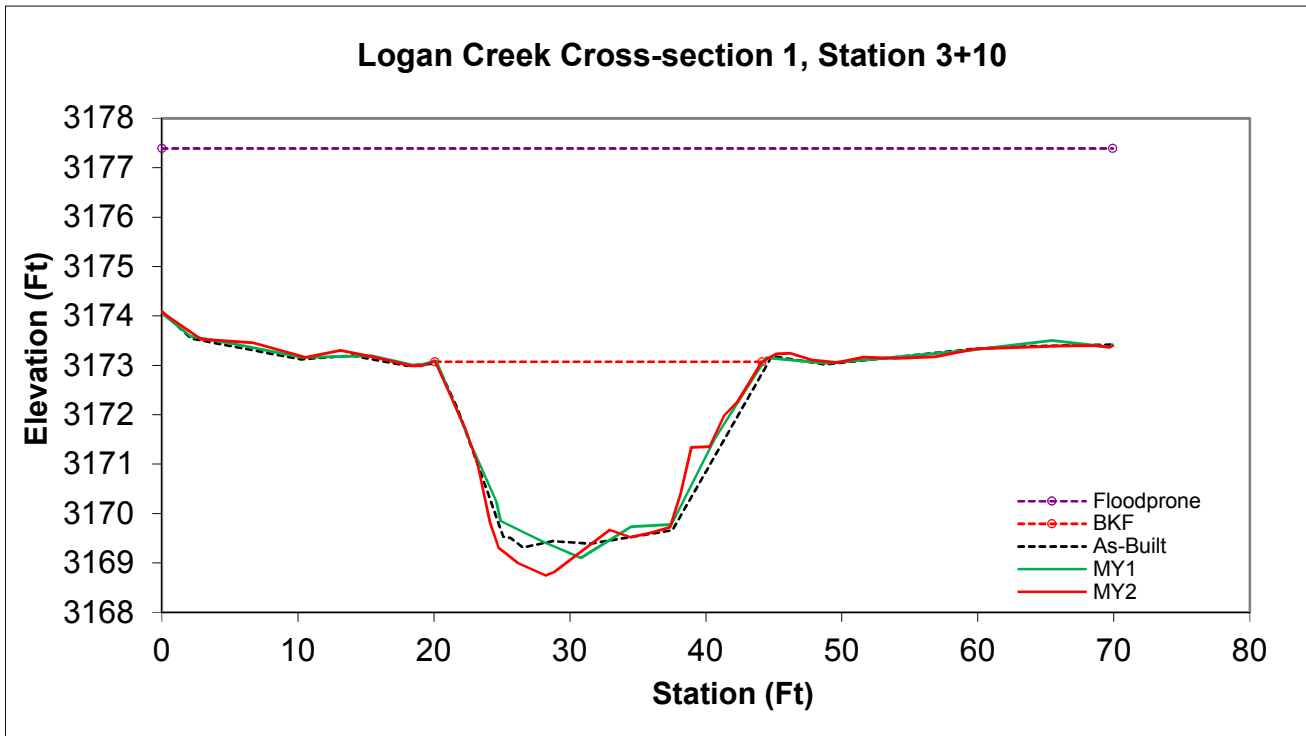
Permanent Cross-Section 1
(MY2 Data - collected October, 2016)

Feature	Stream Type	BKF Area	BKF Width	BKF Depth	Max BKF Depth	W/D	BH Ratio	ER	BKF Elev	TOB Elev
Riffle	E	64.8	24.05	2.7	4.32	8.92	1	2.9	3173.07	3173.16

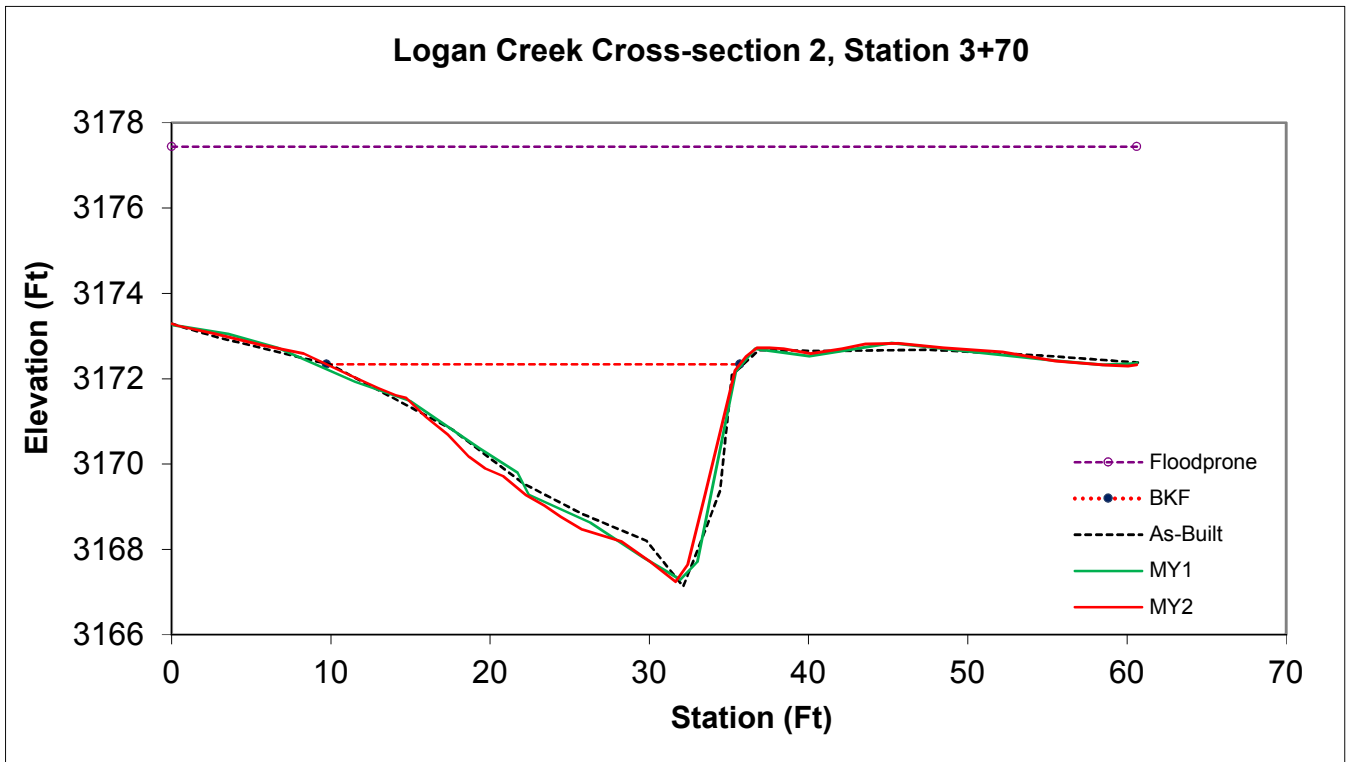
Permanent Cross-Section 2
(MY2 Data - collected October, 2016)

Feature	Stream Type	BKF Area	BKF Width	BKF Depth	Max BKF Depth	W/D	BH Ratio	ER	BKF Elev	TOB Elev
Pool		65.5	25.95	2.52	5.1	10.28	1	2.3	3172.34	3172.59

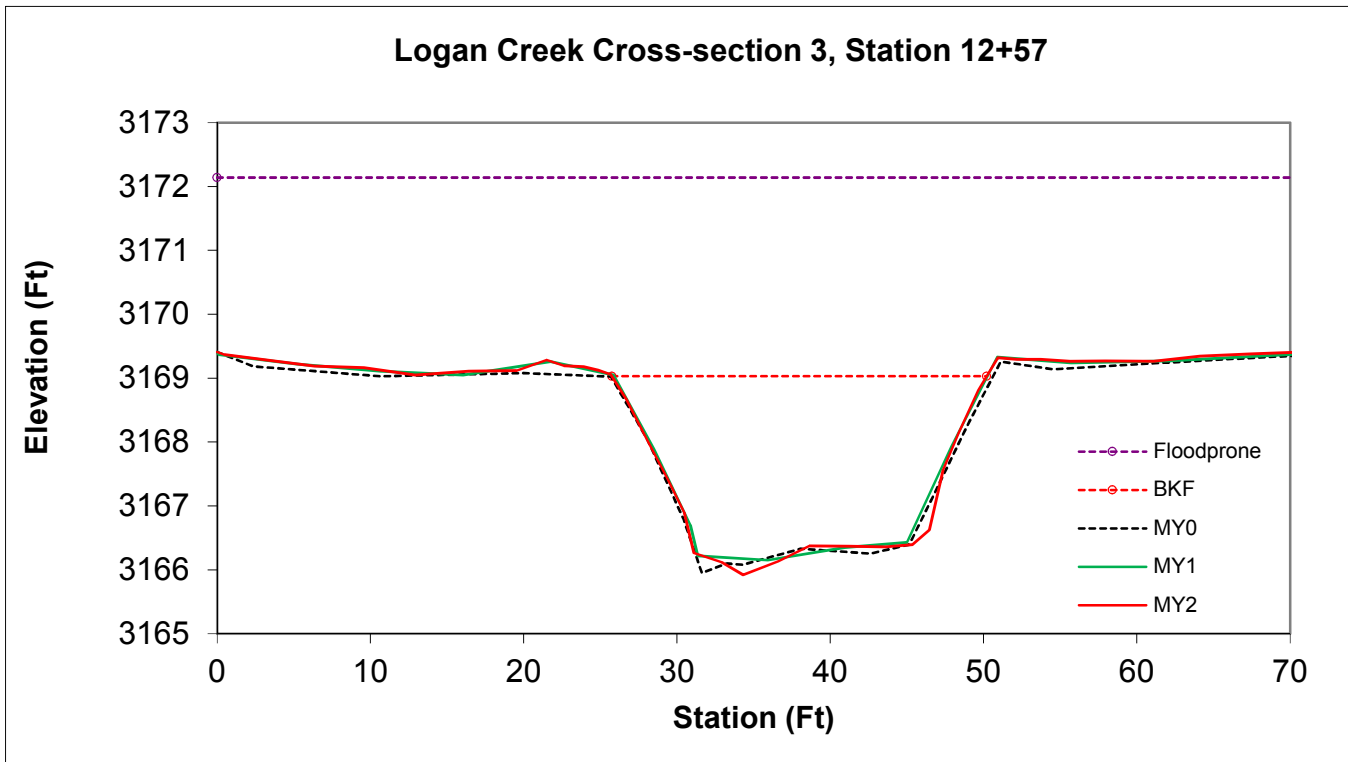
Permanent Cross-Section 3
(MY2 Data - collected October, 2016)

Feature	Stream Type	BKF Area	BKF Width	BKF Depth	Max BKF Depth	W/D	BH Ratio	ER	BKF Elev	TOB Elev
Riffle	E	52.7	24.46	2.15	3.11	11.36	1	4.1	3169.03	3169.18

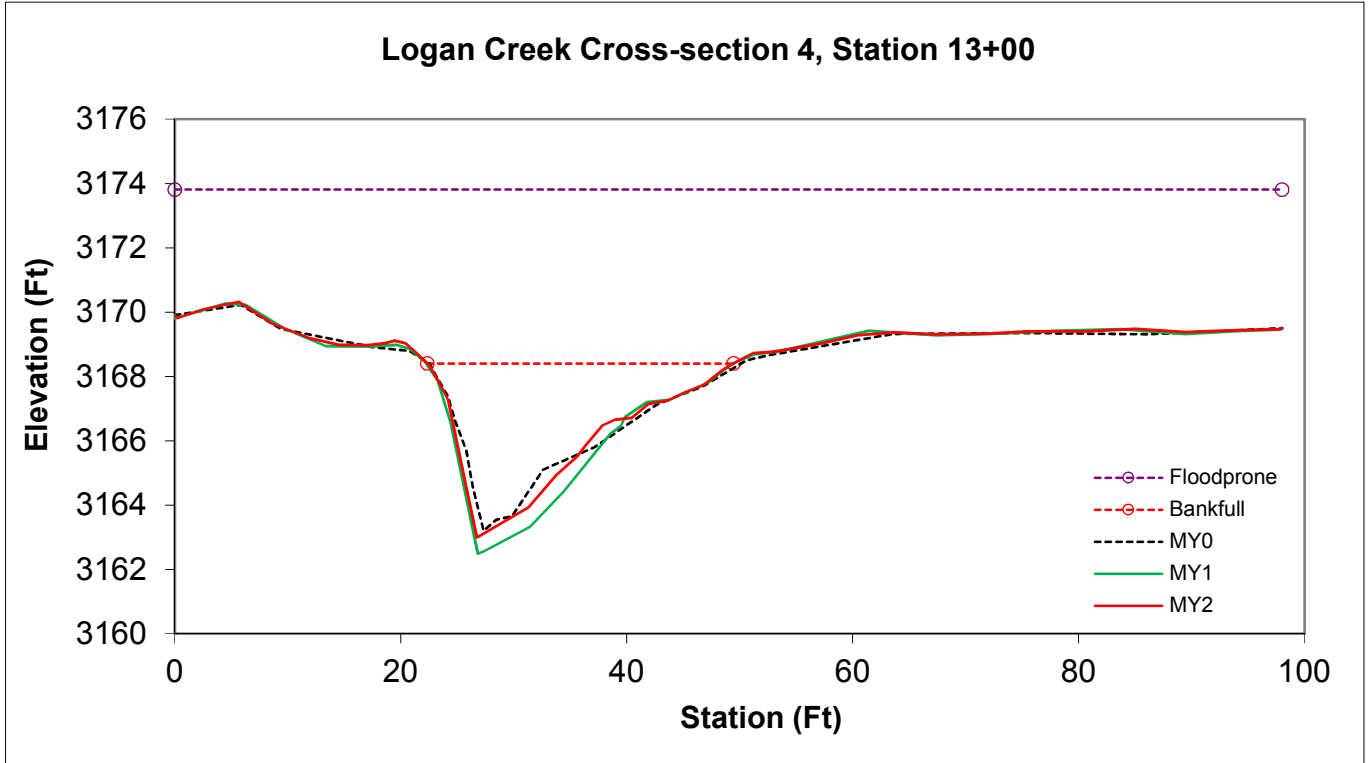
Permanent Cross-Section 4
(MY2 Data - collected October, 2016)

Feature	Stream Type	BKF Area	BKF Width	BKF Depth	Max BKF Depth	W/D	BH Ratio	ER	BKF Elev	TOB Elev
Pool		65.4	27.09	2.41	5.41	11.23	1.1	3.6	3168.4	3168.72

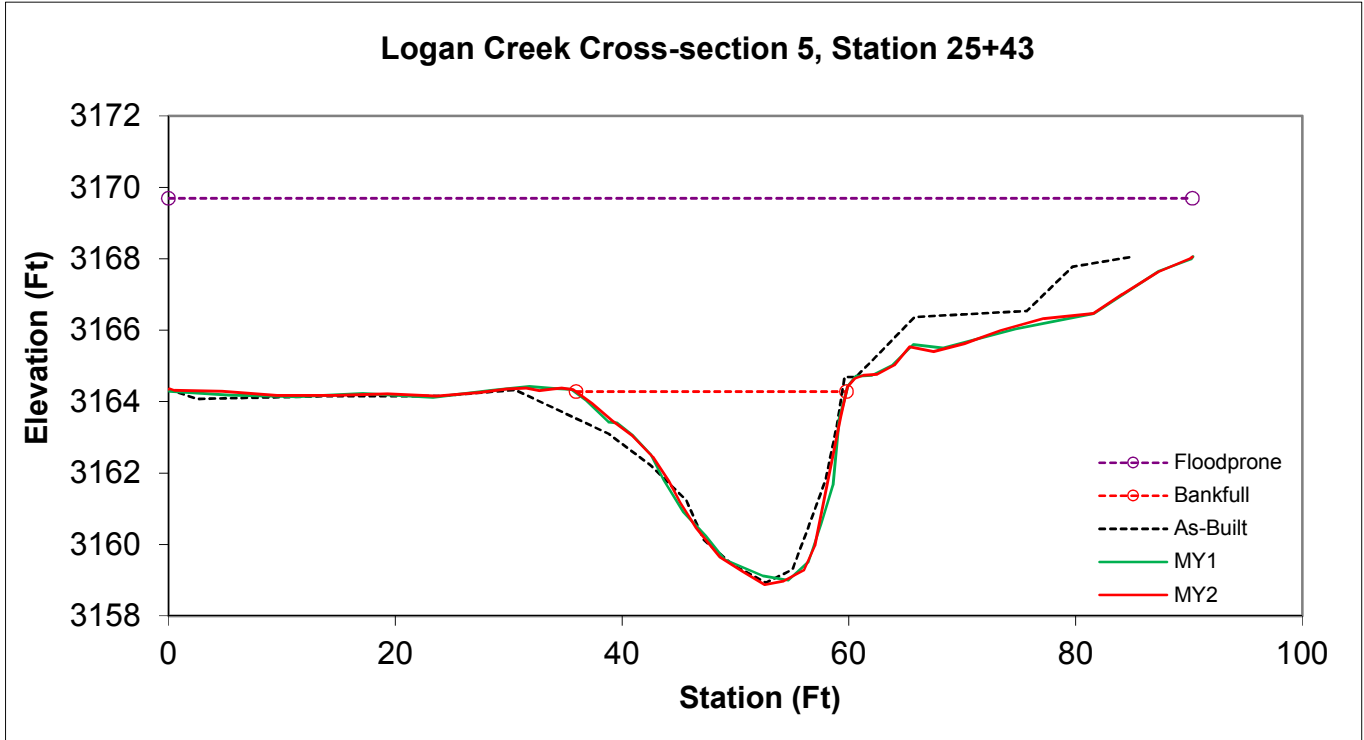
Permanent Cross-Section 5
(MY2 Data - collected October, 2016)

Feature	Stream Type	BKF Area	BKF Width	BKF Depth	Max BKF Depth	W/D	BH Ratio	ER	BKF Elev	TOB Elev
Pool		73.3	23.86	3.07	5.41	7.76	1	3.8	3164.28	3164.34

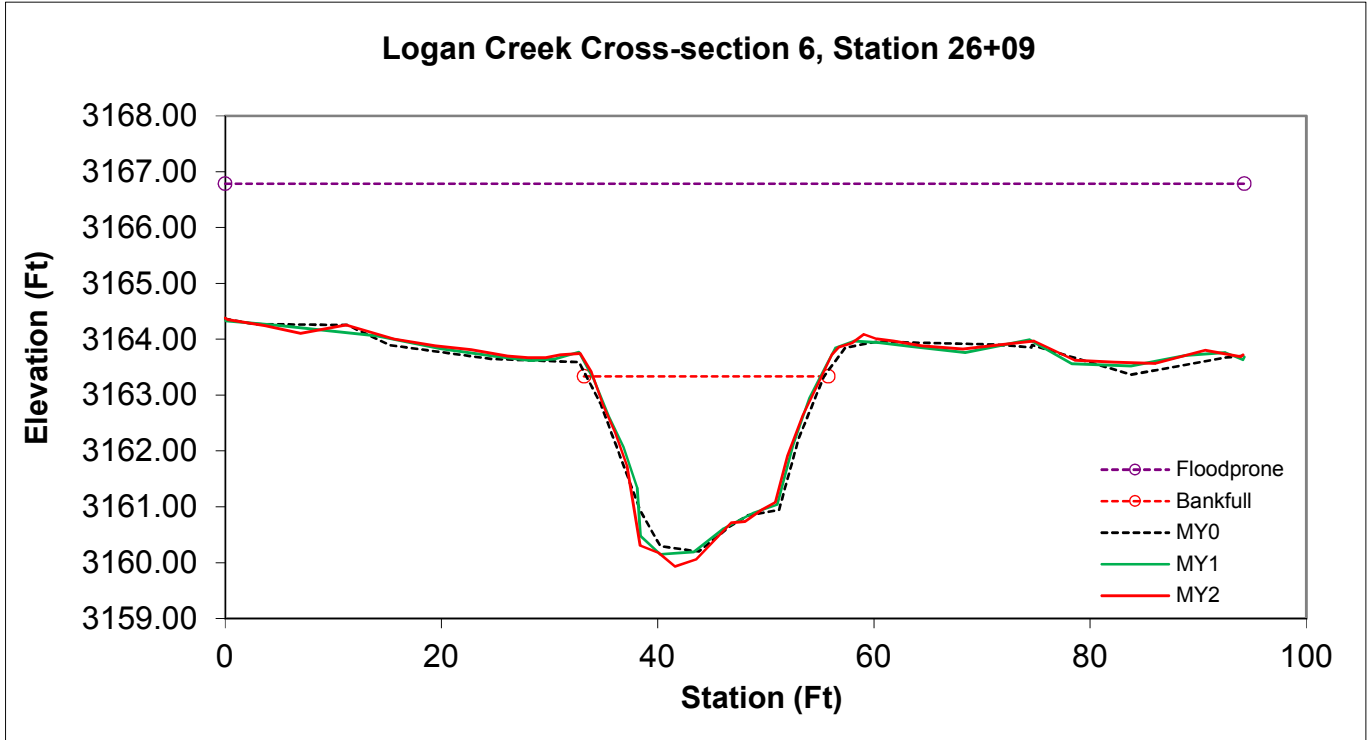
Permanent Cross-Section 6
(MY2 Data - collected October, 2016)

Feature	Stream Type	BKF Area	BKF Width	BKF Depth	Max BKF Depth	W/D	BH Ratio	ER	BKF Elev	TOB Elev
Riffle	E	51.4	22.51	2.28	3.67	9.86	1	4.2	3163.6	3163.75

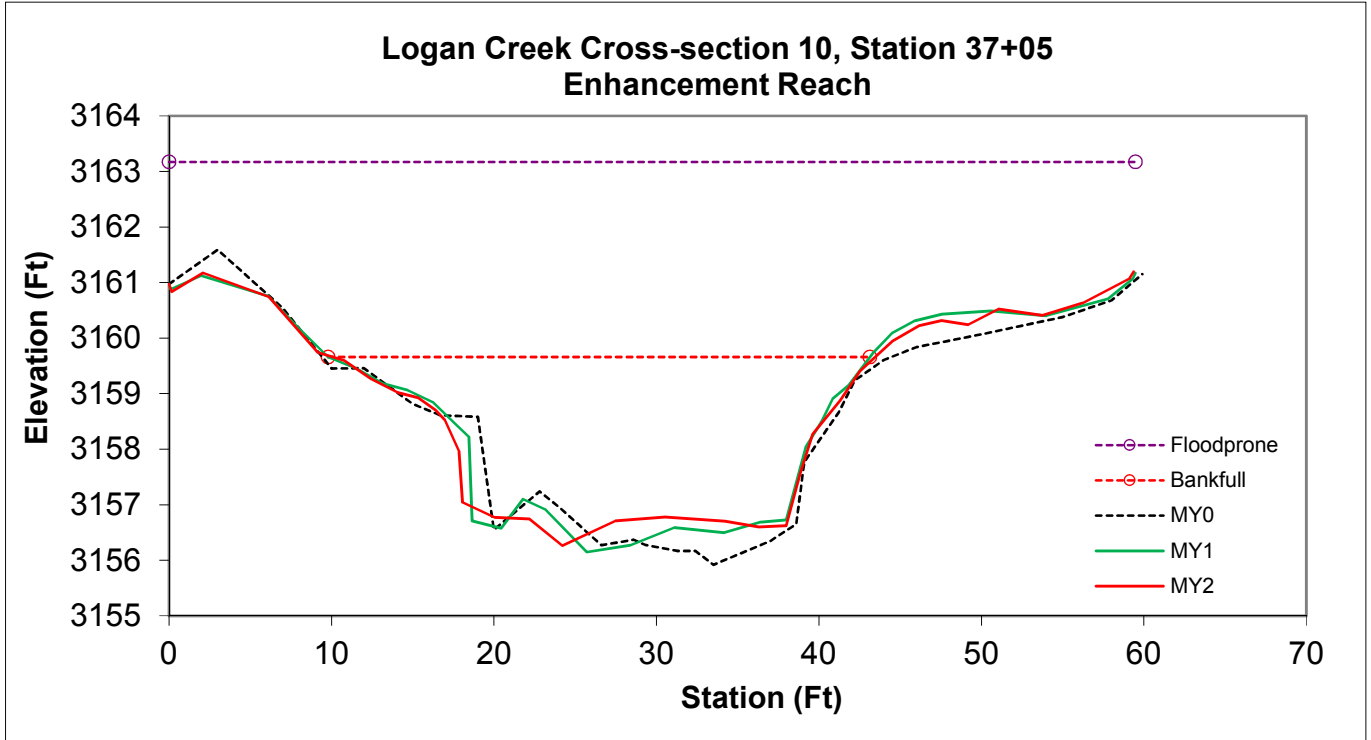
Permanent Cross-section 10
(MY2 Data - collected October, 2016)

Feature	Stream Type	BKF Area	BKF Width	BKF Depth	Max BKF Depth	W/D	BH Ratio	ER	BKF Elev	TOB Elev
Pool		70.3	33.42	2.1	3.39	15.89	1.0	1.8	3159.66	3158.53

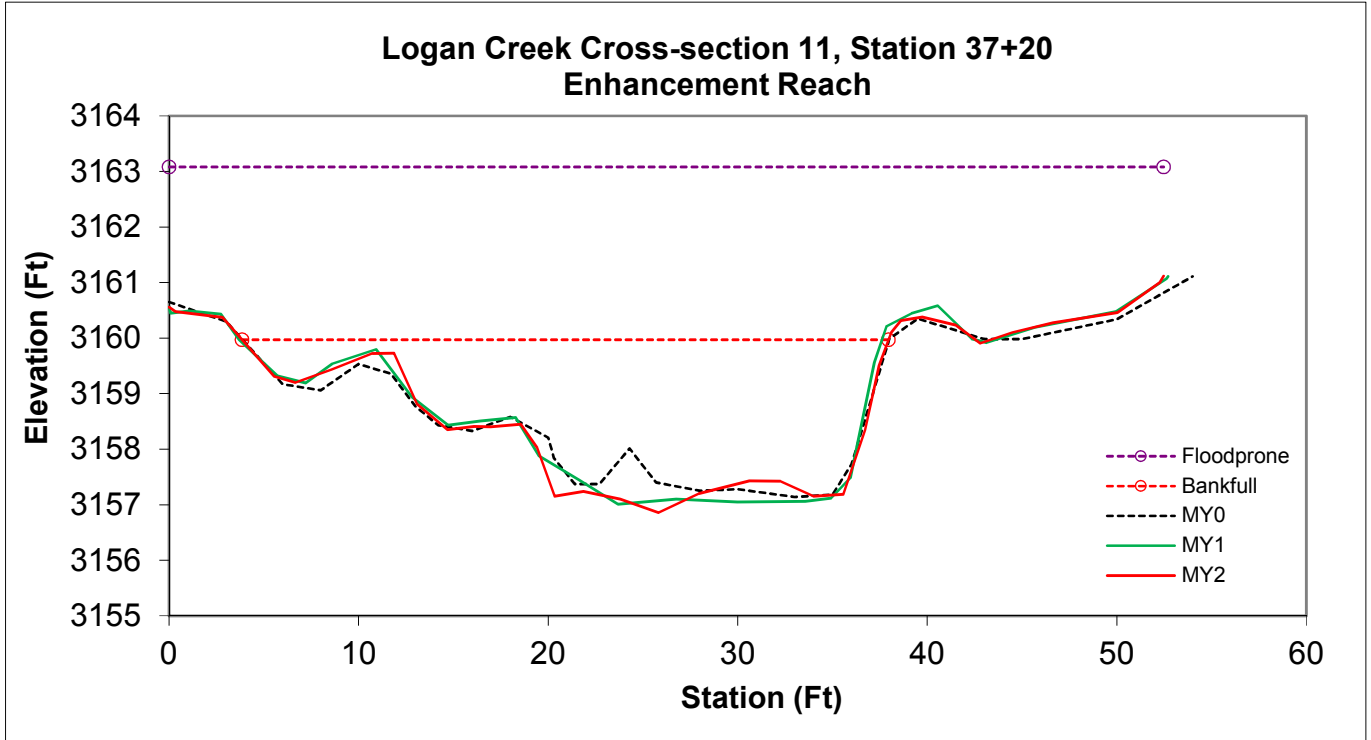
Permanent Cross-section 11
(MY2 Data - collected October, 2016)

Feature	Stream Type	BKF Area	BKF Width	BKF Depth	Max BKF Depth	W/D	BH Ratio	ER	BKF Elev	TOB Elev
Riffle	C	61.8	33.92	1.82	2.96	18.62	1.2	1.6	3159.97	3160.43

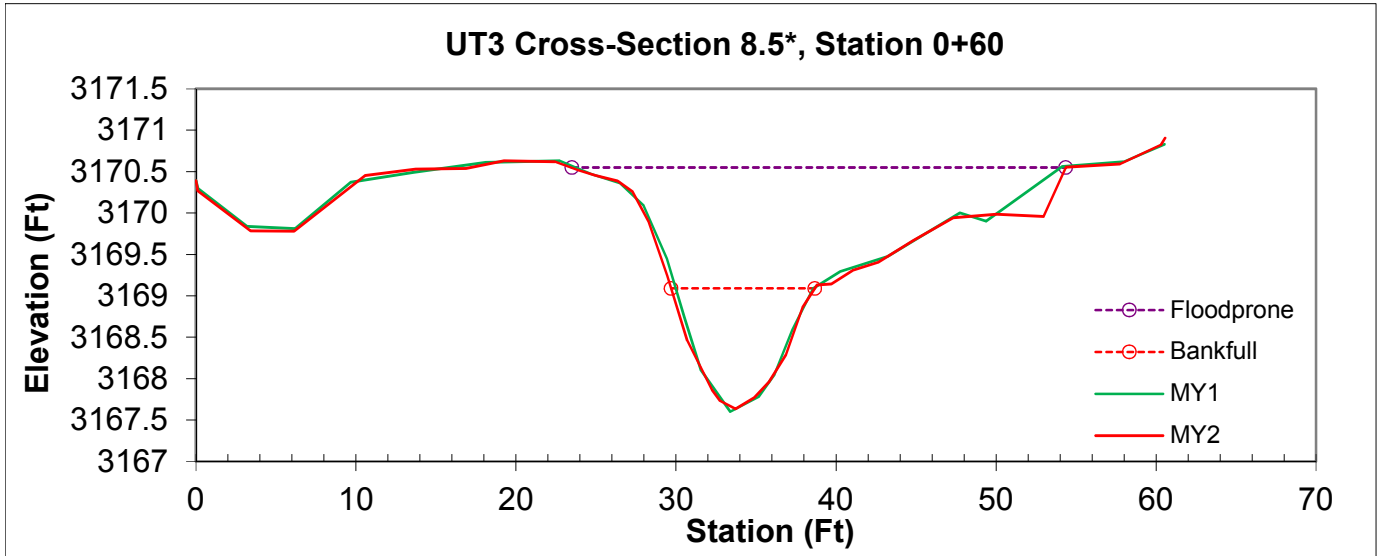
Permanent Cross-section 8.5
(MY2 Data - collected October, 2016)

Feature	Stream Type	BKF Area	BKF Width	BKF Depth	Max BKF Depth	W/D	BH Ratio	ER	BKF Elev	TOB Elev
Pool		8.2	8.98	0.91	1.46	9.88	1	3.4	3169.09	3169.13

* This Pool cross-section was not taken for the baseline but was added during MY1 survey and will be continued each year going forward. The station location has been changed to match the MY2 profile.

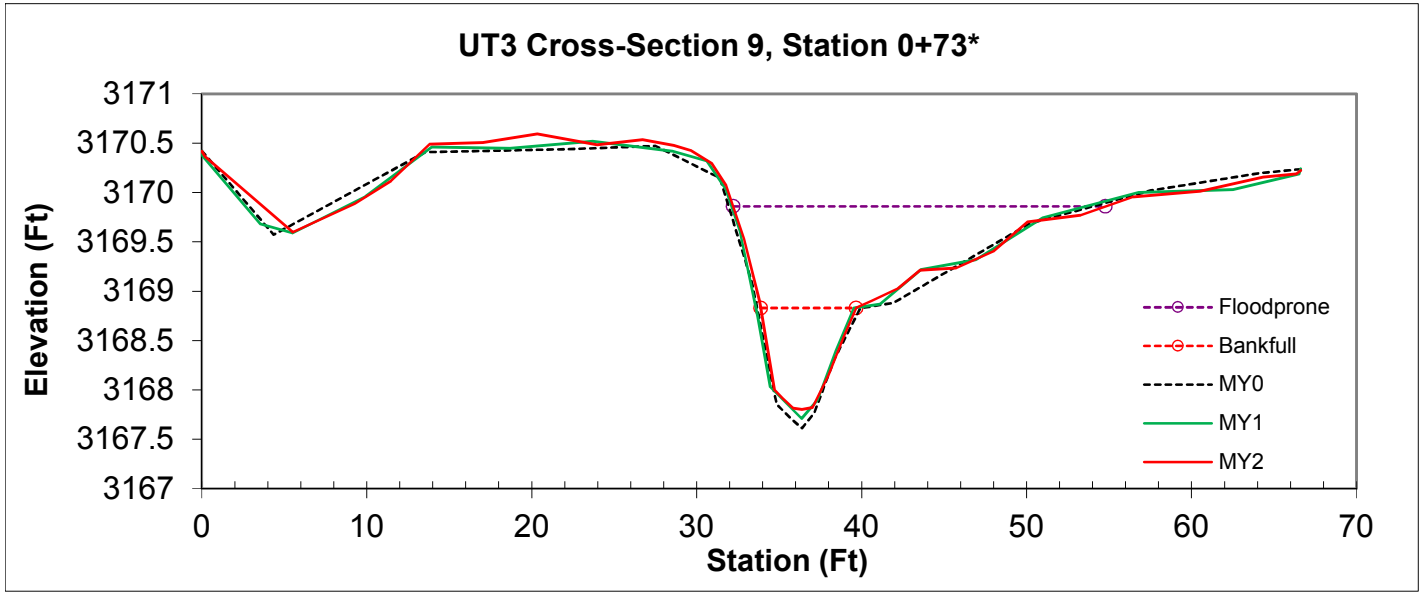
Permanent Cross-section 9
(MY2 Data - collected October, 2016)

Feature	Stream Type	BKF Area	BKF Width	BKF Depth	Max BKF Depth	W/D	BH Ratio	ER	BKF Elev	TOB Elev
Riffle	E	4	5.78	0.69	1.03	8.43	1	3.9	3168.83	3168.83

* Station location is modified with this report because station reported in previous reports was incorrect.
