Subject: Response to DMS comments on the Year 3 Monitoring Report Review for the Logan Creek Stream Restoration Project; Savannah River Basin - CU# 03060101; Jackson County, North Carolina; NCDMS Project # 92515; Contract No. D06046-A

Logan Creek Stream Restoration Project Year 3 Monitoring Report

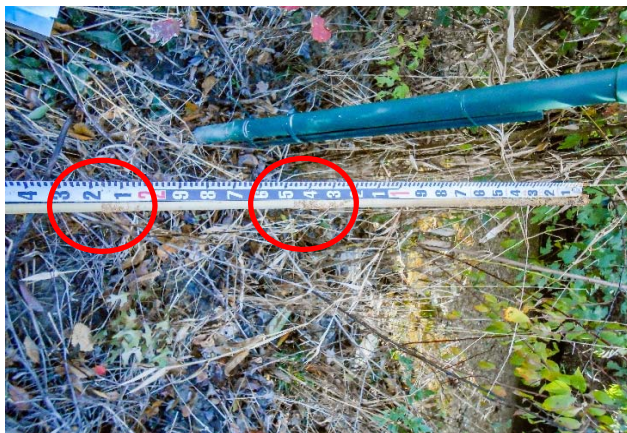
Crest Gauge reading taken on 10/26/2017 shows two distinct high flow events, the lower of which likely occurred on 10/23/2017.

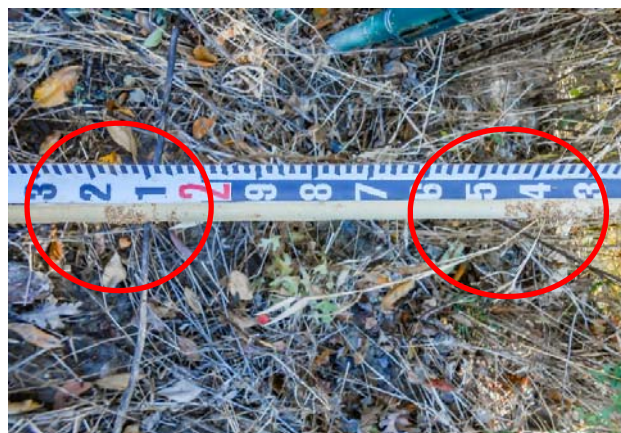
Crest Gauge reading taken on 10/26/2017 shows two distinct high flow events, the lower of which likely occurred on 10/23/2017.

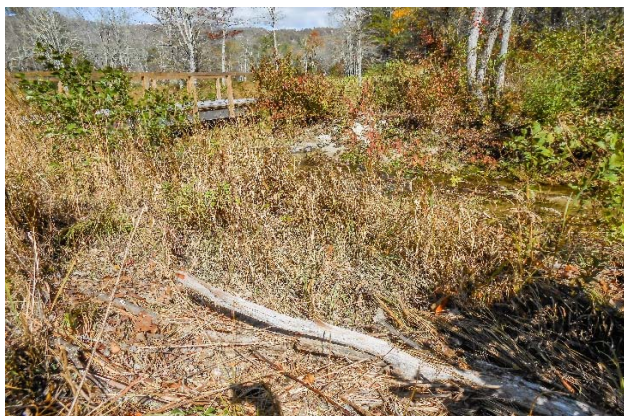
Wrack lines well back from the stream, indicating wide flooding of the floodplain during the storms in October.

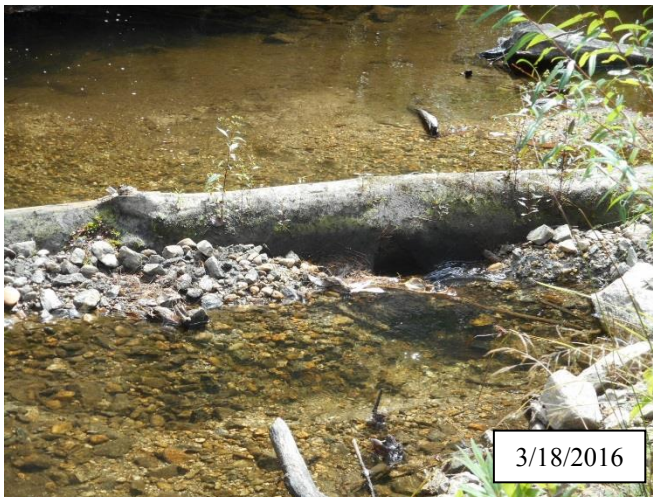
Photo 3. CPA 2-2 – Station 2+00, Piping of log structure after the fabric sealing this structure tore during flooding of December and January.

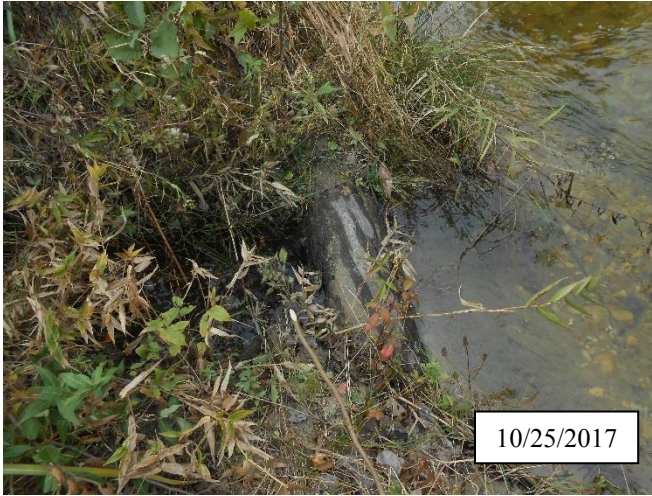
Photo 17. CPA 3-5 – Station UT8 00+40, piping of log structure on UT-8 near the confluence of UT-8 and Logan Creek

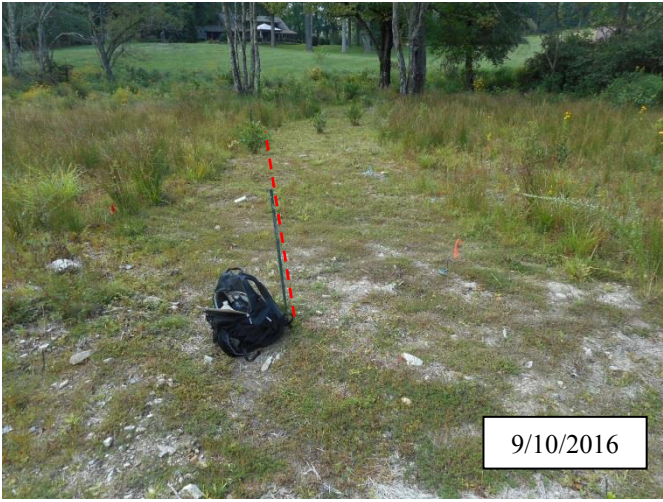
Photo 18. EA 2-1 – Maintenance workers mowed the nature trail wider than the 4-6 feet that had been agreed to earlier, near stationing 23+00 to 28+00.

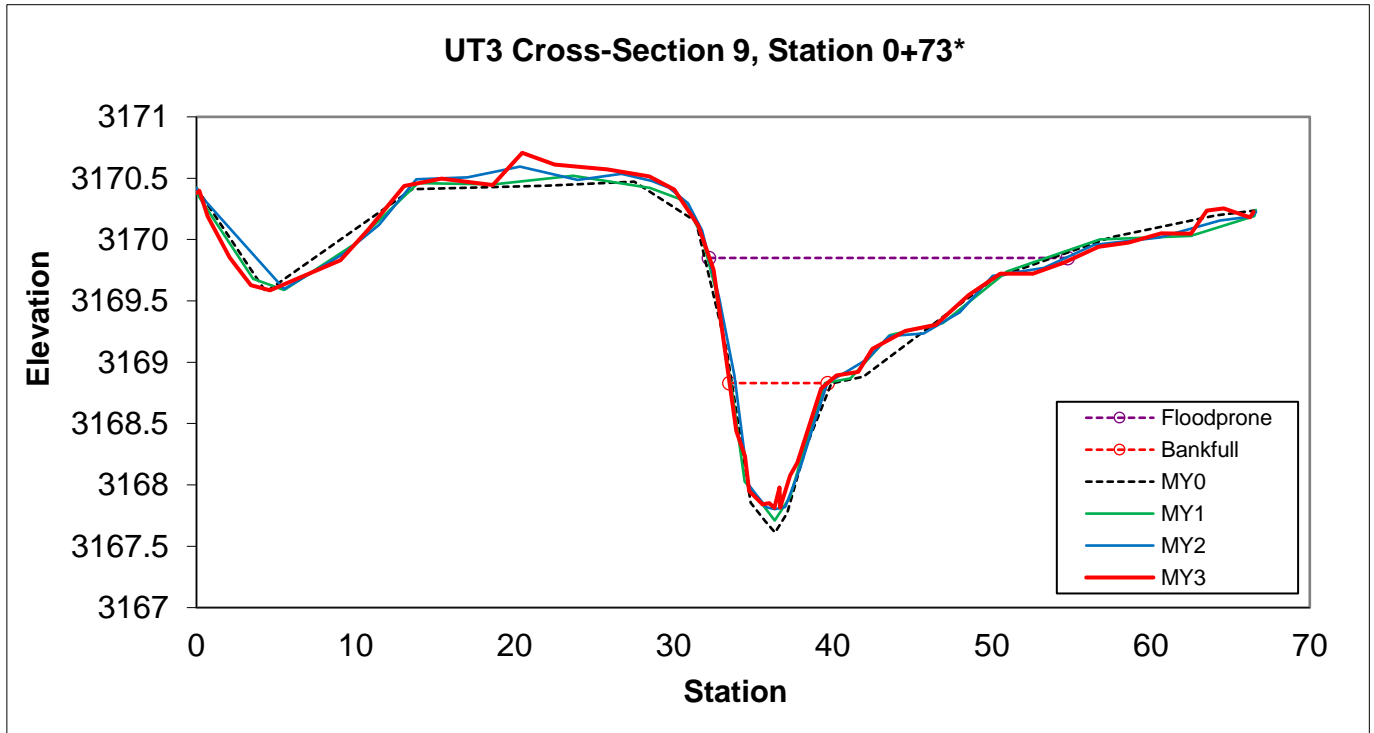
**Permanent Cross-section 9
(MY3 Data - collected October, 2017)**

* The stationing shown on this cross section plot has been changed to correct an error shown in the MY0 plots.

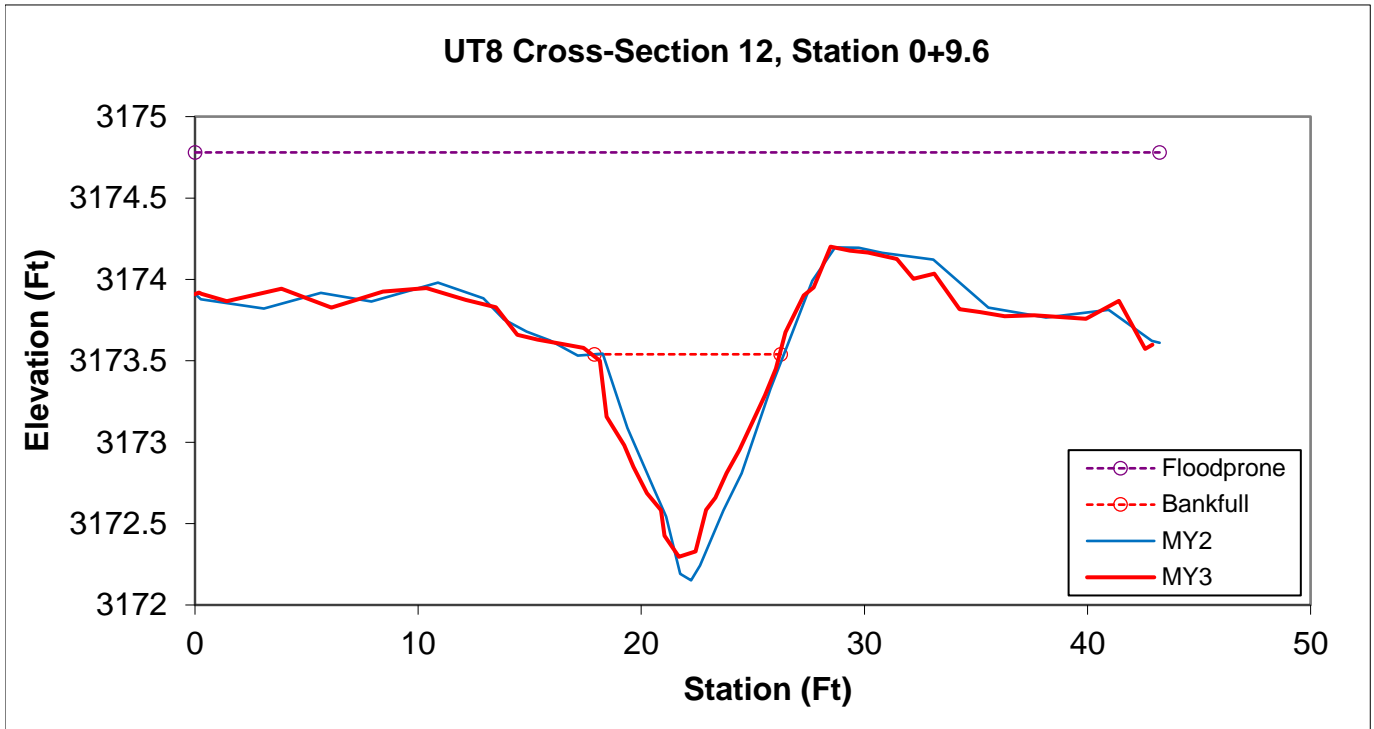
**Permanent Cross-section 12
(MY3 Data - collected October, 2017)**

This Riffle cross-section was not taken during AB or MY1 surveys but was added in MY2 and will be continued each year going forward.

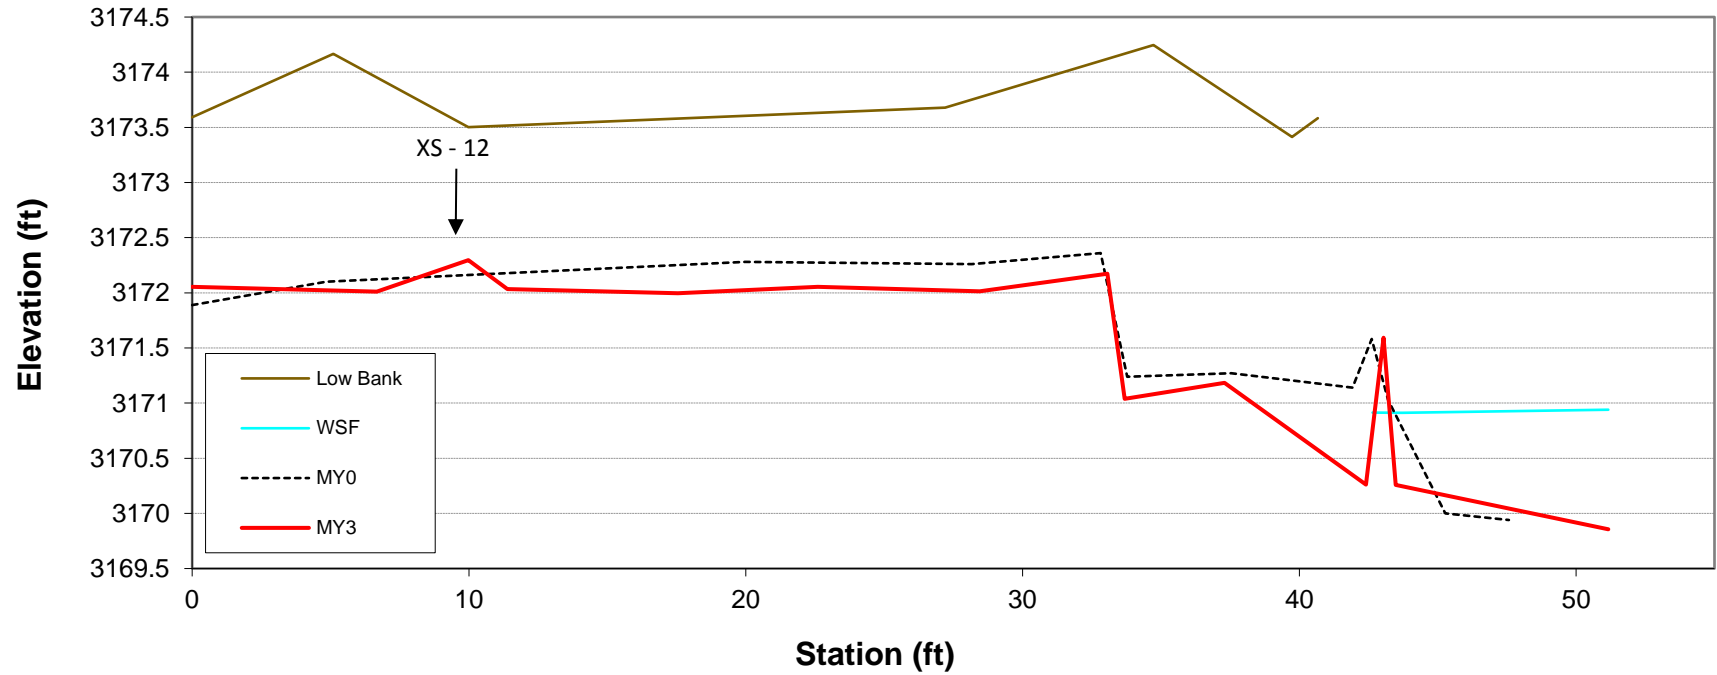
Profile of UT8, Station 0+00 to 0+45 Compared to As-built Thalweg*

* Note: This profile was added in MY1 because restoration credit is being requested for this reach. However, the profile on this reach was not surveyed and included in the MY0 report.
