Logan Creek Stream Restoration Project Year 4 Monitoring Report - Final

Jackson County, North Carolina

NCDMS Project ID No. 92515; Contract No. D06046-A

Project Info: Monitoring Year: 4 of 5
Year of Data Collection: 2018
Year of Completed Construction: May 2015
Submission Date: December 2018

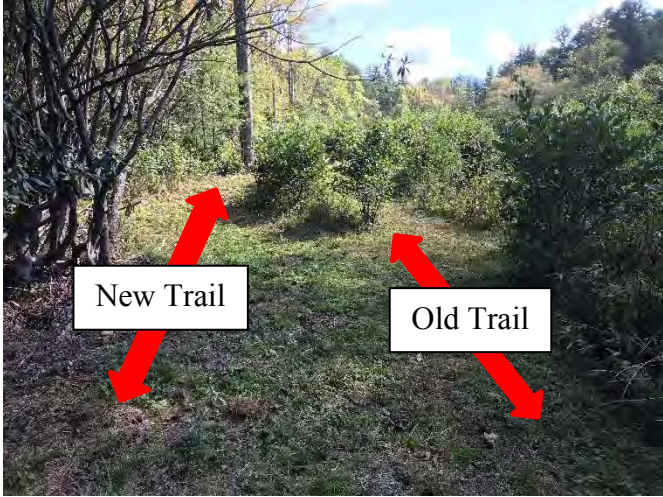
Photo 17. Trail Relocation 1 facing downstream – Trail was relocated away from the stream.

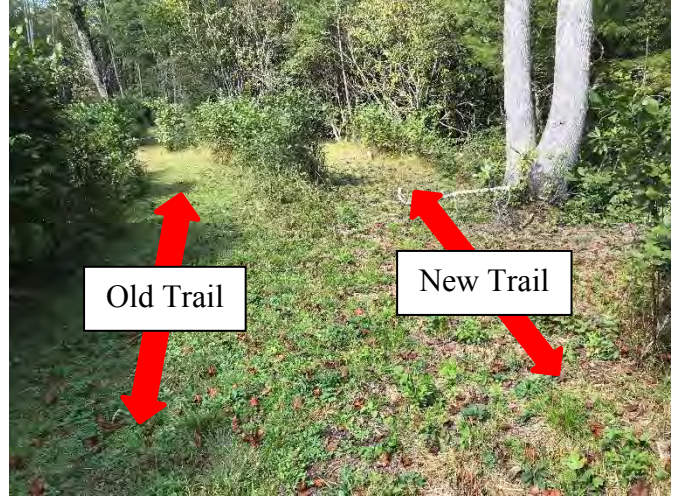
Photo 18. Trail Relocation 1 facing upstream– Trail was relocated away from stream.

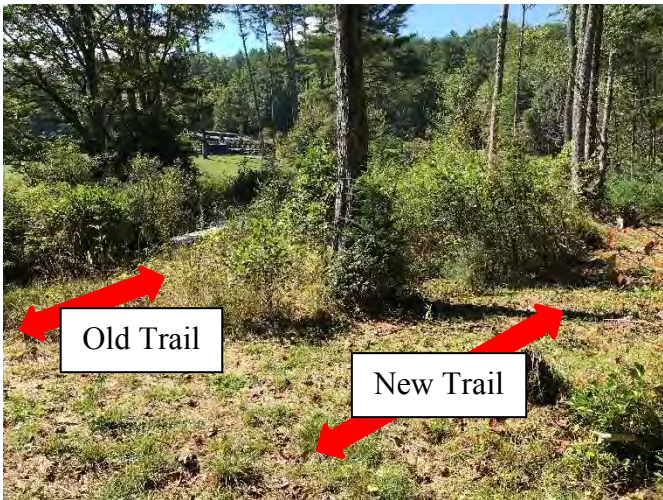
Photo 19. Trail Relocation 2 facing downstream – Trail was relocated away from the stream, bridge will be moved.

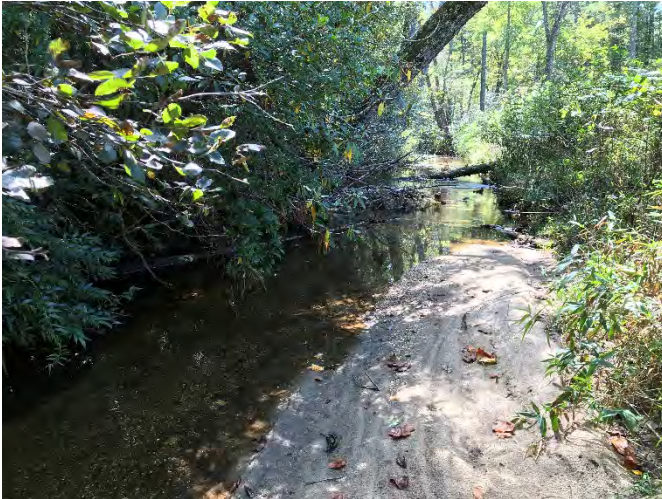
Photo 15. Logan Creek Photo Point 8a – Station 29+75 (October 5, 2018) downstream view from right bank.

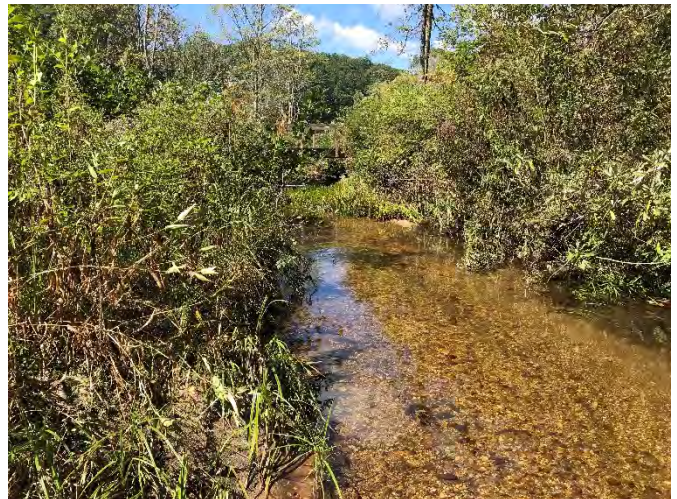
Photo 16. Logan Creek Photo Point 8b – Station 29+25 (October 5, 2018) upstream view from right bank.

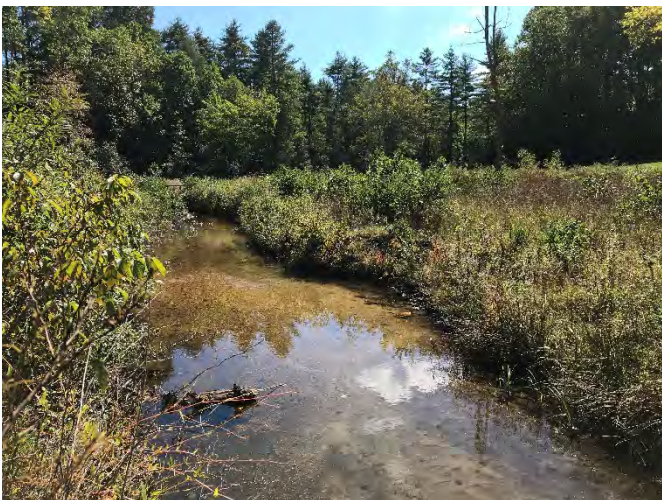
Photo 17. Logan Creek Photo Point 9 – Station 26+75 (October 5, 2018) downstream view from left bank.

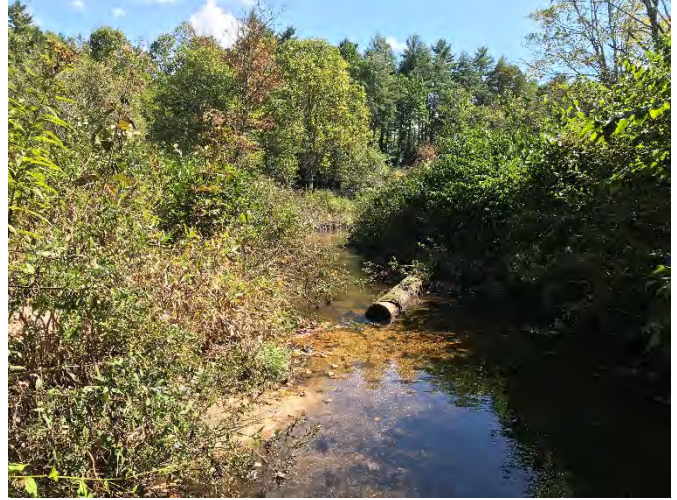
Photo 20. Logan Creek Photo Point 10 – Station 25+25 (October 5, 2018) downstream view from right bank.

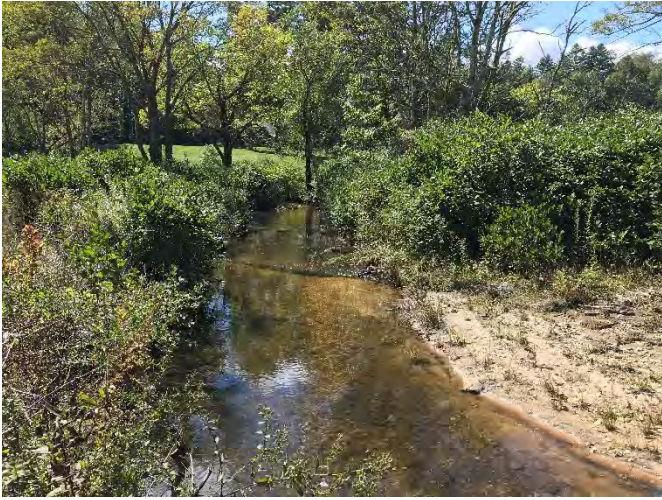
Photo 21. Logan Creek Photo Point 11 – Station 23+20 (October 5, 2018) downstream view from left bank.

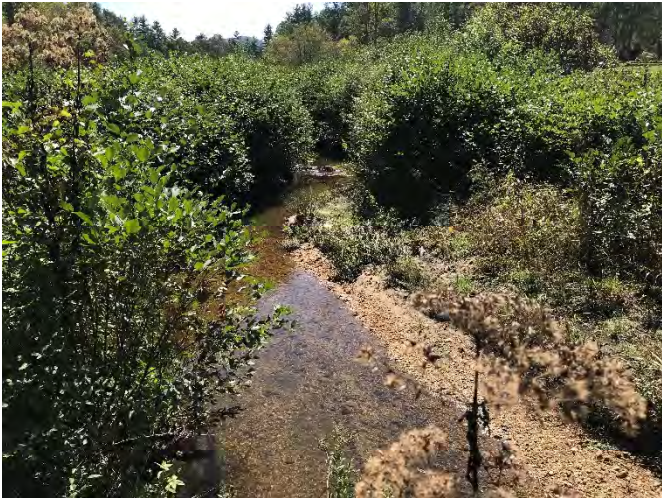
Photo 27. Logan Creek Photo Point 14 – Station 19+45
(October 5, 2018) downstream view from left bank.

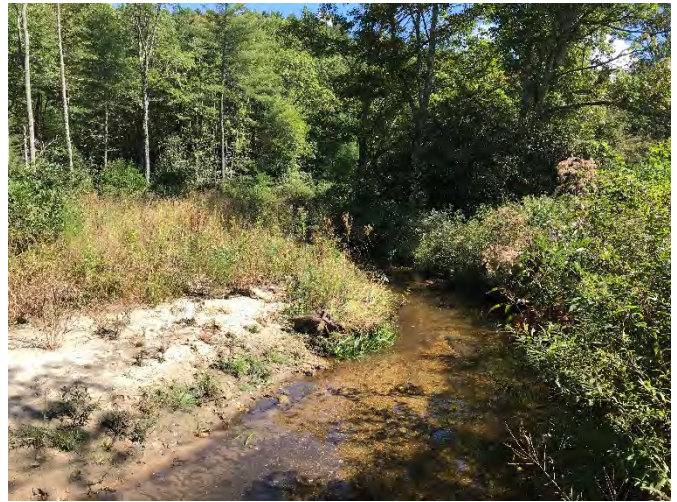
Photo 34. Logan Creek Photo Point 17 – Station 15+50
(October 5, 2018) downstream view from right bank.

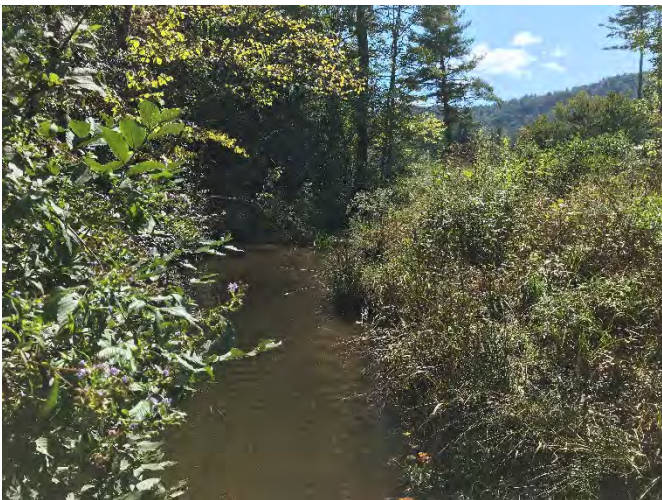
Photo 35. Logan Creek Photo Point 18 – Station 12+90
(October 5, 2018) downstream view from left bank.

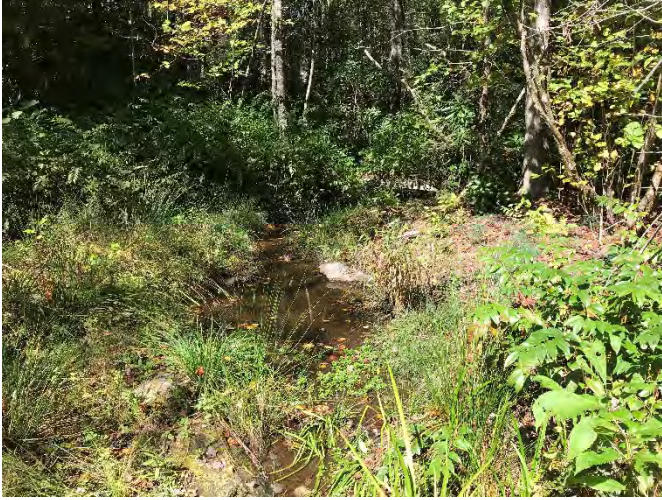
Photo 37. UT3 Photo Point 19 – Station 00+60 (October 5, 2018) upstream from left bank.

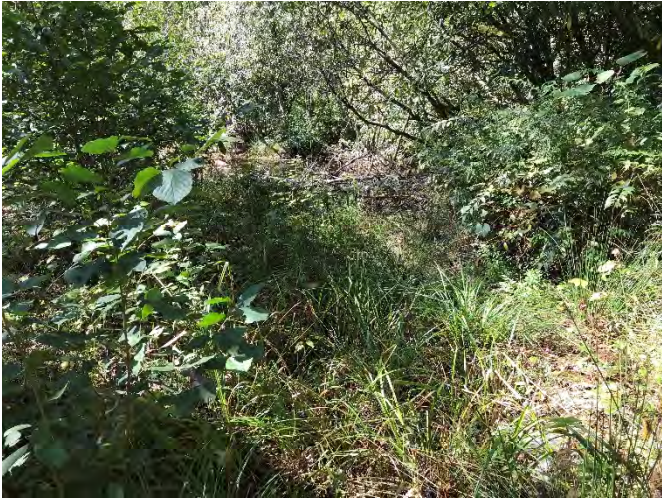
Photo 39. UT3 Photo Point 19 – Station 00+60 (October 5, 2018) upstream from left bank to vernal pool.

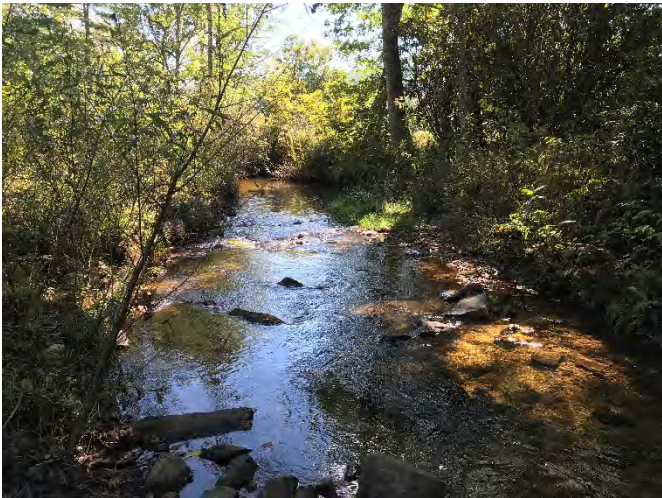
Photo 40. Logan Creek Photo Point 20 – Station 10+60 (October 5, 2018) downstream view from left bank.

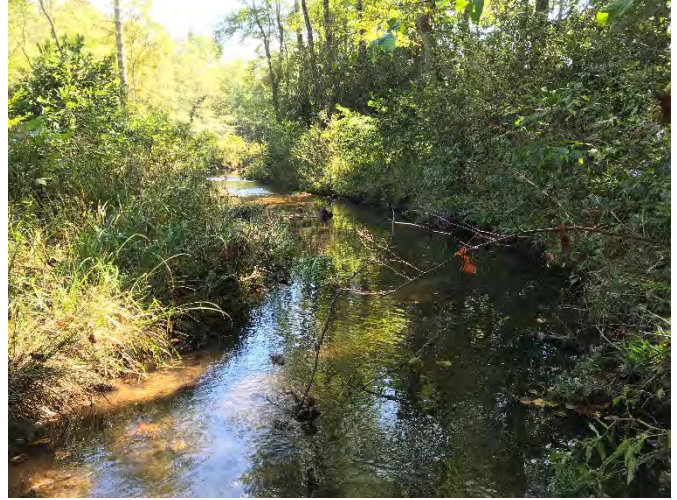
Photo 43. Logan Creek Photo Point 21 – Station 9+40 (October 5, 2018) downstream view from right bank.

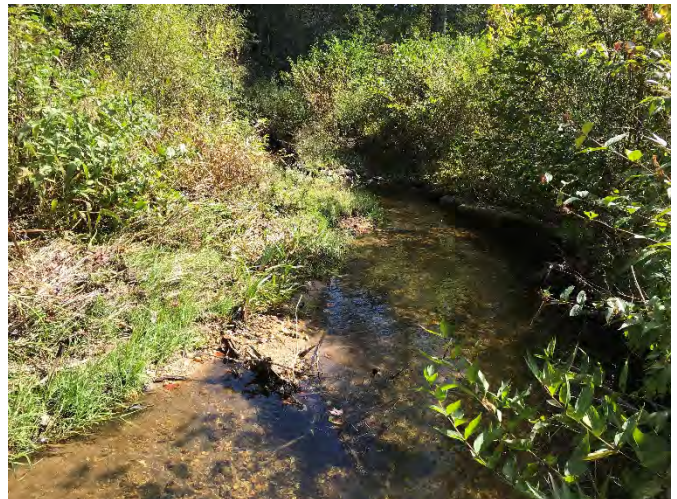
Photo 53. Logan Creek, Photo Point 26 – Station 3+80 (October 5, 2018) downstream view from right bank.

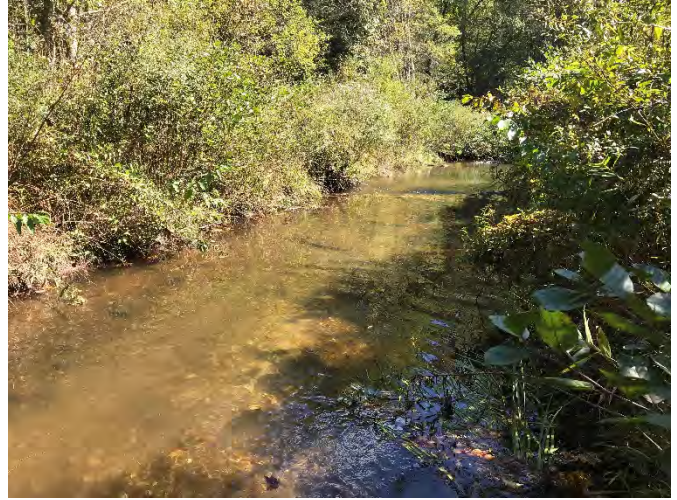
Photo 55. Logan Creek, Photo Point 27 – Station 1+12 (October 5, 2018) downstream view from right bank.

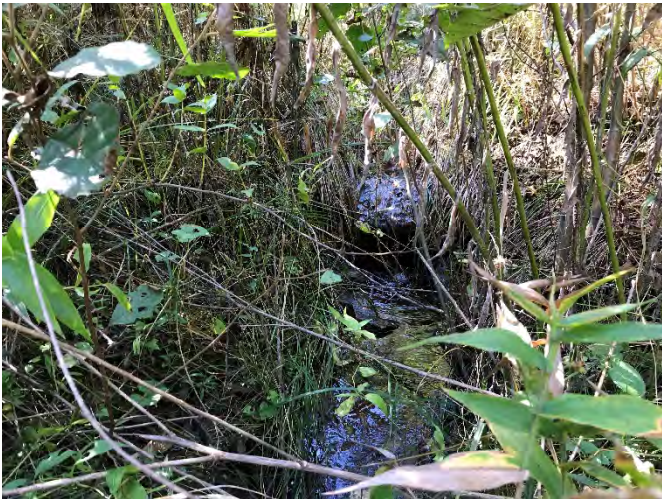
Photo 56. UT8, Photo Point 28 – Station 1+10 (October 5, 2018) upstream view from right bank and confluence.

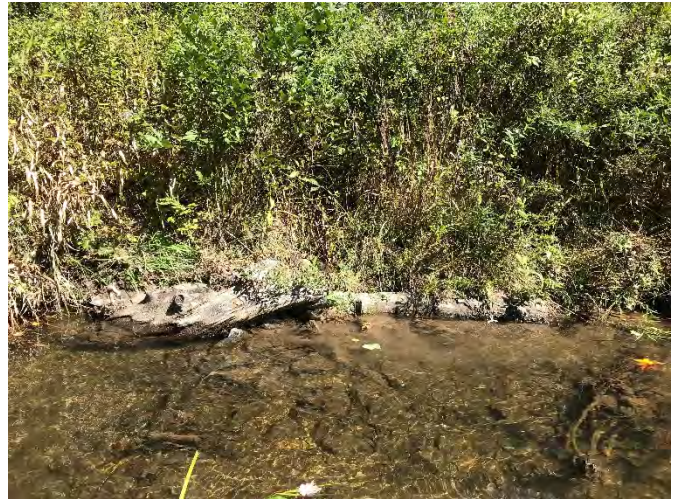
Photo 57. UT1, Photo Point 29 – Station 0+50 (October 5, 2018) view upstream and confluence.

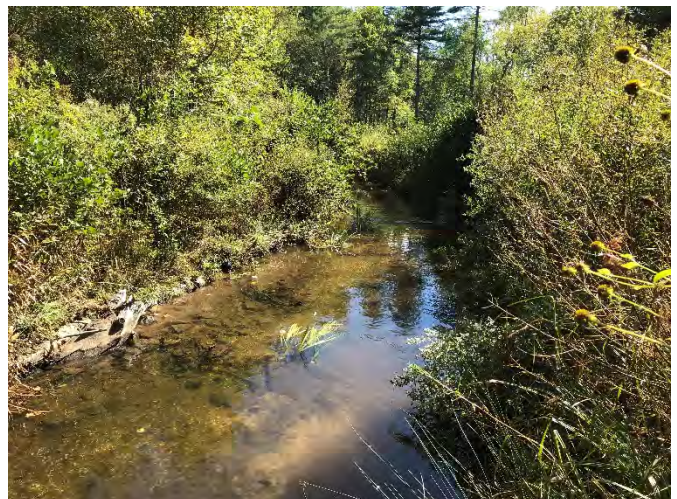
Photo 59. Logan Creek, Photo Point 30 – Station 0+50 (October 5, 2018) downstream view from right bank.

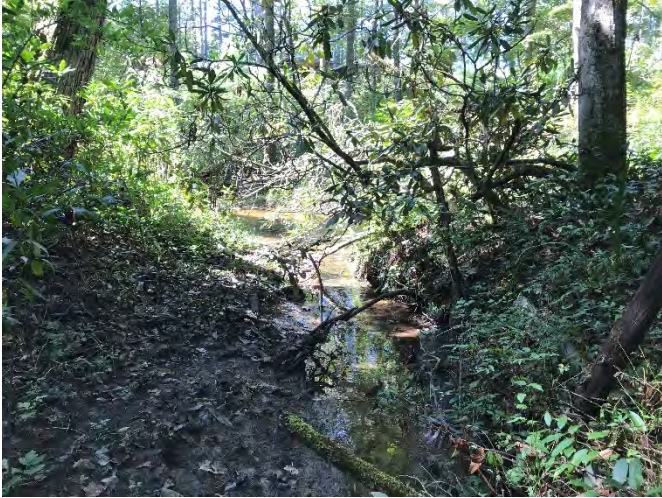
Photo 60. UT5 - Preservation, Photo Point 31 – Station 1+80 (October 5, 2018) downstream view from mid-channel to confluence.

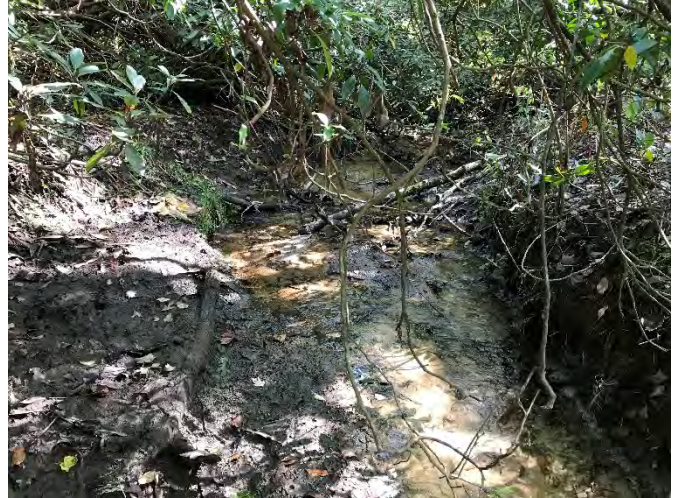
Photo 61. UT5 - Preservation, Photo Point 31 – Station 1+80 (October 5, 2018) upstream view from mid-channel to confluence.

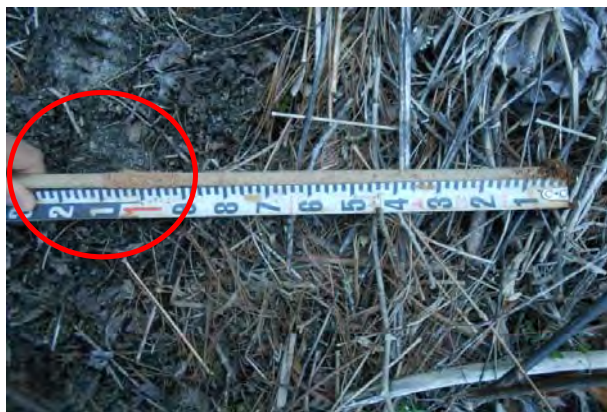
Crest Gauge reading taken on 3/16/2018 shows a distinct high flow event at 12.84 inches on the crest gauge.

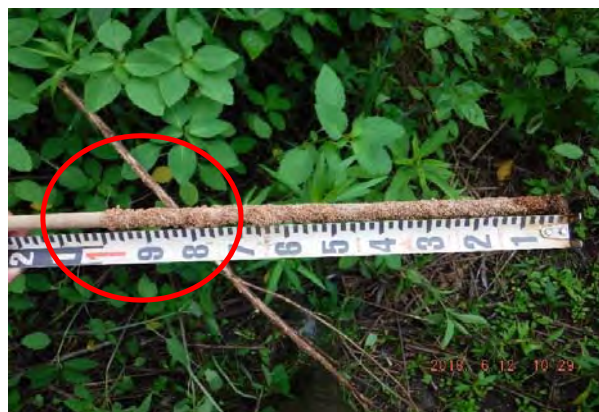
Crest Gauge reading taken on 6/12/2018 shows a distinct high flow event at 11.88 inches on the crest gauge.

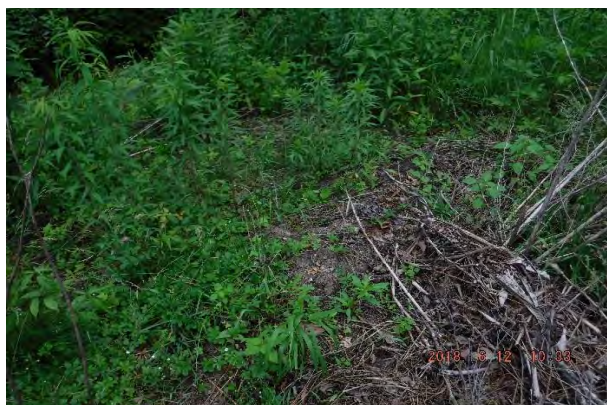
Wrack lines and debris above bankfull near station 29+00 (6/12/2018).

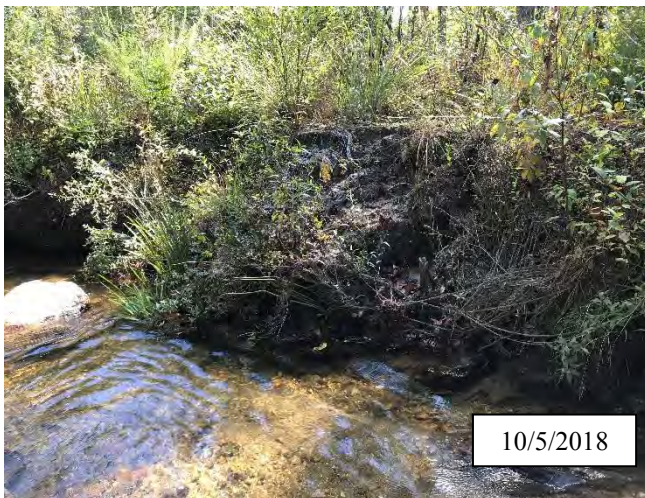
Photo 9. CPA 2-3 – Station 4+60, bank scour area has vegetated but is still eroding. Will be monitored in MY5.

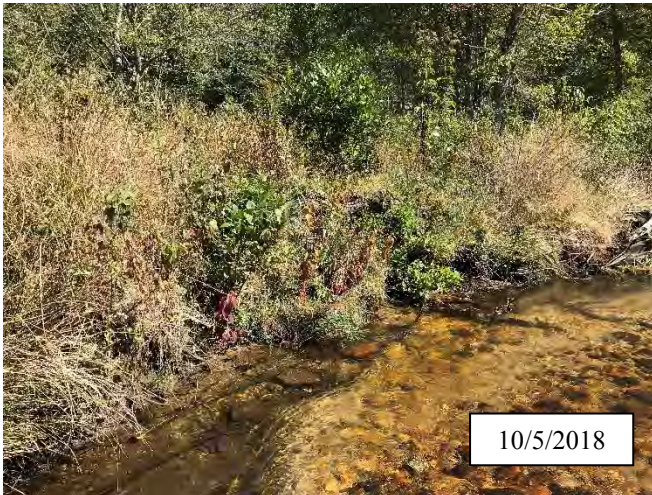
Photo 15. CPA 2-5 – Station 26+60, Scour area has revegetated and stabilized.

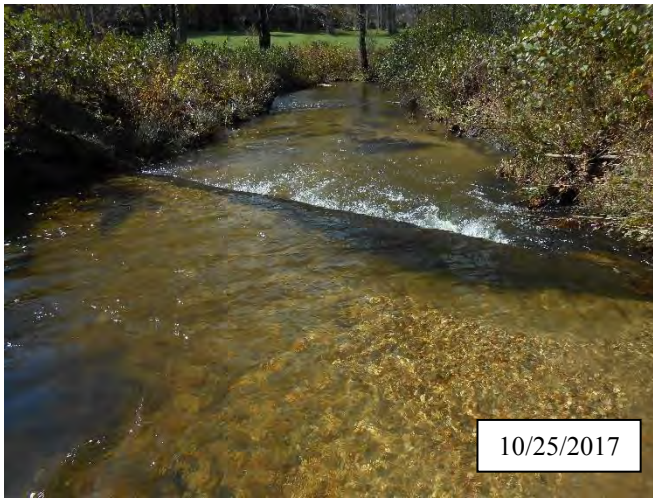
Photo 19. CPA 3-1 – Station 23+75, piping of log structure after the fabric sealing this structure tore in 2017.

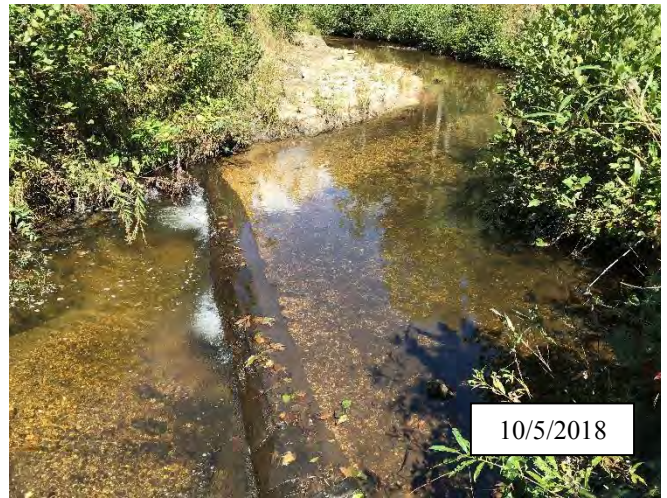
Photo 20. CPA 3-1 – Log structure has stabilized and is no longer piping.

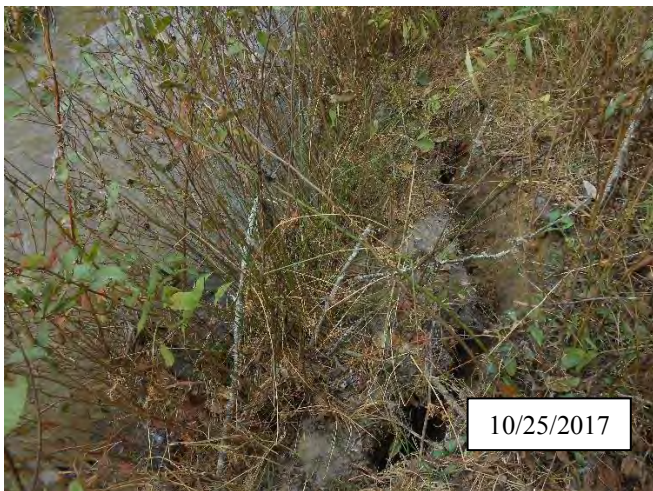
Photo 21. CPA 3-2 – Station 21+00, small bank slump area (approx. 6 ft.) along left bank of main stem.

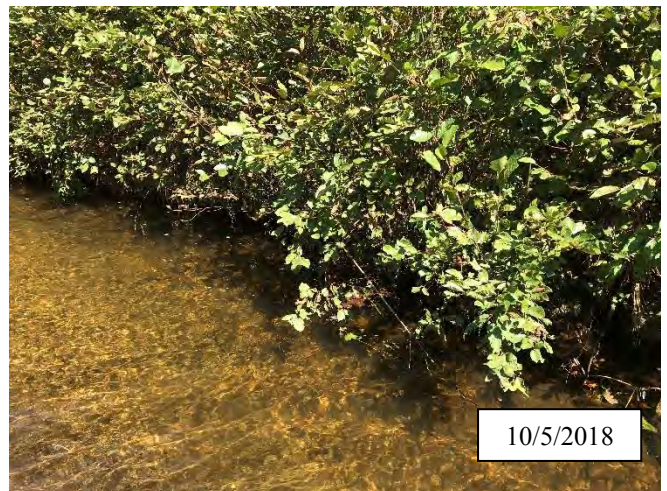
Photo 22. CPA 3-2 – Area has stabilized and is fully vegetated.

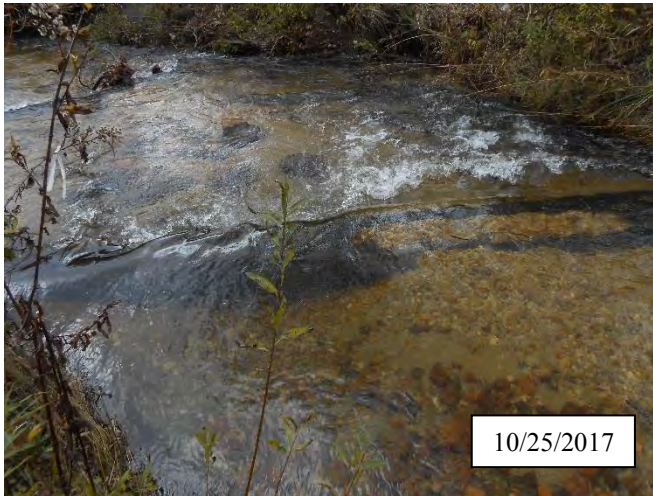
Photo 23. CPA 3-3 – Station 14+75, piping of log structure after the fabric sealing this structure tore in 2017.

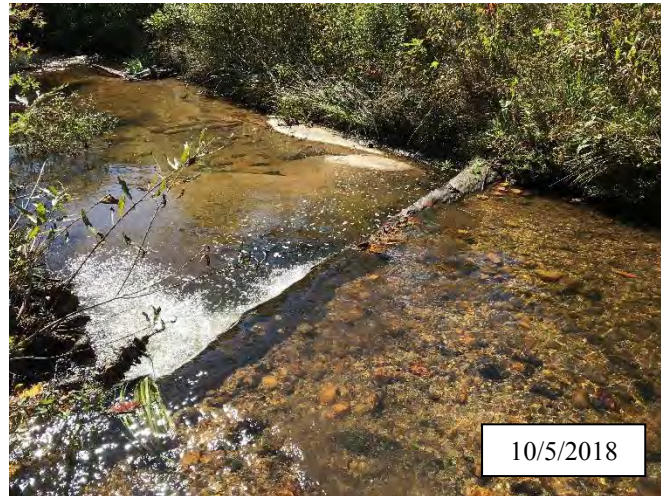
Photo 24. CPA 3-3 – Station 14+75, piping log structure has stabilized and is no longer piping in 2018.

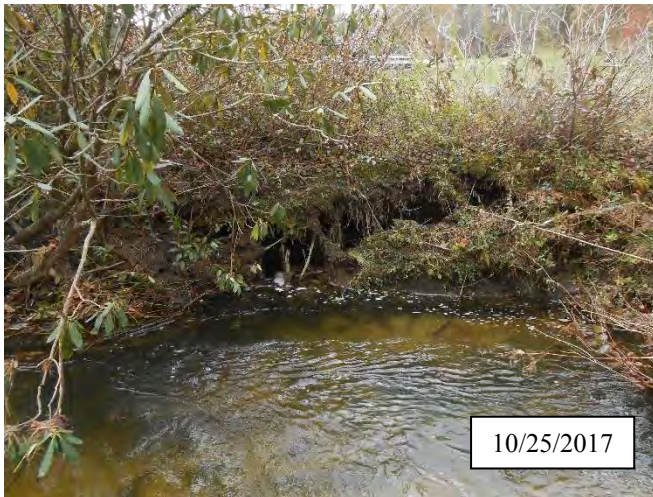
Photo 25. CPA 3-4 – Station 11+50, small bank slump (approx. 8 ft.) along right bank of main stem.

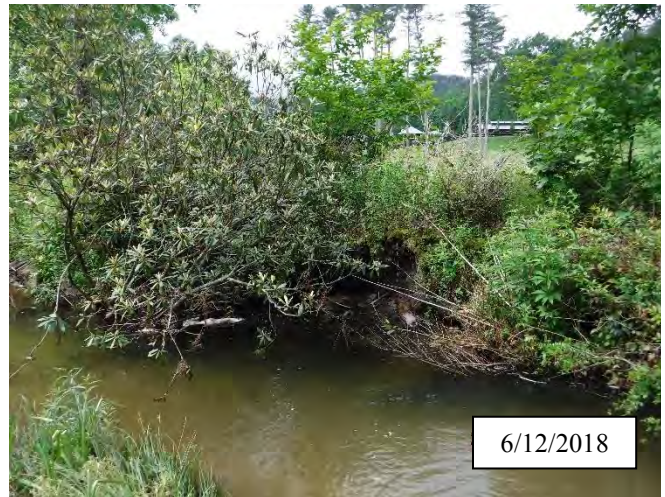
Photo 26. CPA 3-4 – Station 11+50, slump area has not stabilized but has not worsened in 2018. Will continue to monitor in MY5.

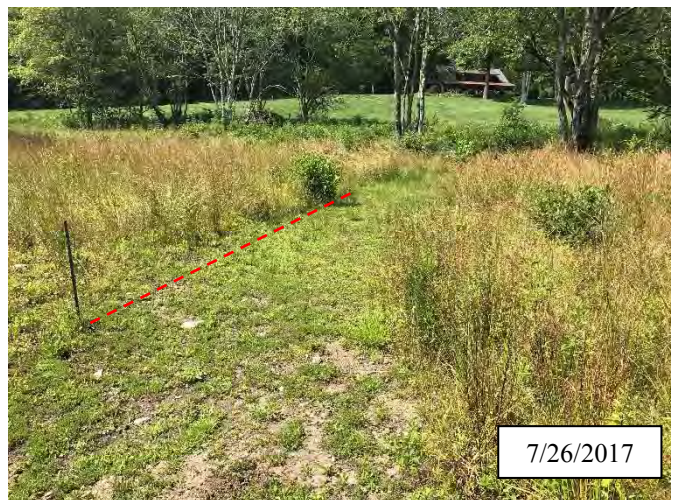
2+00	CPA 2-2. Piping of log structure after the fabric sealing this structure tore during flooding of December and January. Structure was repaired in 2017 and was no longer piping in 2018.	4,5,6
Encroachments	Station (approximately) 23+00 to 28+00	EA-1. New maintenance workers mowed the nature trail (an allowance in the easement); however, they mowed a wider width than was agreed. We discussed this with staff at Lonesome Valley and they were going to discuss this with a new trails manager.	28,29

Photo 29. EA 2-1 – In July of 2017, the path was still being mowed wide through Veg Plot 3.
