Subject: Response to DMS comments on the Year 5 Monitoring Report Draft review for the Logan Creek Stream Restoration Project; Savannah River Basin - CU# 03060101; Jackson County, North Carolina; NCDMS Project # 92515; Contract No. D06046-A

**Figure 2 - Overview
 Current Conditions Plan View
 Monitoring Year 5
 Logan Creek Site**

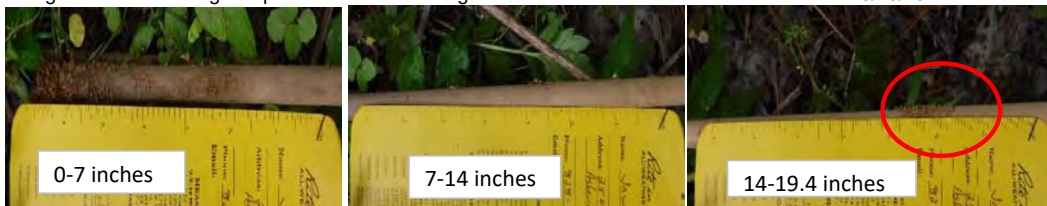
Crest Gauge reading taken on 5/7/2019 shows a distinct high flow event at 19.4 inches. Reading was taken with three consecutive measurements.

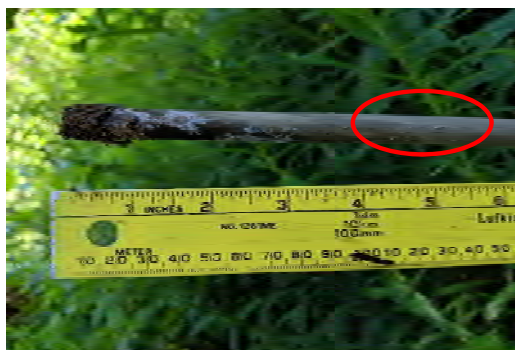
Crest gauge reading taken on 8/8/19 shows a distinct high flow event at 5.2 inches.

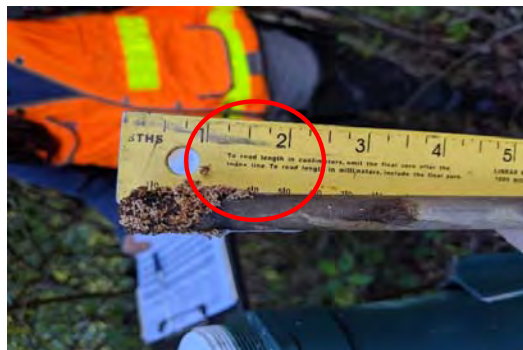
Crest gauge reading taken on 10/23/19 shows a high flow event at 1.5 inches.

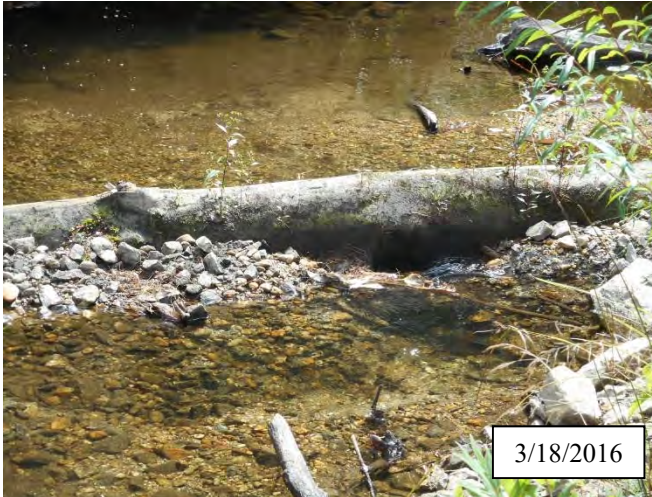
Table 12. continued				
Engineered Structures	2+00	CPA 2-2. Identified MY2. Piping of log structure after the fabric sealing this structure tore during flooding of December and January. Structure was repaired in 2017 and was no longer piping in MY5.	Resolved	5, 6, 7 & 8
	23+75	CPA 3-1. Identified MY3. Piping of log structure has stabilized and is no longer piping in MY5.	Resolved	26, 27 & 28
	14+75	CPA 3-3. Identified MY3. Piping of log structure after the fabric sealing this structure tore. Structure has stabilized and is no longer piping in MY5.	Resolved	32, 33 & 34
	UT8 - 00+40	CPA 3-5. Identified MY3. Piping of log structure on UT-8 near the confluence of UT-8 and Logan Creek. Hand repairs made Feb-20. It is no longer piping.	Resolved	38 & 39
Encroachments	(approximately) 23+00 to 28+00	EA-1. Identified MY2. The nature trail (an allowance in the easement); was mowed wide. We discussed this with staff at Lonesome Valley and they reduced the width they are maintaining.	Resolved, working with Stewardship Program to document agreed to width.	40, 41

Photo 5. CPA 2-2 – Station 2+00, Piping of log structure after the fabric sealing this structure tore during flooding of December and January.

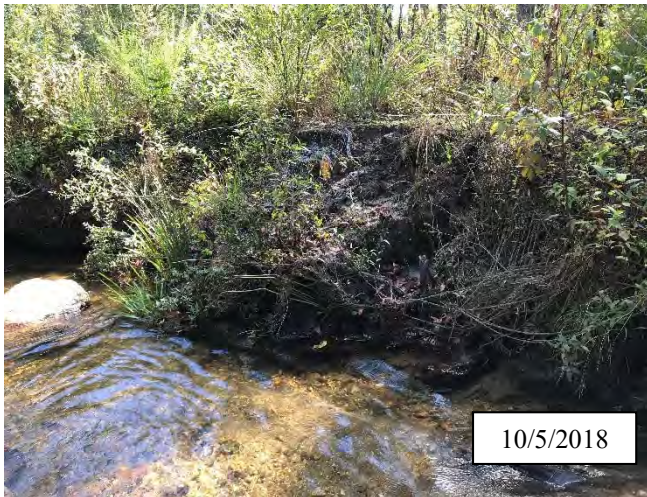
Photo 11. CPA 2-3 – Station 4+60, bank scour area has vegetated but not completely stable.

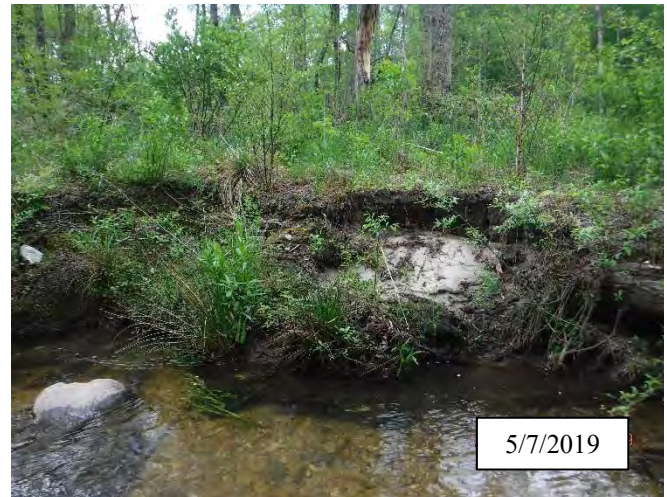
Photo 12. CPA 2-3 – Station 4+60, bank scour area maintaining vegetation but still some signs it is not completely stable.

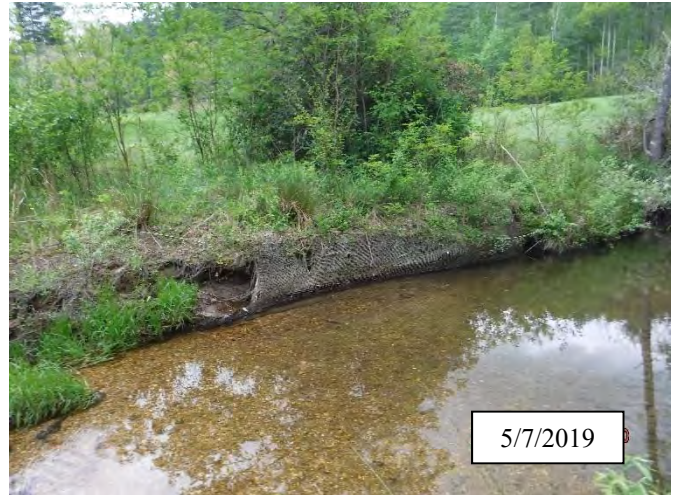
Photo 16. CPA 2-4 – Station 11+70, Bank maintained not completely stable but improving with growing vegetation in 2019

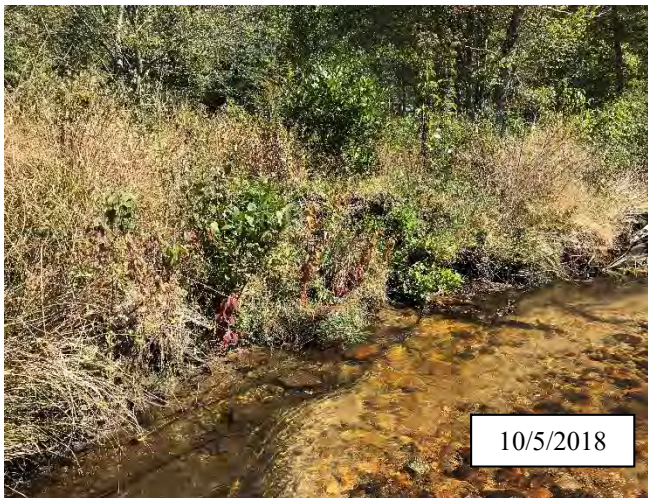
Photo 19. CPA 2-5 – Station 26+60, Scour area has revegetated and stabilized.

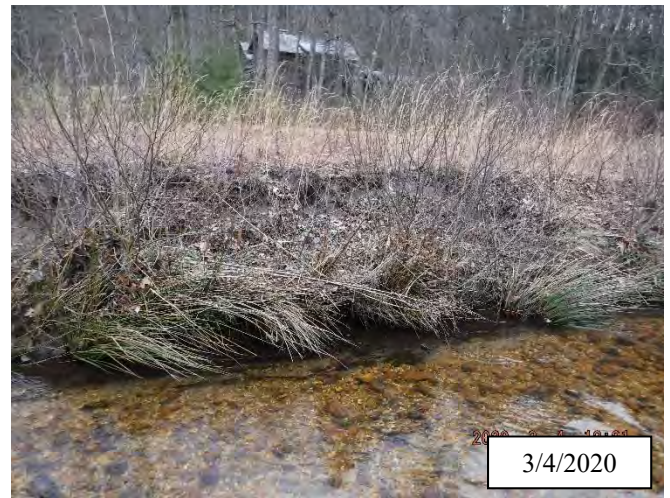
Photo 20. CPA 2-5 – Station 26+60, Scour area stabilized with vegetation in 2019, late winter photo (3-2020).

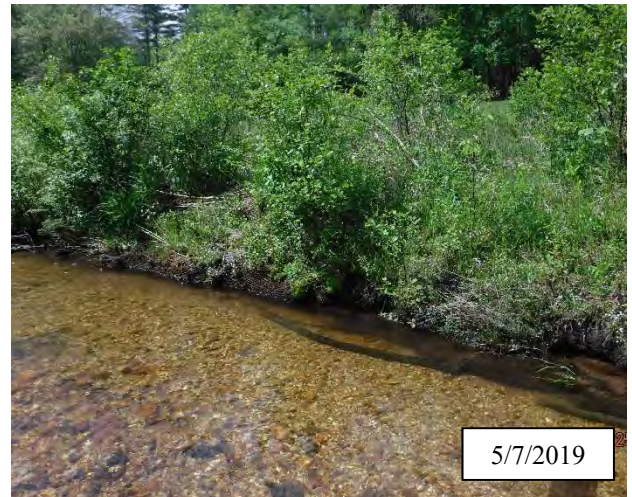
Photo 24. CPA 2-6 – Station 27+00, scour area remained vegetated and stable in 2019.

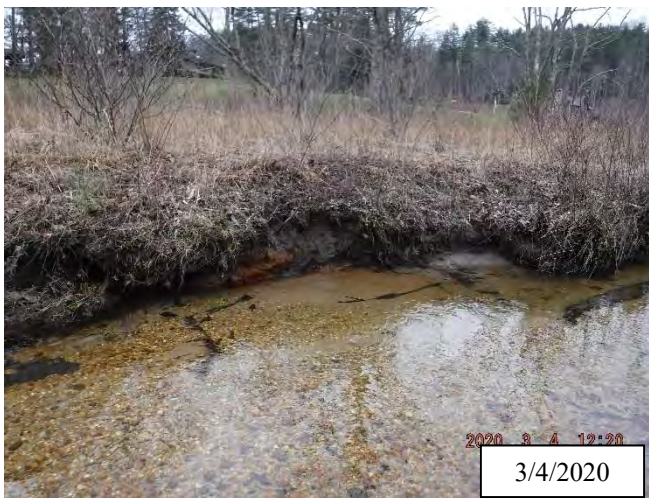
27+00	CPA 2-6. Identified MY2. Flooding during December and January 2017 caused a small area of bank scour at this location. Scour area was repaired in 2017 and has revegetated and stabilized in 2018 and remains stable in 2019.	Resolved	21, 22, 23, 24 & 25
	21+00	CPA 3-2. Identified MY3. Bank slump (approx. 6 ft.) along left bank of main stem. Has stabilized and is no longer eroding.	Resolved	29, 30 & 31
	11+50	CPA 3-4. Identified MY3. Bank slump (approx. 8 ft.) along right bank of main stem. The slump area has not worsened, is stabilizing and is supporting more vegetation in 2019.	Resolved	35, 36 & 37

Photo 25. CPA 2-6 – Station 27+00, scour area vegetated and stable, some bare bank late winter (3-2020).

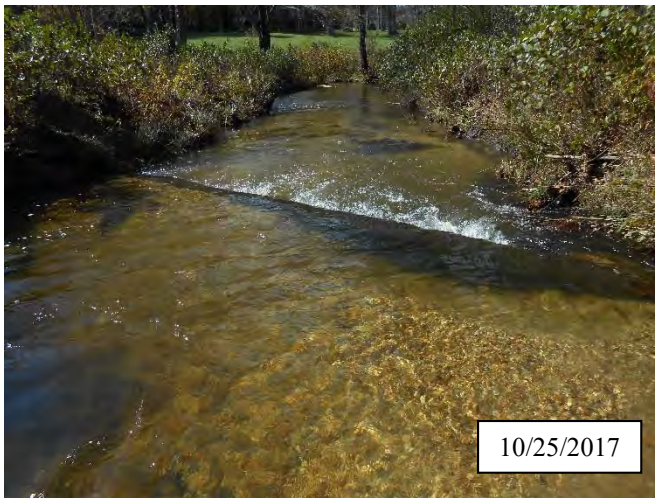
Photo 26. CPA 3-1 – Station 23+75, piping of log structure after the fabric sealing this structure tore in 2017.

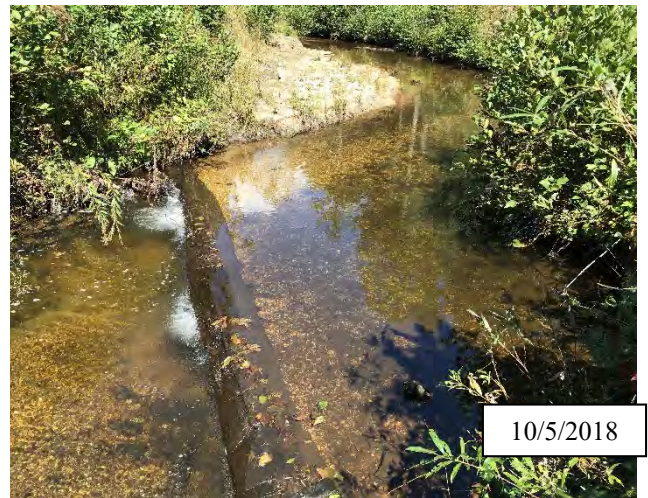
Photo 27. CPA 3-1 – Log structure has stabilized and is no longer piping.

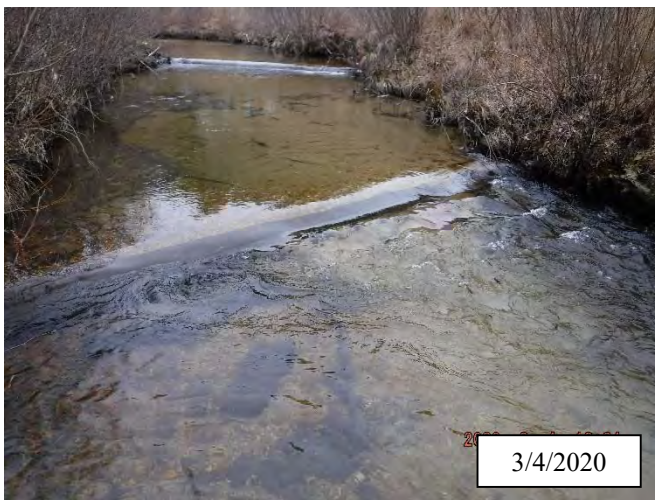
Photo 28. CPA 3-1 – Log structure continues to be stable in late winter 2020.

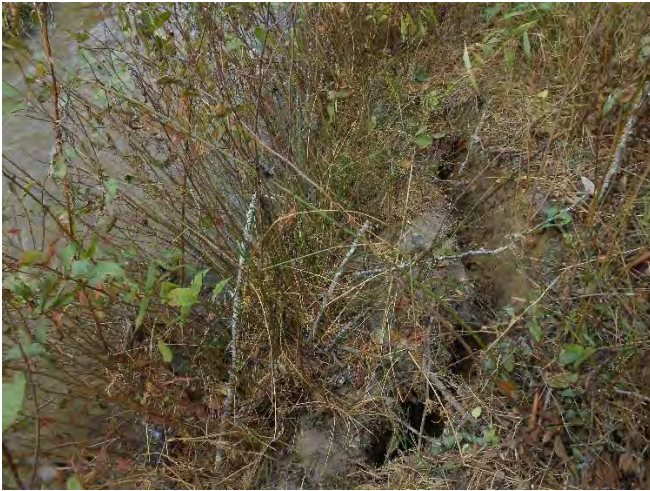
Photo 29. CPA 3-2 – Station 21+00, small bank slump area (approx. 6 ft.) along left bank of main stem.

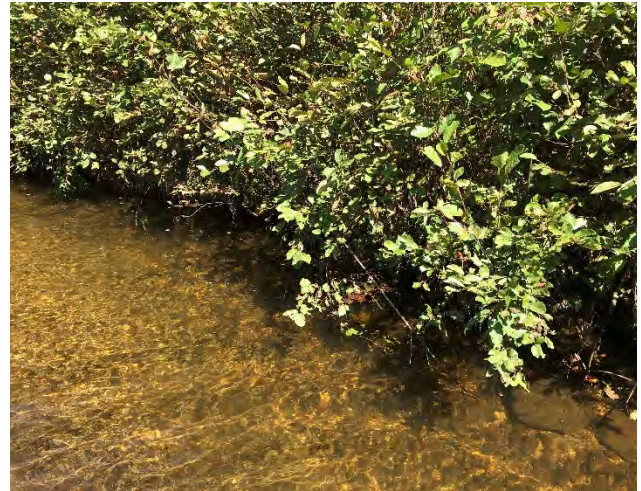
Photo 30. CPA 3-2 – Area has stabilized and is fully vegetated.

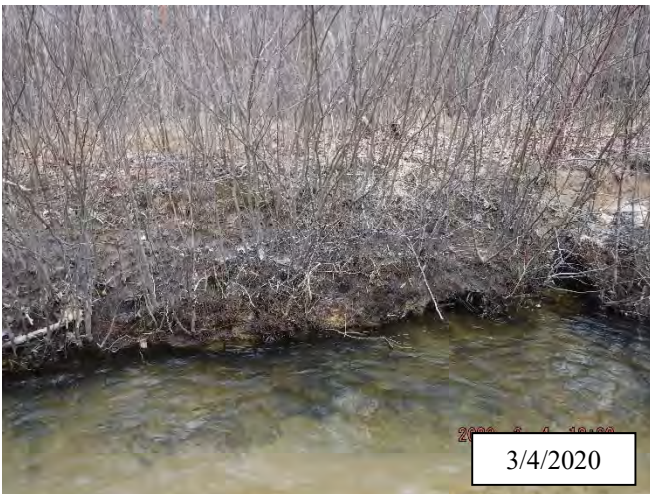
Photo 31. CPA 3-2 – Area has stabilized and is fully vegetated, in late winter 2020.

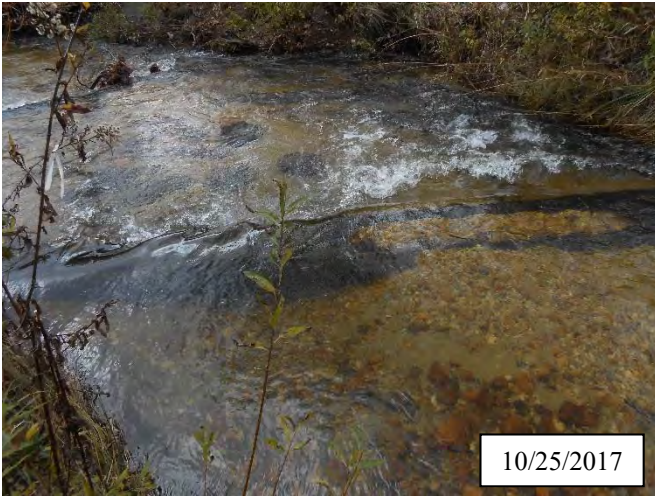
Photo 32. CPA 3-3 – Station 14+75, piping of log structure after the fabric sealing this structure tore in 2017.

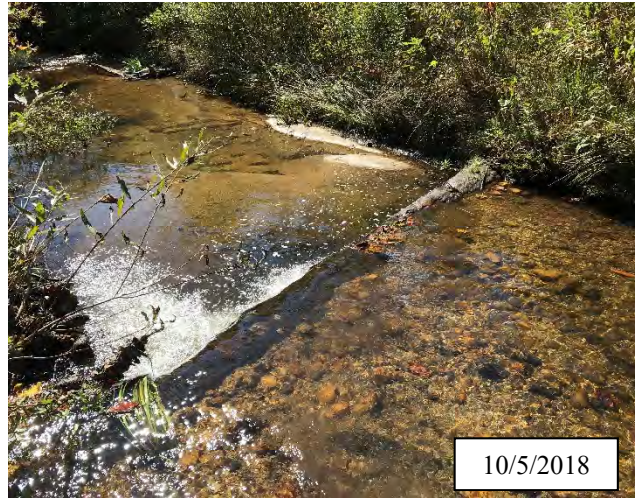
Photo 33. CPA 3-3 – Station 14+75, piping log structure has stabilized and is no longer piping in 2018.

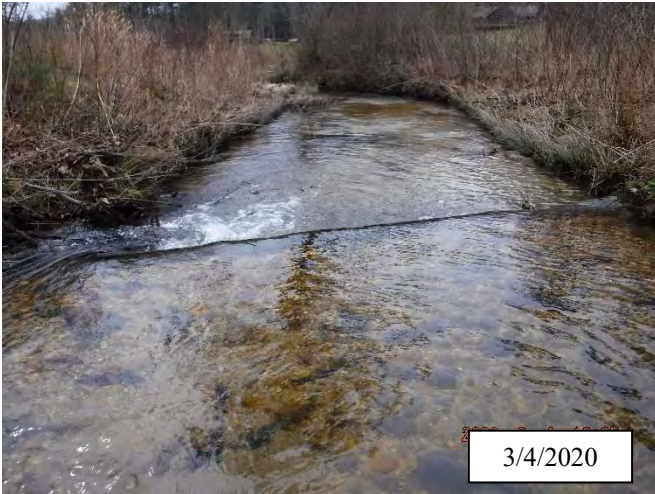
Photo 34. CPA 3-3 – Station 14+75, Log structure continues to be stable in late winter 2020.

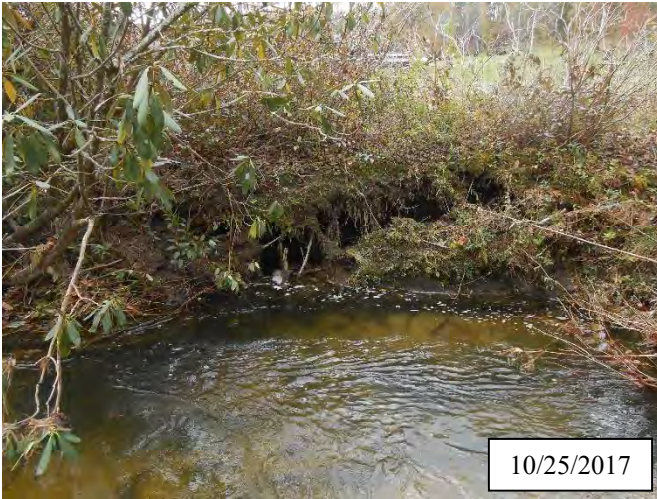
Photo 35. CPA 3-4 – Station 11+50, small bank slump (approx. 8 ft.) along right bank of main stem.

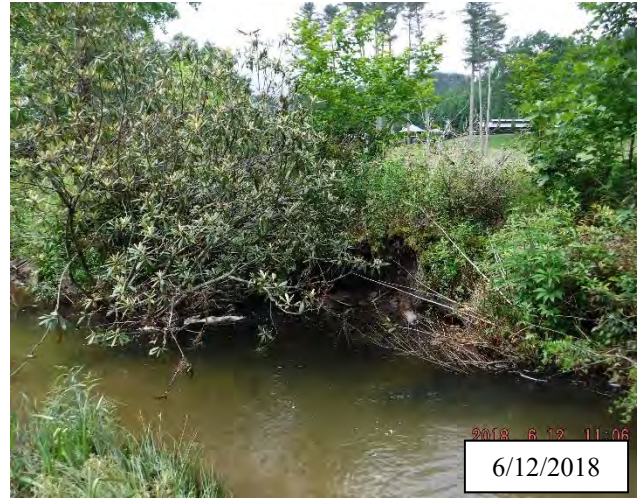
Photo 36. CPA 3-4 – Station 11+50, slump area has not stabilized but has not worsened in 2018.

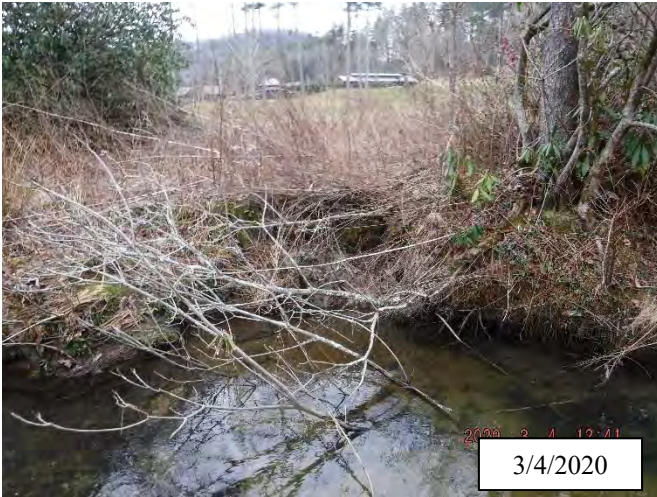
Photo 37. CPA 3-4 – Station 11+50, slump area left a gap in the bank but it is stable in late winter 2020.

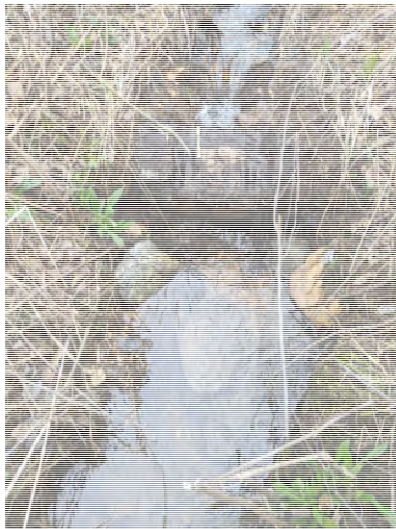
Photo 38. CPA 3-5 – Station UT8 00+40, piping of log structure on UT-8 near the confluence of UT-8 and Logan Creek

Photo 39. CPA 3-5 – Station UT8 00+40, piping of log structure repaired, in late winter 2020.

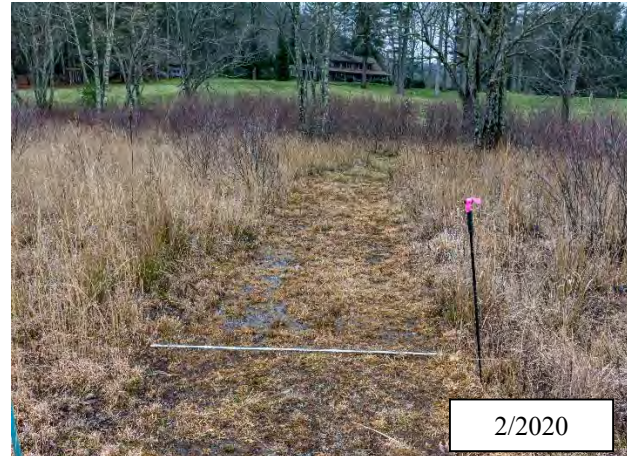
Photo 41. EA 2-1 – Maintenance workers now maintaining the trail at 7' width.

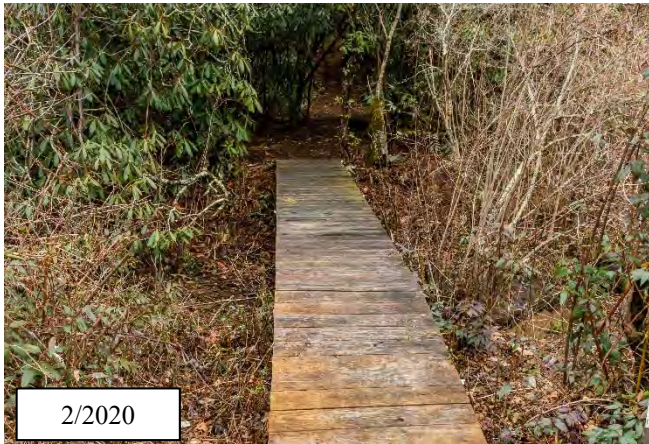
Photo 42. EA 2. Older foot bridge that was installed by Lonesome Valley and later abandoned, but not removed. Landowner now is using it to access the easement area.

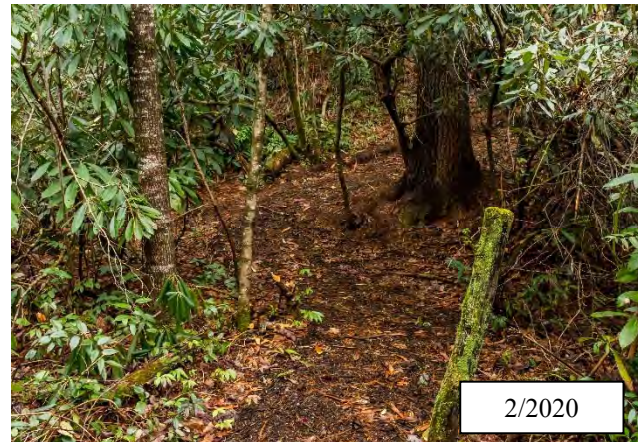
Photo 43. EA 2. Appears that a landowner is maintaining a trail down the slope to the foot bridge.
