**UT to TAR RIVER (Louisburg)  
FINAL MONITORING REPORT  
YEAR 3  
2008**

EEP Project # 234  
Franklin County, North Carolina

**Monitoring Firm:**

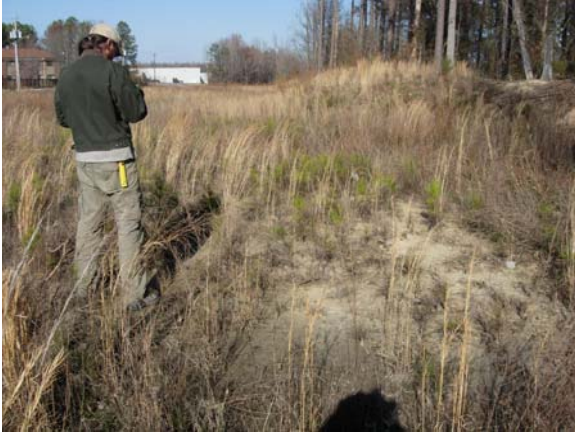
Photo 1: Representative bare floodplain (Station No. 16+00; view downstream; 2-20-2008)

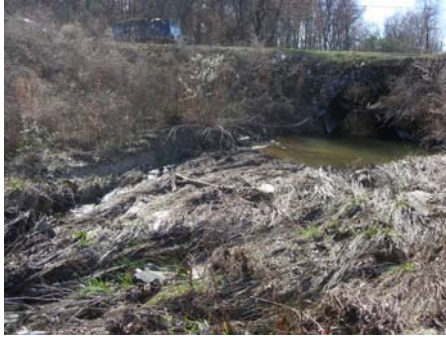
Photo 1: Representative fine sediment aggradation and bar formation problem area (Station No. 10+08; view upstream 2-20-2008).

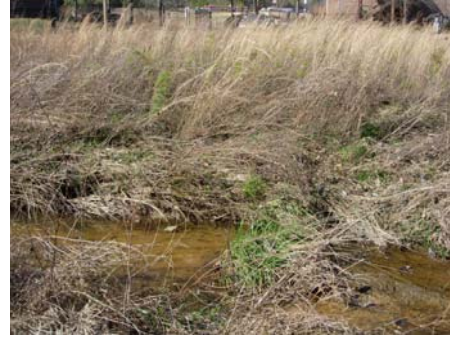
Photo 2: New side bar formation problem area (Station No. 17+80; view of left bank; 2-20-2008).

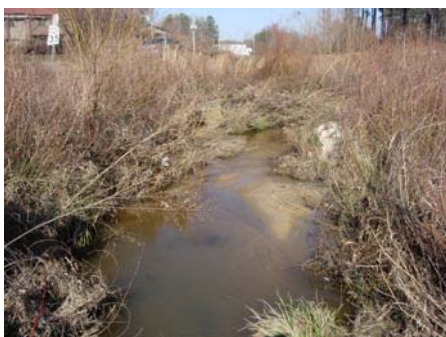
Photo 5: Aggradation and bar formation problem area (Station No. 14+33; view downstream; 2-20-2008).

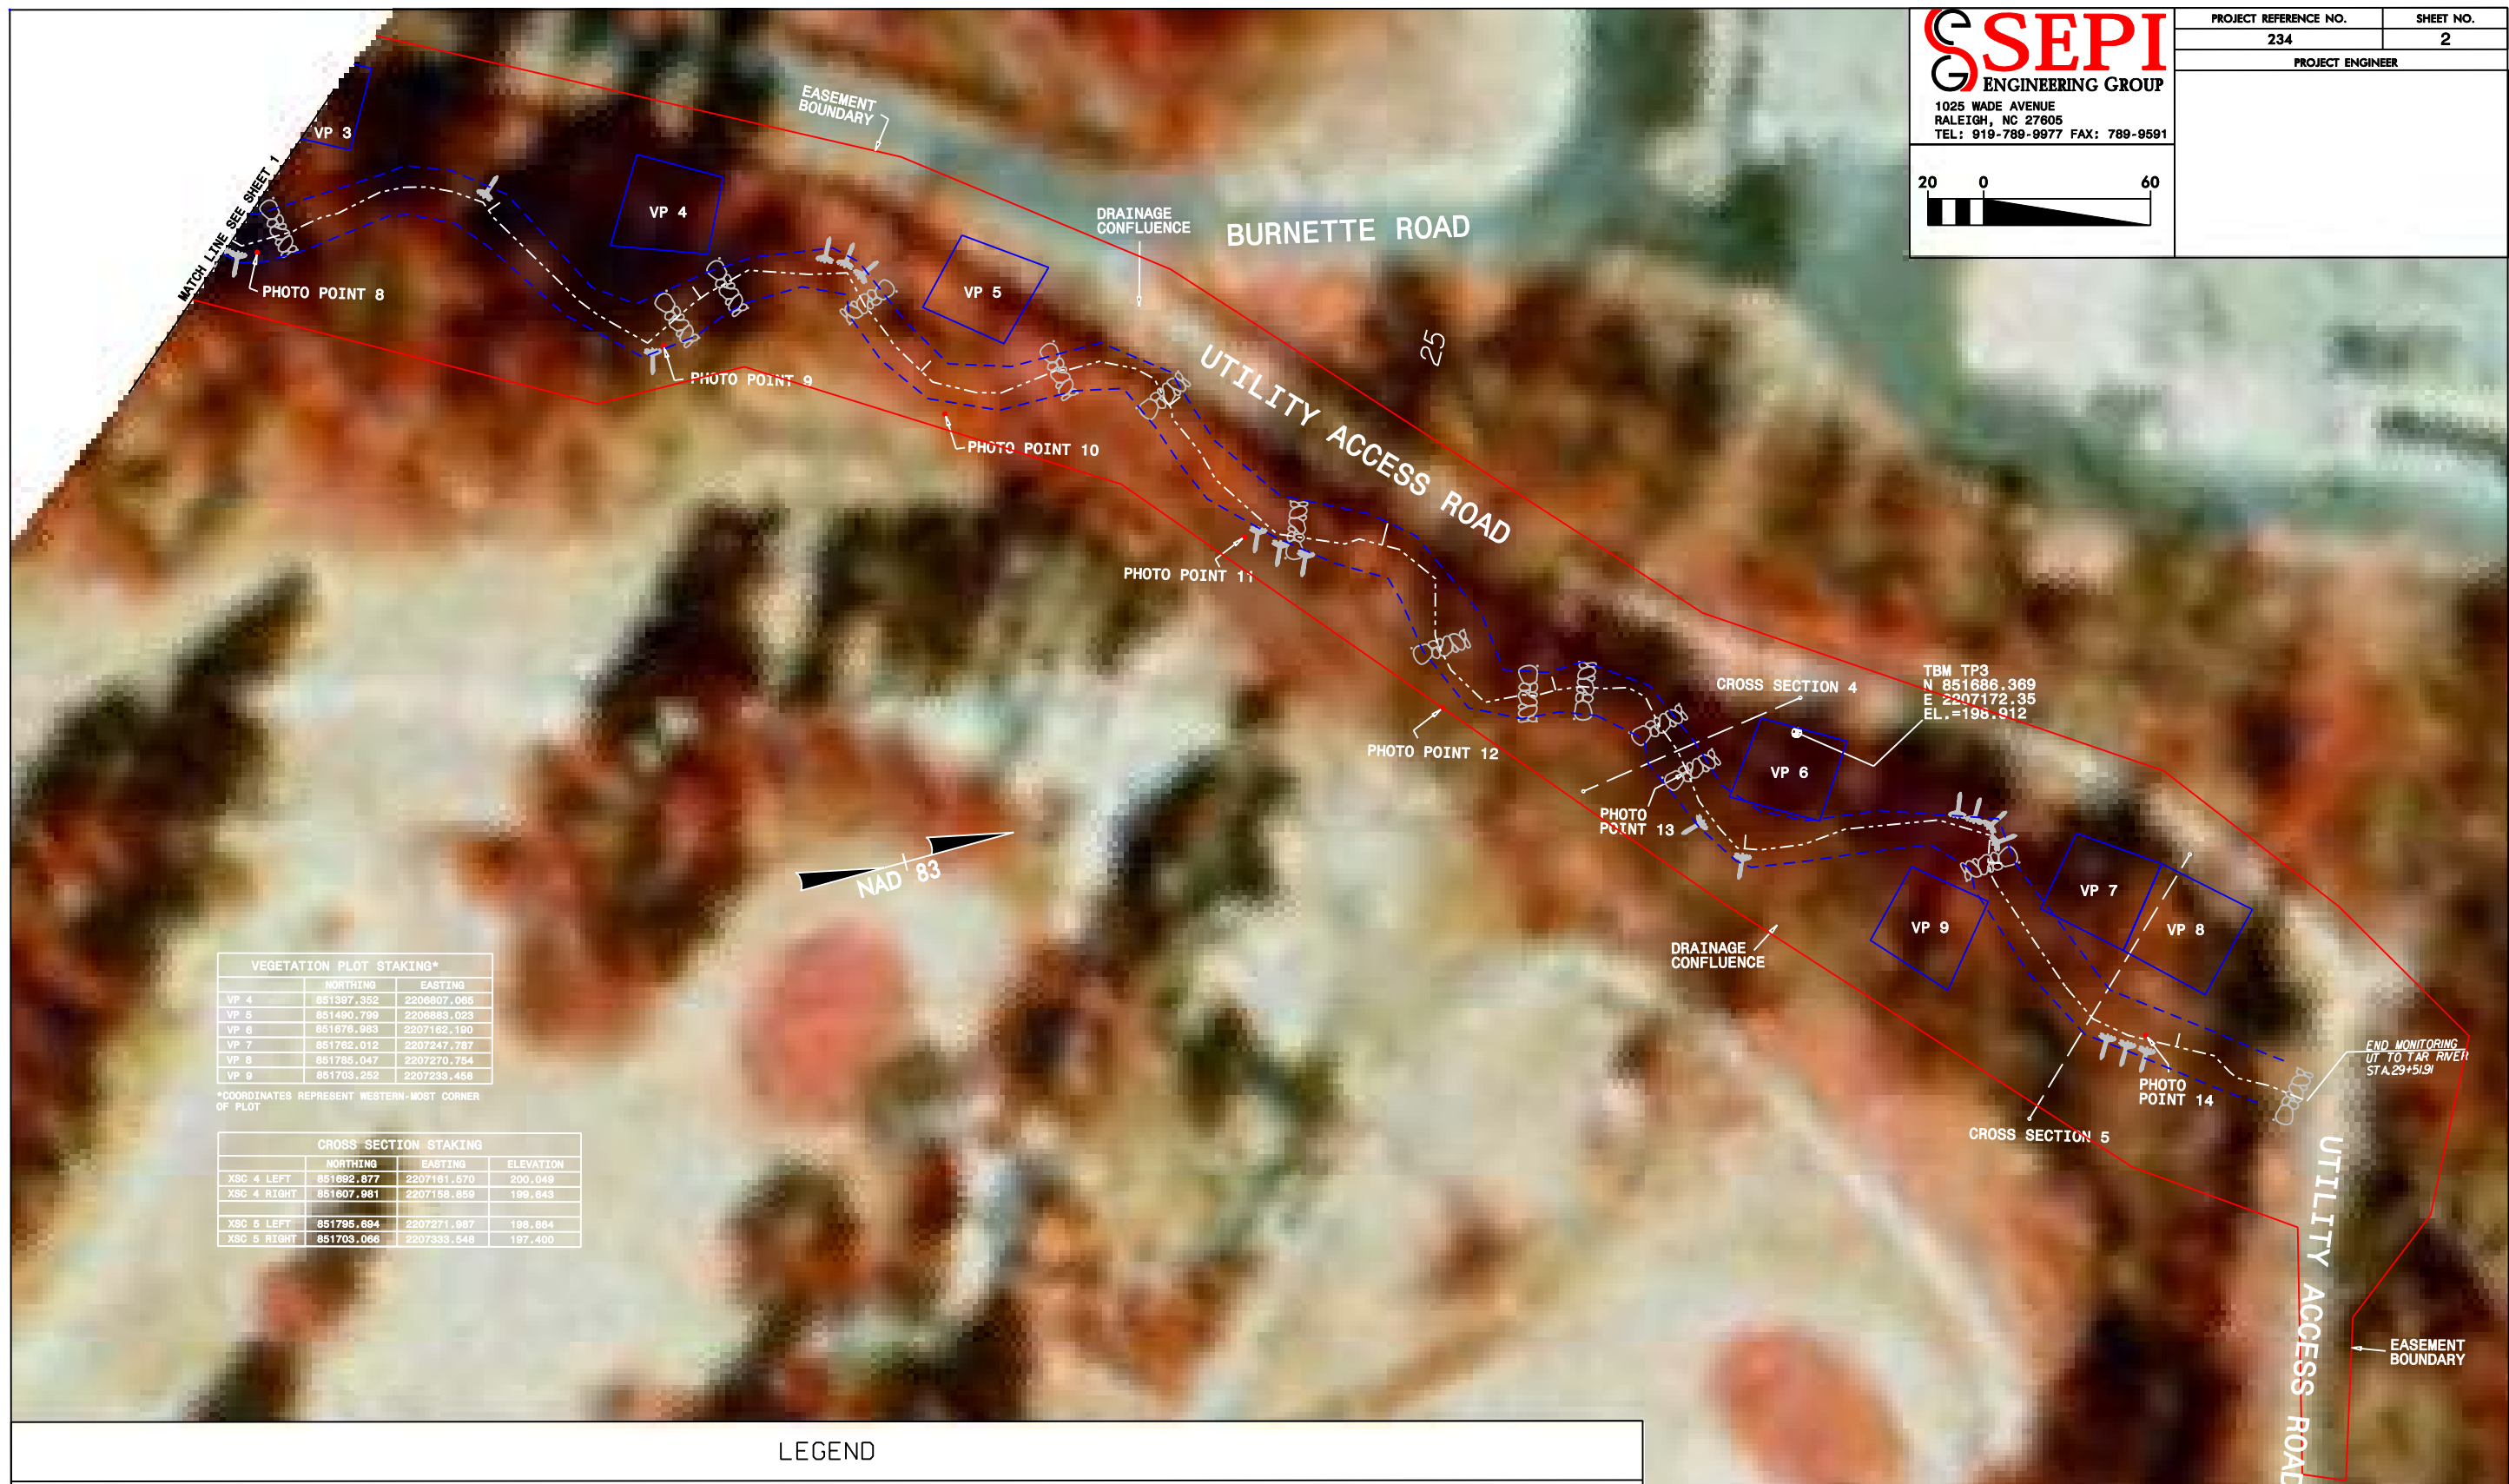
LOCATION: <b>UT TO TAR RIVER</b>	
<b>CURRENT CONDITIONS PLAN VIEW</b>	
<b>STREAM MONITORING - YEAR 3</b>	
PROJ #: <b>234</b>	COUNTY: <b>FRANKLIN</b>
PREPARED BY: <b>IPJ</b>	
CHECKED BY: <b>PDB</b>	DATE: <b>2/10/09</b>

All problems associated with in-stream structures included situations where the structure was placed at the improper location or angle, or the structure was providing inadequate protection to an eroding bank. These structures were solely listed because their placement location or angle could be the cause of another adjacent problem. For example, if bank erosion is occurring at a specific location just downstream of a structure and this erosion could have been prevented if the structure had been placed further downstream, the structure was listed as a problem. Another example would be that if a structure is located along a straight section and is forming a pool where a riffle should be, the structure was listed. No serious structural integrity problems were found for any of the structures.

UT Tar			
Feature Issue	Station numbers	Suspected Cause	Photo number
Bank Erosion (left bank, severe)	10+08.00	Back eddy from culvert and/or unstable soil characteristics and lack of vegetation.	1, 3
	10+35.75		
Aggradation/Bar Formation	10+08.00	Excess fine sediment deposit from adjacent severe bank erosion and/or other upstream sources.	3
	10+22.45		
Bank Erosion (right bank)	10+27.66	Probably caused by high shear stress along the unprotected bank due to increased flow velocities leaving the culvert during peak flows.	
	10+38.81		
Aggradation	14+33.00	Excess fine sediment deposit from upstream severe bank erosion and/or other upstream sources.	5
	14+72.04		
Rock Sill	16+67.28	Placed too far upstream of the start of the meander to adequately protect the outside of the meander, forming pool in straight section.	
Aggradation	17+15.04	Small central bar; probably deposition resulting from upstream bank erosion and/or other upstream sources.

17+31.17		
Bar Formation (Left)	17+81.11	Inadequate bank protection, possibly due to misplacement of bank protection measures and or lack of vegetation/soil instability.	2
	17+88.25		
Aggradation	18+12.97	Excess fine sediment deposits from adjacent/upstream bank erosion and/or other upstream sources.	
	18+19.74		
Aggradation/Central Bar Formation	18+59.14	Excess fine sediment deposit from upstream bank erosion and/or other upstream sources.	4
	18+65.73		
Aggradation	18+65.18	Channel possibly over-sinuuous or bankfull dimensions incorrect.	4
	18+82.68		
Aggradation	18+92.07	Excess fine sediment deposits from adjacent/upstream bank erosion and/or other upstream sources.	
	19+14.43		
Central Bar Formation	21+88.96	Lack of bank protection between rootwad and rock structure.	
	22+01.96		
Bar Formation (Left)	22+82.62	Matting undercutting due to lack of bank protection early in meander and lack of vegetation.

22+87.61		
Bank Erosion (left bank)	23+60.83	Lack of bank protection along outside of meander bend. Structure directly upstream should be a cross vane.	
	23+68.09		
Rock Sill	23+95.66	Inadequate structure to protect banks directly downstream from increased discharge from tributary. Should be cross vane.	
Bank Erosion (left bank, severe)	24+00.07	Back eddy downstream of rock structure and/or lack of protective vegetation/soil stability characteristics.	
	24+25.64		
Bank Erosion (right bank)	23+95.44	Back eddy downstream of rock structure and/or lack of protective vegetation/soil stability characteristics.	
	24+16.53		
Aggradation/Bar Formation	24+02.63	Excess fine sediment deposits from adjacent/upstream bank erosion and/or other upstream sources.	
Bank Erosion (right bank)	24+21.20	Lack of bank protection.	
	24+82.02		
Rock Sill	24+98.36	Angle/placement possibly causing severe bank erosion directly upstream.

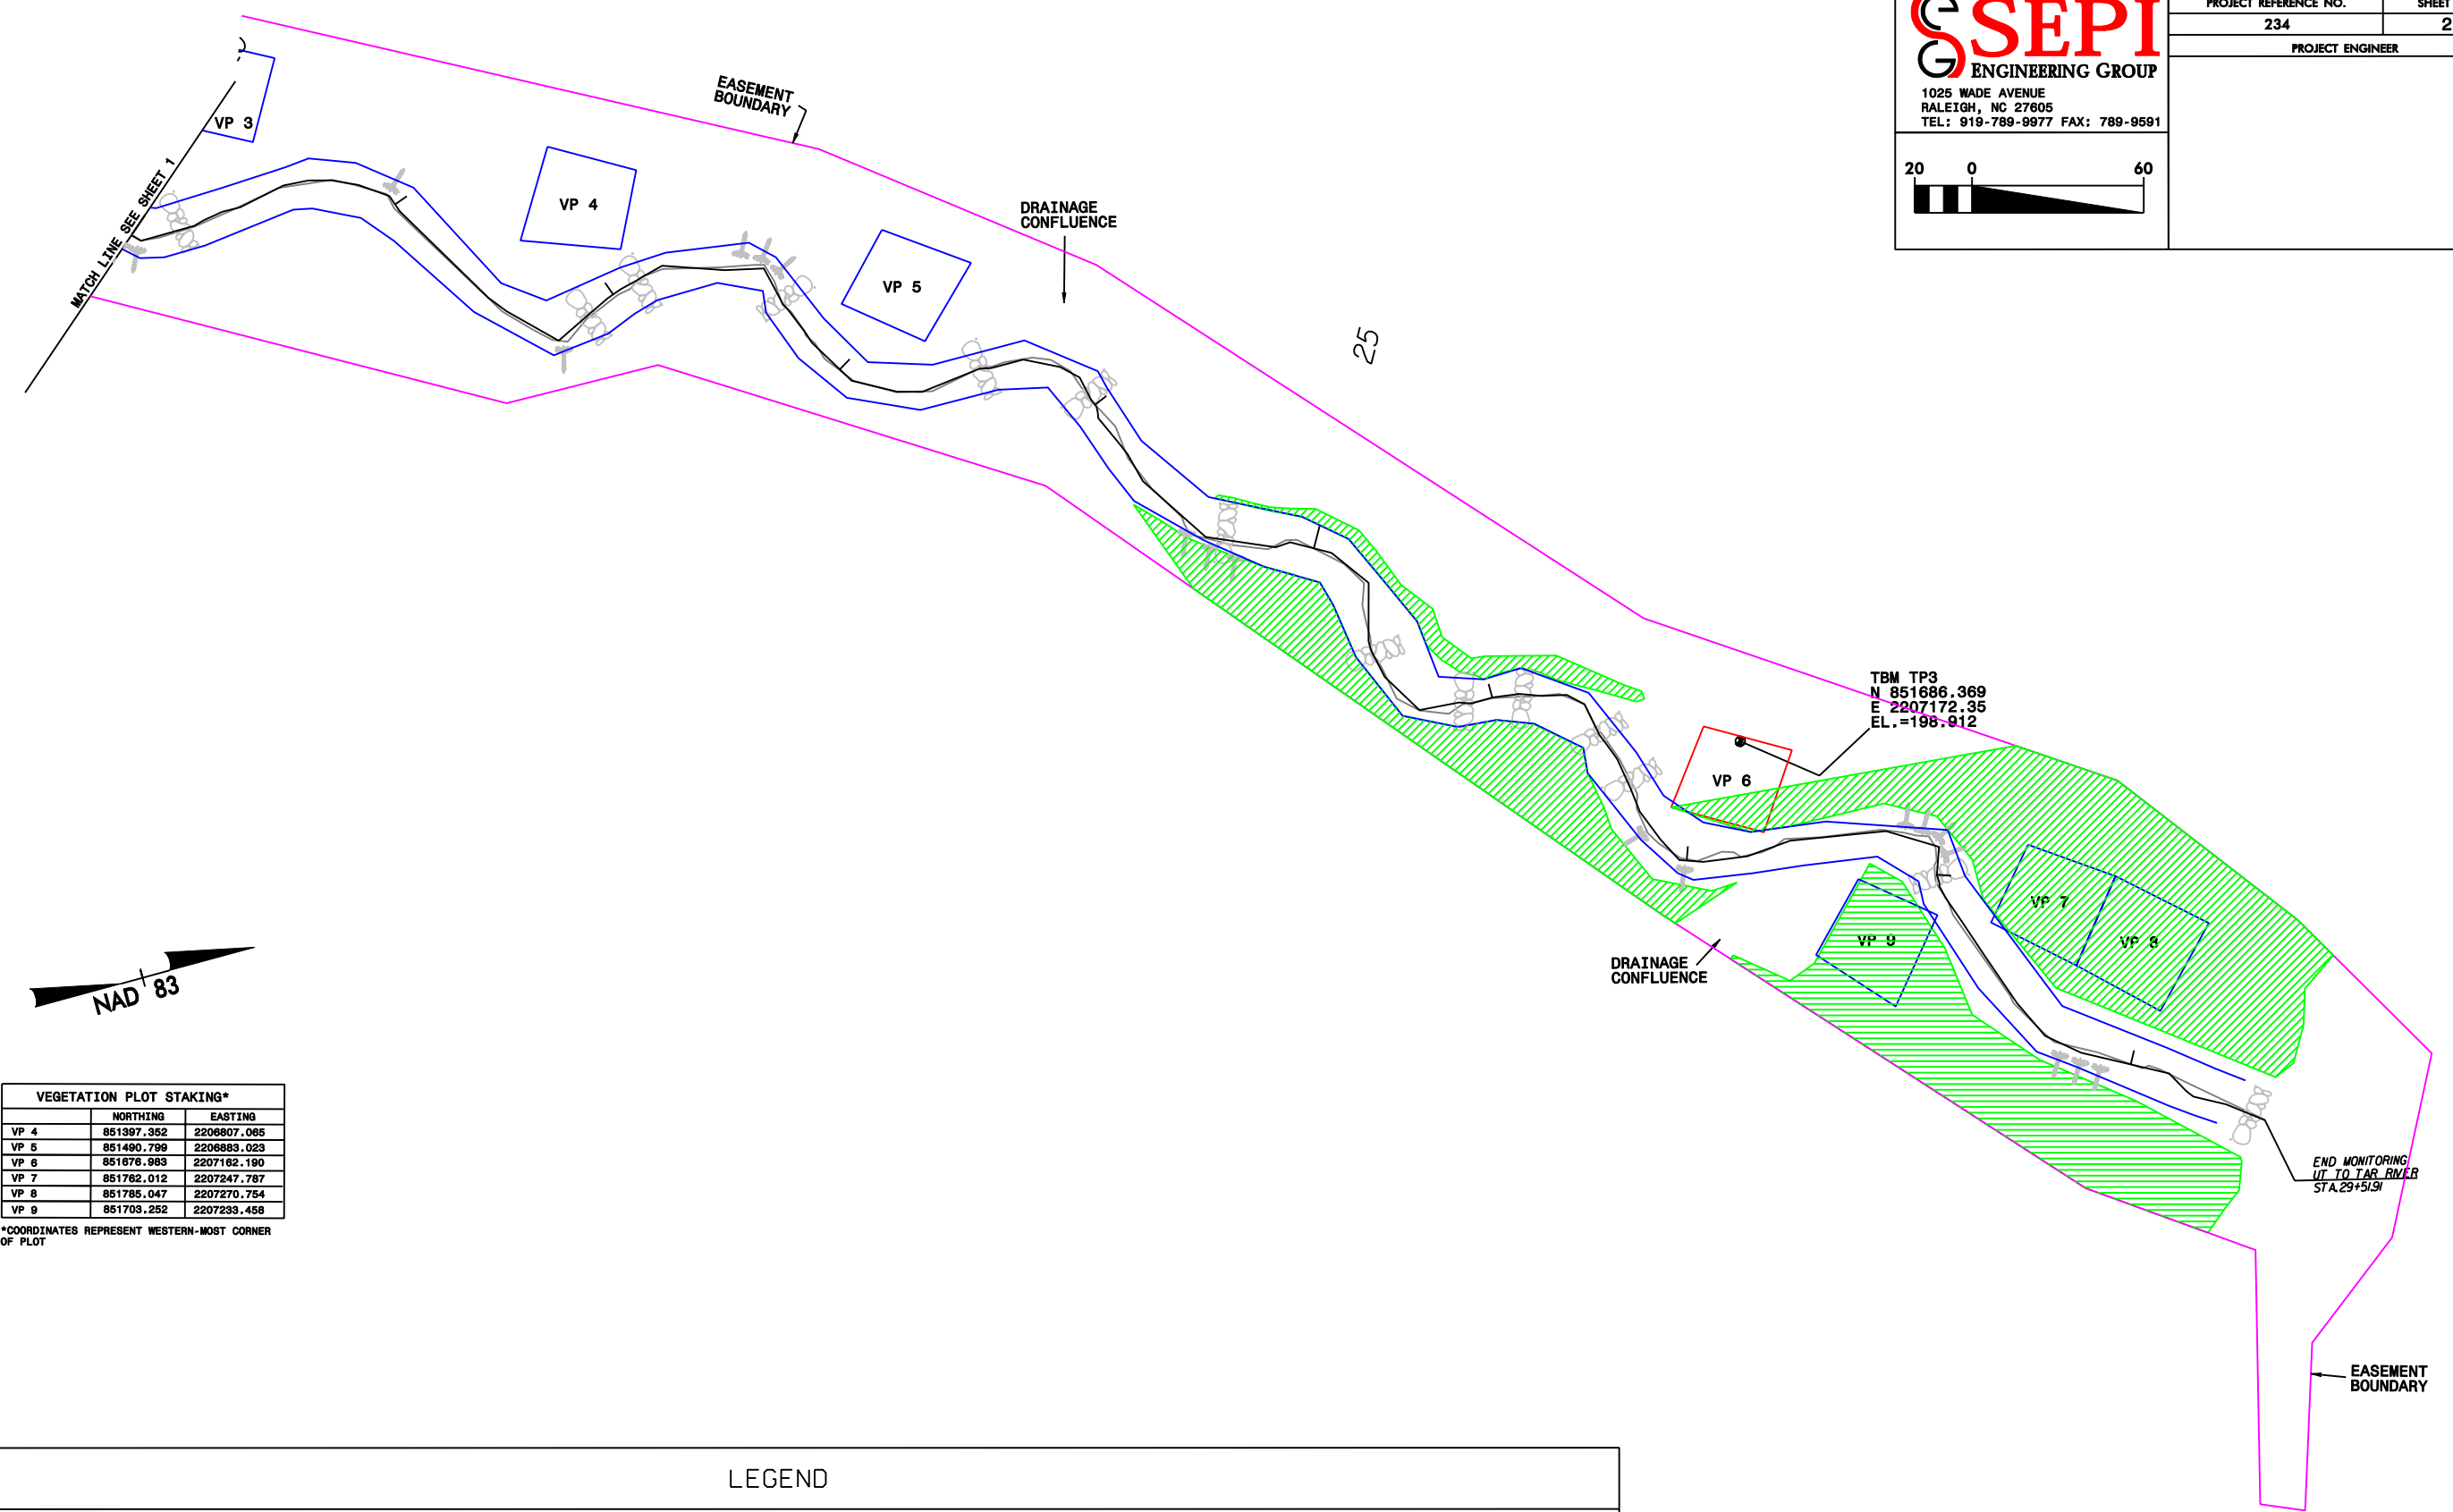
LOCATION:	UT TO TAR RIVER	
	CURRENT CONDITIONS PLAN VIEW	
	VEGETATION ASSESSMENT - YEAR 3	
PROJ #:	234	COUNTY: FRANKLIN
PREPARED BY:	IPJ	
CHECKED BY:	PDB	DATE: 2/10/09

Streamside vegetation exhibited a noticeable boost during Monitoring Year 3, as is evident in most photographs. There are two areas of bare floodplain along the project (Station 14+19 and Station 16+21) where the terrace above the floodplain on the right side is actively eroding. Japanese stilt grass (*Microstegium vimineum*) remains a problem along the downstream half of the project (see Table VI in Appendix A3). In addition, cattails were found at one location within the stream channel (Station 18+82). The planted stem densities for all the Vegetation Plots (VP), except VP #1, #2, and #6 were below the Monitoring Year 5 goal of 260 stems/acre. However, it should be noted that there were several species for which 'volunteer' individuals were noted for in at least one vegetation plot. With the inclusion of these 'volunteers,' all of the vegetation plots probably would meet the Monitoring Year 5 stem density goal. Noted volunteer species include: *Baccharis halimifolia*, *Prunus serotina*, *Diospyros virginiana*, *Quercus spp.*, *Cephalanthus occidentalis*, *Liriodendron tulipifera*, *Alnus serrulata*, *Pinus taeda*, *Liquidambar styraciflua*, and *Aronia arbutifolia*.

<b>Feature/Issue</b>	<b>Station # / Range</b>	<b>Probable Cause</b>	<b>Photo #</b>
Bare Floodplain (Right Bank)	14+19 to 14+26	Lack of vegetative cover; weak soil characteristics on terrace.	
Bare Floodplain (Right Bank)	16+21 to 16+50	Lack of vegetative cover; weak soil characteristics on terrace.	1
Microstegium virmenium (Left Bank)	24+55 to 26+40	Invasive vegetative opportunism	2
Microstegium virmenium (Right Bank)	24+35 to 27+16	Invasive vegetative opportunism	
Microstegium virmenium (Left Bank)	26+80 to 29+51	Invasive vegetative opportunism	
Microstegium virmenium (Right Bank)	27+12 to 29+51	Invasive vegetative opportunism
