# Lyle Creek Restoration

## 2003 Annual Monitoring Report

March, 2004

## 2003 Lyle Creek Monitoring Abstract

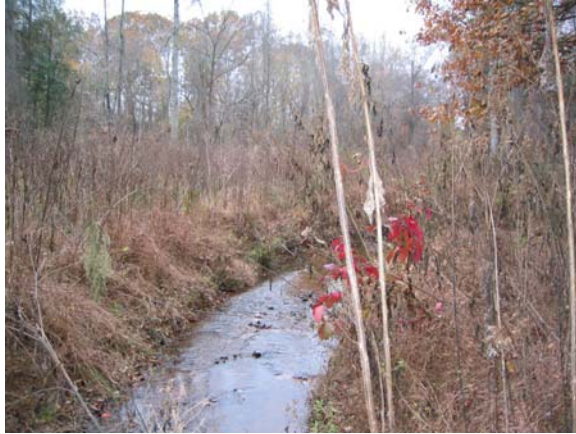
**Typical Riffle on Lyle Creek.**

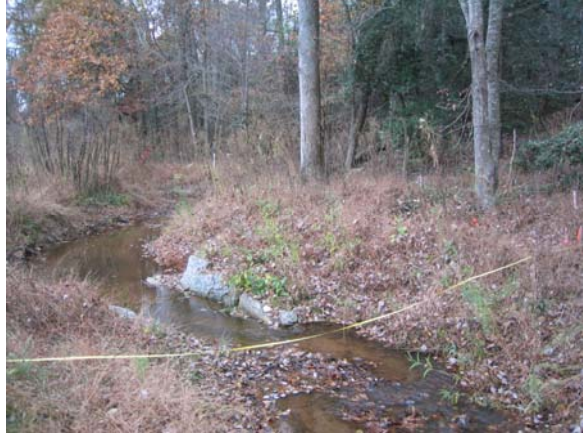
**Typical Pool on Lyle Creek.**

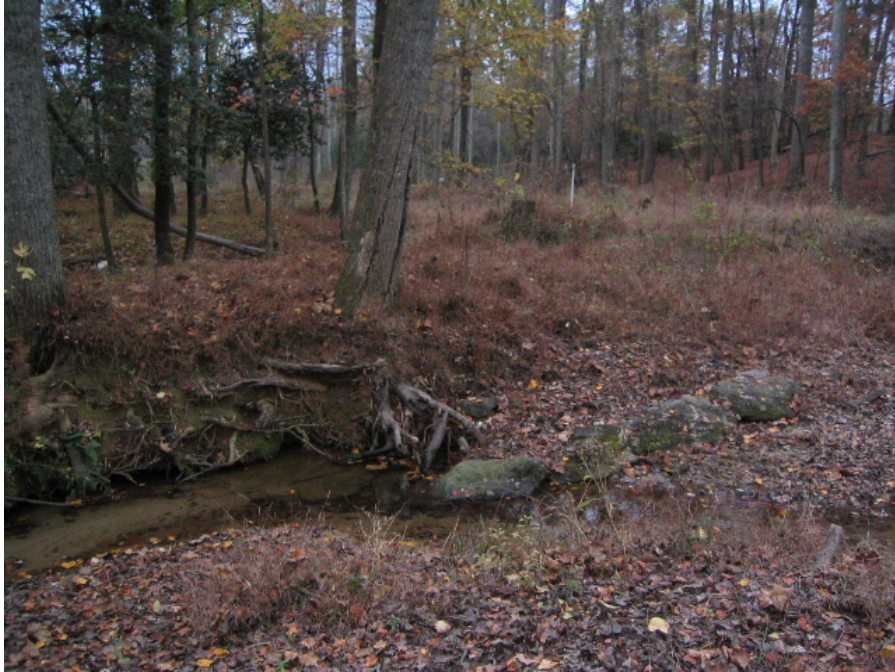
**PHOTO PLOT 1**

**J-Hook**

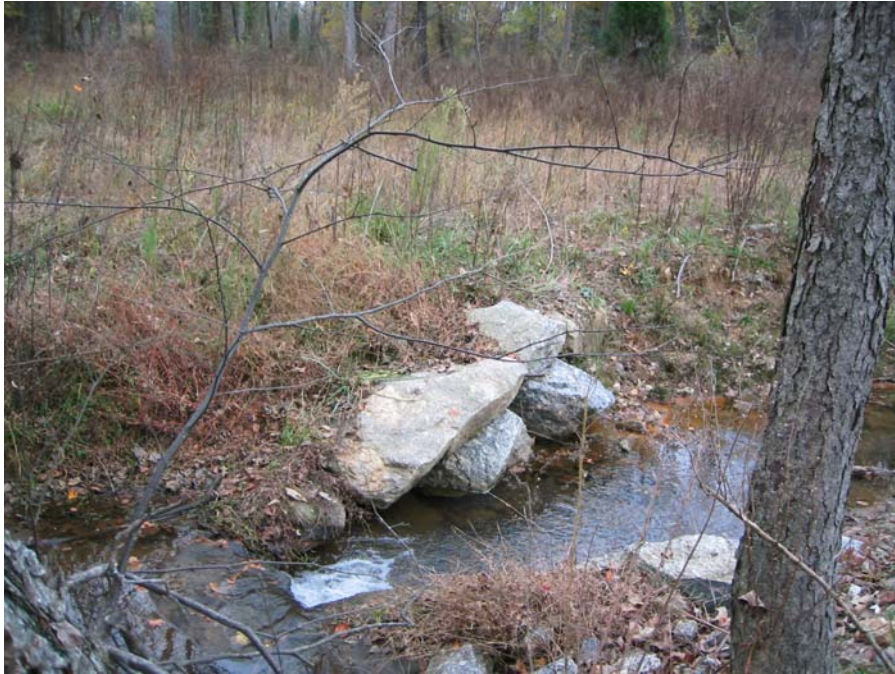
**PHOTO PLOT 5**

**Cross-Vane Weir**

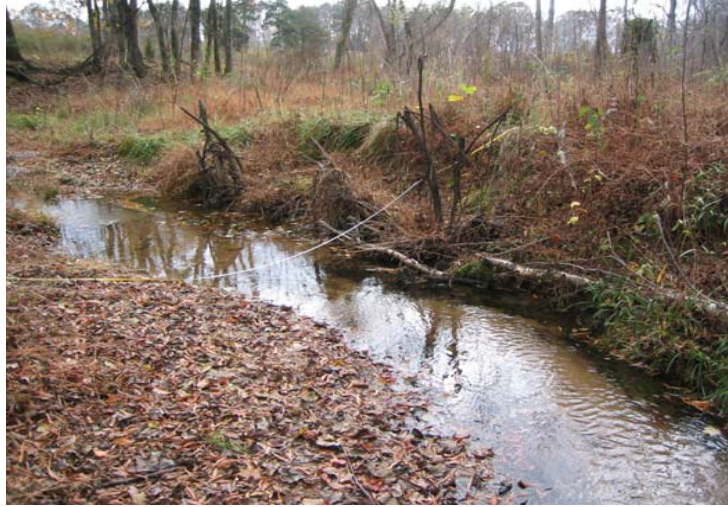
Photo of Cross-Section #1 - Looking Downstream

2002	2003
Area	20.79	14.07
Width	16.3	16.5
Mean Depth	1.3	0.9
Max Depth	3.1	1.7

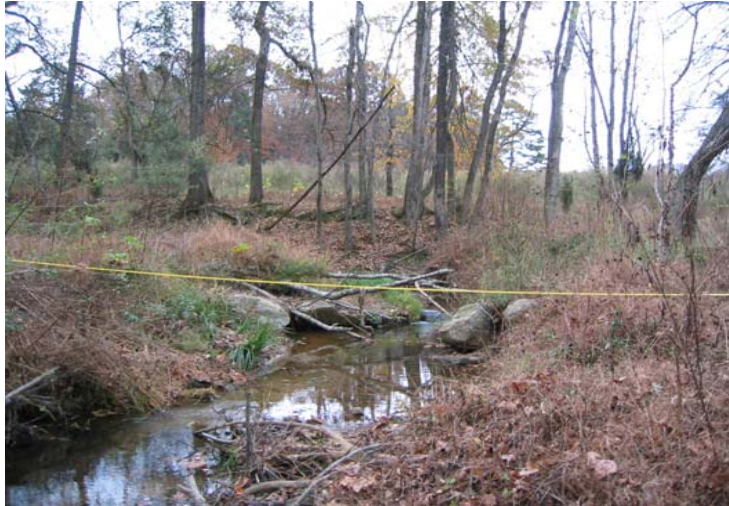
Photo of Cross-Section #2 - Looking Upstream

2002	2003
Area	16.50	28.07
Width	11.8	18.6
Mean Depth	1.4	1.5
Max Depth	2.2	2.4

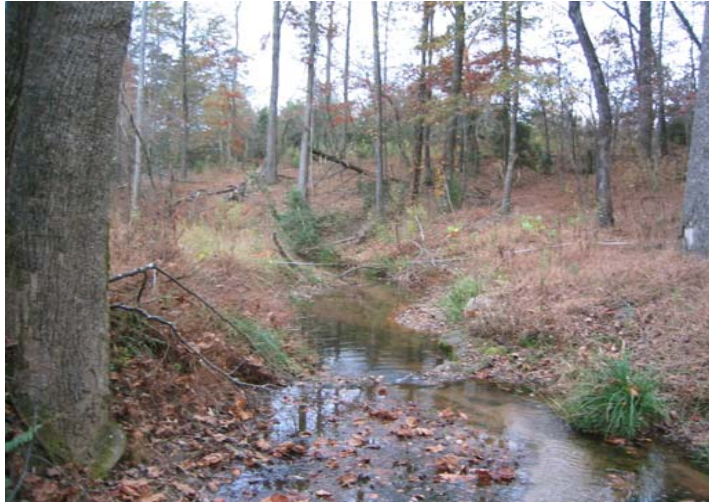
Photo of Cross-Section #3 - Looking Downstream

2002	2003
Area	15.60	26.08
Width	13.2	16.2
Mean Depth	1.2	1.6
Max Depth	2.2	2.0

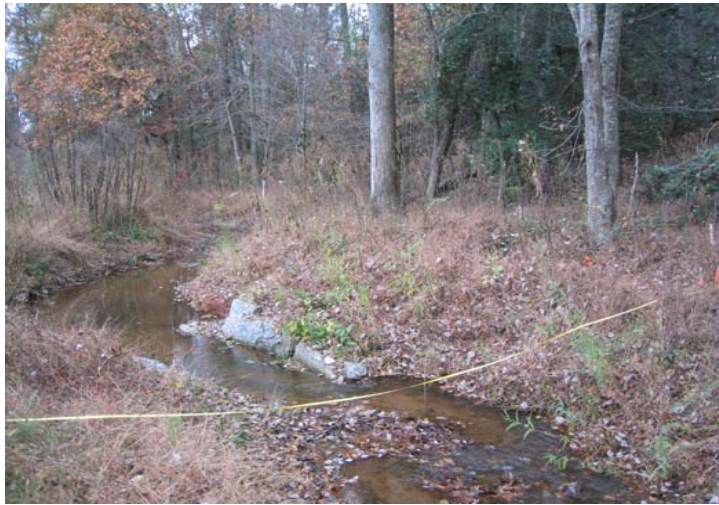
Photo of Cross-Section #4 - Looking Downstream

Cross-sections 4 through 7 are located within the relocated reach. Cross-sections 4 and 7 show little change from as-built conditions. Cross sections 5 and 6 have increased in area due to the effects of incision from the above-mentioned headcut and channel widening due to bank erosion. See table 1 for summary results and the appendix for detailed data results.

2002	2003
Area	17.49	17.76
Width	10.8	10.8
Mean Depth	1.6	1.6
Max Depth	2.7	2.6
