Lyle Creek Stream Restoration 2004 Annual Monitoring Report

February, 2005

2004 Lyle Creek Monitoring Abstract

This is the 2nd year of the 5-year monitoring plan for Lyle Creek.

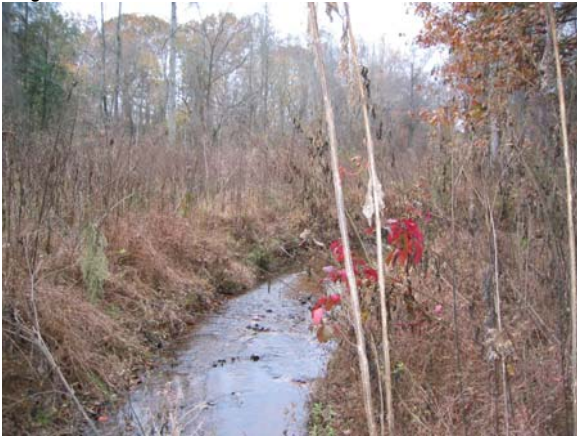
Typical Riffle on Lyle Creek.

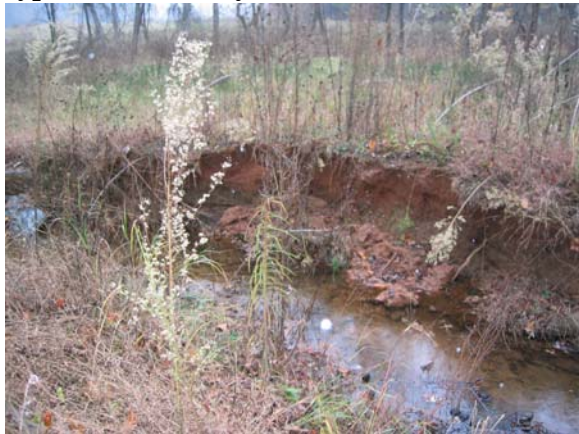
**Issue Photo 1
Lyle Creek Pool near station 9+40.
Typical Bank Slump on Left Bank**
