Year 4 Monitoring Report

Lyle Creek Stream Restoration

February 2006

S&EC Project No. 9442.D1
EEP Project No. 00102

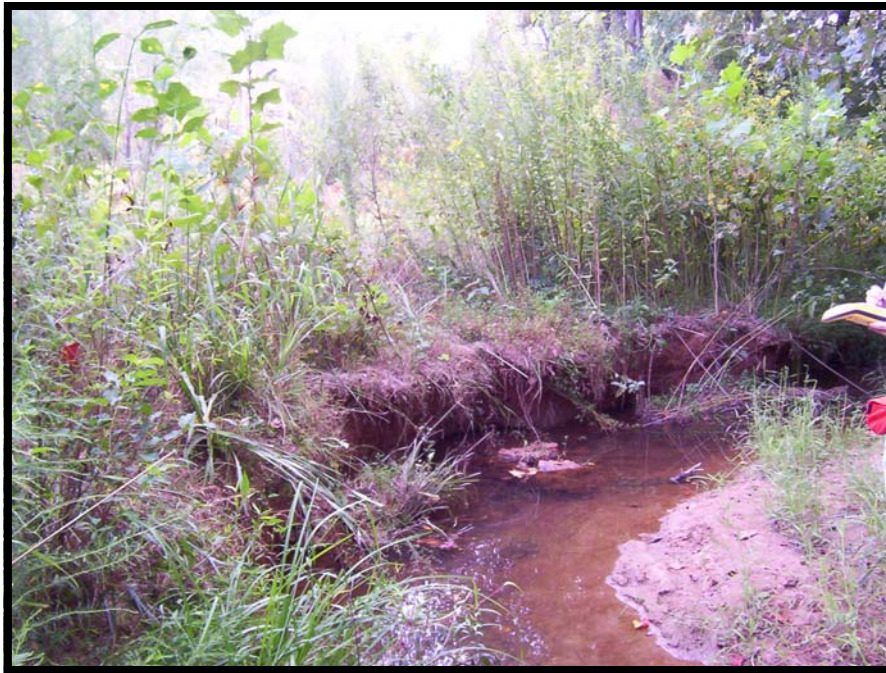
Table IXa: Stream Problem Areas Lyle Creek Stream Restoration Site (EEP Project #00102)			
Feature Issues	Station numbers	Suspected Cause	Photo number
Bank Scour	10+50 to 10+75	Excessive shear stress on banks	Photos 1-3
	11+05 to 11+40	Excessive shear stress on banks	
	12+50 to 12+75	Excessive shear stress on banks	
	14+05 to 14+50	Excessive shear stress on banks	
	16+00 to 16+25	Excessive shear stress on banks	
	16+50 to 17+25	Excessive shear stress on banks	
	18+00 to 18+25	Excessive shear stress on banks	
	18+70 to 19+00	Excessive shear stress on banks	
	19+20 to 19+40	Excessive shear stress on banks	
Stressed or Failing Structures	16+65	Excessive shear stress on banks	Photo 4
	19+25	Excessive shear stress on banks

Figure 1— Typical Bank Scour

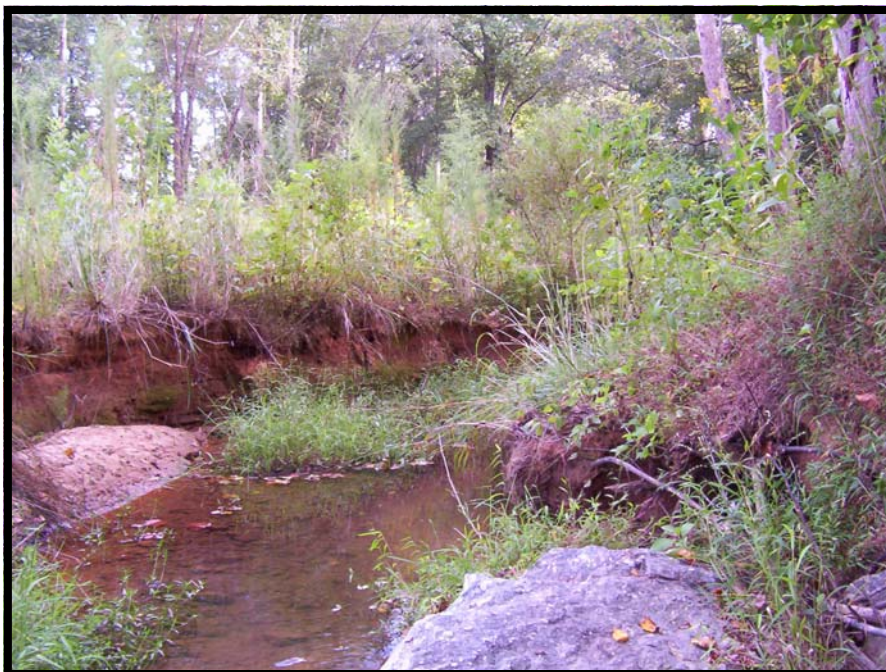
Figure 2—Typical Bank Scour
