Lyle Creek Stream Restoration

Project No. 423

2006 Monitoring Report: Year 4 of 5

March 2007

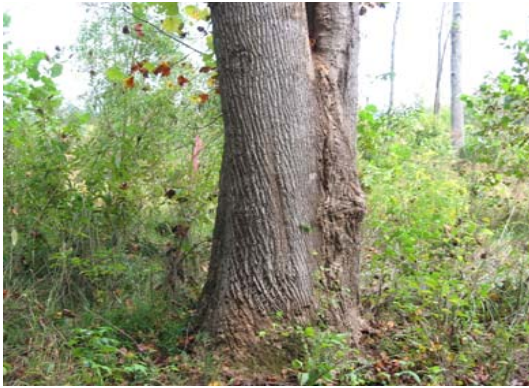
1. Monitoring Plot 1

Vegetative Issue	Location	Probable Cause	
Invasive population	Plot 1	existing seed source, storm flows, and land disturbance	
Invasive population	Plot 2	existing seed source, storm flows, and land disturbance	
Invasive population	Plot 3	existing seed source, storm flows, and land disturbance	
Invasive population	Plot 5	existing seed source, storm flows, and land disturbance	
Invasive population	Plot 6	existing seed source, storm flows, and land disturbance	
Invasive population	Plot 7	existing seed source, storm flows, and land disturbance	
Vegetative Issue	Station	Probable Cause	Photo Point #
moderate bank erosion / loss of stream bank vegetation	0+25 to 0+35	storm flows	A2.1
moderate bank erosion / loss of stream bank vegetation	4+25 to 4+50	storm flows	A2.1
severe bank erosion / loss of stream bank vegetation	5+75 to 6+00	storm flows	A2.2
severe bank erosion / loss of stream bank vegetation	9+25 to 9+40	storm flows	A2.2
