**Lyle Creek Stream Restoration**  
**Project No. 423**  
**2007 Monitoring Report (Final): Year 5 of 5**

**March 2008**

Prepared by: Jordan, Jones, and Goulding, Inc.  
9101 Southern Pine Blvd., Suite 160  
Charlotte, NC 28273

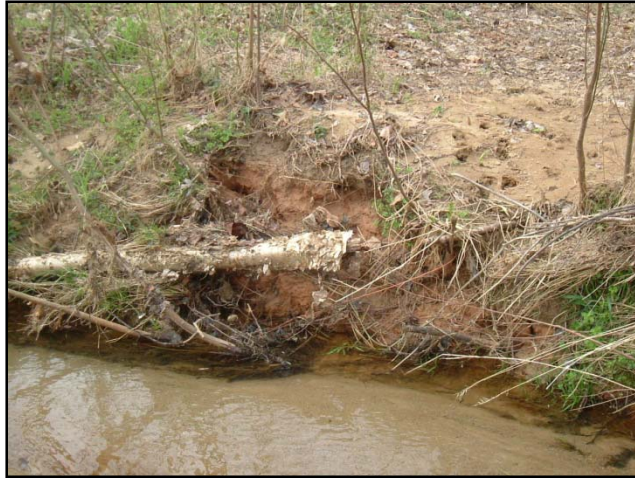
1. Moderate Bank Erosion-3/22/2007
