# **MONITORING YEAR 5 ANNUAL REPORT**

## **LYLE CREEK MITIGATION SITE**

Catawba County, NC  
DEQ Contract 003241  
DMS Project Number 94643

Data Collection Period: February - November 2016  
Draft Submission Date: November 30, 2016  
Final Submission Date: December 5, 2016

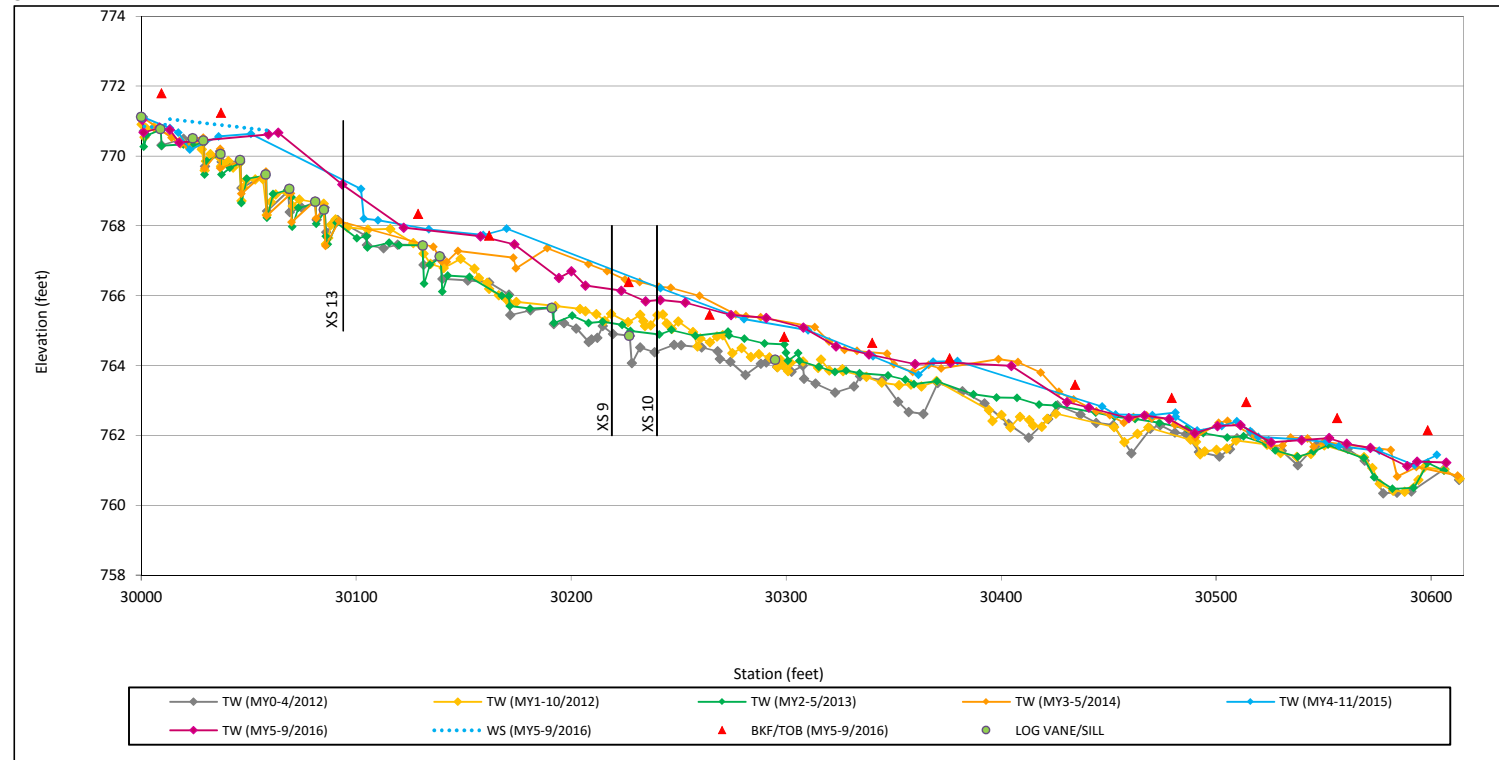
Streams within the site are stable and functioning as designed. Aggradation documented in UT1A persists. Wildlands has removed this 394 LF from the credit request. Lesser amounts of aggradation were observed on the upper portion of UT1 and UT1B however these channels are stable and functioning as single thread channels. It is anticipated that aggraded sediment in UT1 and UT1B will be evacuated from the system. The average stem density for the site has met the MY5 success criteria. There have been more than two bankfull events recorded in separate monitoring years along each restored project reach since construction commenced; therefore, the site has met the MY5 stream hydrology attainment requirement. A majority of groundwater gages (9 out of 11 gages) met the wetland hydrology success criteria for MY5. Wildlands has removed 0.6 acres of wetland creation located on the west side of UT1 in the area represented by GWG 6 and 9 from our credit request.

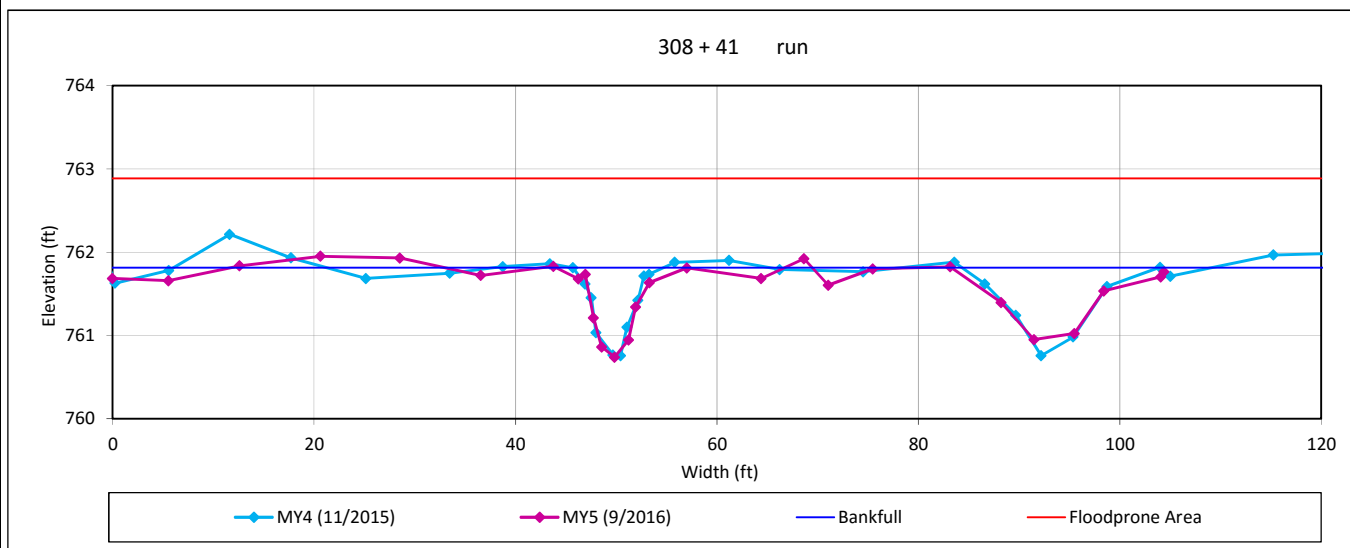
#### Cross Section 14 - UT1A

4.5	x-section area (ft.sq.)
7.0	width (ft)
0.6	mean depth (ft)
1.1	max depth (ft)
7.4	wetted perimeter (ft)
0.6	hyd radi (ft)
11.0	width-depth ratio

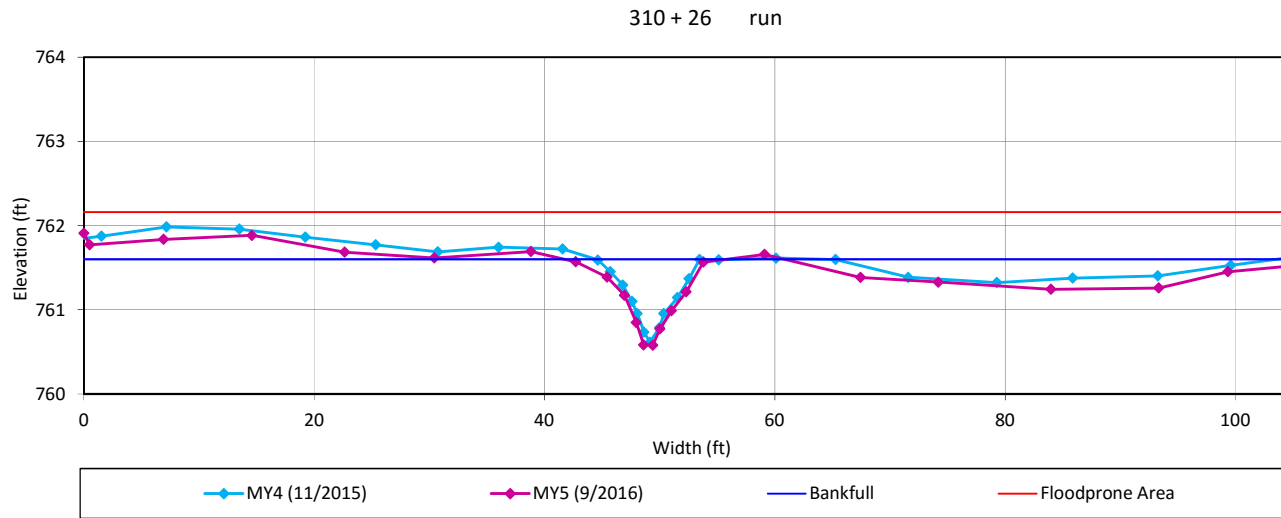
#### Cross Section 15 - UT1A

2.9	x-section area (ft.sq.)
7.4	width (ft)
0.4	mean depth (ft)
0.8	max depth (ft)
7.6	wetted parimeter (ft)
0.4	hyd radi (ft)
19.2	width-depth ratio
