**BASELINE MONITORING
DOCUMENT AND AS-BUILT
BASELINE REPORT**
Final

LYON HILLS MITIGATION SITE

Wilkes County, NC
NCDEQ Contract No. 7620
DMS Project Number 100085
USACE Action ID Number SAW-2018-01784
NCDWR Project Number 2018-1274 v1

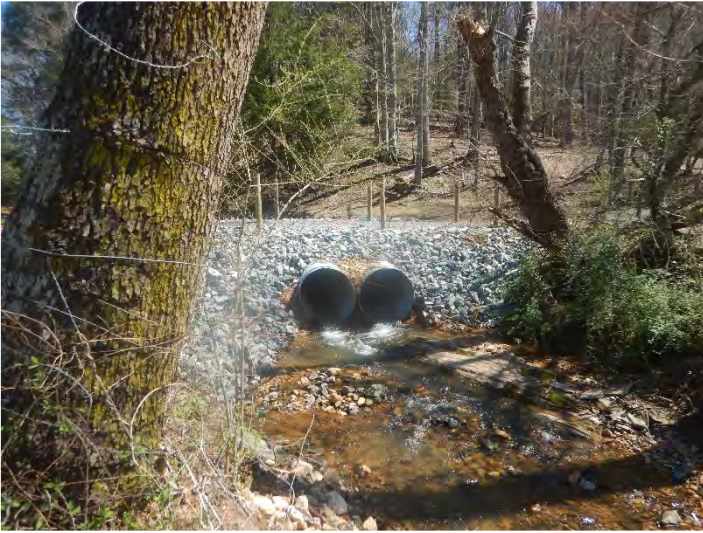
Hanks Branch R3 - Perched - Looking Upstream (03/29/2021)

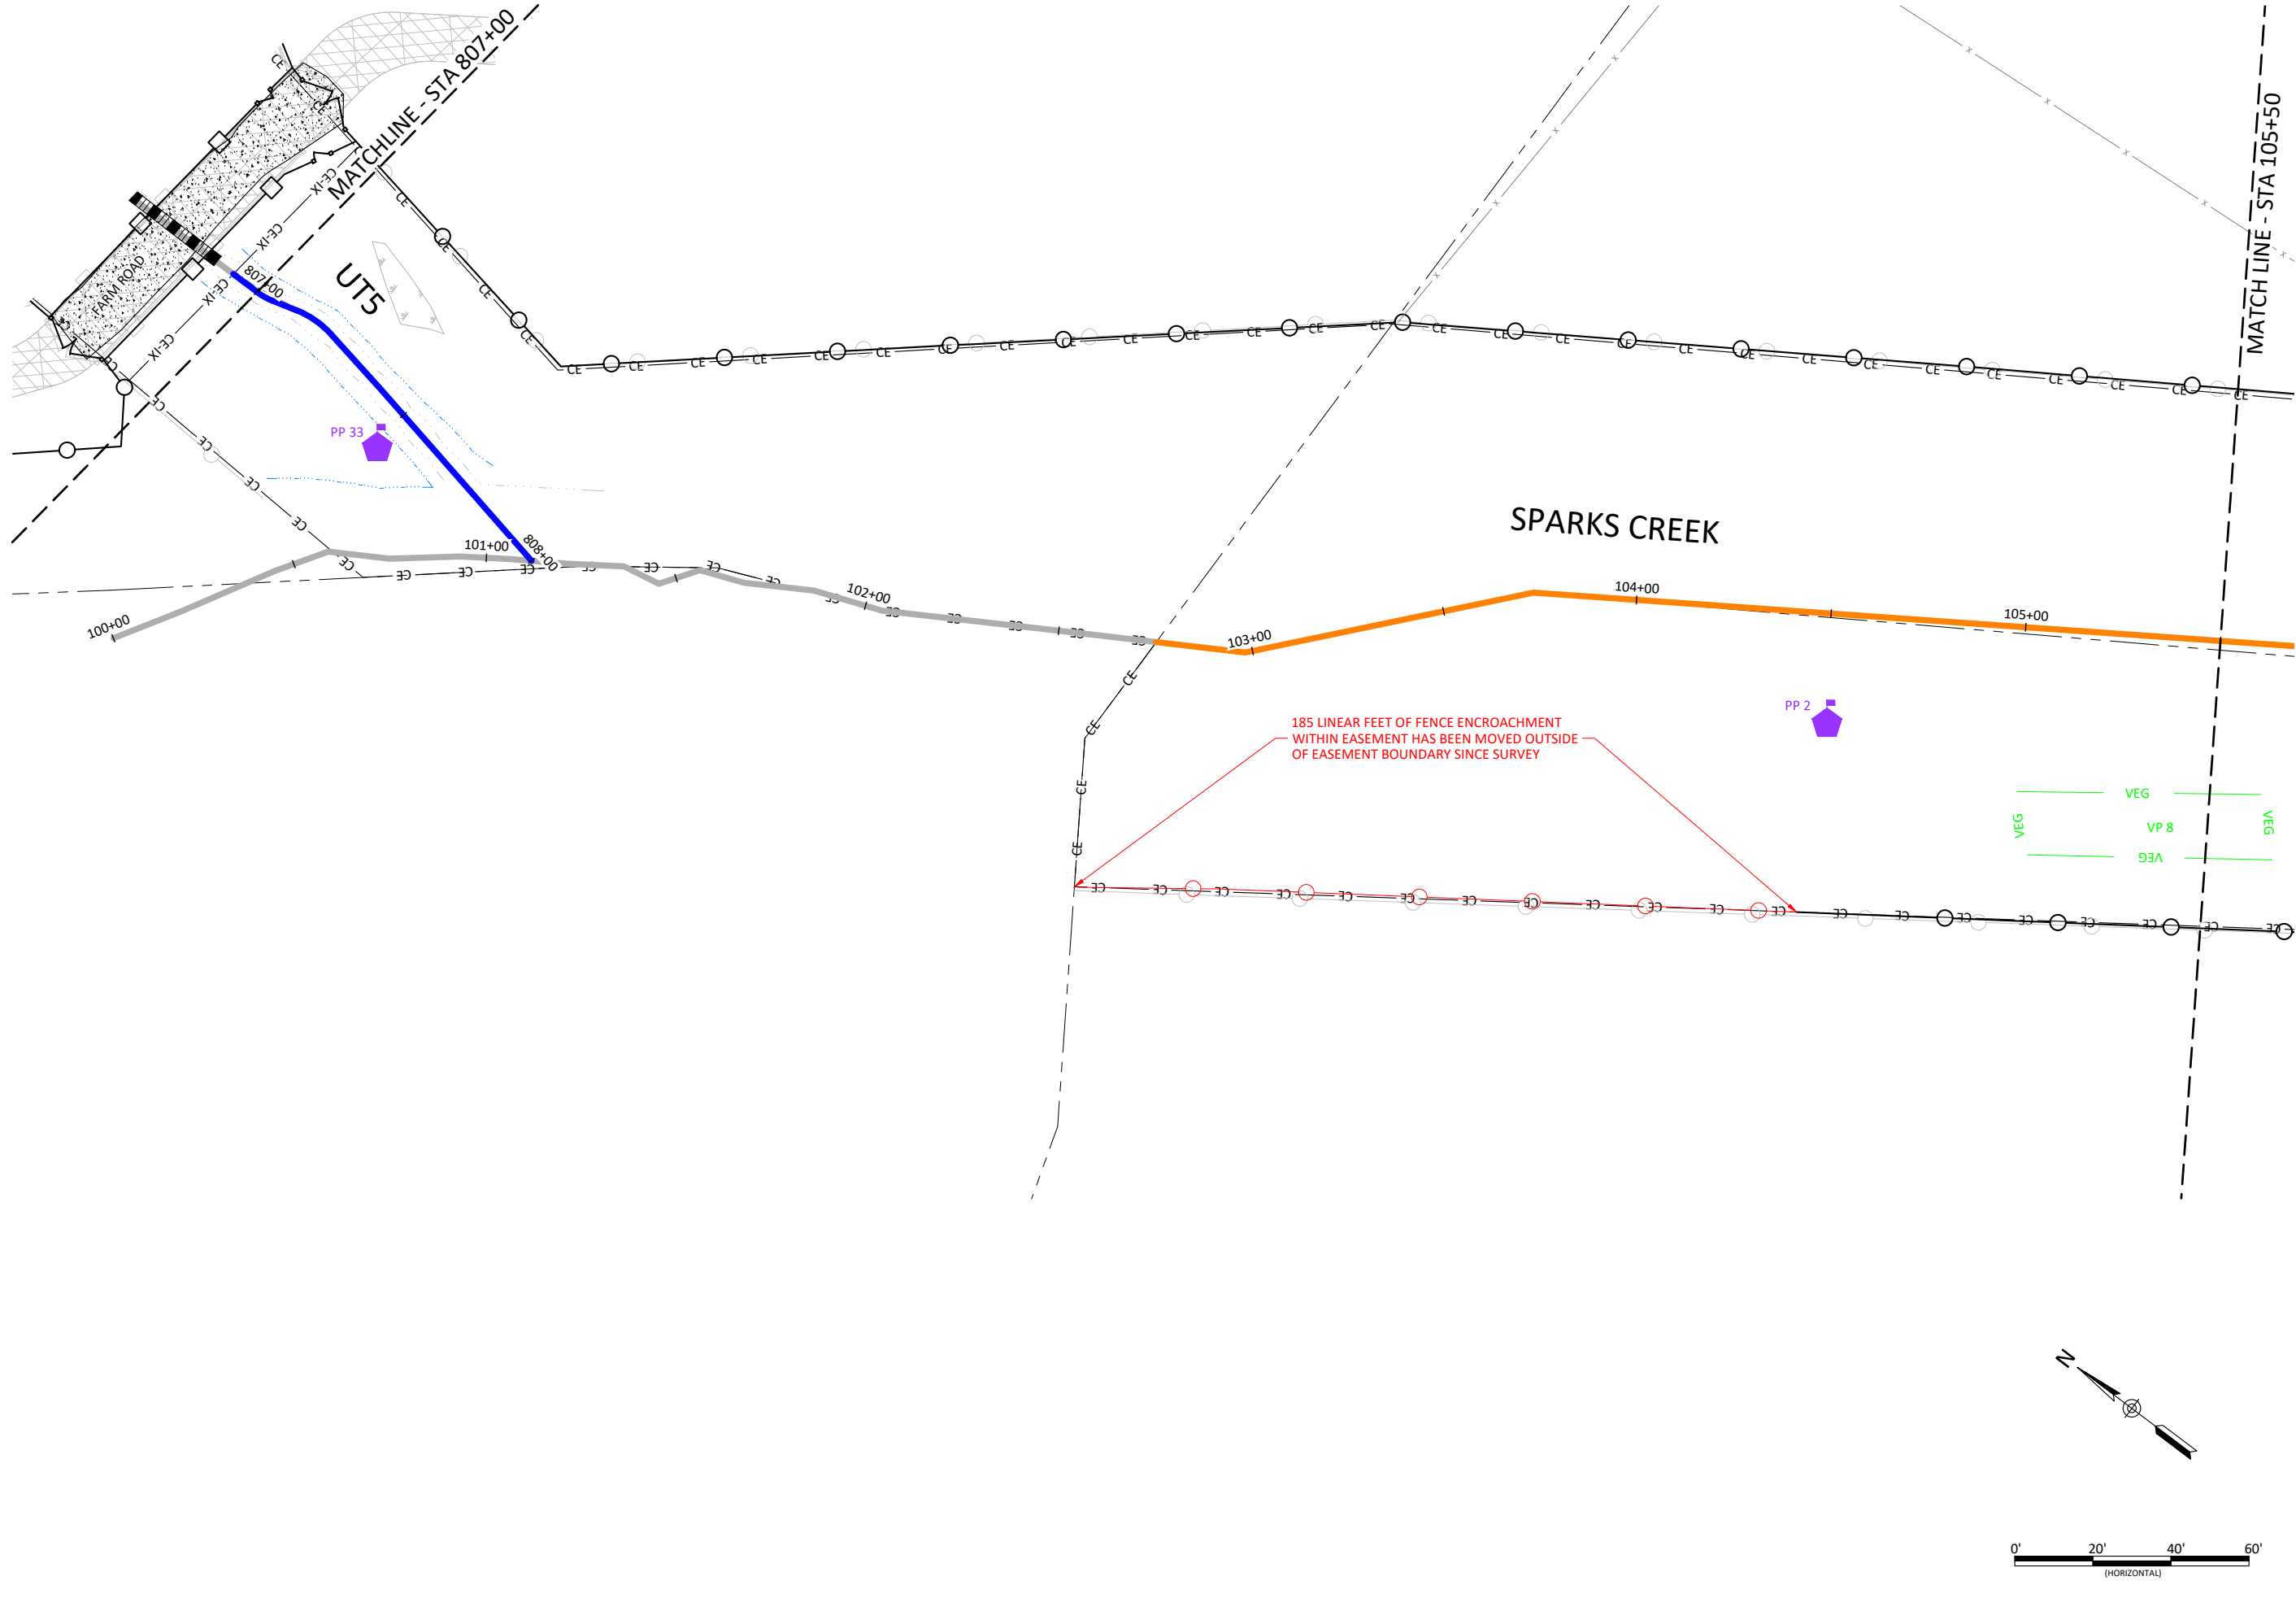
Lyon Hills Mitigation Site As-Built
Wilkes County, North Carolina
Sparks Creek
Fencing Plan

Fencing was completed in March 2021. During survey, three areas were discovered to be installed slightly inside the conservation easement. These included a 185 linear foot section at the top of Sparks Creek, a 135 linear foot section at the top of UT5, and a 98 linear foot section along the top of UT5A. These locations can be found in Appendix 5 As-Built and Record Drawings: Sheet 4.07 and Sheet 4.17. In each of these areas, the fence has been moved to the appropriate one-foot offset outside the easement since the survey was completed. Two 95 linear foot sections of fencing along the stream crossing on Sparks Creek were not installed to comply with the landowner's request. Sparks Creek has a drainage area of 9.5 square miles and frequently floods. Fencing across Sparks Creek would catch debris and most likely fail during storm events. To avoid frequent repairs this section of fencing was not installed. Based on discussions with the landowner, gates on both sides of the Sparks Creek crossing will remain closed when not actively moving cattle. Cattle will actively be supervised when crossing Sparks Creek to prevent them from accessing the easement.

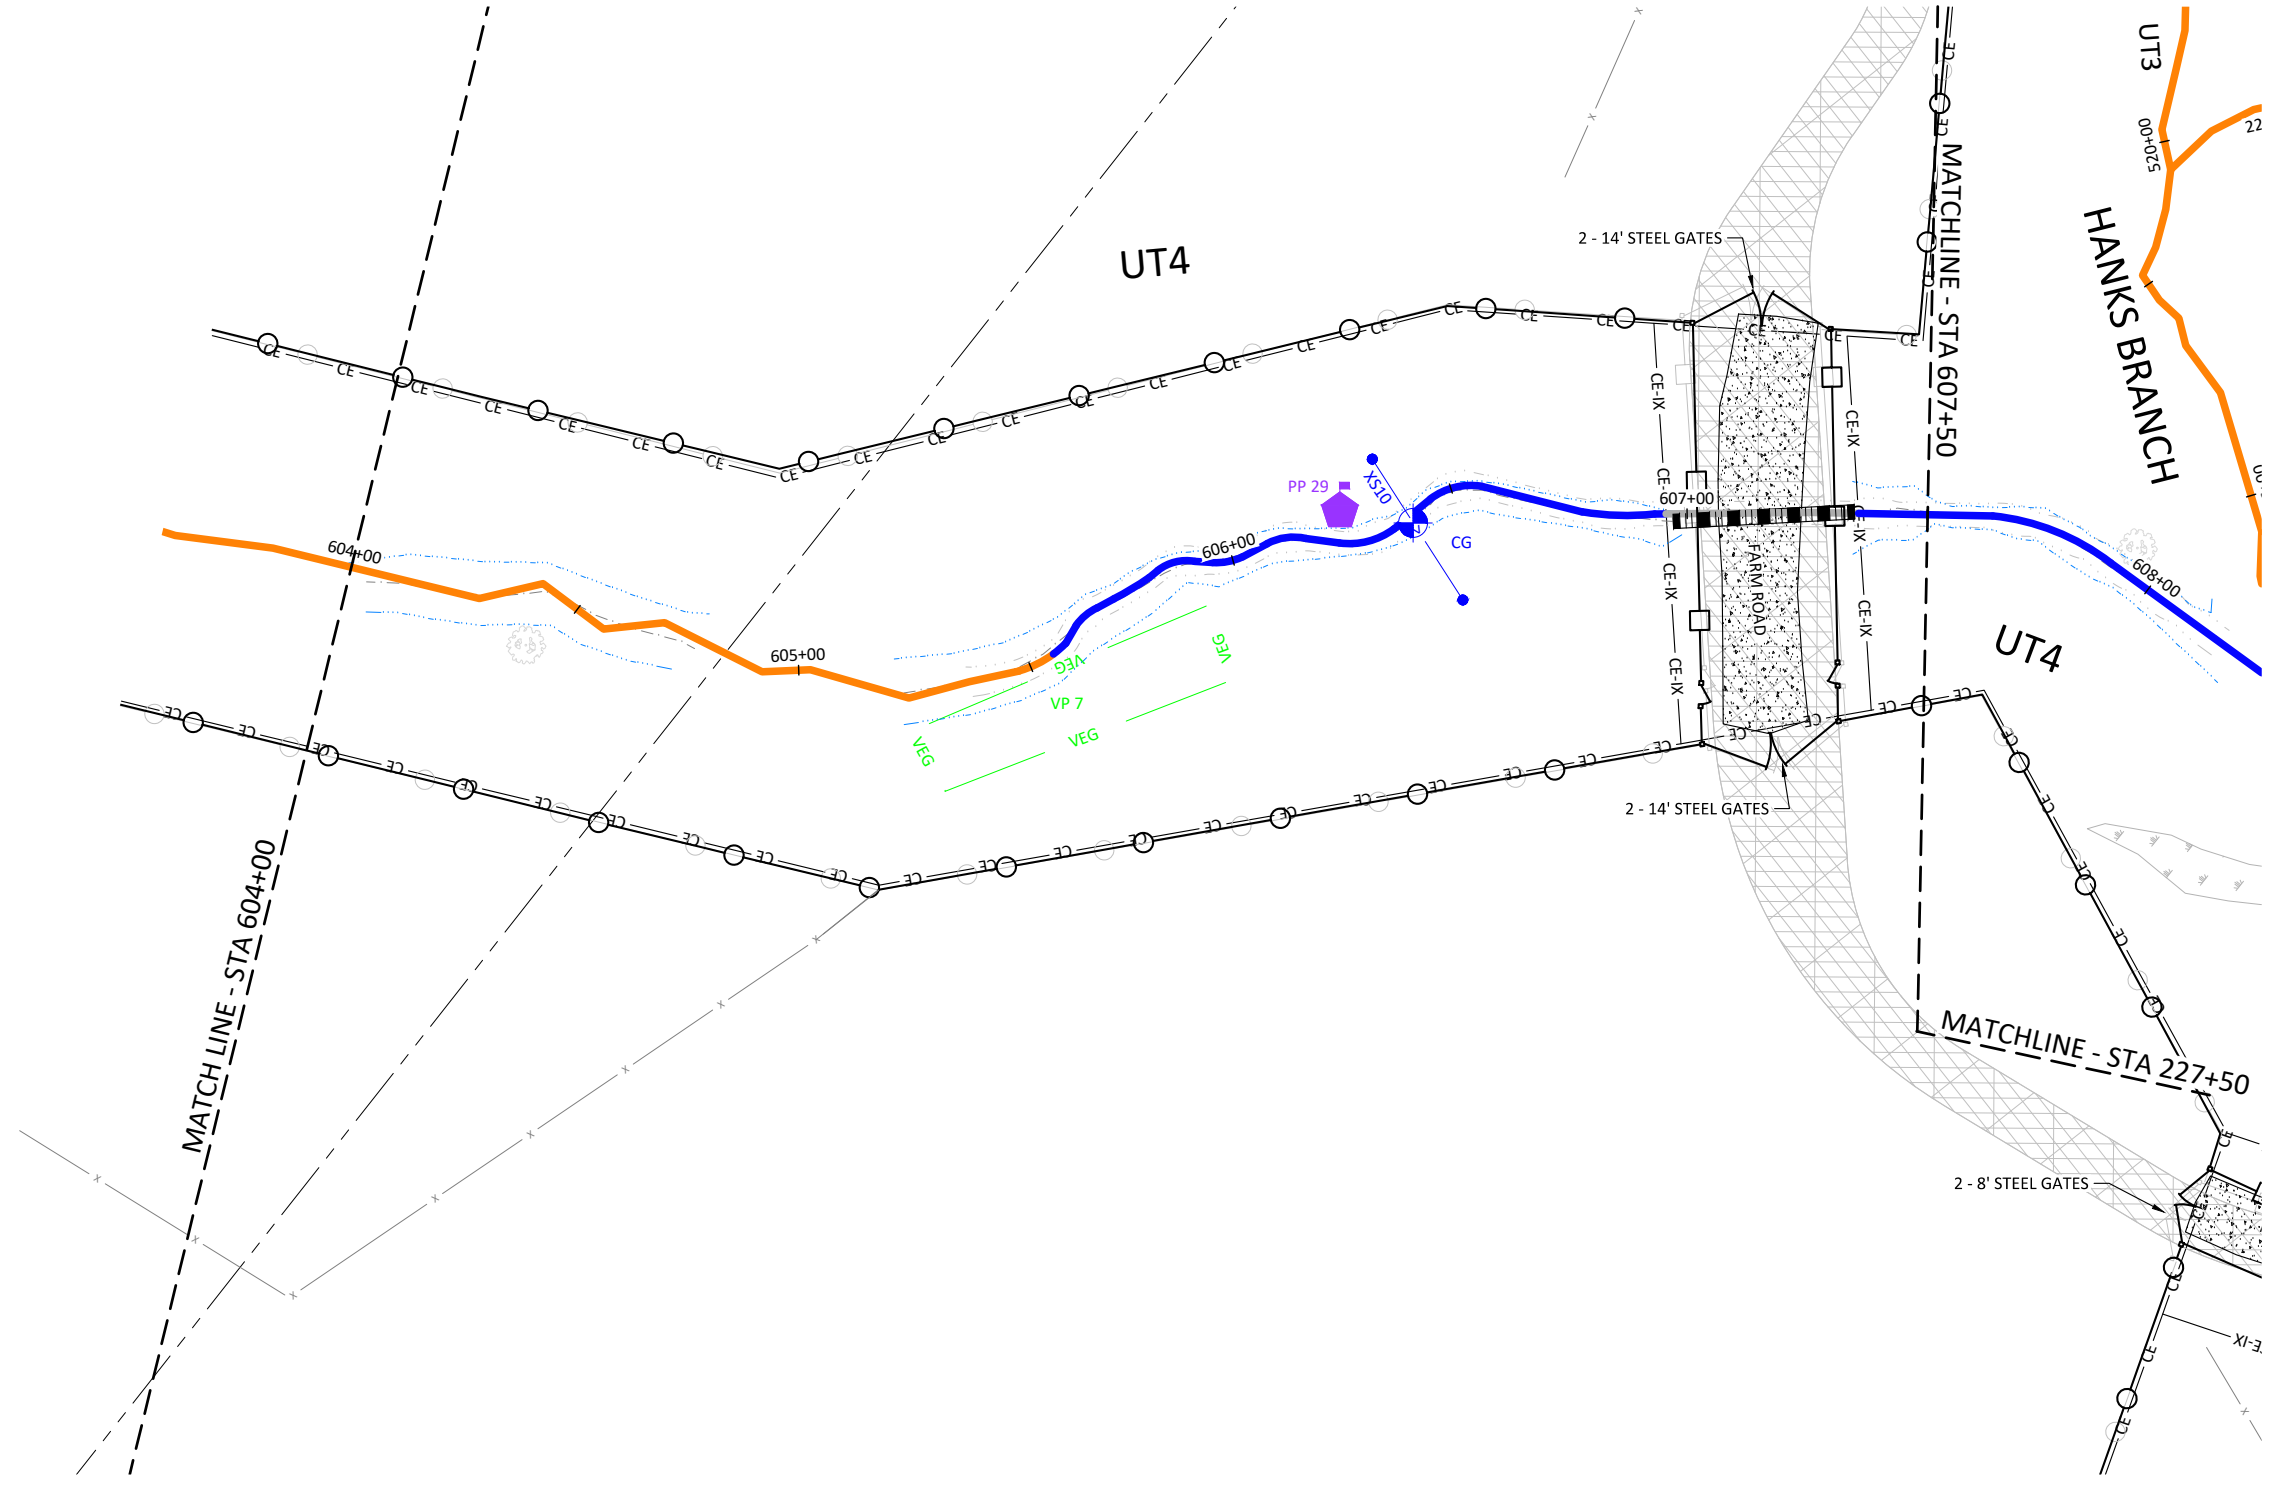
UT4
Fencing Plan

98 LINEAR FEET OF FENCE ENCROACHMENT WITHIN EASEMENT HAS BEEN MOVED OUTSIDE OF EASEMENT BOUNDARY SINCE SURVEY
