**MONITORING YEAR 2
ANNUAL REPORT**
Final

January 2023

LYON HILLS MITIGATION SITE

Wilkes County, NC
Yadkin River Basin
HUC 03040101

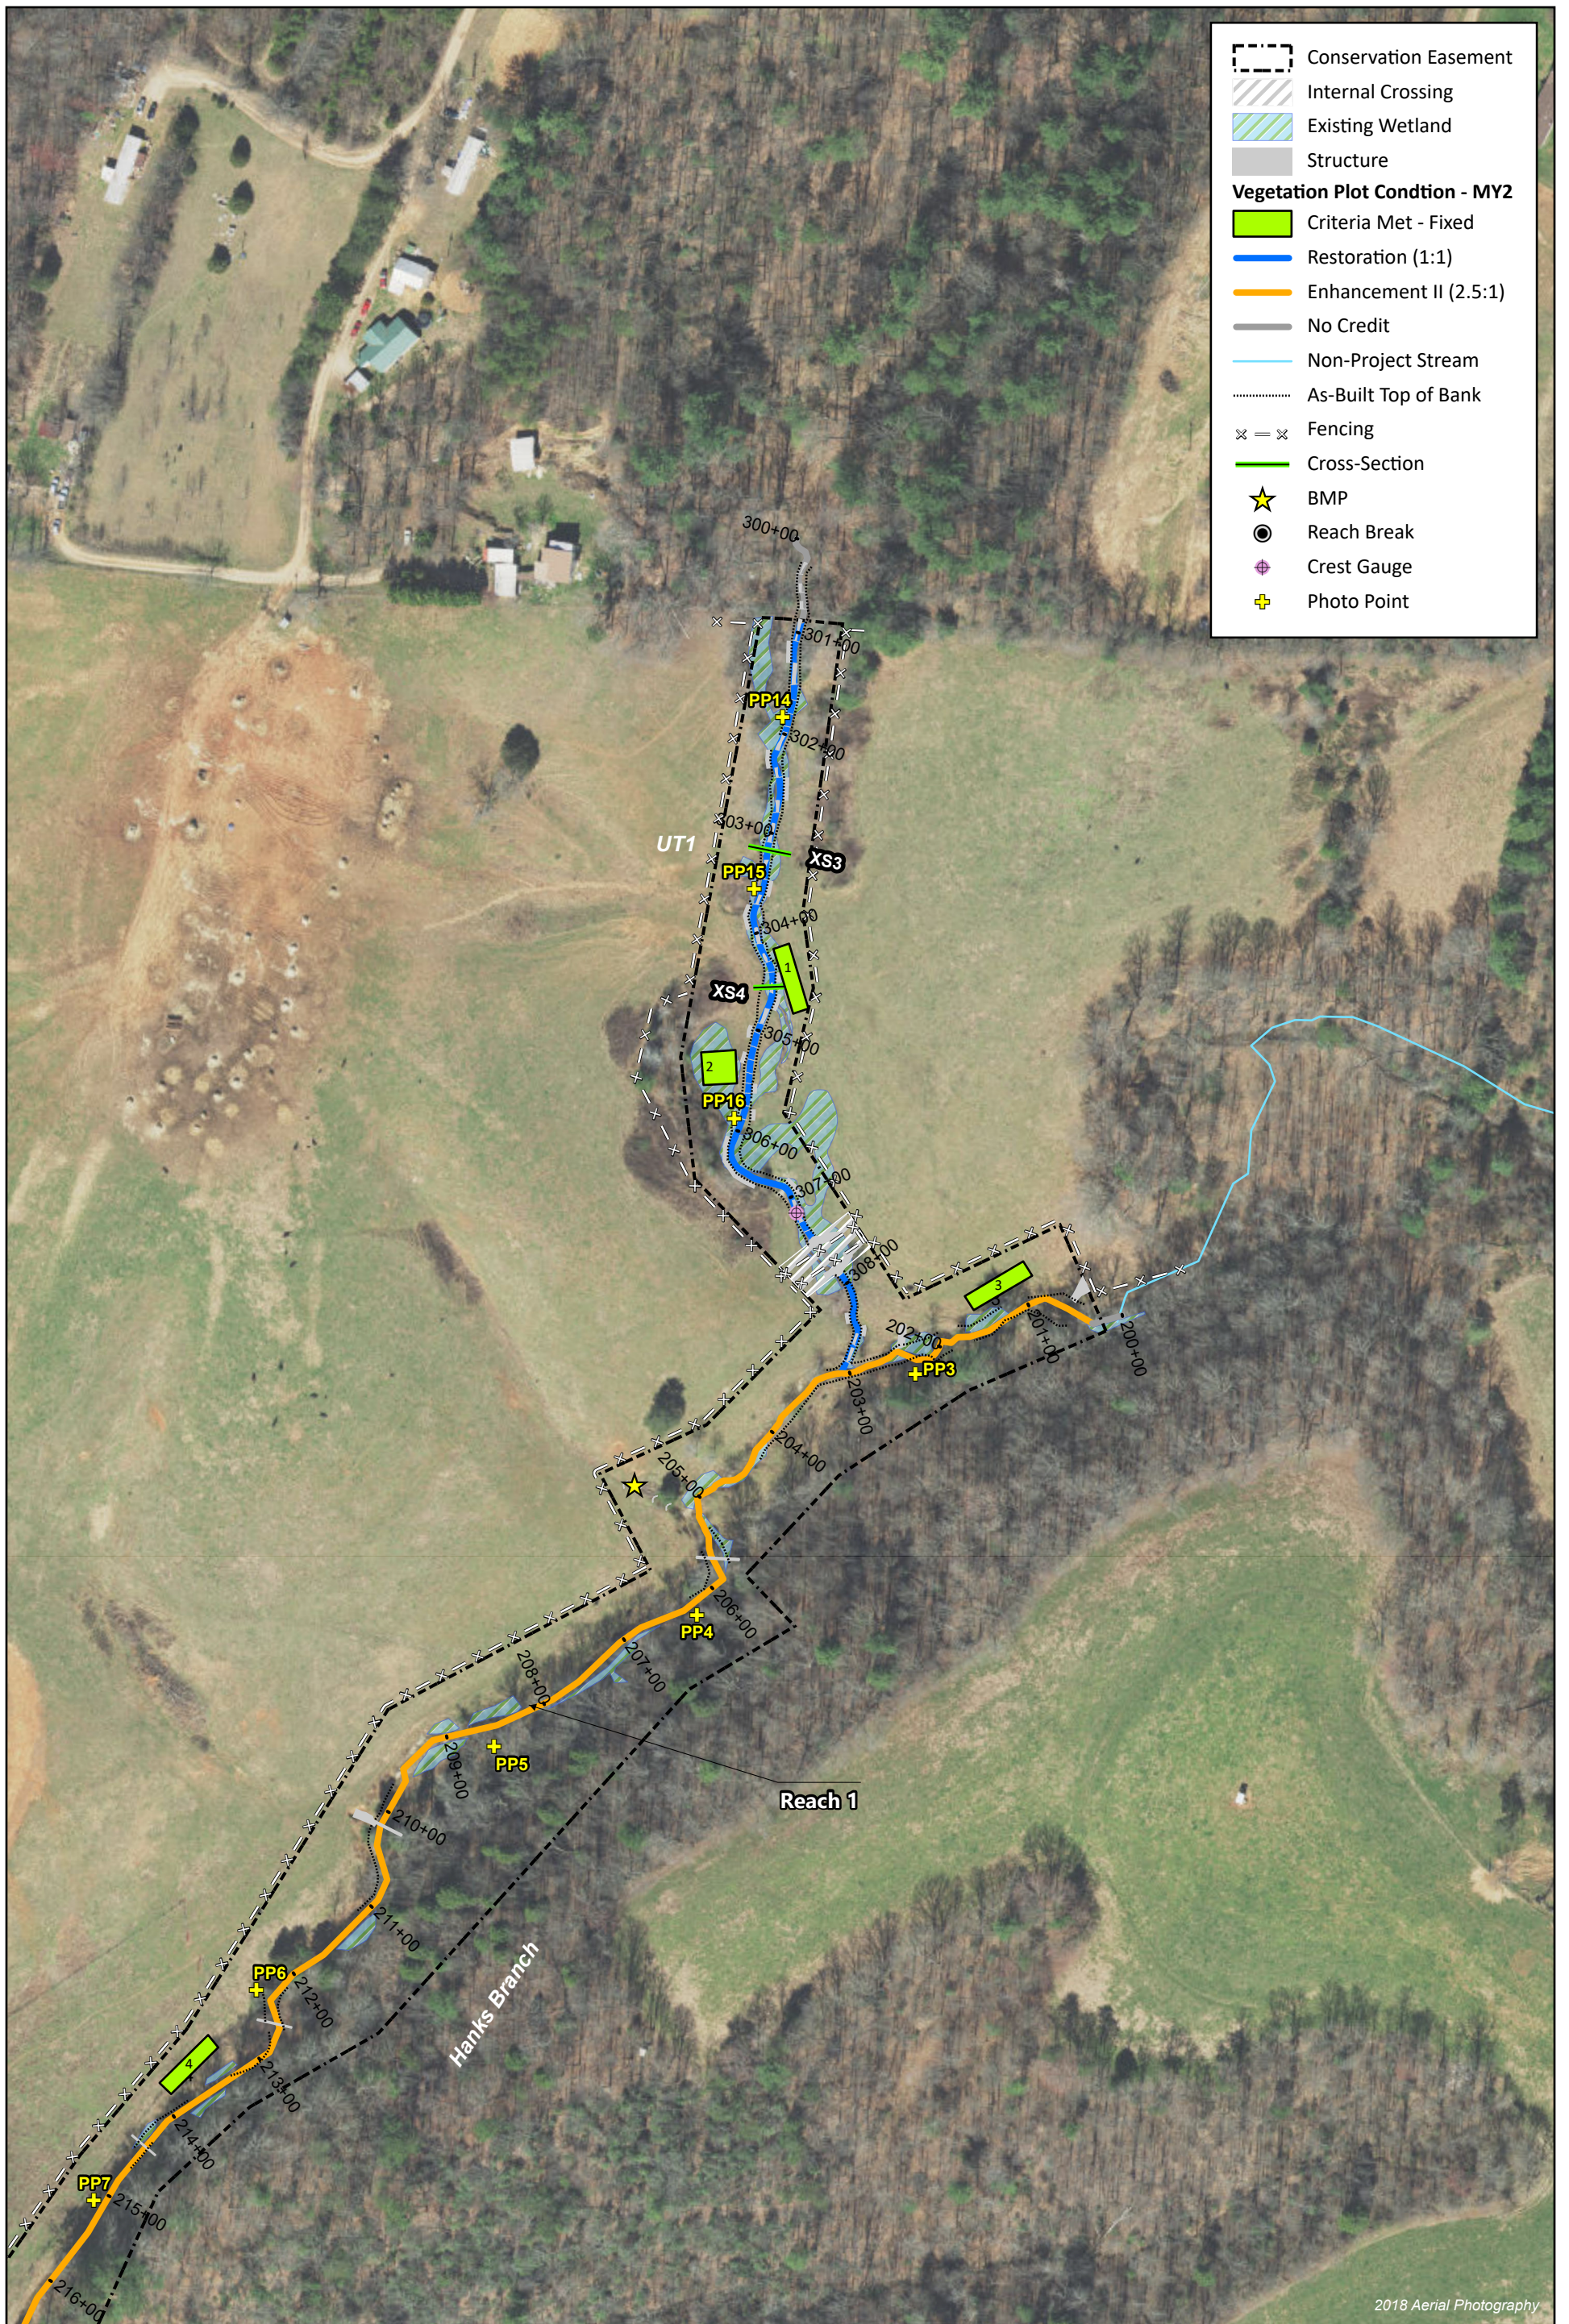
Figure 1a. Current Condition Plan View
 Lyon Hills Mitigation Site
 DMS Project No. 100085
 Monitoring Year 2 - 2022
 Wilkes County, NC

During MY2 in-stream vegetation was only observed sporadically along UT5 Reach 2 (Figure 1c). This area of in-stream vegetation should continue to become less problematic as trees continue to grow and ultimately shade the stream and suppress the in-stream vegetation. After a chemical and manual in-stream vegetation treatment in August 2022, most of the accumulated sediment flushed through UT5. Wildlands will continue to monitor in-stream vegetation growth and will continue to treat it as necessary.

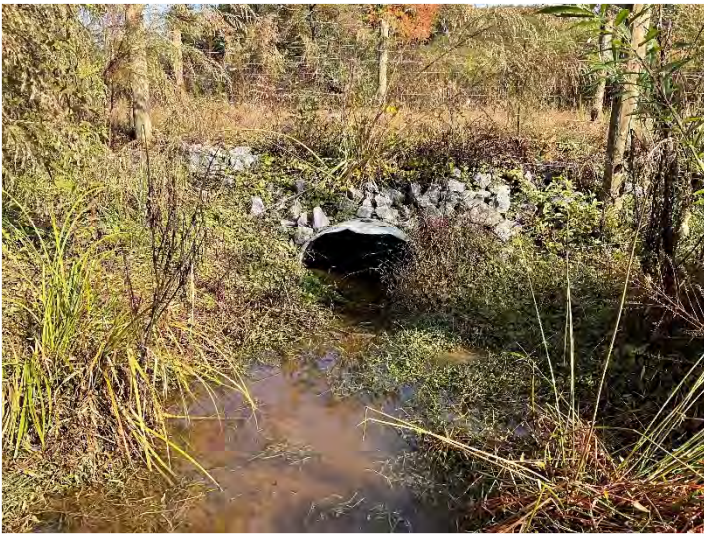
UT5 R2 - Looking Upstream (10/17/2022)
