MONITORING YEAR 3 ANNUAL REPORT FINAL

LYON HILLS MITIGATION SITE

Wilkes County, NC
Yadkin River Basin
HUC 03040101

DMS Project No. 100085
NCDEQ Contract No. 7620
USACE Action ID No. SAW-2018-01784
DWR Project No. 2018-1274 v1
Data Collection Dates: January-November 2023

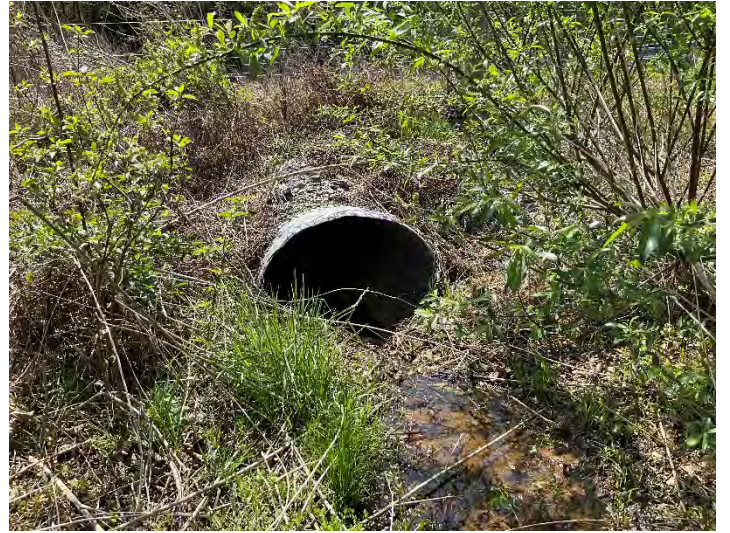
UT4 R3 - Looking Upstream (4/20/2023)

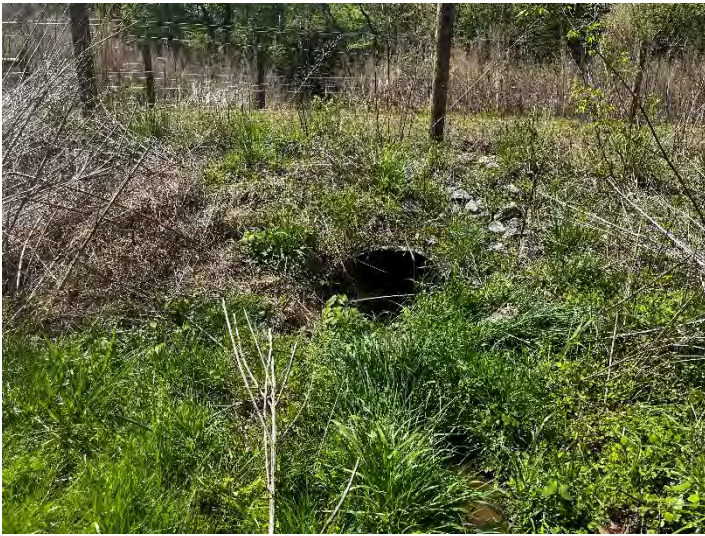
UT4 R3 - Looking Downstream (4/20/2023)

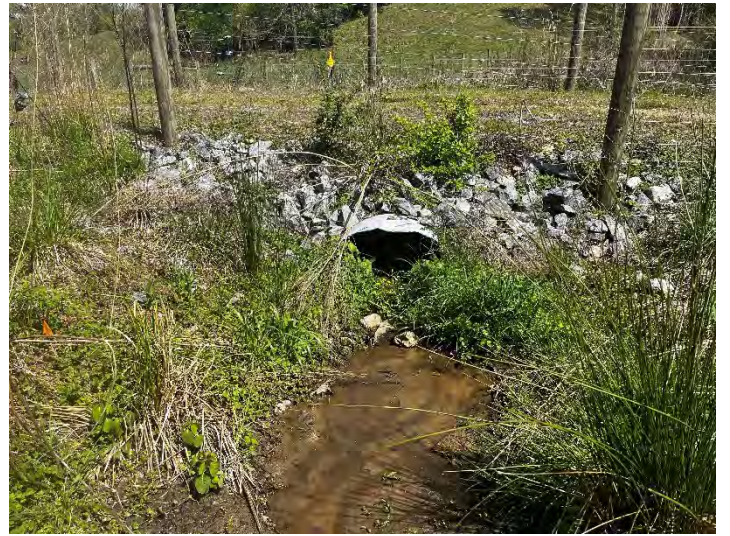
UT5 R2 - Looking Upstream (4/20/2023)

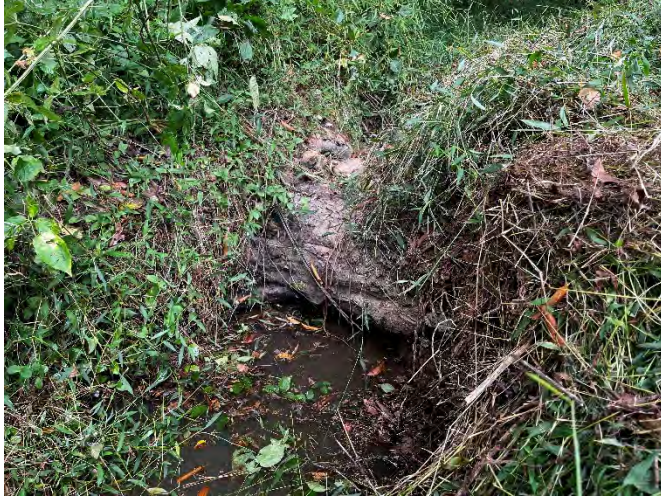
UT4 Reach 2, station 604+40 – Log sill piping (10/1/2023)

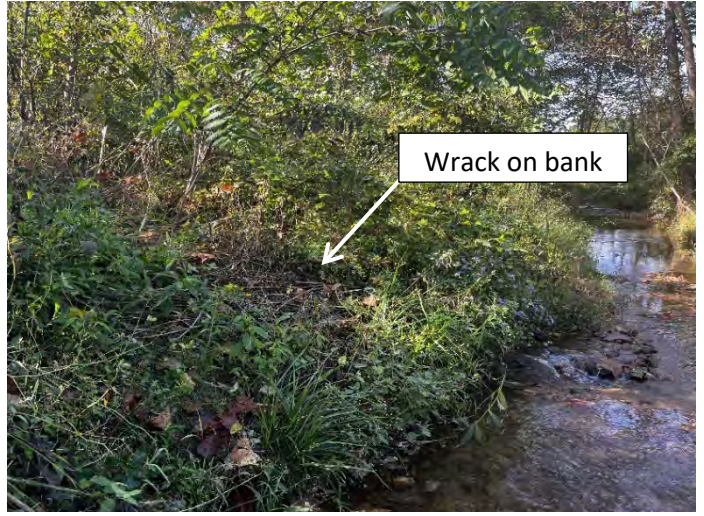
Hanks Branch R3, station 232+61 – Left Bank Wrack Line
(10/5/2023)
