FINAL
AS-BUILT BASELINE
MONITORING REPORT (MY0)

MAJOR HILL STREAM AND WETLAND MITIGATION SITE
Alamance County, North Carolina

DMS Project ID No. 100015
Full Delivery Contract No. 7193
USACE Action ID No. SAW-2017-01472
DWR No. 17-0921
RFP No. 16-006990

Data Collection: September 2018 – January 2019
Submission: March 2019

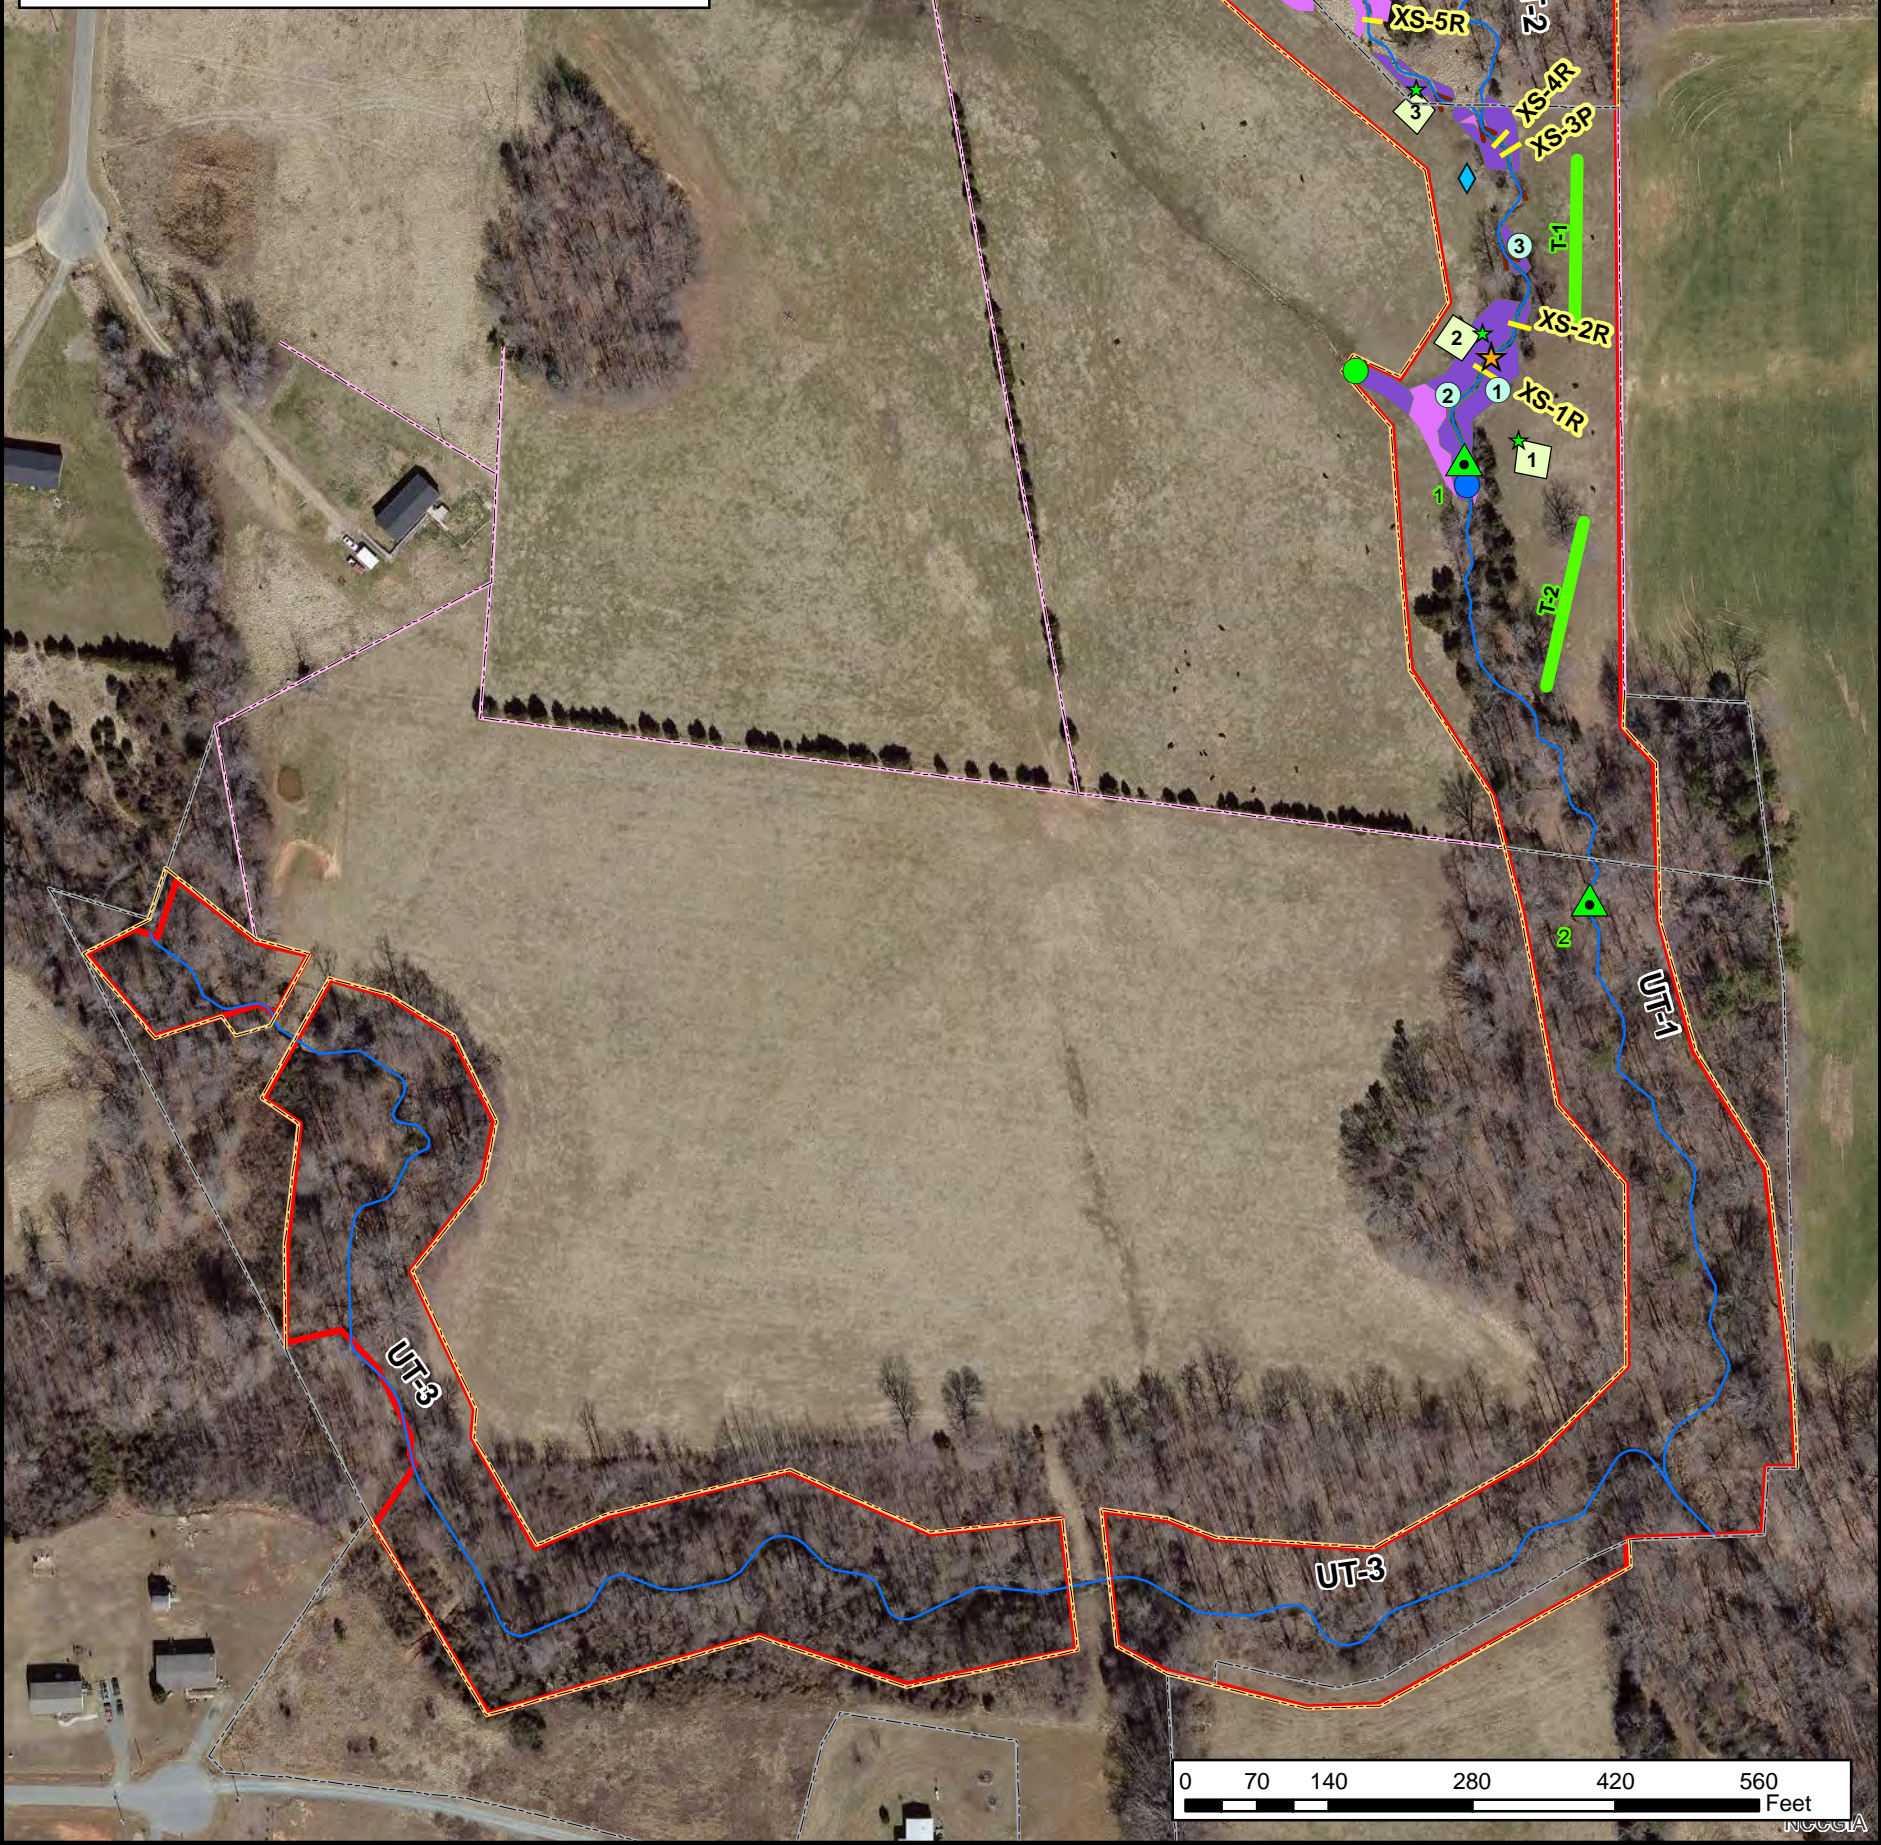
Dwn. By: KRJ	FIGURE 2
Date: Feb 2019	
Project: 17-009

- Table 2, the RFP issue date is 9/16/2016. Add 404 permit date to table (6/28/2018, see excel table guidance). *This was adjusted/added.*
- Figure 2, CCPV, Please increase text on legend so it is more legible. Show location of fences on CCPV. *Font size in the legend was increased, and fences were added to the CCPV.*

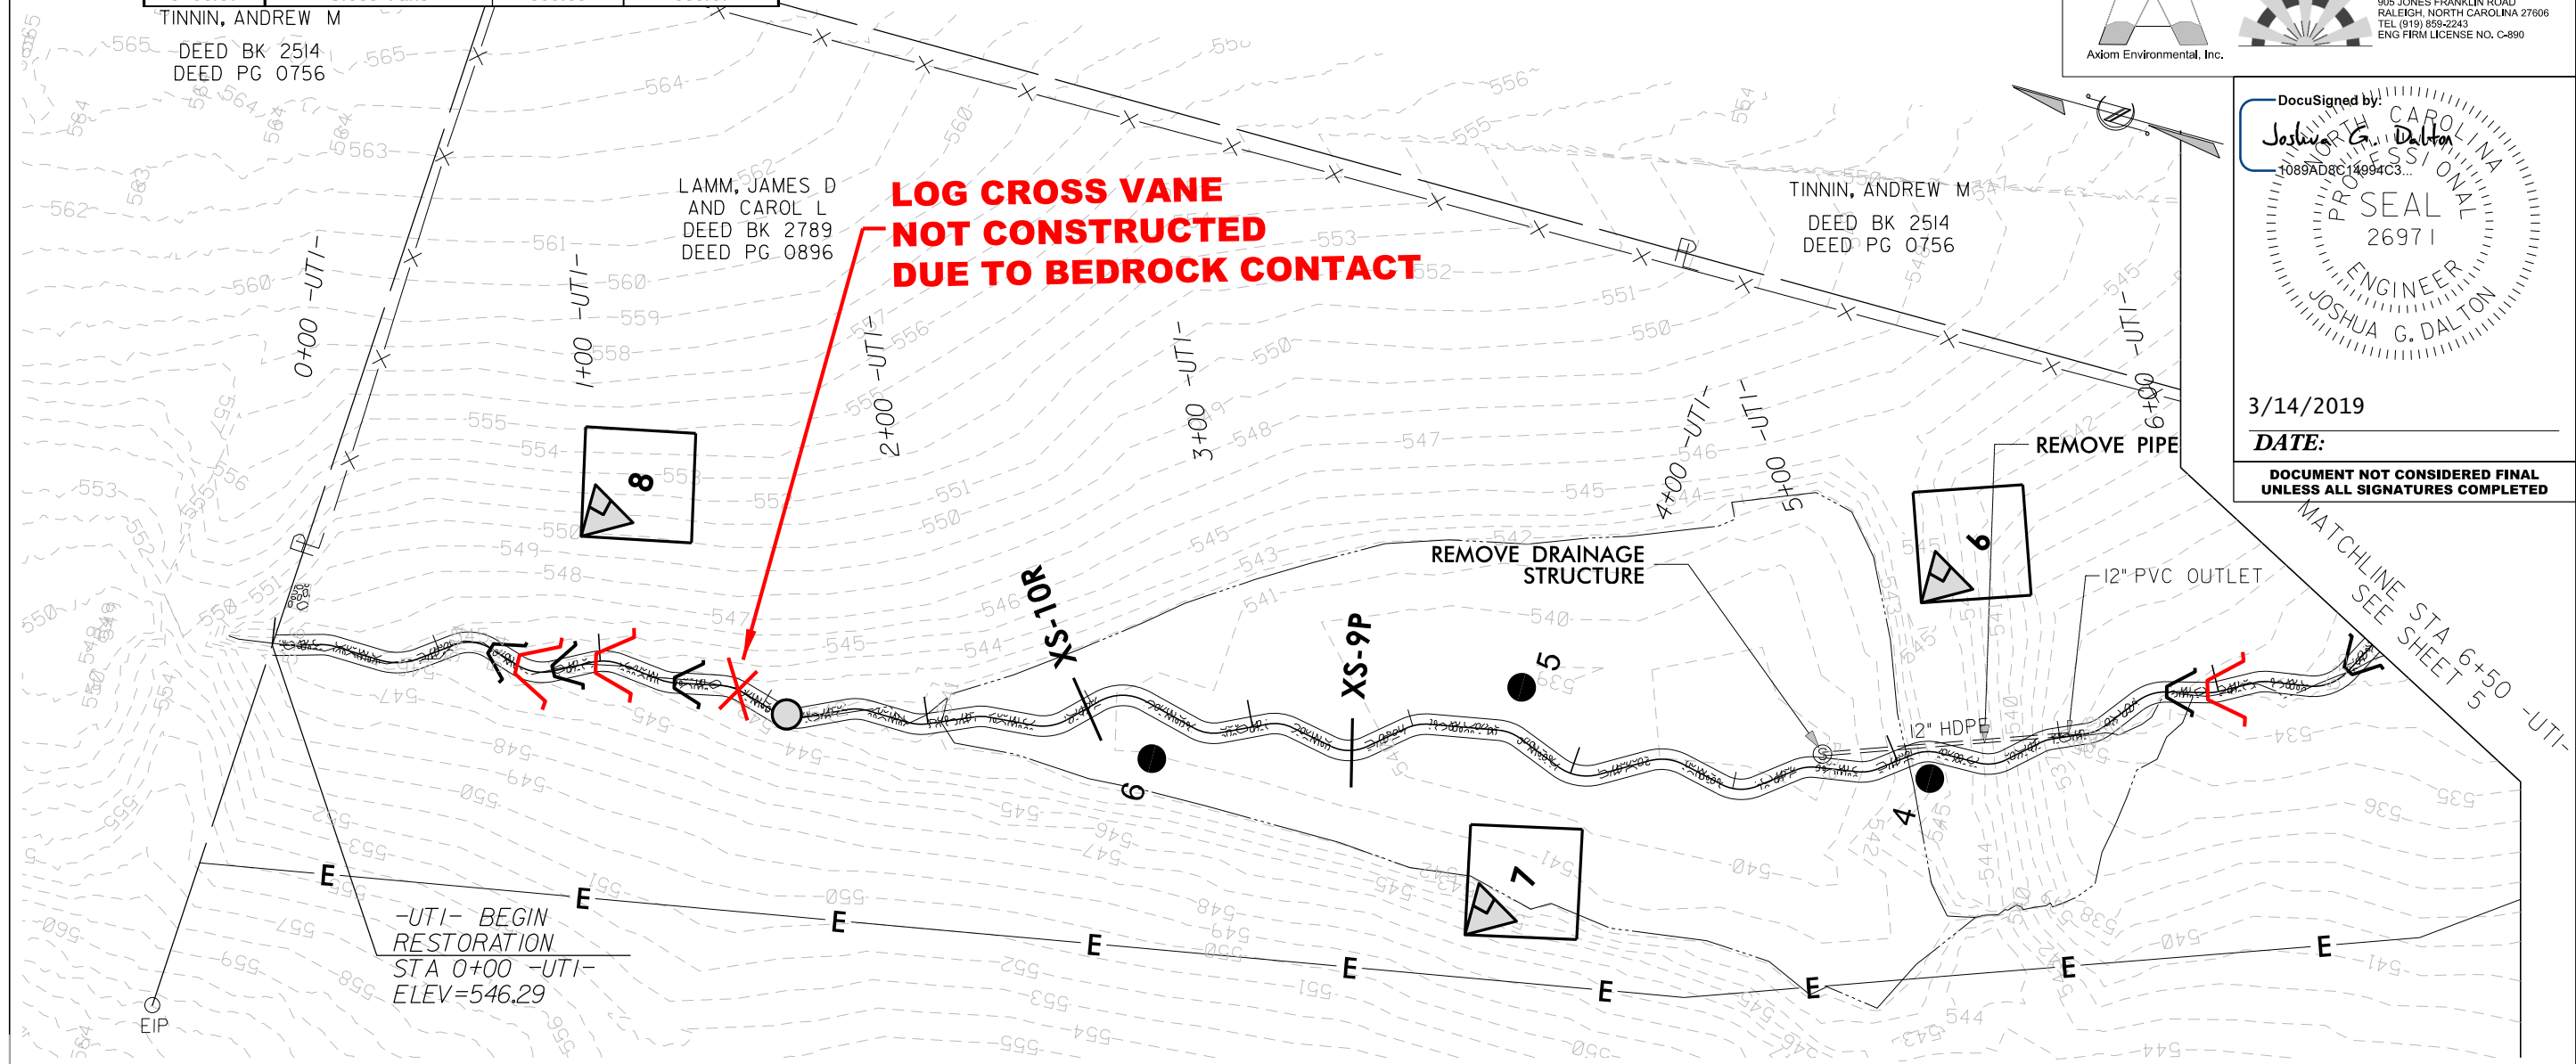
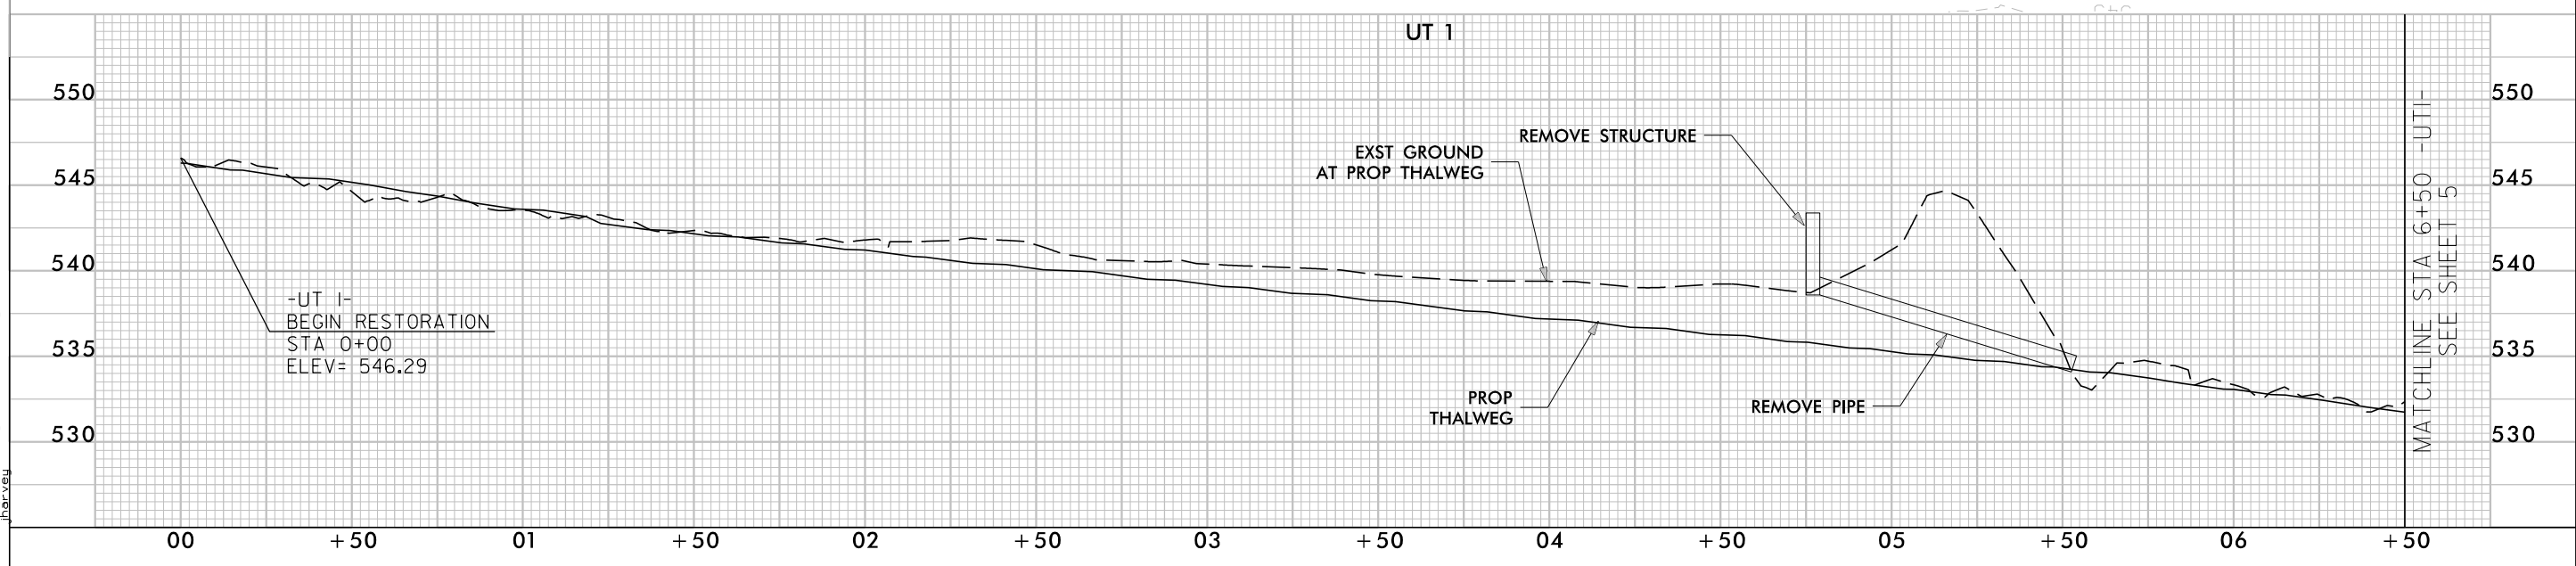
3/14/2018 Major Hill_Hyd_AB_PSH_04.dgn

Deviations from the construction plans included not constructing 2 log cross-vanes, constructing 15 structures at the bottom of riffles that were shown at the top of riffle on construction plans, and not constructing the Terracell drop structure; the restoration channel was tied into existing bedrock (Appendix G). No other deviations of significance occurred between construction plans and the as-built condition. In addition, no issues have arisen since construction occurred."

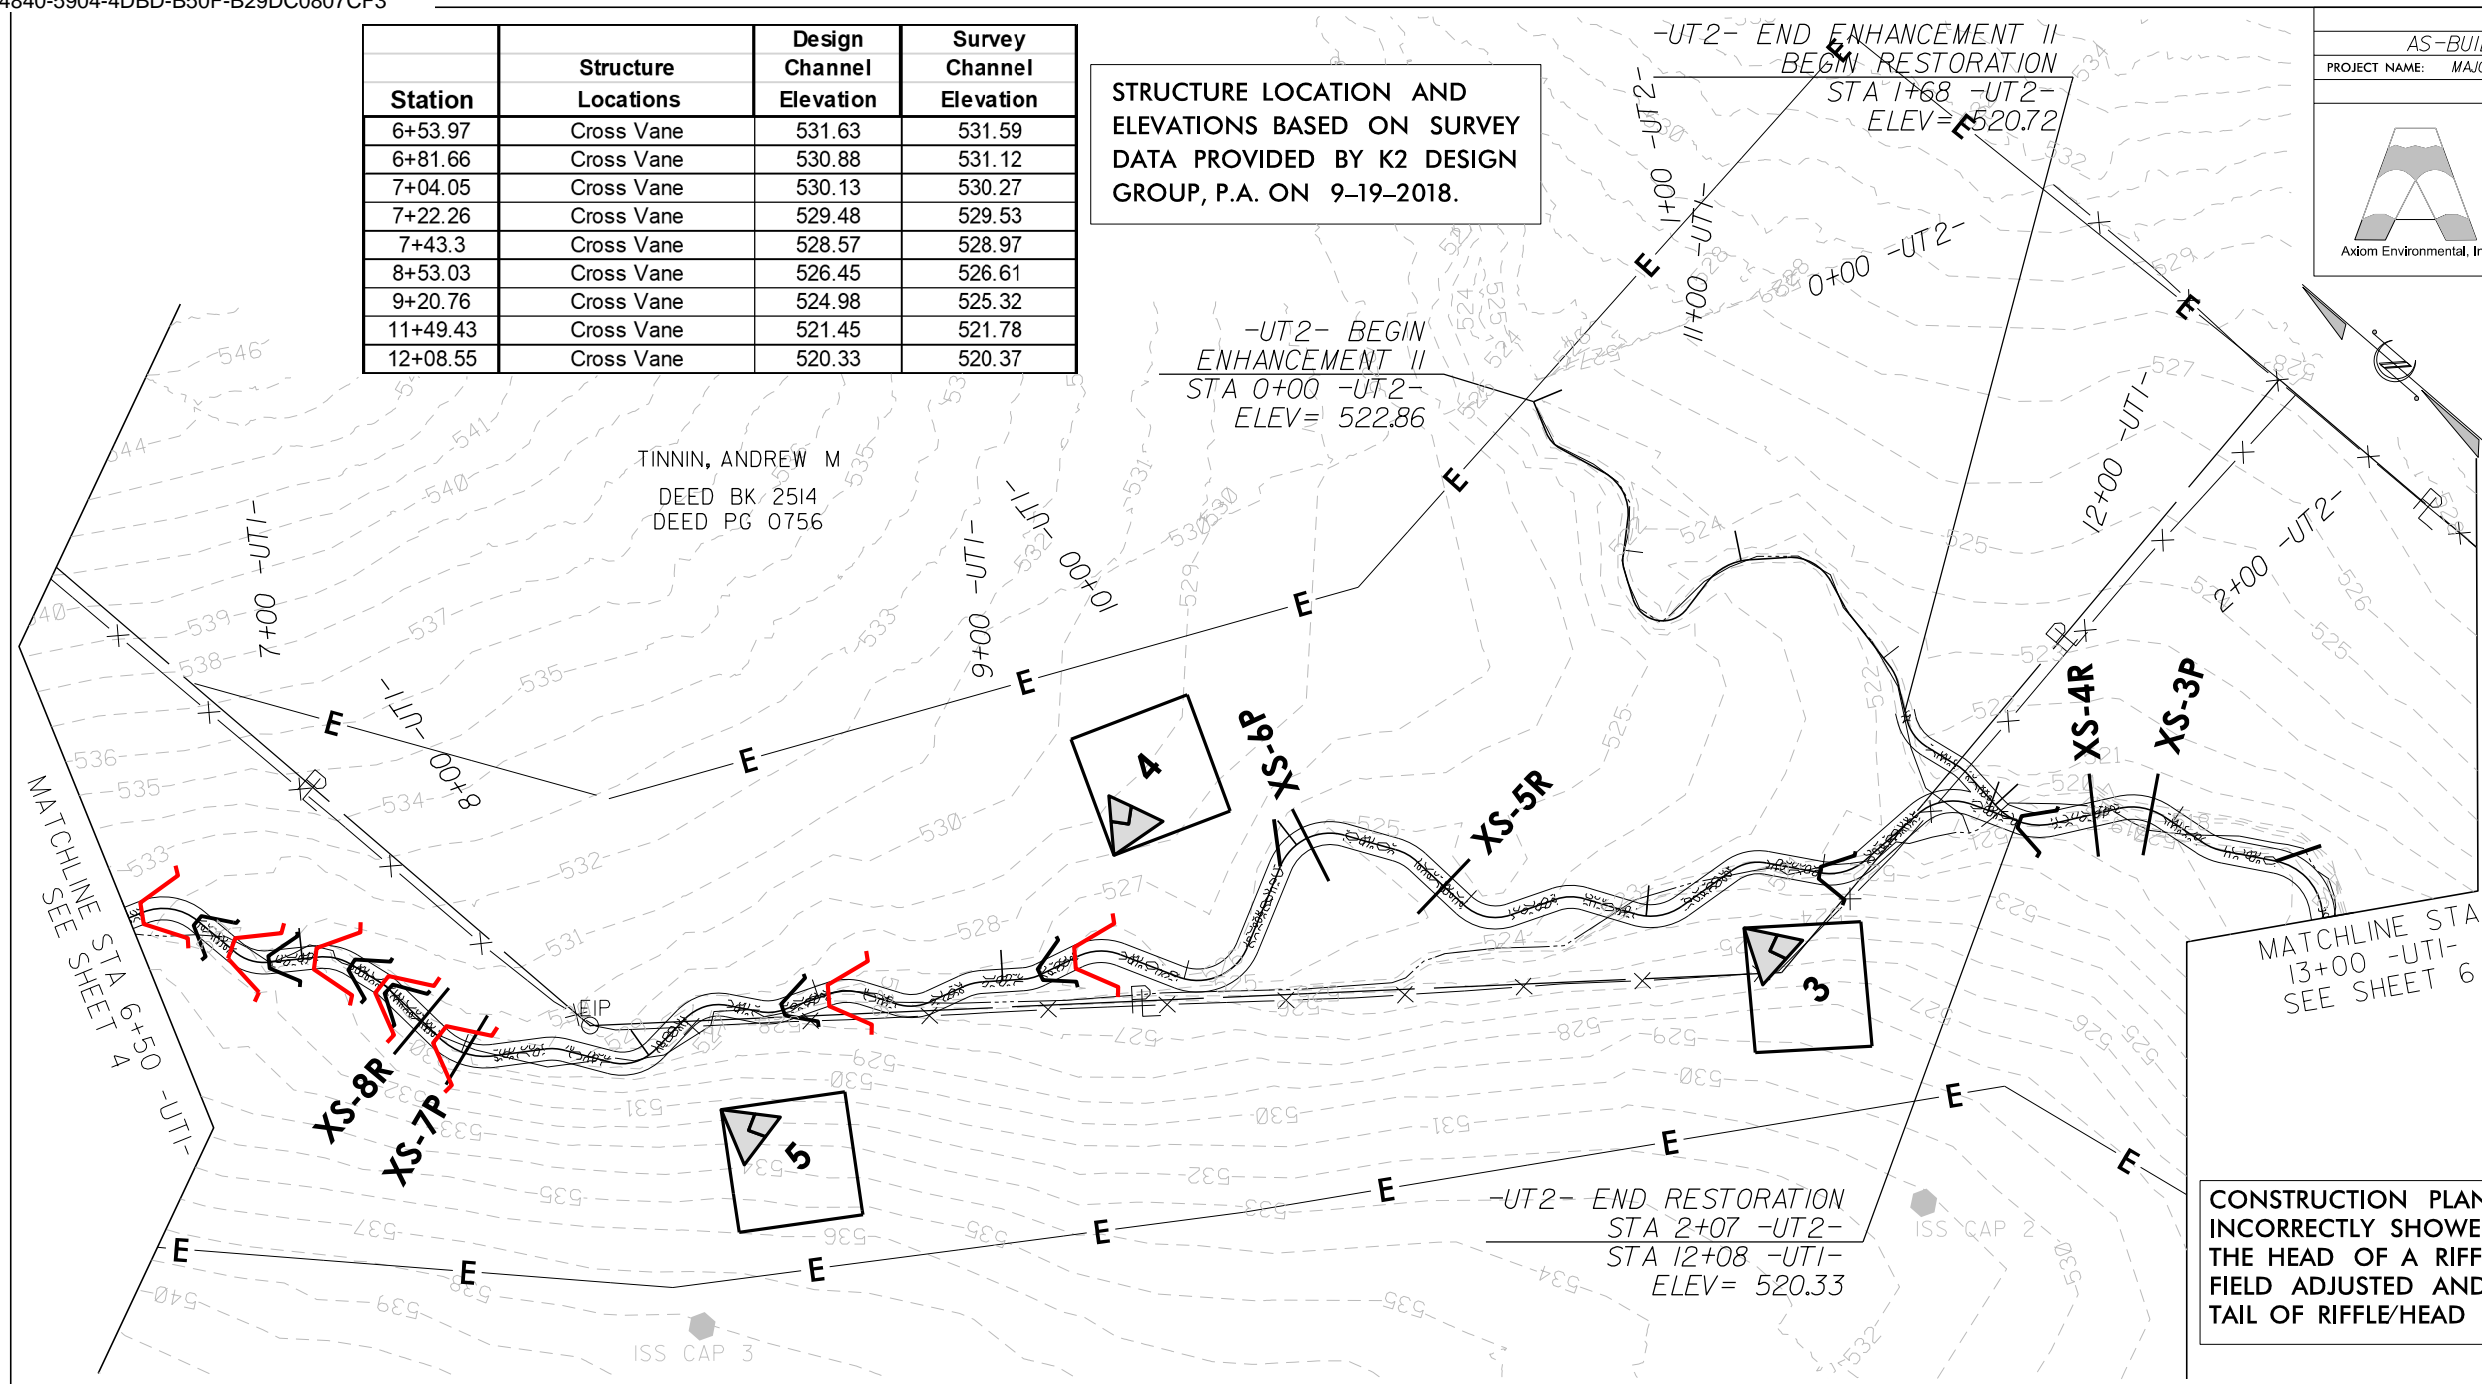
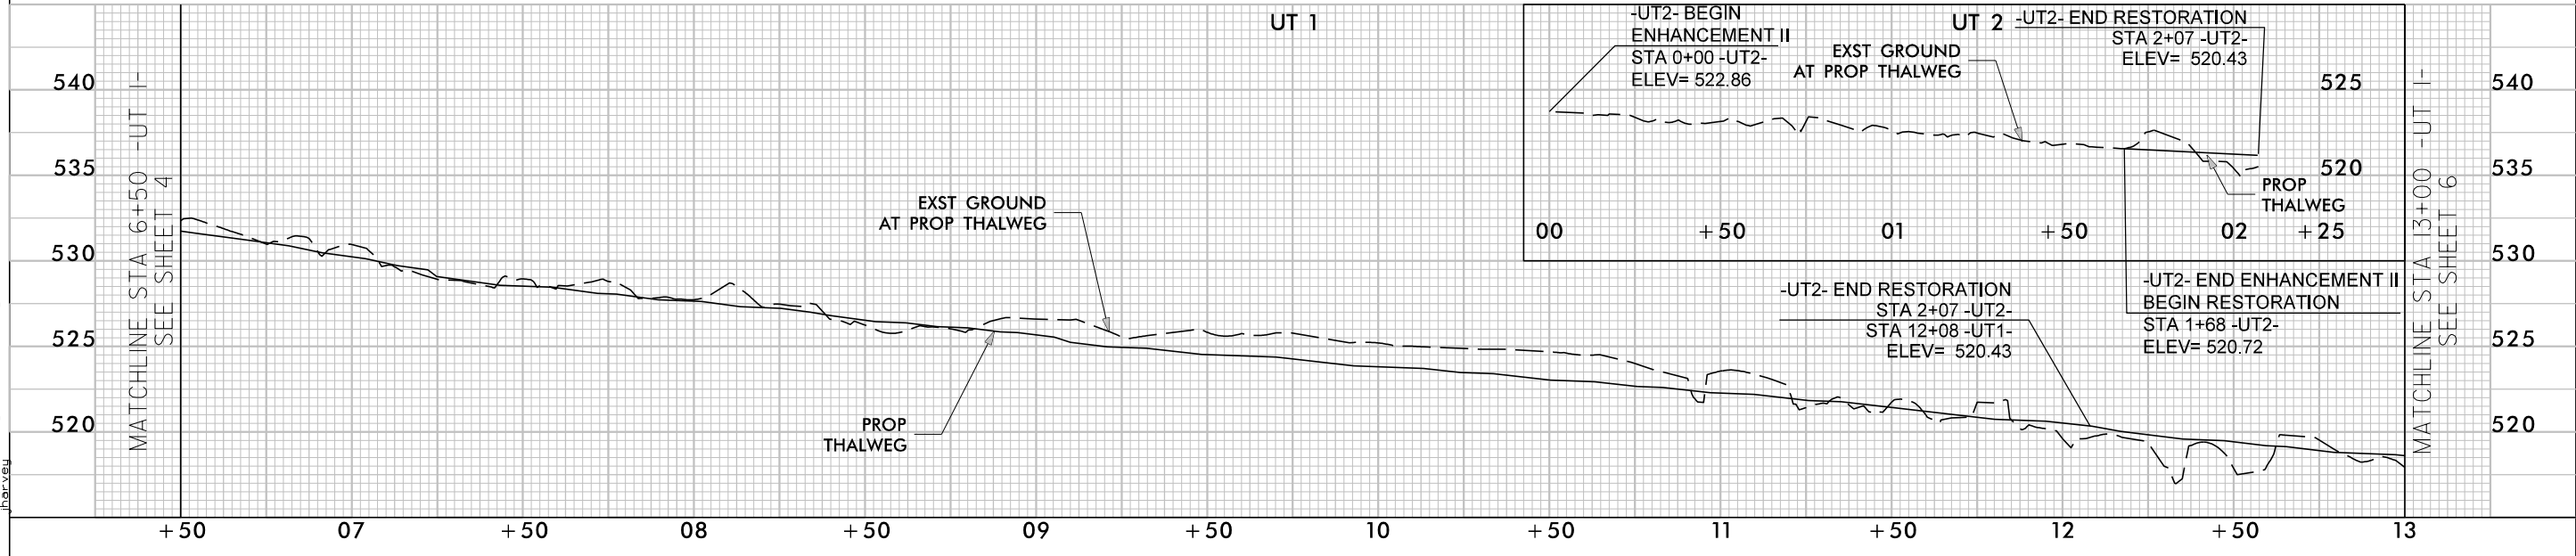
SHEET NAME	SHEET NUMBER
AS-BUILT STRUCTURES	6
PROJECT NAME: MAJOR HILL STREAM AND WETLAND RESTORATION SITE	COUNTY: ALAMANCE DATE: 2018

CONSTRUCTION PLANS DATED 07-23-2018 INCORRECTLY SHOWED SEVERAL STRUCTURES AT THE HEAD OF A RIFFLE. THESE STRUCTURES WERE FIELD ADJUSTED AND CONSTRUCTED AT THE TAIL OF RIFFLE/HEAD OF POOL.
