MONITORING REPORT
2019 (Year 1)

MAJOR HILL STREAM AND WETLAND MITIGATION SITE
Alamance County, North Carolina

DMS Project ID No. 100015
Full Delivery Contract No. 7193
USACE Action ID No. SAW-2017-01472
DWR No. 17-0921
RFP No. 16-006990

Data Collection: January 2019 – November 2019
Submission: January 2020

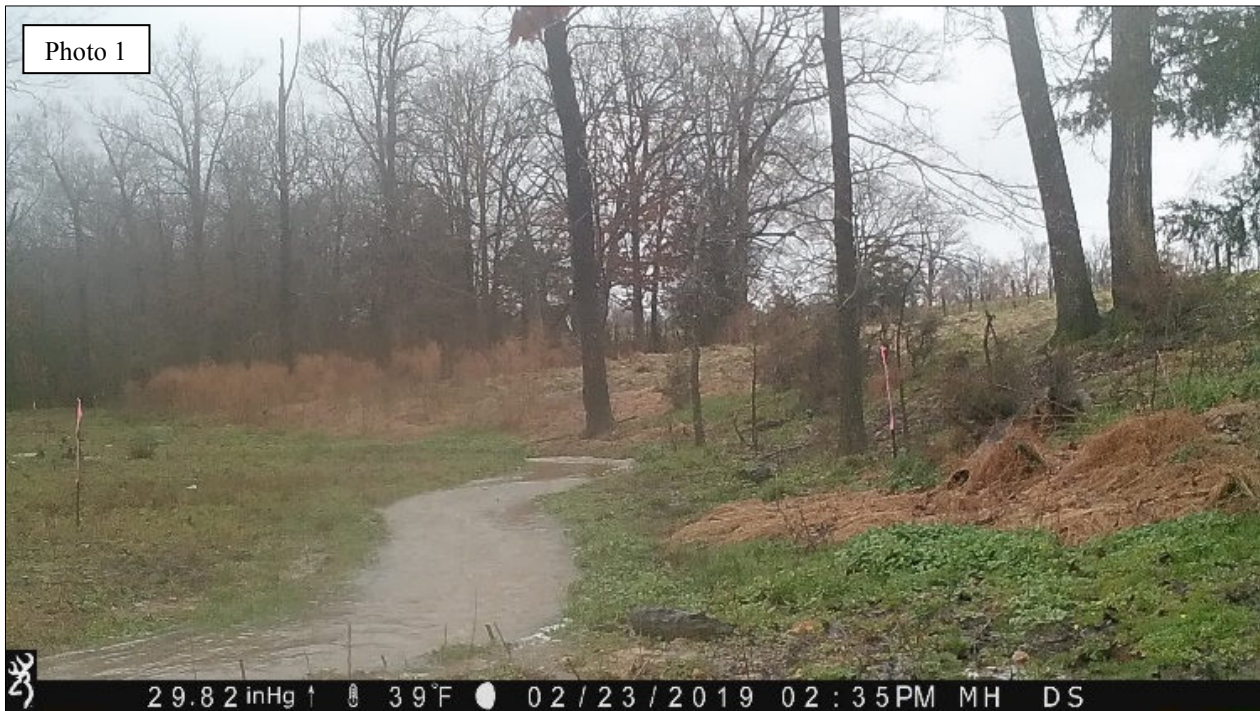
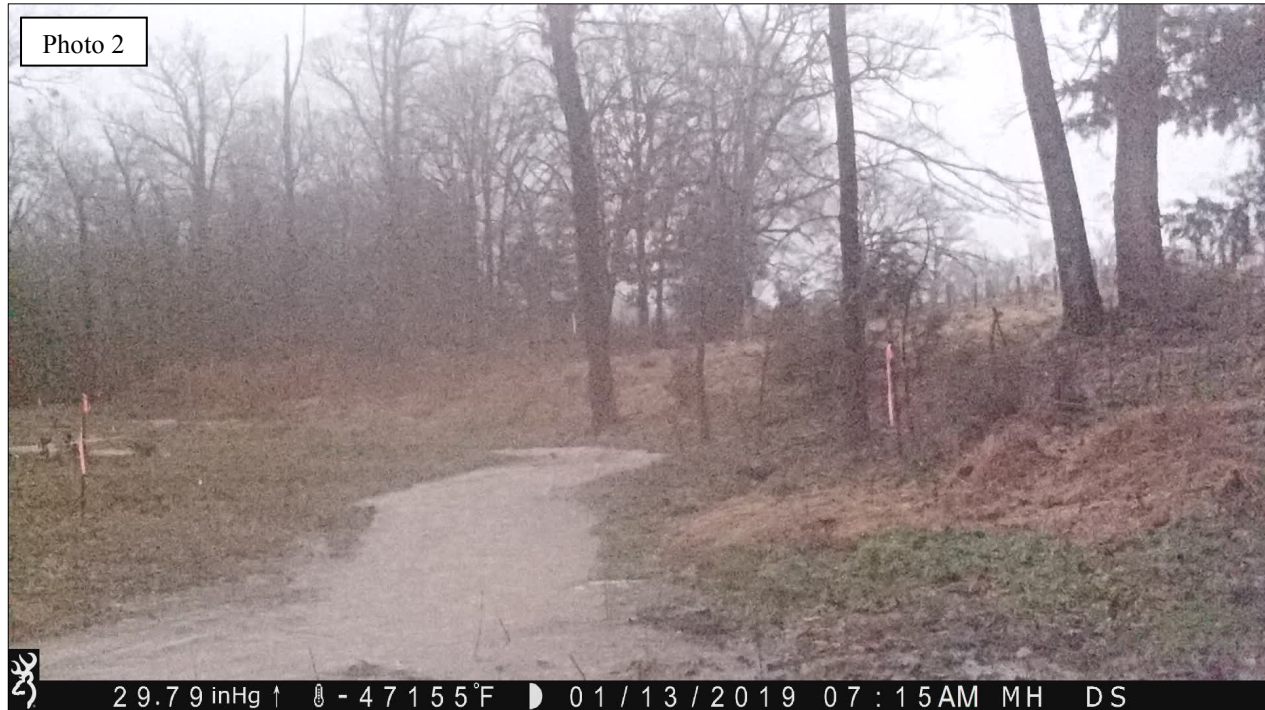
Table 15. Verification of Bankfull Events

Date of Data Collection	Date of Occurrence	Method	Photo (if available)
March 19, 2019	January 13, 2019	A trail camera captured the stream at bankfull after 1.10 inches of rain was documented on January 13, 2019 at an onsite rain gauge.	1
March 19, 2019	February 23, 2019	A trail camera captured the stream at bankfull after 2.74 inches of rain was documented between February 22-23, 2019 at an onsite rain gauge.	2
June 27, 2019	April 13, 2019	Stream gauge data indicates a bankfull event occurred after 4.11 inches of rain was documented between April 12-13, 2019 at an onsite rain gauge.	--
September 9, 2019	July 24, 2019	A bankfull event likely occurred after 3.02 inches of rain was documented between July 23-24, 2019 at an onsite rain gauge.	--
September 9, 2019	August 1, 2019	A bankfull event likely occurred after 1.96 inches of rain was documented on August 1, 2019 at an onsite rain gauge.	--

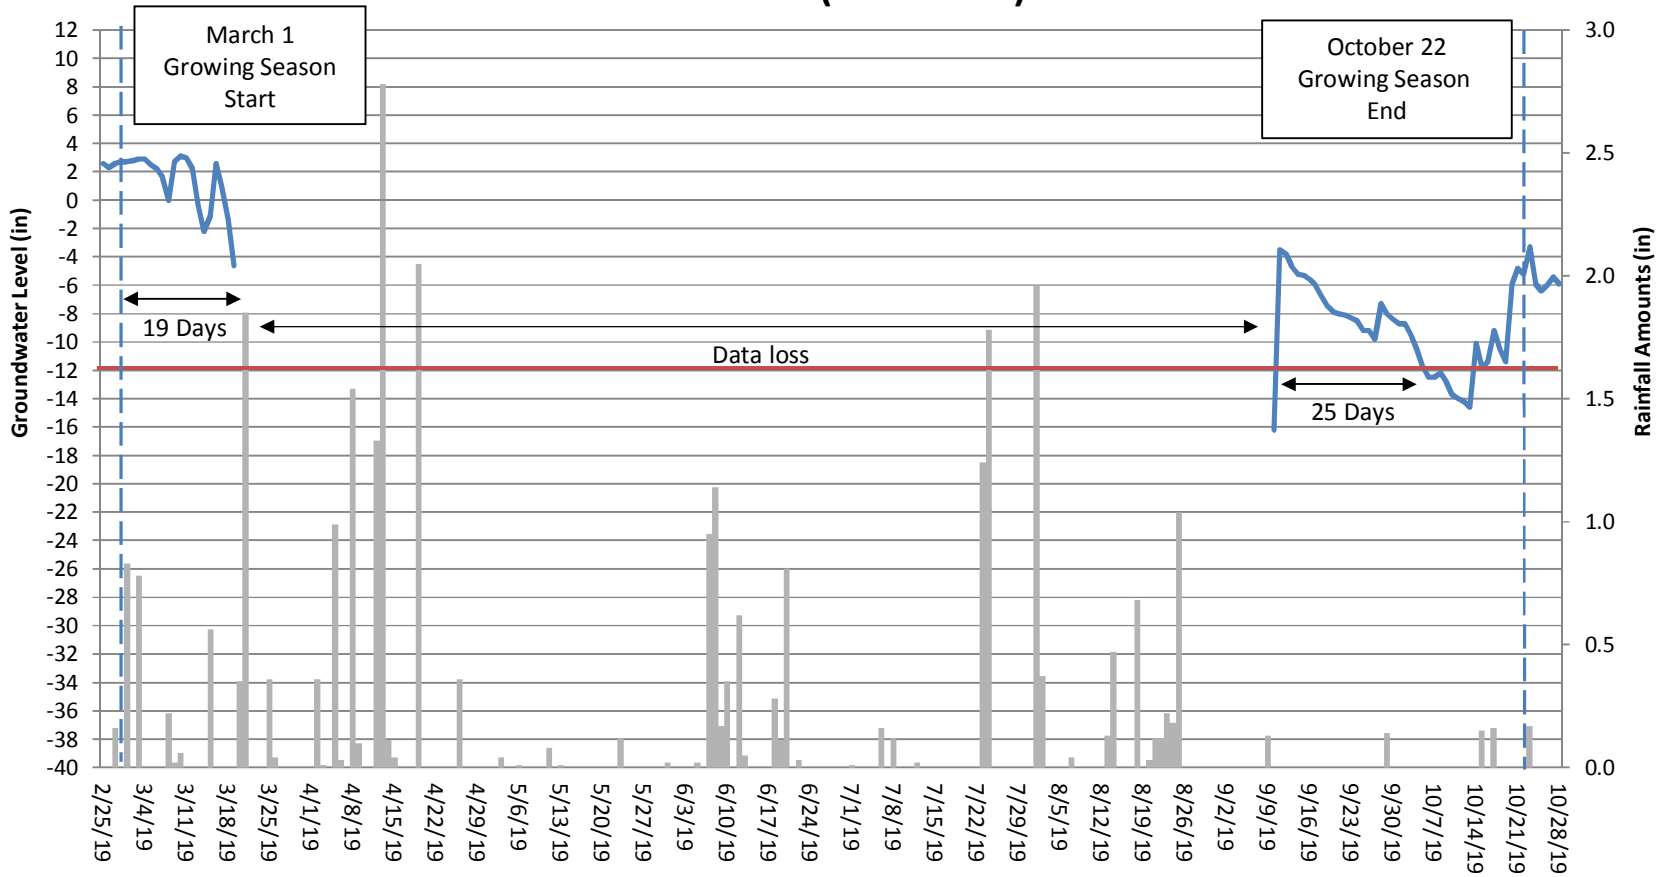
Major Hill Groundwater Gauge 3 Year 1 (2019 Data)

Gauge	Success Criteria Achieved/Max Consecutive Days During Growing Season (Percentage)						
	Year 1 (2019)	Year 2 (2020)	Year 3 (2021)	Year 4 (2022)	Year 5 (2023)	Year 6 (2024)	Year 7 (2025)
1	No/14 days* 6.0 percent						
2	No/19 days* 8.1 percent						
3	Yes/25 days 10.6 percent						
4	Yes/34 days 14.5 percent						
5	Yes/119 days 50.6 percent						
6	Yes/77 days 32.8 percent
