MONITORING REPORT
2020 (Year 2)

MAJOR HILL STREAM AND WETLAND MITIGATION SITE
Alamance County, North Carolina

DMS Project ID No. 100015
Full Delivery Contract No. 7193
USACE Action ID No. SAW-2017-01472
DWR No. 17-0921
RFP No. 16-006990

Data Collection: July 2020 – October 2020
Submission: January 2021

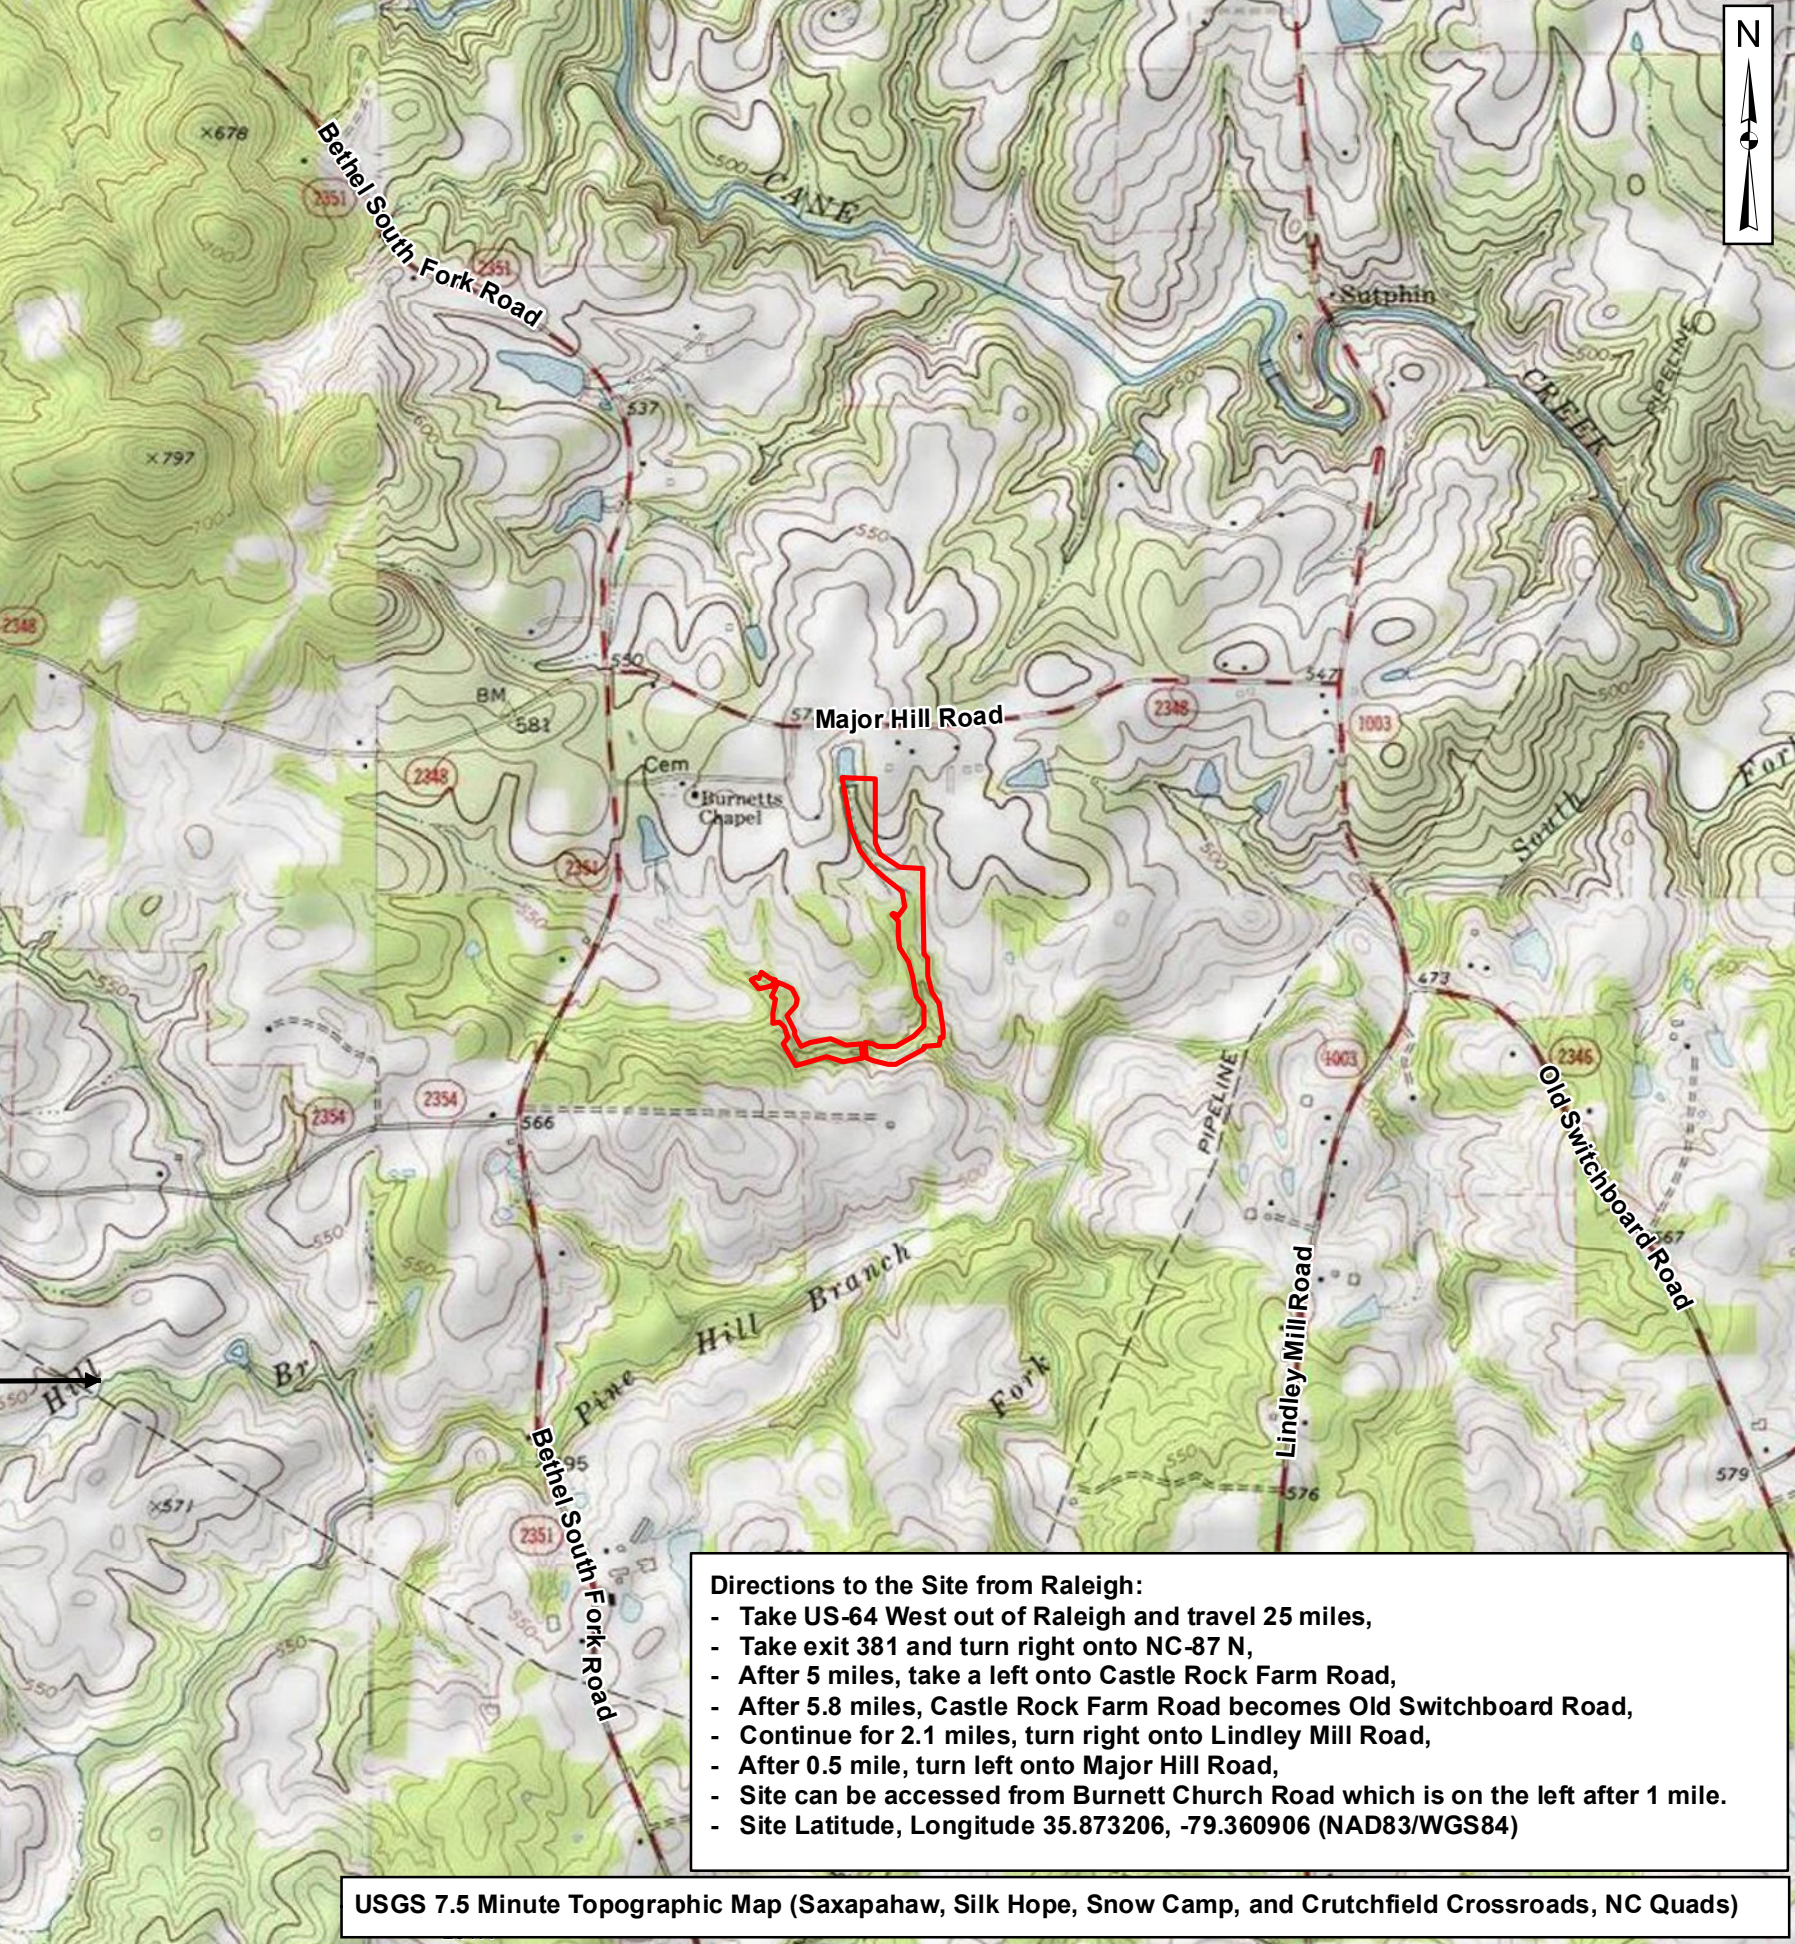
CURRENT CONDITIONS PLAN VIEW
Major Hill Stream and Wetland Mitigation
Alamance County, North Carolina

All streams are functioning as designed, and no stream areas of concern were observed during year 2 (2020) monitoring. Stream morphology and water quality data is available in Appendix D.
