FINAL
MONITORING REPORT
2021 (Year 3)

MAJOR HILL STREAM AND WETLAND MITIGATION SITE

Alamance County, North Carolina

DMS Project ID No. 100015
Full Delivery Contract No. 7193
USACE Action ID No. SAW-2017-01472
DWR No. 17-0921
RFP No. 16-006990

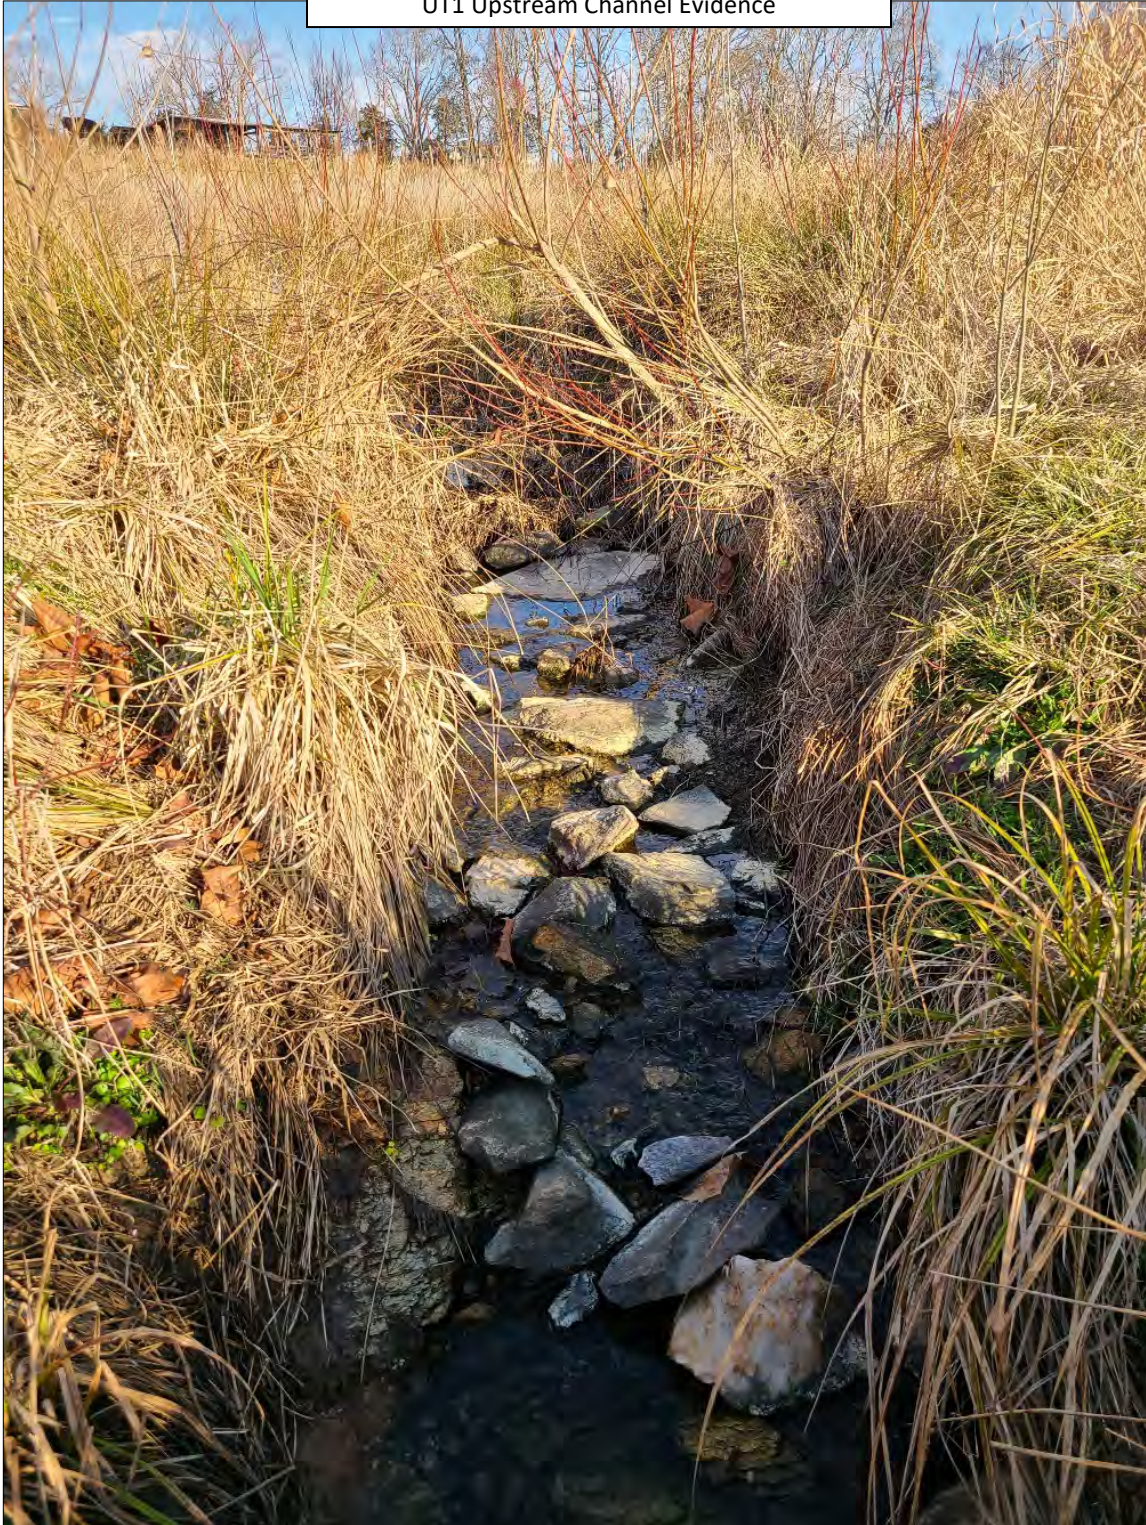
UT1 Upstream Channel Evidence

Exposure of woody plant roots within the primary path of flow	No	Yes	Yes
Other:

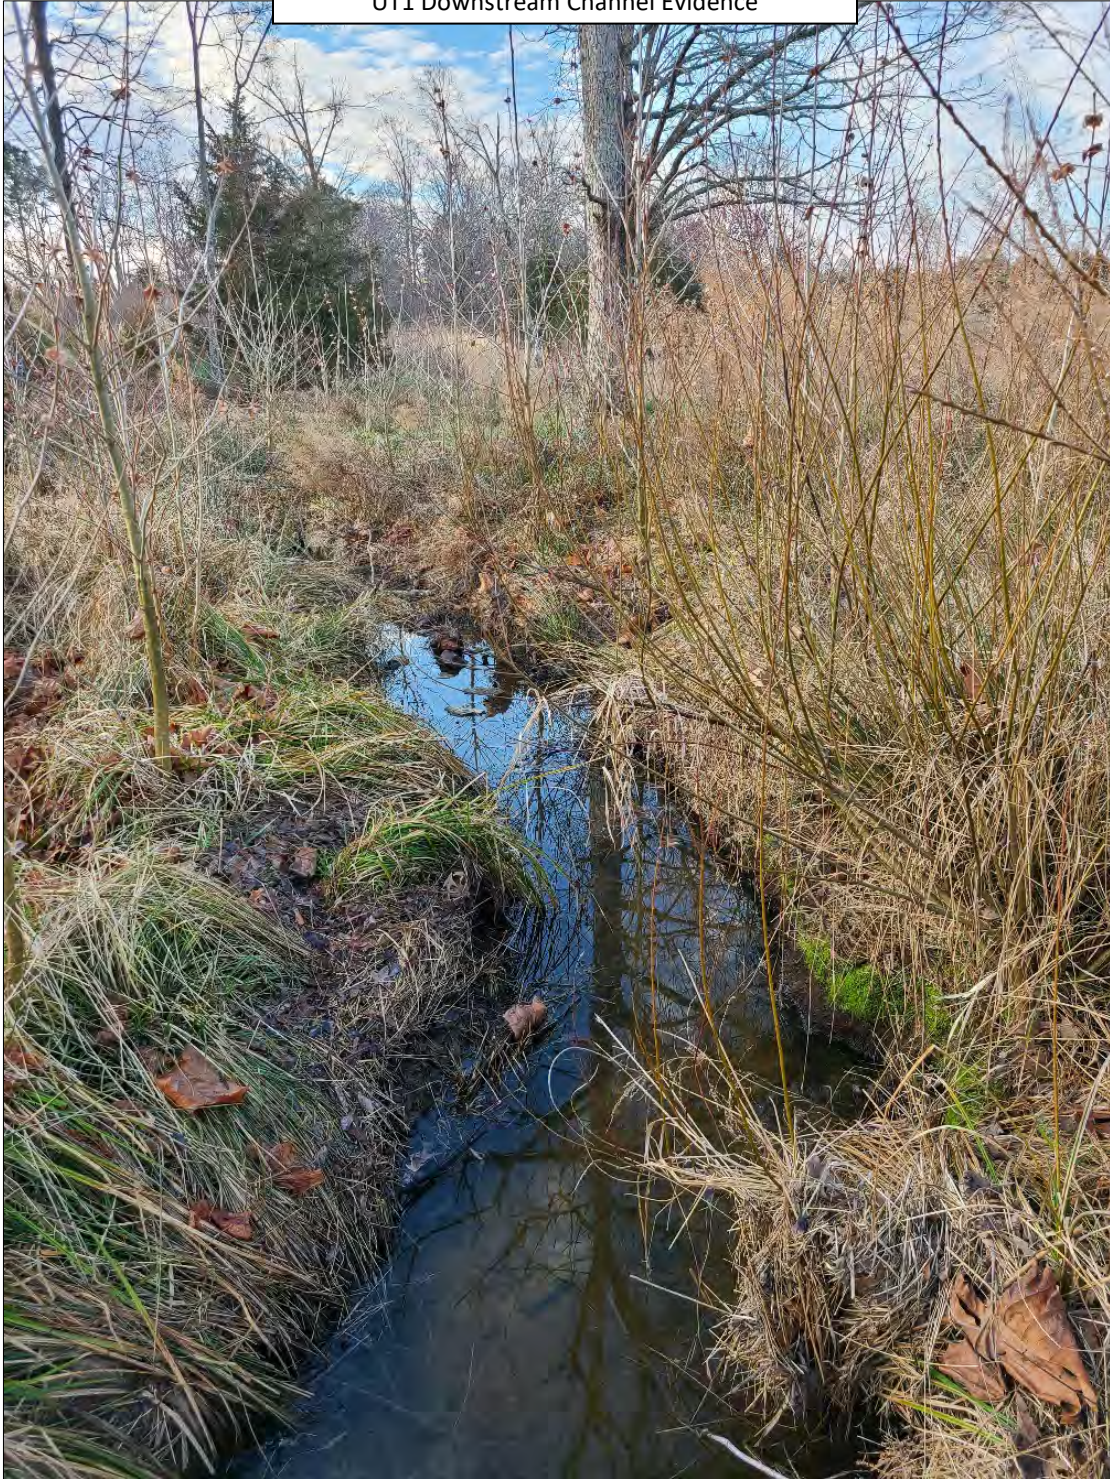
UT1 Downstream Channel Evidence	Year 1 (2019)	Year 2 (2020)	Year 3 (2021)
Max consecutive days channel flow	52	236	285
Presence of litter and debris (wracking)	Yes	Yes	Yes
Leaf litter disturbed or washed away	Yes	Yes	Yes
Matted, bent, or absence of vegetation (herbaceous or otherwise)	Yes	Yes	Yes
Sediment deposition and/or scour indicating sediment transport	Yes	Yes	Yes
Water staining due to continual presence of water	Yes	Yes	Yes
Formation of channel bed and banks	Yes	Yes	Yes
Sediment sorting within the primary path of flow	Yes	Yes	Yes
Sediment shelving or a natural line impressed on the banks	Yes	Yes	Yes
Change in plant community (absence or destruction of terrestrial vegetation and/or transition to species adapted for flow or inundation for a long duration, including hydrophytes)	Yes	Yes	Yes
Development of channel pattern (meander bends and/or channel braiding) at natural topographic breaks, woody debris piles, or plant root systems	Yes	Yes	Yes

Exposure of woody plant roots within the primary path of flow	No	Yes	Yes
Other:		Bankfull event documented.

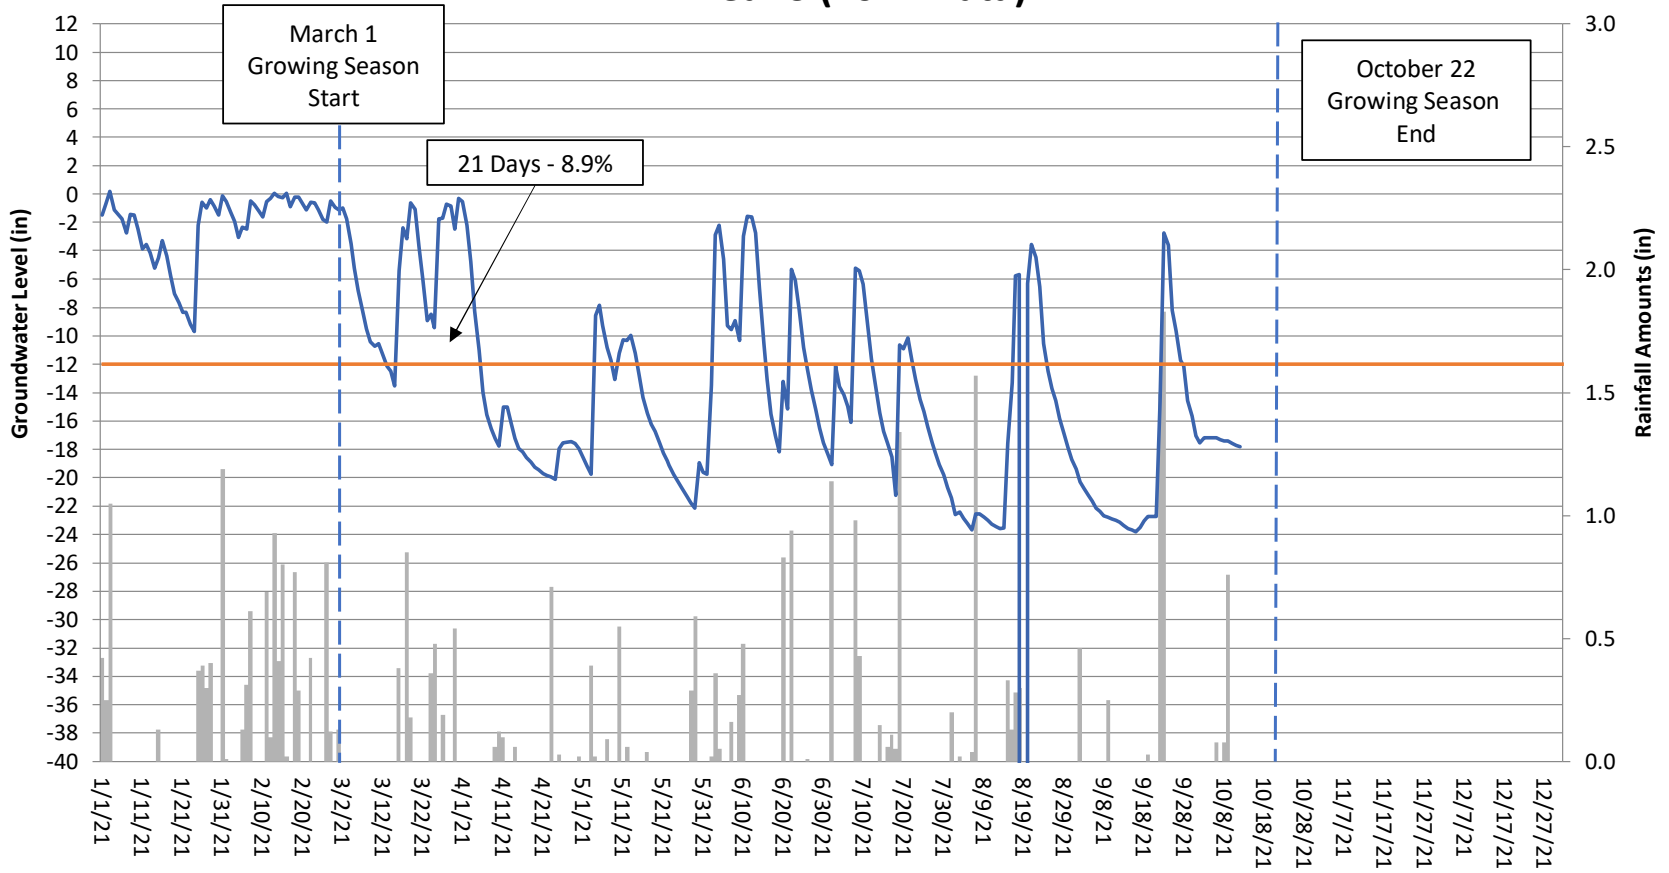
Major Hill Groundwater Gauge 2 Year 3 (2021 Data)

Gauge	Success Criteria Achieved/Max Consecutive Days During Growing Season (Percentage)						
	Year 1 (2019)	Year 2 (2020)	Year 3 (2021)	Year 4 (2022)	Year 5 (2023)	Year 6 (2024)	Year 7 (2025)
1	No/14 days* 6.0 percent	Yes/136 days 57.9 percent	Yes/74 days 31.4 percent				
2	No/19 days* 8.1 percent	No/19 days 8.0 percent	No/21 days 8.9 percent				
3	Yes/25 days 10.6 percent	Yes/235 days 100 percent	Yes/226 days 95.8 percent				
4	Yes/34 days 14.5 percent	Yes/72 days 30.5 percent	Yes/60 days 25.4 percent				
5	Yes/119 days 50.6 percent	Yes/135 days 57.4 percent	Yes/53 days 22.5 percent				
6	Yes/77 days 32.8 percent	Yes/44 days 18.7 percent	Yes/80 days 33.9 percent
