MONITORING REPORT
2022 (Year 4)

MAJOR HILL STREAM AND WETLAND MITIGATION SITE

Alamance County, North Carolina

Data Collection: January 2022 – October 2022
Submission: February 2023

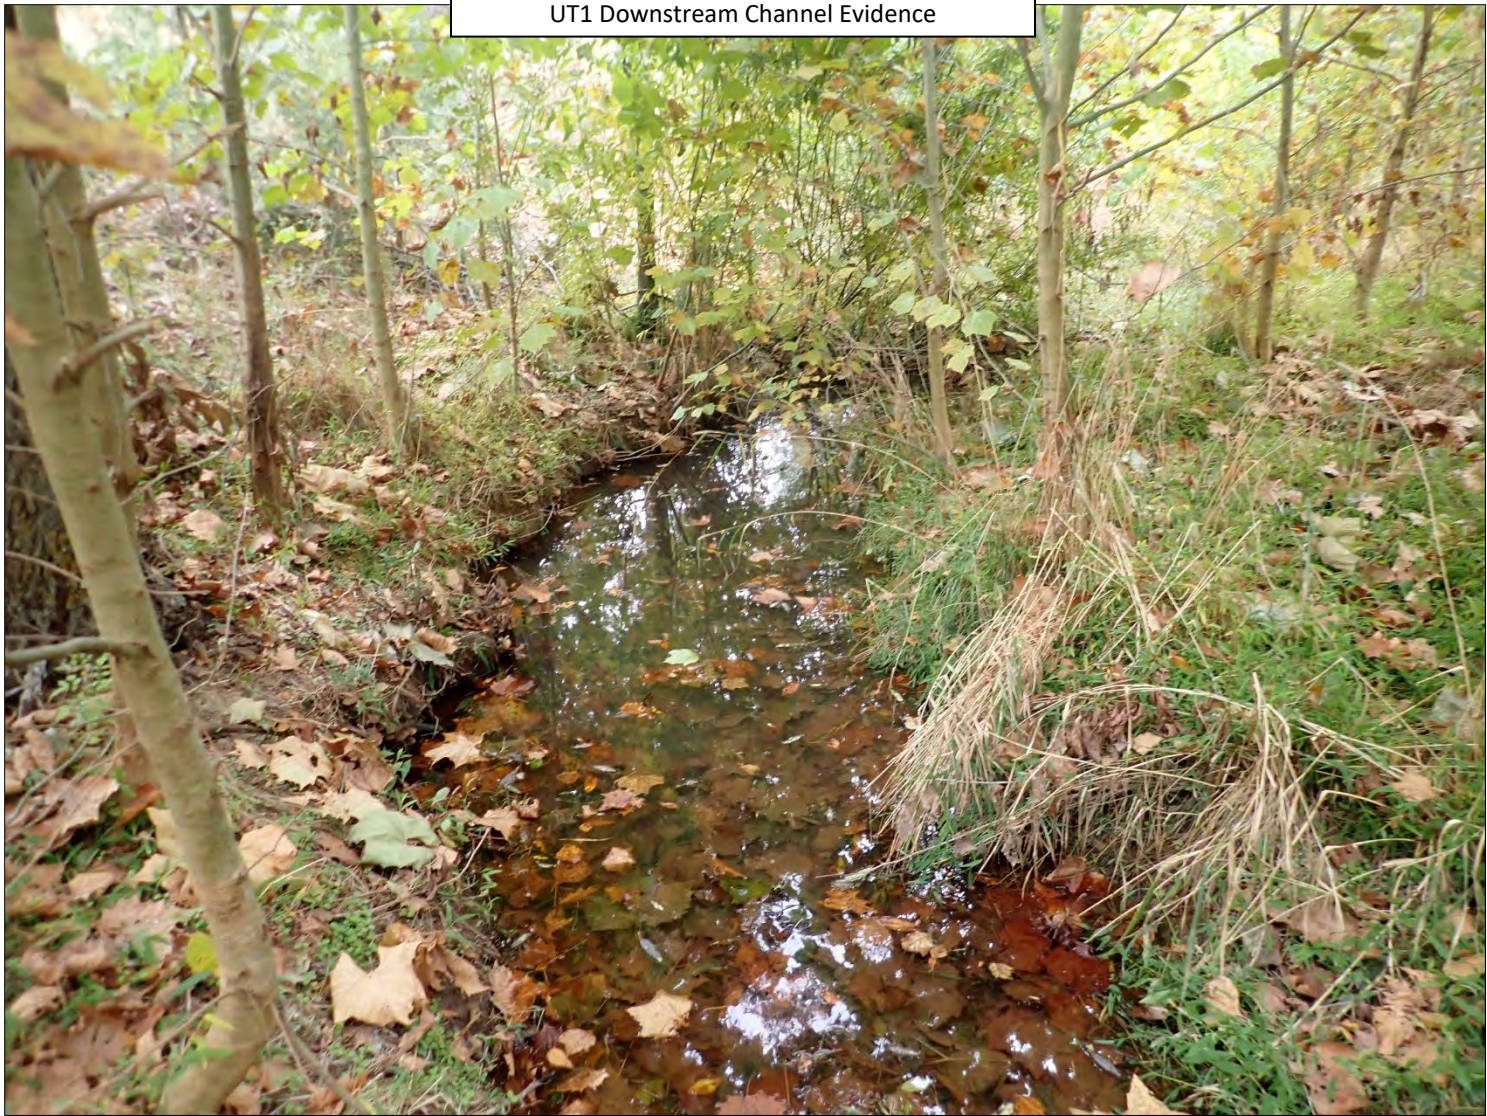
UT1 Downstream Channel Evidence	Year 1 (2019)	Year 2 (2020)	Year 3 (2021)	Year 4 (2022)
Max consecutive days channel flow	52	236	285	216
Presence of litter and debris (wracking)	Yes	Yes	Yes	Yes
Leaf litter disturbed or washed away	Yes	Yes	Yes	Yes
Matted, bent, or absence of vegetation (herbaceous or otherwise)	Yes	Yes	Yes	Yes
Sediment deposition and/or scour indicating sediment transport	Yes	Yes	Yes	Yes
Water staining due to continual presence of water	Yes	Yes	Yes	Yes
Formation of channel bed and banks	Yes	Yes	Yes	Yes
Sediment sorting within the primary path of flow	Yes	Yes	Yes	Yes
Sediment shelving or a natural line impressed on the banks	Yes	Yes	Yes	Yes
Change in plant community (absence or destruction of terrestrial vegetation and/or transition to species adapted for flow or inundation for a long duration, including hydrophytes)	Yes	Yes	Yes	Yes
Development of channel pattern (meander bends and/or channel braiding) at natural topographic breaks, woody debris piles, or plant root systems	Yes	Yes	Yes	Yes

Exposure of woody plant roots within the primary path of flow	No	Yes	Yes	Yes
Other:		Bankfull event documented.

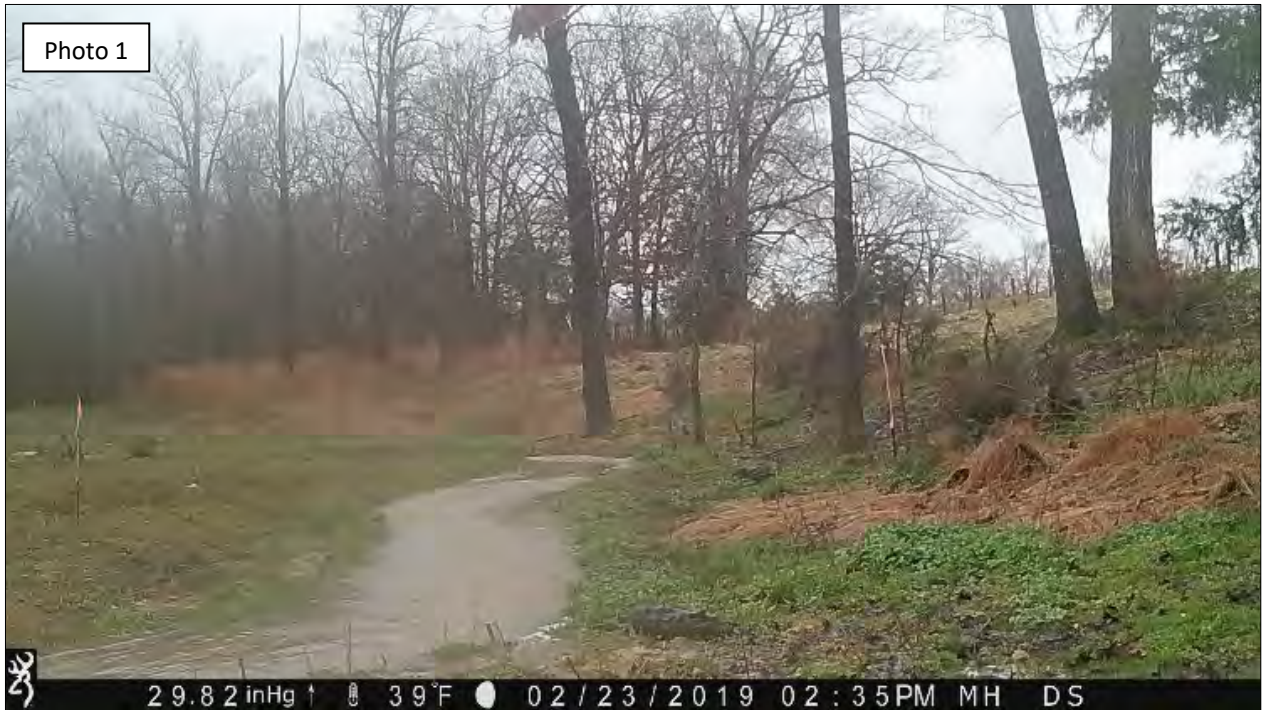
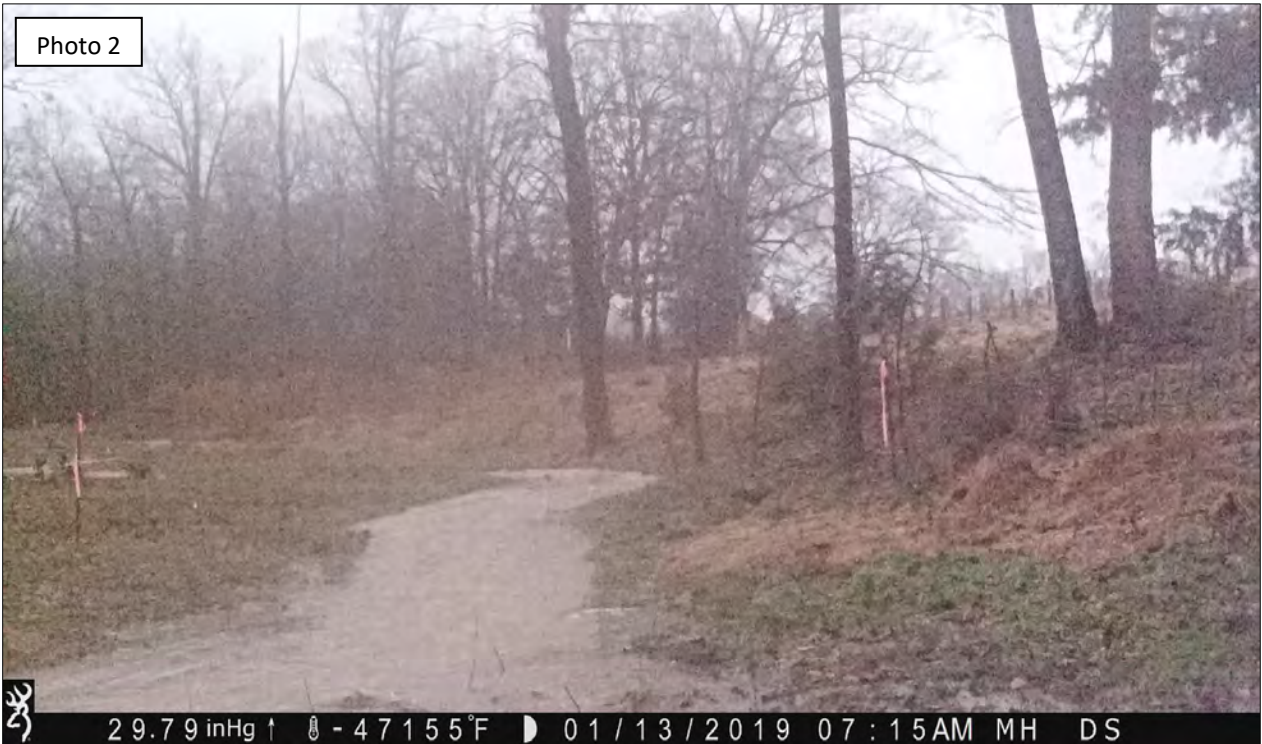
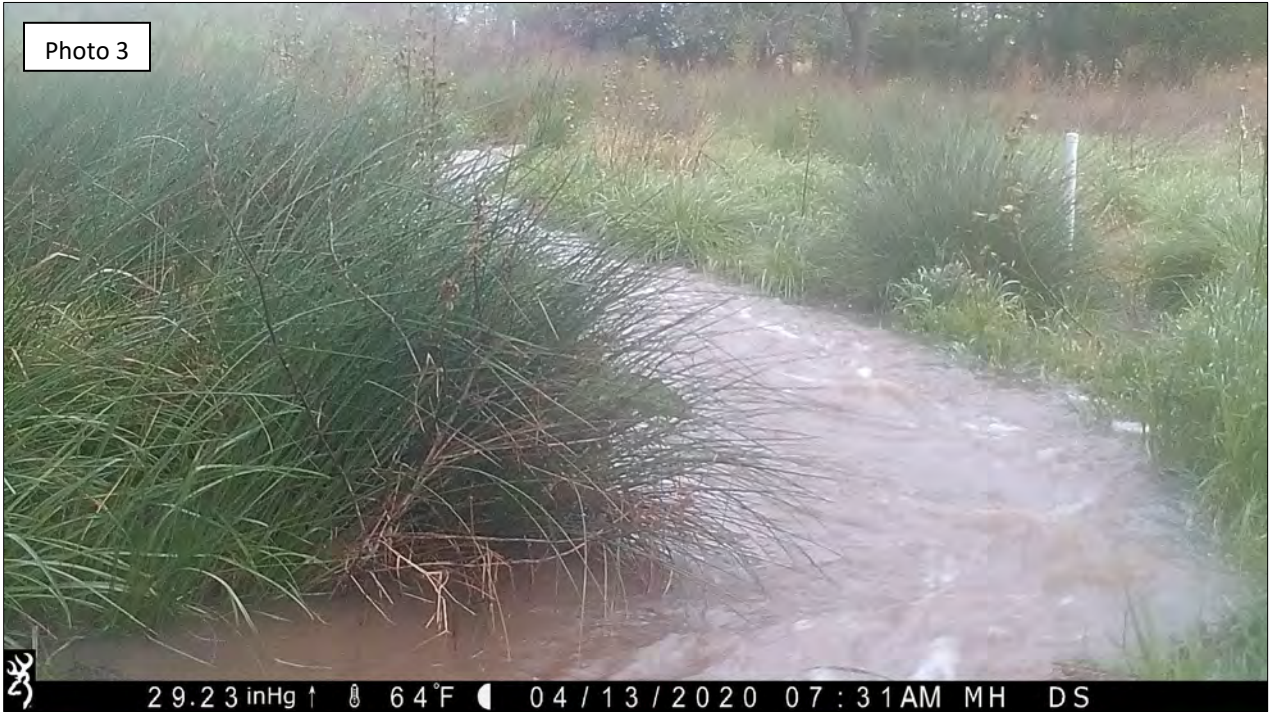
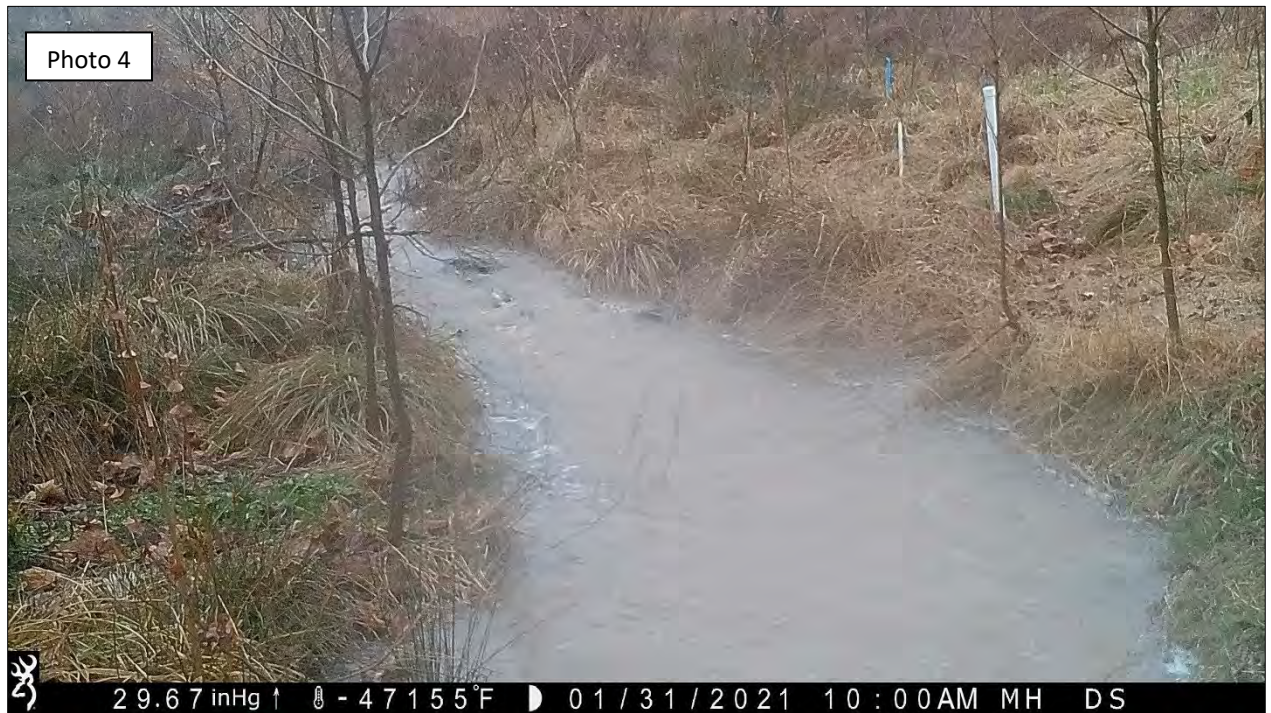
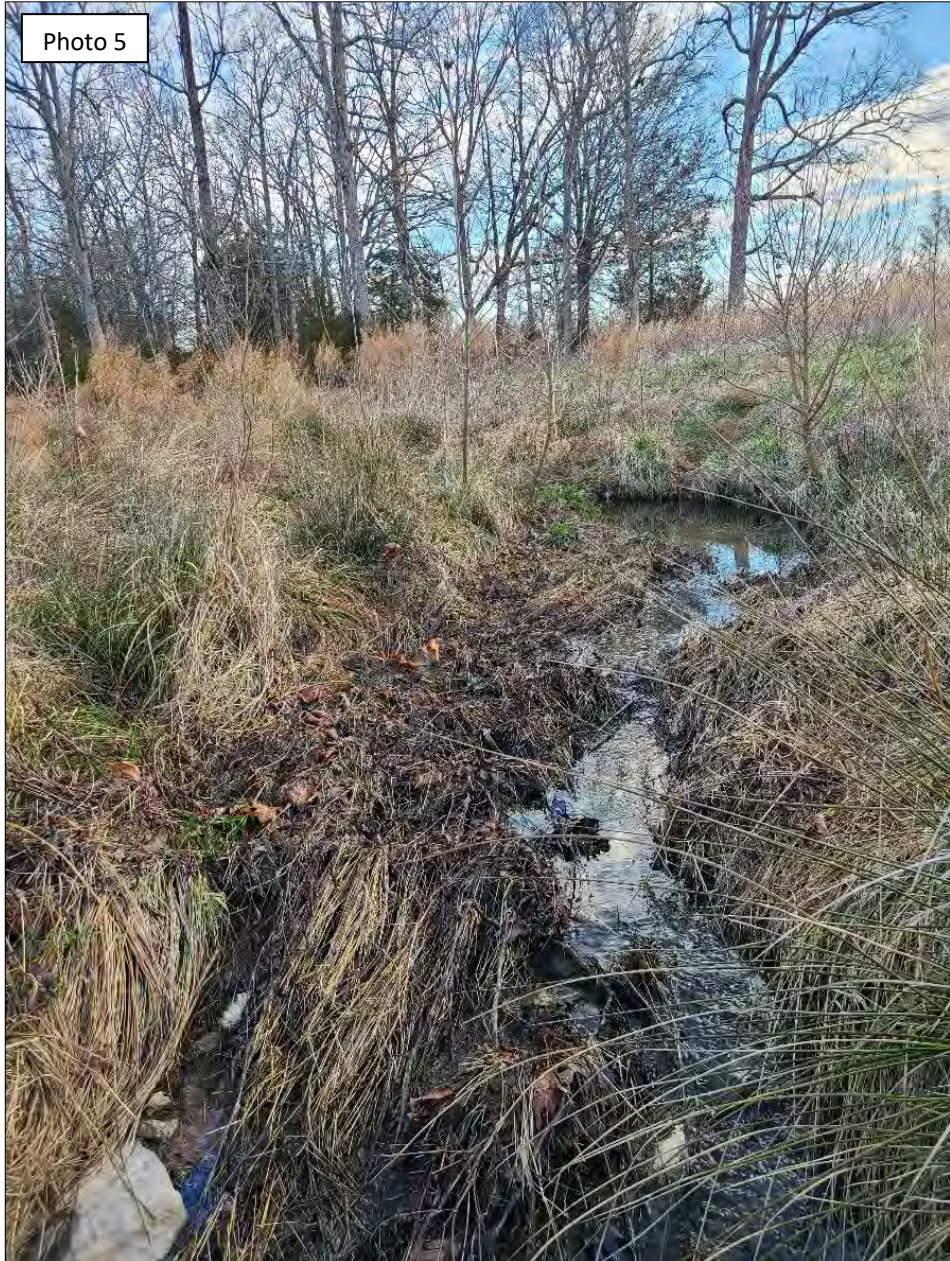
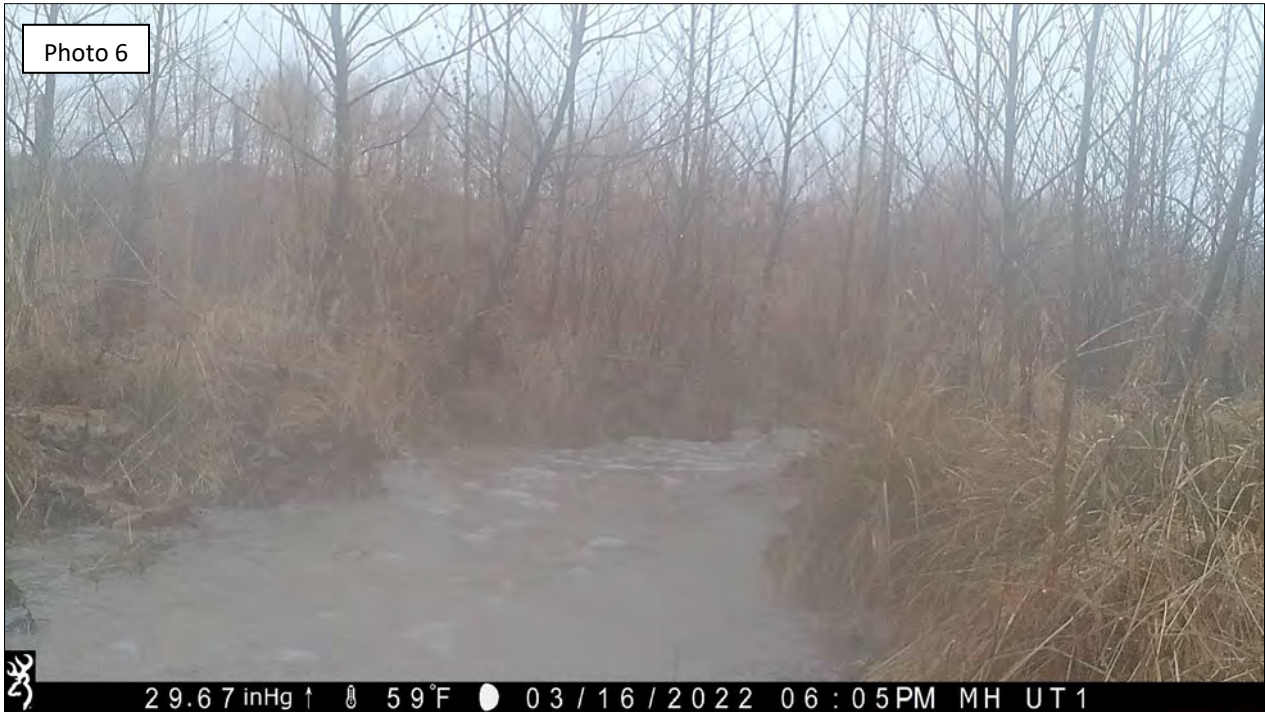
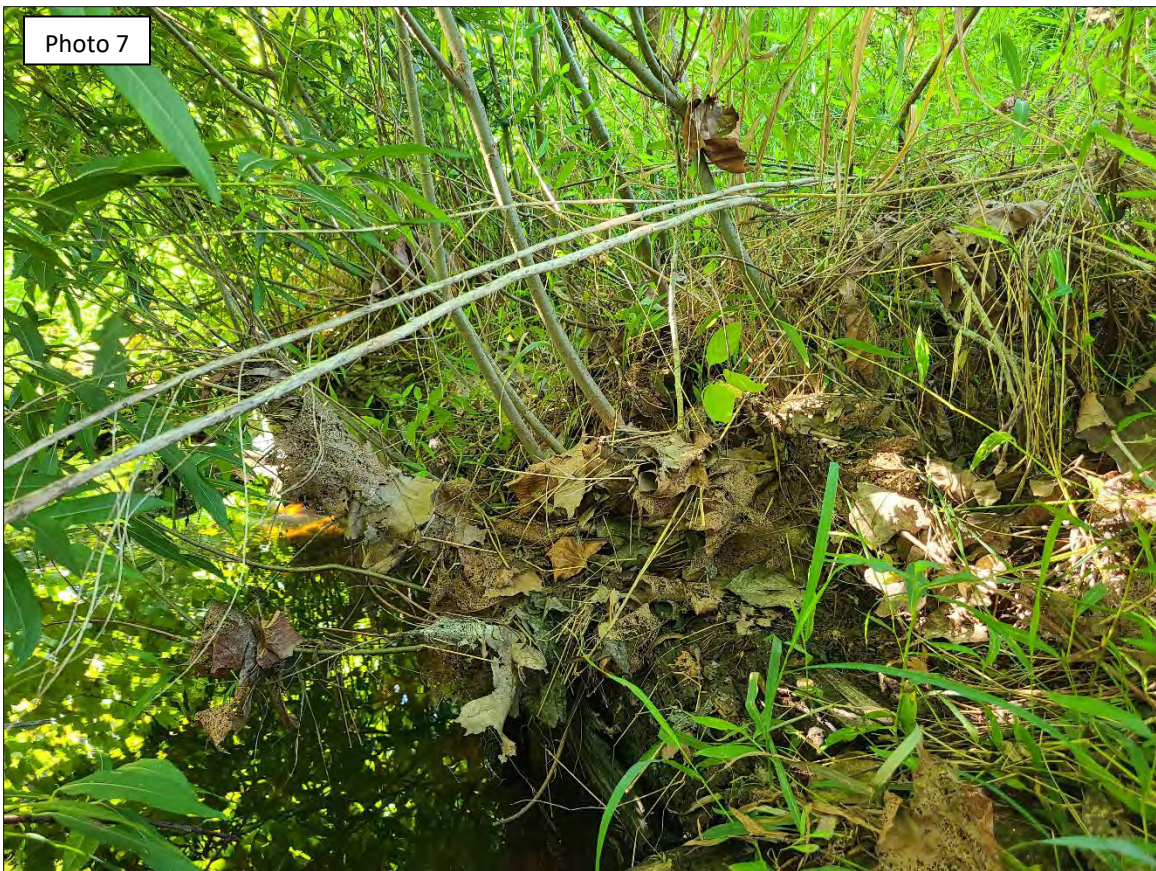
Table 11. Verification of Bankfull Events

Date of Data Collection	Date of Occurrence	Method	Photo (if available)
March 19, 2019	January 13, 2019	A trail camera captured the stream at bankfull after 1.10 inches of rain was documented on January 13, 2019 at an on-site rain gauge.	1
March 19, 2019	February 23, 2019	A trail camera captured the stream at bankfull after 2.74 inches of rain was documented between February 22-23, 2019 at an on-site rain gauge.	2
June 27, 2019	April 13, 2019	Stream gauge data indicates a bankfull event occurred after 4.11 inches of rain was documented between April 12-13, 2019 at an on-site rain gauge.	--
September 9, 2019	July 24, 2019	A bankfull event likely occurred after 3.02 inches of rain was documented between July 23-24, 2019 at an on-site rain gauge.	--
September 9, 2019	August 1, 2019	A bankfull event likely occurred after 1.96 inches of rain was documented on August 1, 2019 at an on-site rain gauge.	--

April 13, 2020	April 13, 2020	A bankfull event was documented via trail camera after approximately 2.31 inches of rain was recorded at an on-site rain gauge	3
January 31, 2021	January 31, 2021	A bankfull event was documented via trail camera after approximately 1.19 inches of rain was recorded at an on-site rain gauge	4
March 11, 2021	February 15, 2021	Wrack and laid-back vegetation were observed along the top of bank and floodplain of UT-1 indicating a bankfull event occurred after 2.93 inches of rain was documented between February 11 and 15, 2021.	5
March 16, 2022	March 16, 2022	A trail camera captured the stream at bankfull after 1.47 inches of rain was documented on March 16, 2022 at an on-site rain gauge.	6
August 2, 2022	July 27, 2022	Wrack piles were observed along the top of bank and floodplain of UT-1 indicating a bankfull event occurred after 1.73 inches of rain was documented on July 27, 2022.	7
