# ANNUAL REPORT FOR 2000

**Mallard Creek Mitigation Site  
Mecklenburg County  
Project No. 8.1999974 (M-316)  
TIP No. R-211 WM**

Prepared By:  
Natural Systems Unit & Roadside Environmental Unit  
North Carolina Department of Transportation  
December 2000

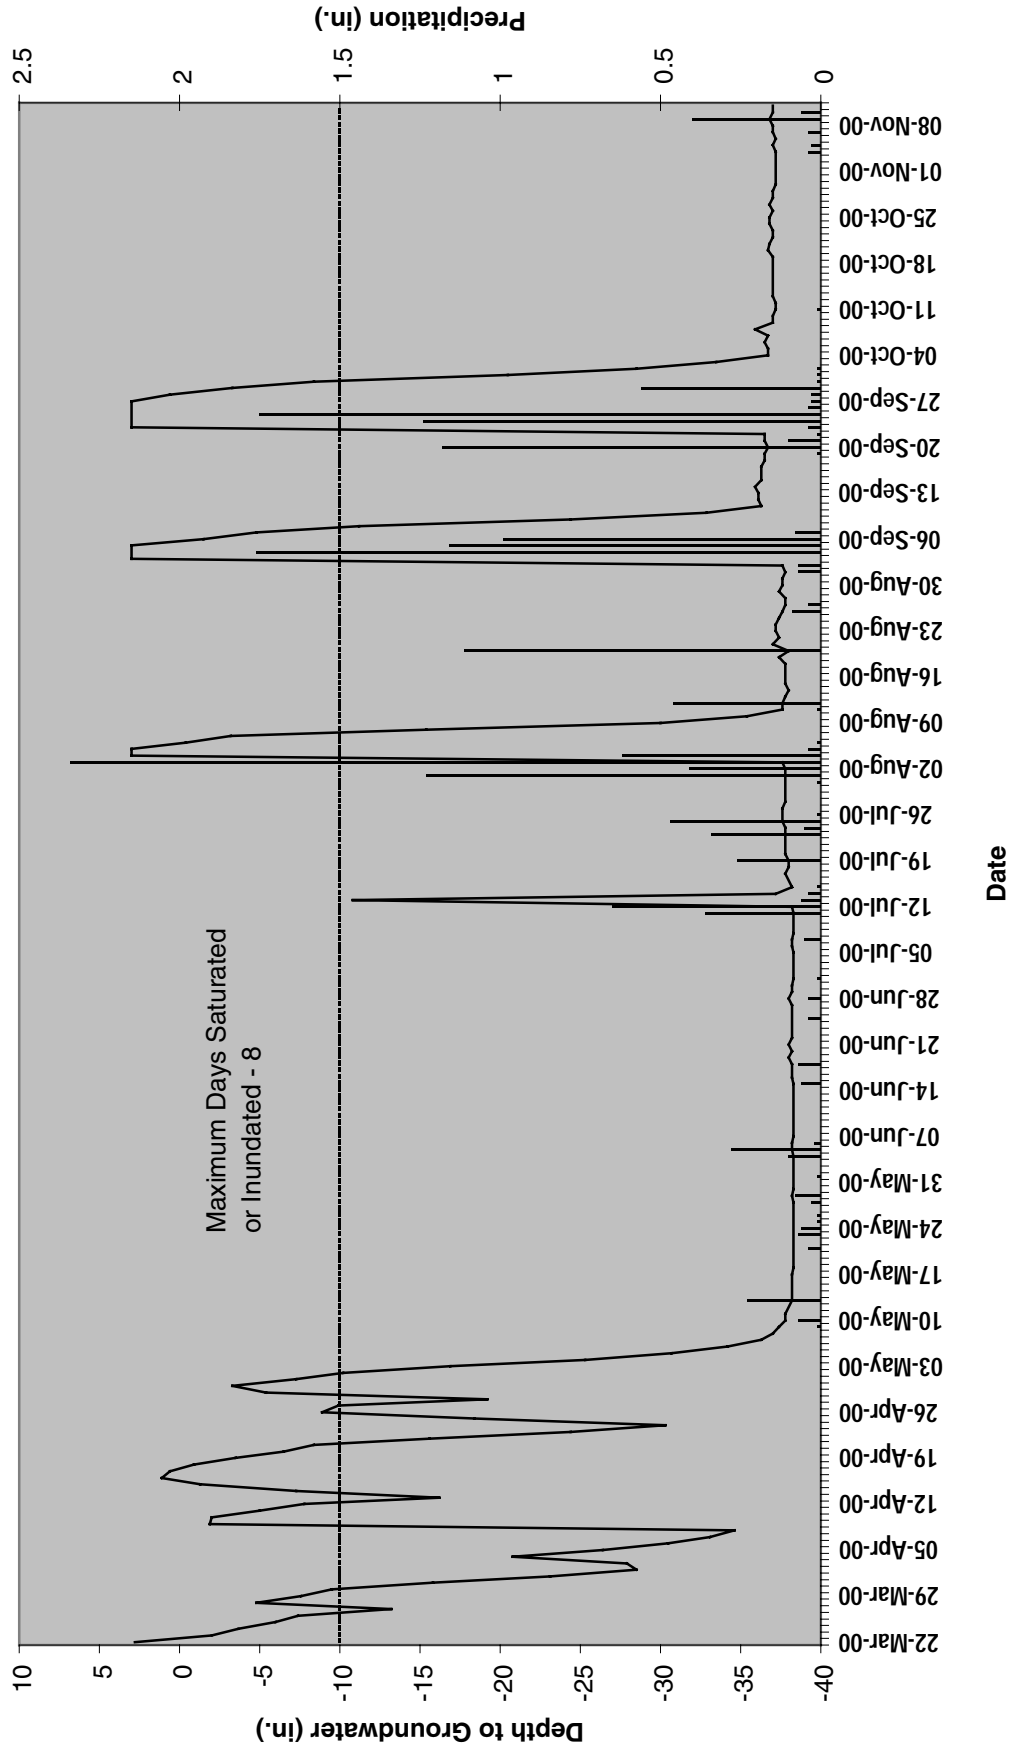
### Mallard Creek MW-4

Site 2 hydrologic data indicates that only three of six gauges met the hydrologic success criteria established for the site. Only gauges 6, 7, and 9 showed saturation or inundation greater than 26 days of the growing season. Gauges 4, 5, and 8 failed to meet the hydrologic success criteria. The data for Site 2, as in 1999, still indicates that the groundwater levels drop quickly after rainfall.

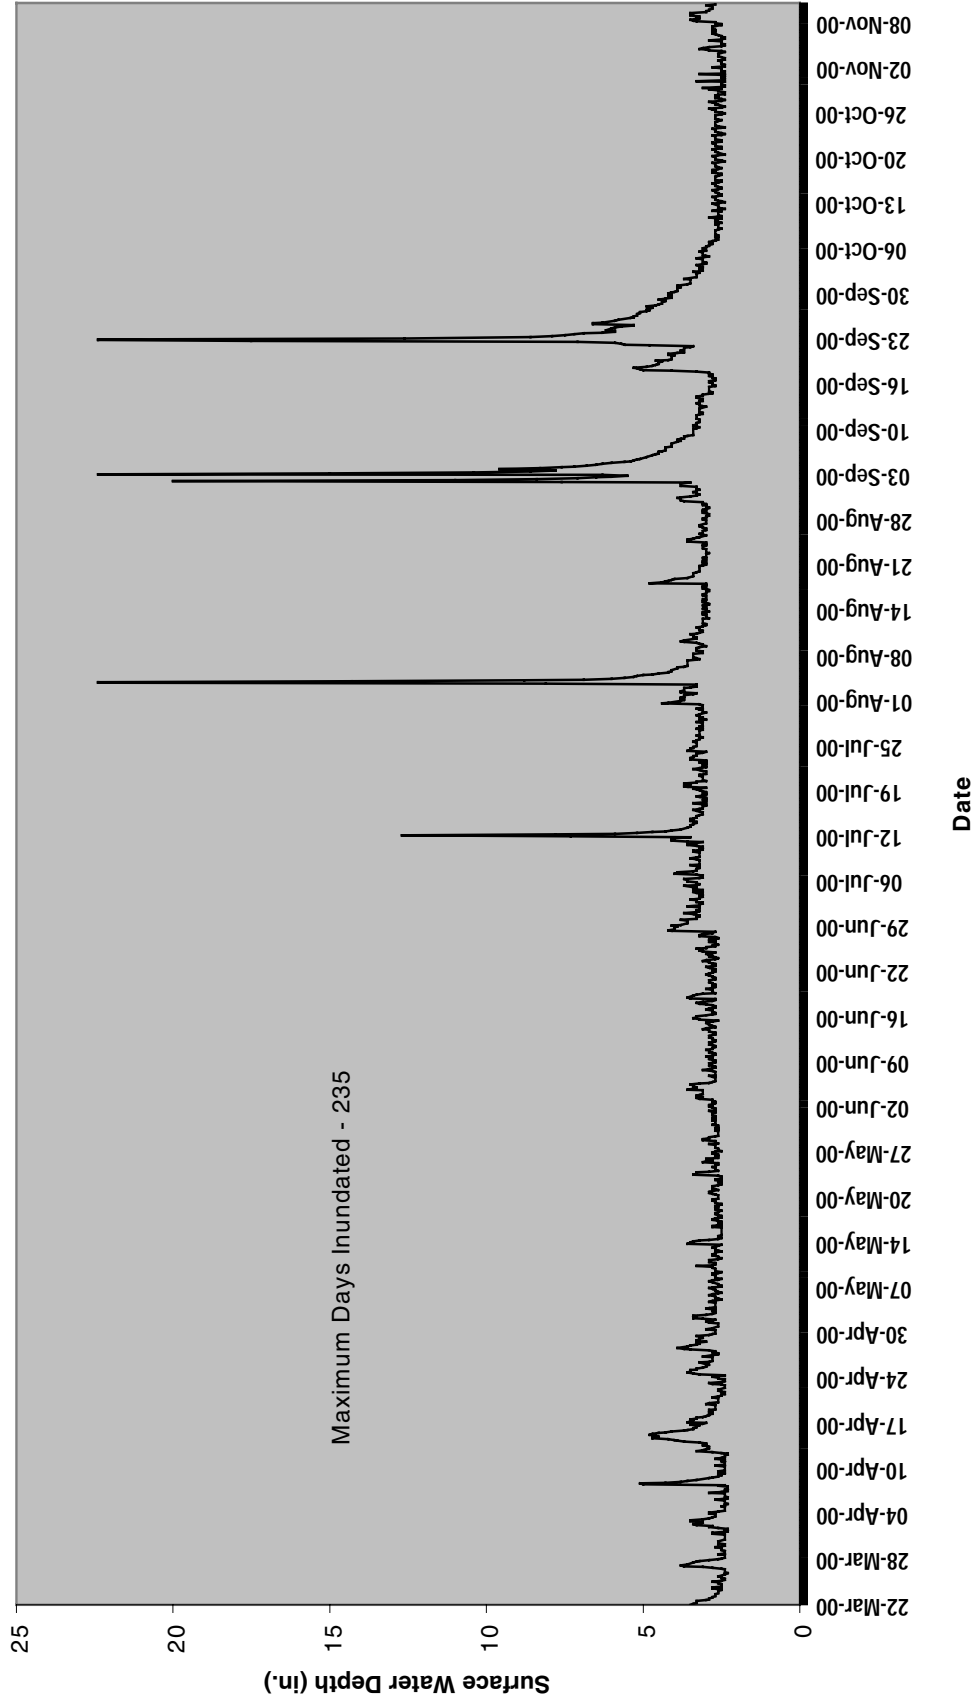
# Mallard Creek SG-11

Site 1 hydrologic data indicates that the site meets the hydrologic success criteria established by the USACE permit. The site was saturated or inundated for more than 26 days of the growing season. The surface gauge located on Site 1 also showed consistent inundation throughout the growing season. A 12" water main leak adjacent to his site has effected the hydrology at this location. The extent of the effect is unknown at this time.
