MONITORING YEAR 2 ANNUAL REPORT

MANEY FARM MITIGATION PROJECT

Chatham County, NC
NCDEQ Contract 005793
DMS ID No. 96314

Data Collection Period: March - September 2017
Draft Submission Date: November 14, 2017
Final Submission Date: December 6, 2017

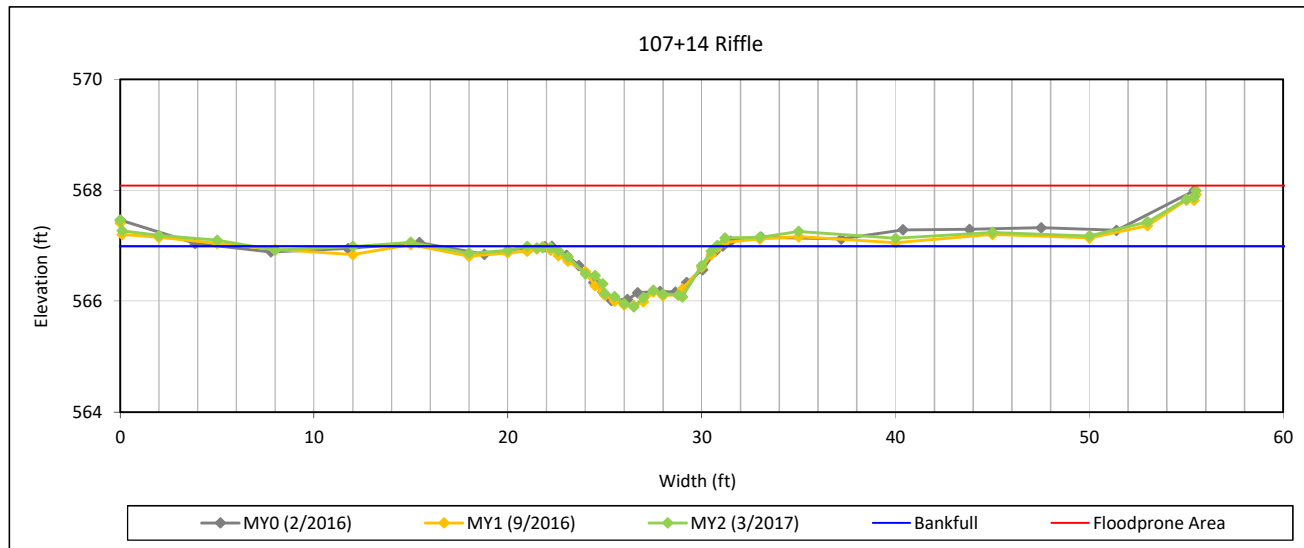
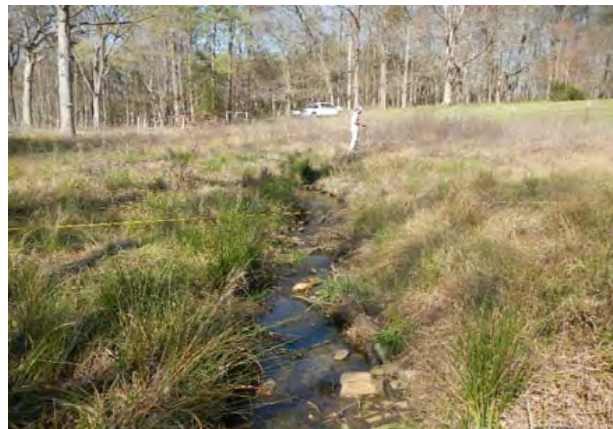
Cross Section 1, UTSF Reach 1

5.4	x-section area (ft.sq.)
8.6	width (ft)
0.6	mean depth (ft)
1.1	max depth (ft)
9.1	wetted perimeter (ft)
0.6	hydraulic radius (ft)
13.5	width-depth ratio
85.0	W flood prone area (ft)
9.9	entrenchment ratio
1.0	low bank height ratio

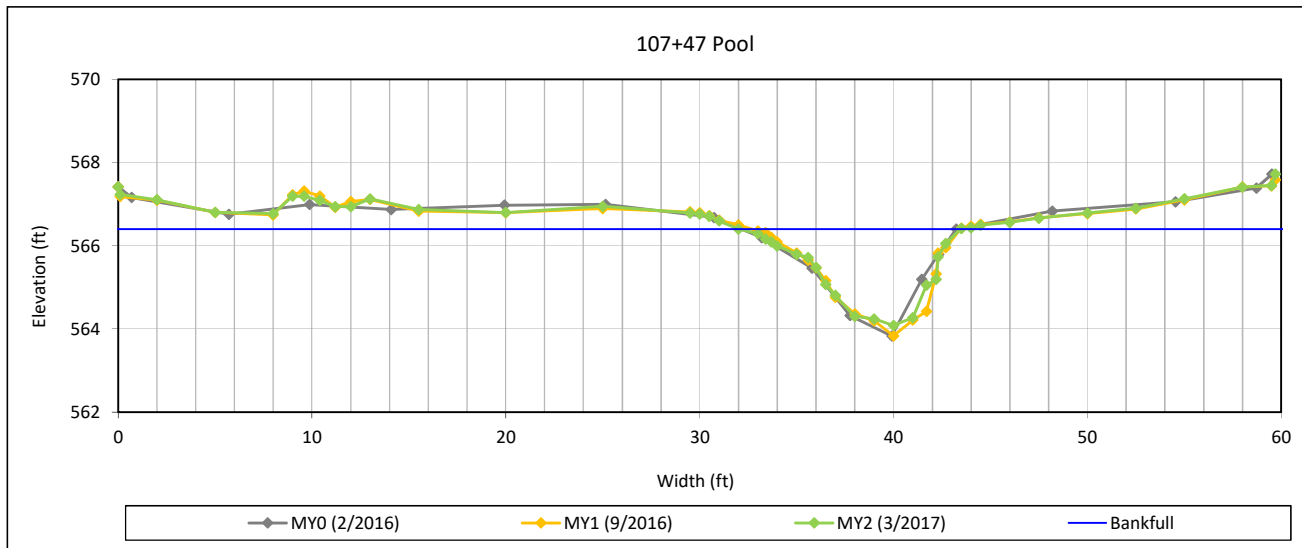
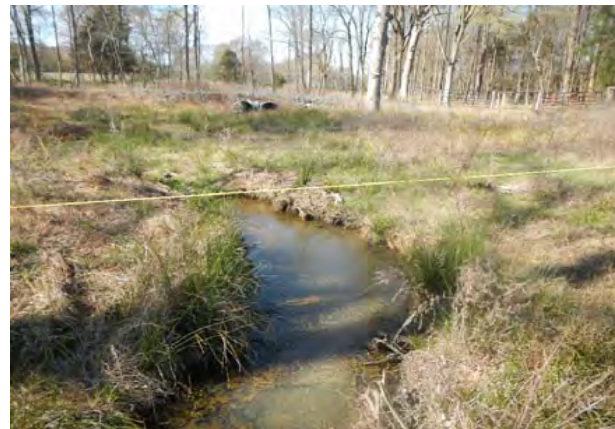
Cross Section 2, UTSF Reach 1

13.6	x-section area (ft.sq.)
11.5	width (ft)
1.2	mean depth (ft)
2.3	max depth (ft)
13.0	wetted perimeter (ft)
1.0	hydraulic radius (ft)
9.7	width-depth ratio

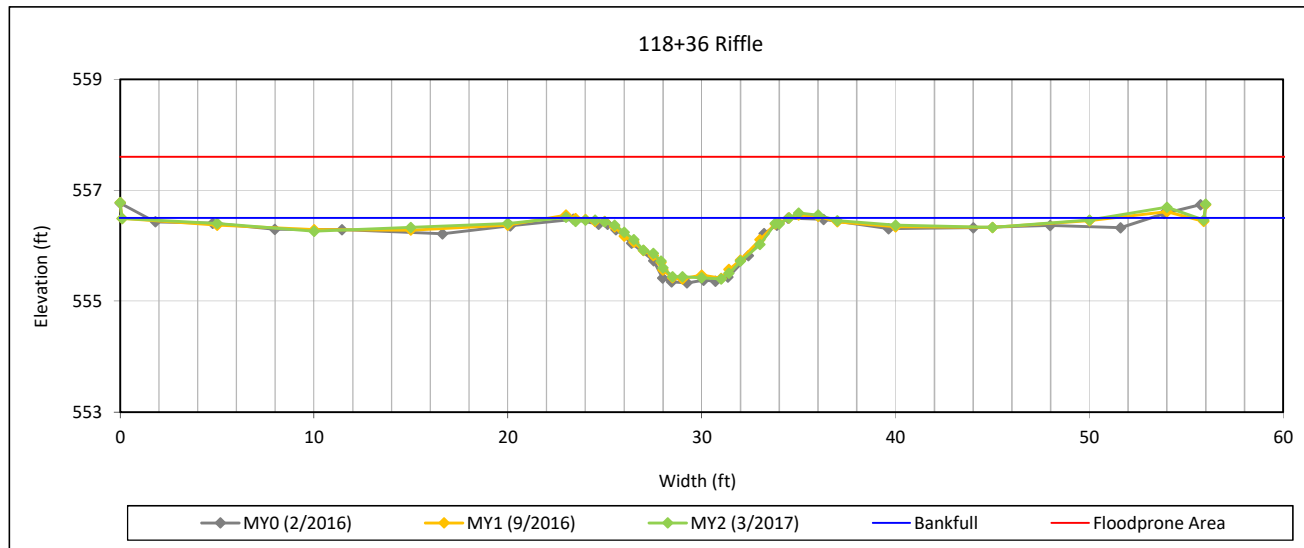
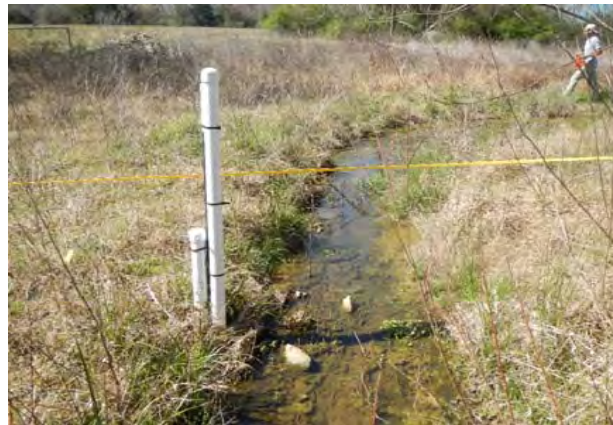
Cross Section 3, UTSF Reach 1

6.2	x-section area (ft.sq.)
9.0	width (ft)
0.7	mean depth (ft)
1.1	max depth (ft)
9.4	wetted perimeter (ft)
0.7	hydraulic radius (ft)
13.0	width-depth ratio
85.0	W flood prone area (ft)
9.4	entrenchment ratio
1.0	low bank height ratio

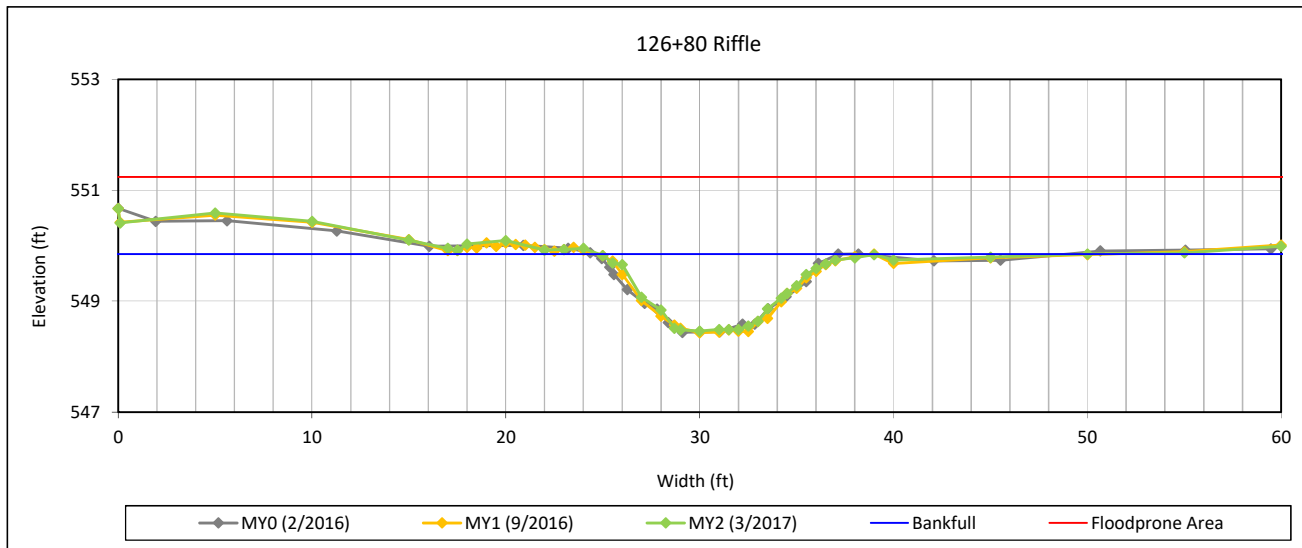
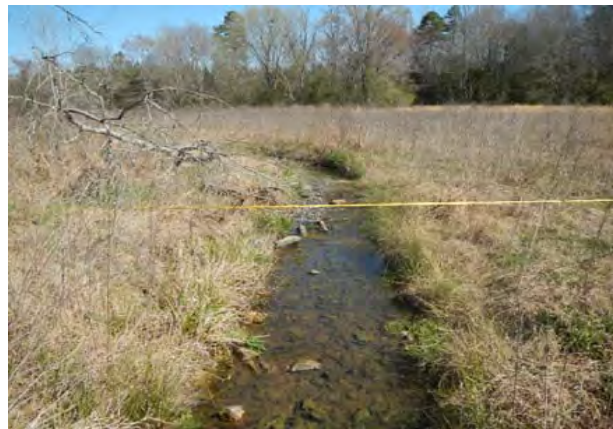
Cross Section 5, UTSF Reach 2

10.5	x-section area (ft.sq.)
12.2	width (ft)
0.9	mean depth (ft)
1.4	max depth (ft)
12.7	wetted perimeter (ft)
0.8	hydraulic radius (ft)
14.3	width-depth ratio
150.0	W flood prone area (ft)
12.3	entrenchment ratio
1.0	low bank height ratio

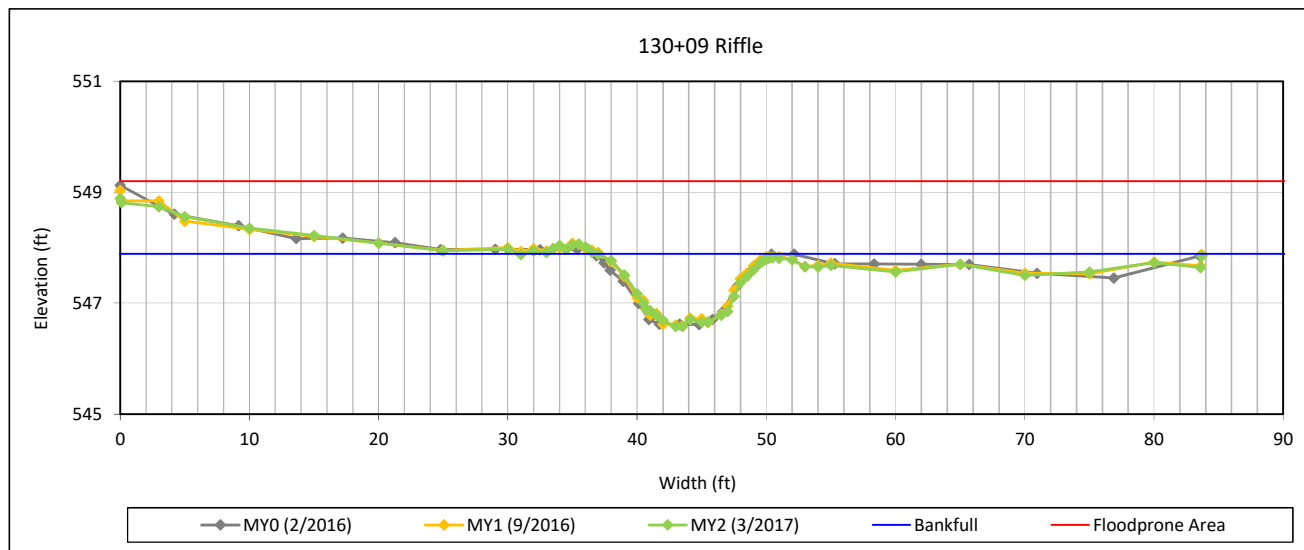
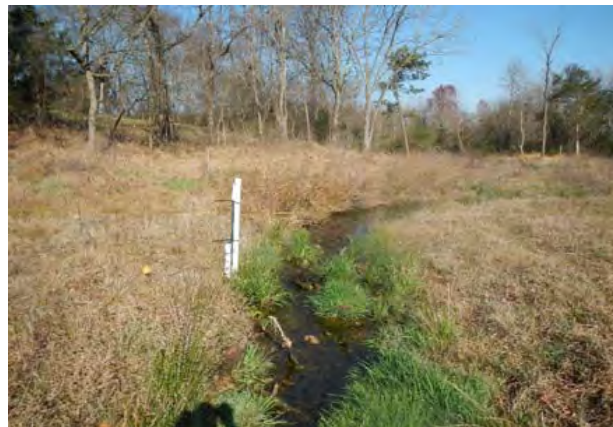
Cross Section 6, UTSF Reach 2

10.4	x-section area (ft.sq.)
13.9	width (ft)
0.7	mean depth (ft)
1.3	max depth (ft)
14.3	wetted perimeter (ft)
0.7	hydraulic radius (ft)
18.7	width-depth ratio
150.0	W flood prone area (ft)
10.8	entrenchment ratio
1.0	low bank height ratio

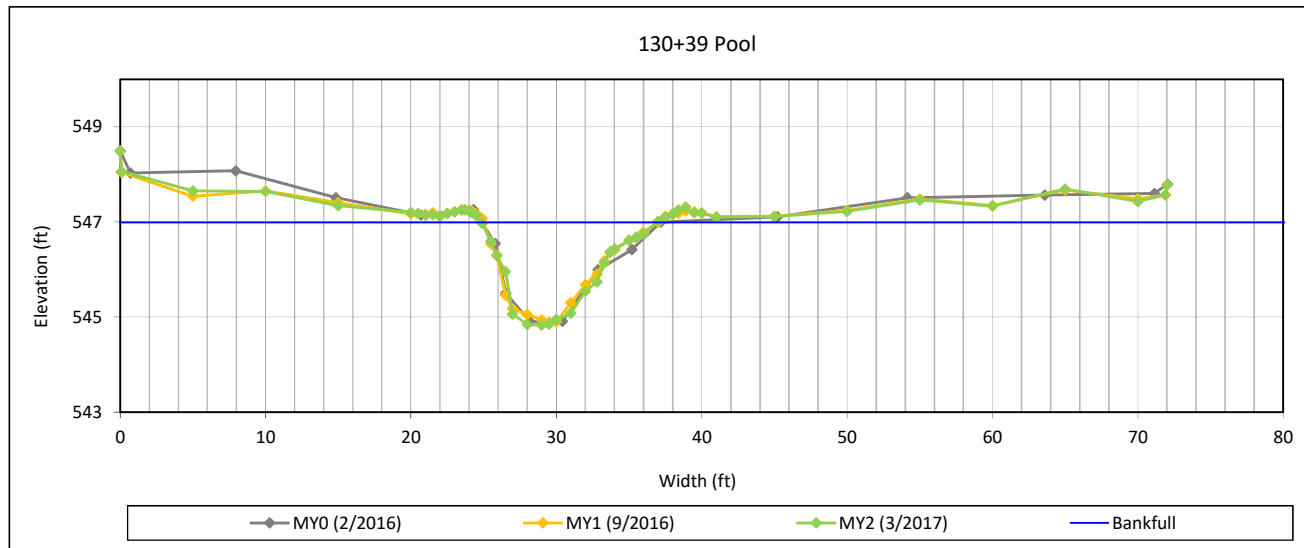
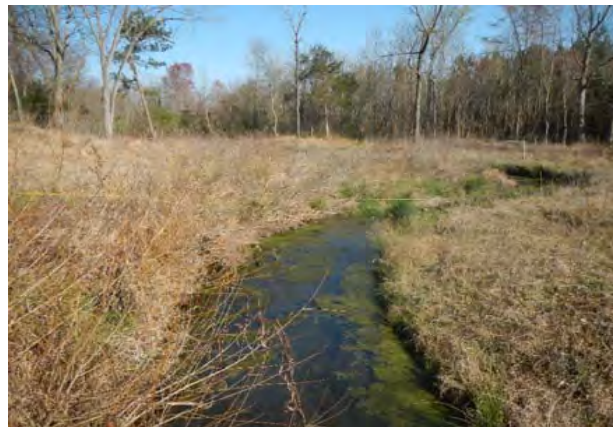
Cross Section 7, UTSF Reach 2

14.5	x-section area (ft.sq.)
12.1	width (ft)
1.2	mean depth (ft)
2.2	max depth (ft)
13.3	wetted perimeter (ft)
1.1	hydraulic radius (ft)
10.0	width-depth ratio

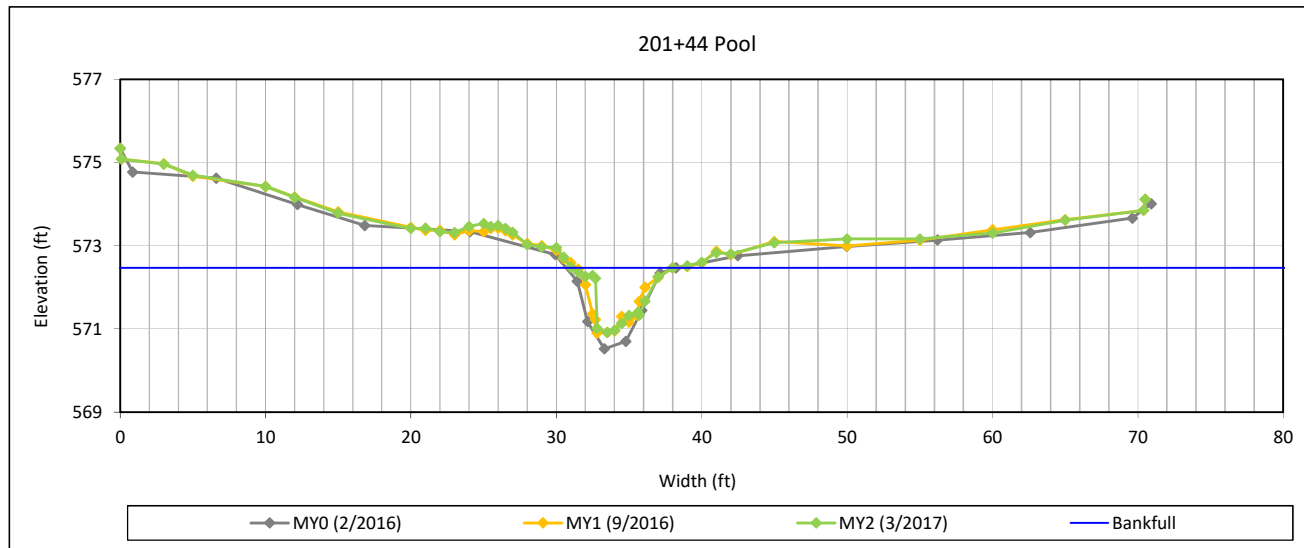
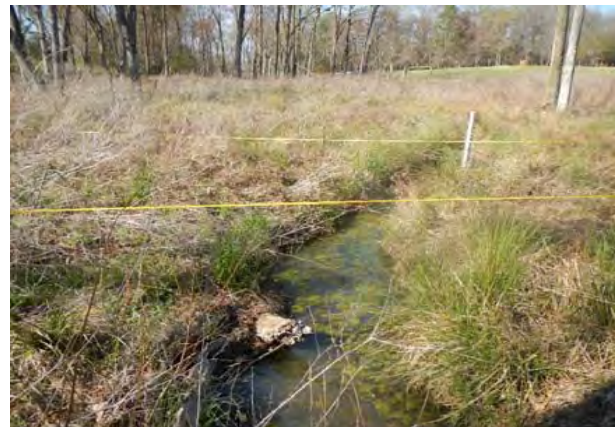
Cross Section 8, UT1C

5.2	x-section area (ft.sq.)
7.0	width (ft)
0.8	mean depth (ft)
1.6	max depth (ft)
8.5	wetted perimeter (ft)
0.6	hydraulic radius (ft)
9.3	width-depth ratio

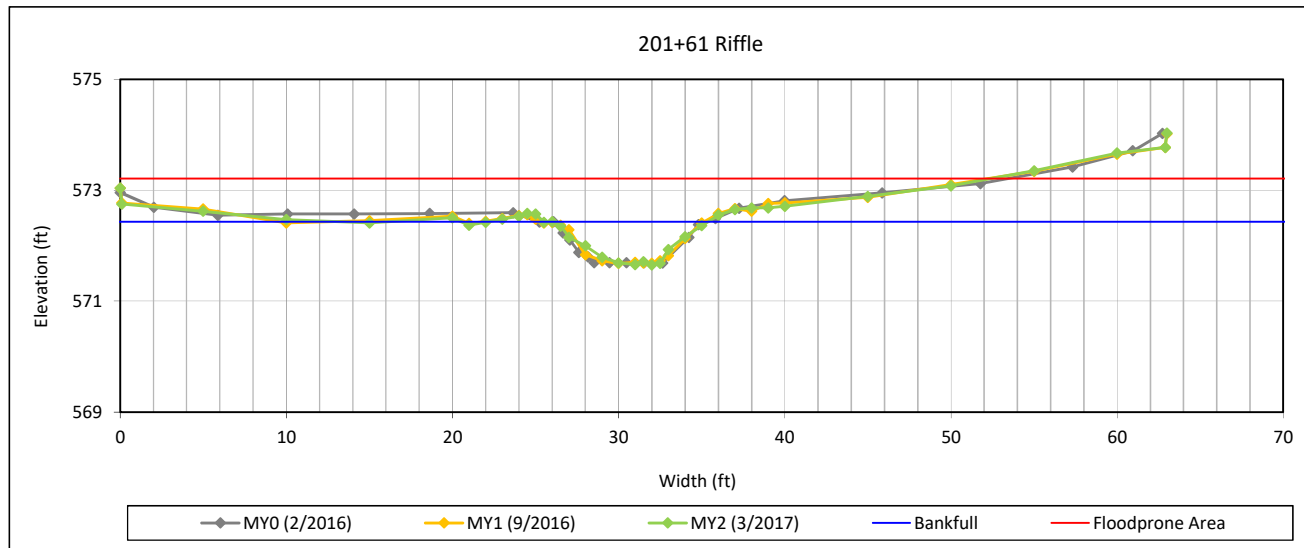
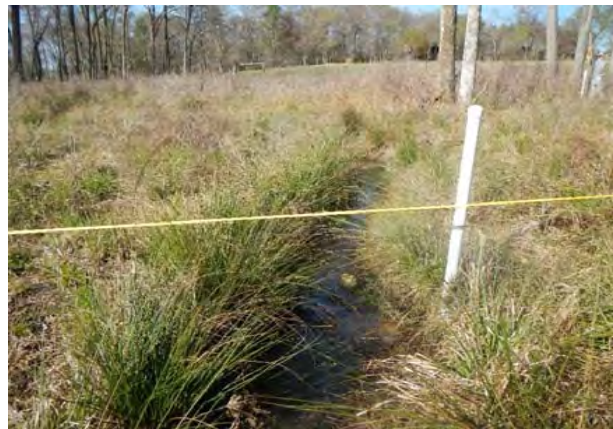
Cross Section 9, UT1C

4.5	x-section area (ft.sq.)
9.9	width (ft)
0.5	mean depth (ft)
0.8	max depth (ft)
10.1	wetted perimeter (ft)
0.4	hydraulic radius (ft)
21.8	width-depth ratio
60.0	W flood prone area (ft)
6.1	entrenchment ratio
1.0	low bank height ratio

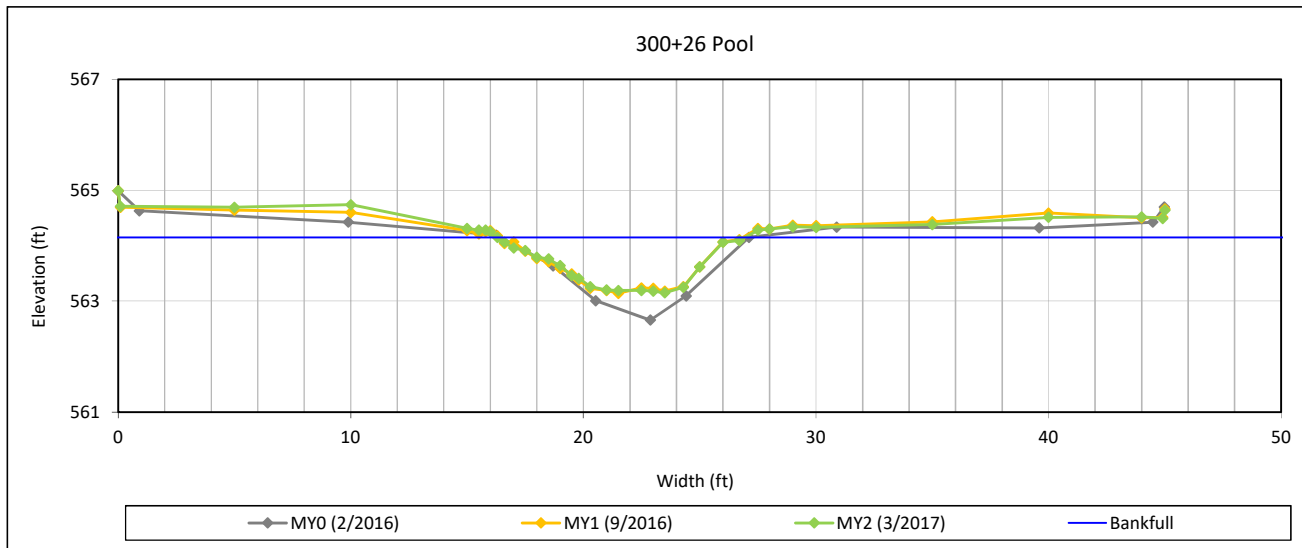
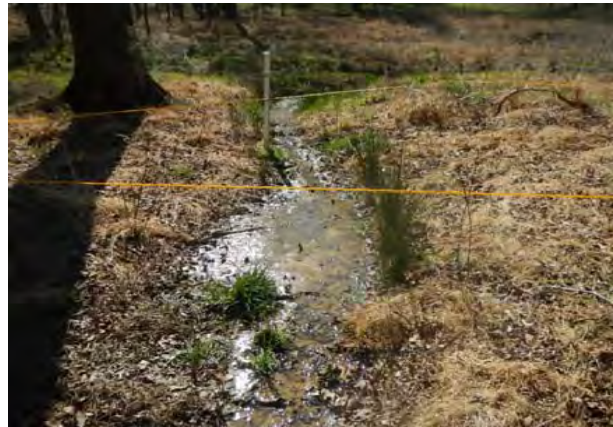
Cross Section 10, UT2B

6.3	x-section area (ft.sq.)
10.7	width (ft)
0.6	mean depth (ft)
1.0	max depth (ft)
11.0	wetted perimeter (ft)
0.6	hydraulic radius (ft)
17.9	width-depth ratio

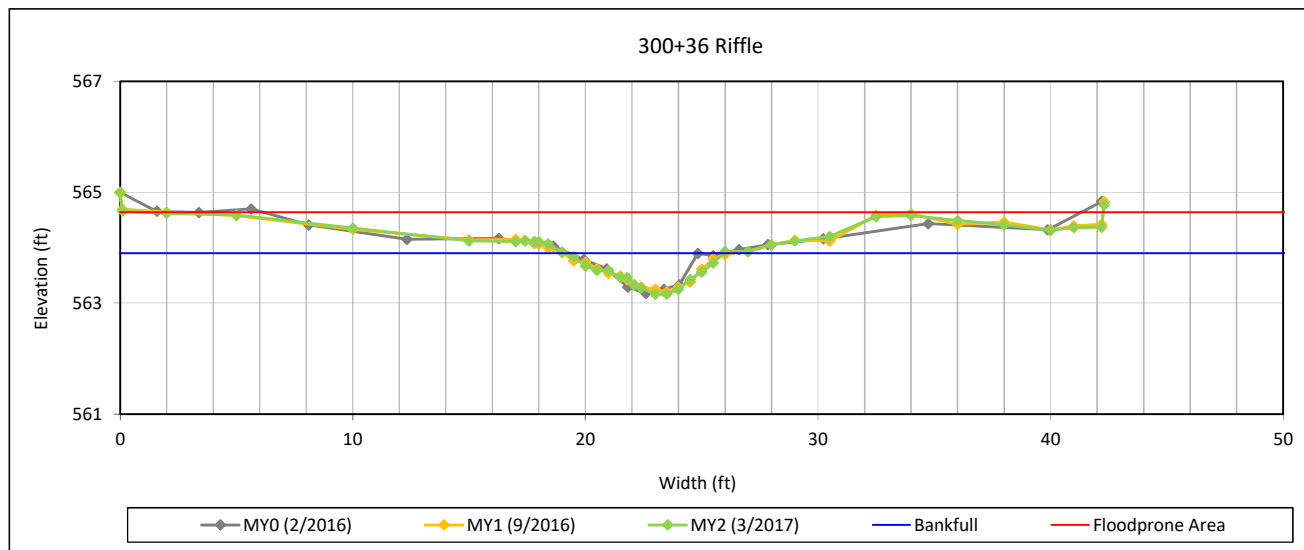
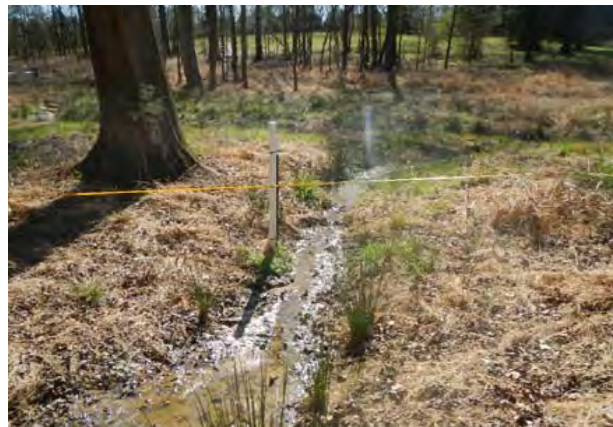
Cross Section 11, UT2B

2.8	x-section area (ft.sq.)
6.8	width (ft)
0.4	mean depth (ft)
0.7	max depth (ft)
7.0	wetted perimeter (ft)
0.4	hydraulic radius (ft)
16.5	width-depth ratio
60.0	W flood prone area (ft)
8.8	entrenchment ratio
1.0	low bank height ratio

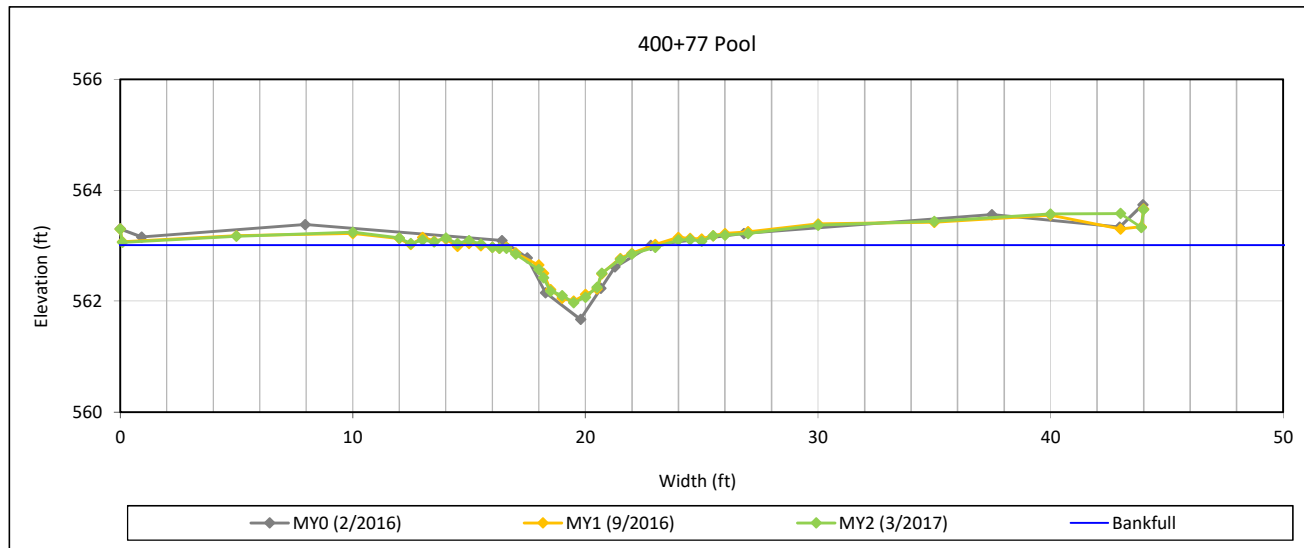
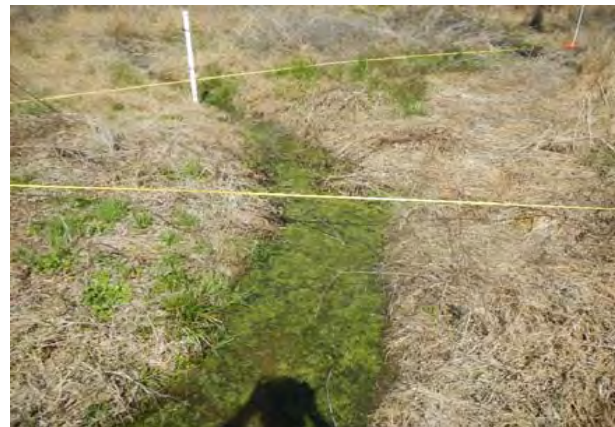
Cross Section 12, UT3B

3.2	x-section area (ft.sq.)
7.0	width (ft)
0.5	mean depth (ft)
1.0	max depth (ft)
7.4	wetted perimeter (ft)
0.4	hydraulic radius (ft)
15.5	width-depth ratio

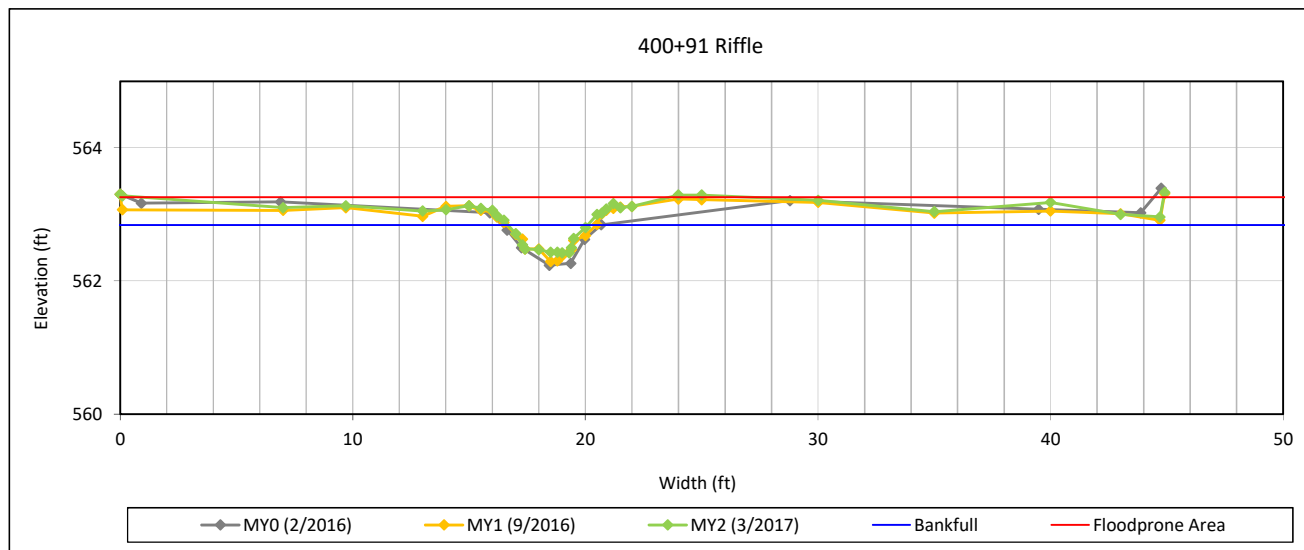
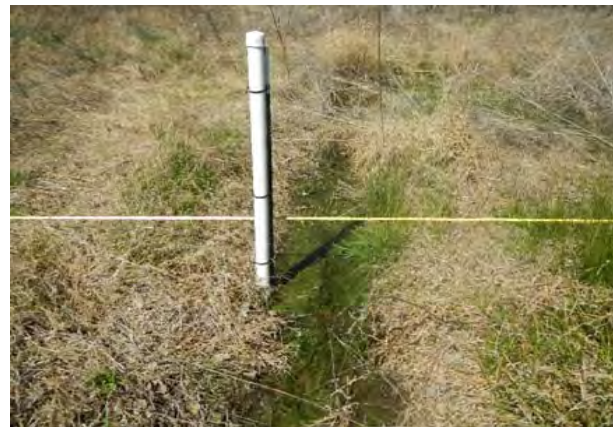
Cross Section 13, UT3B

1.0	x-section area (ft.sq.)
3.4	width (ft)
0.3	mean depth (ft)
0.4	max depth (ft)
3.6	wetted perimeter (ft)
0.3	hydraulic radius (ft)
11.8	width-depth ratio
60.0	W flood prone area (ft)
17.5	entrenchment ratio
1.3	low bank height ratio

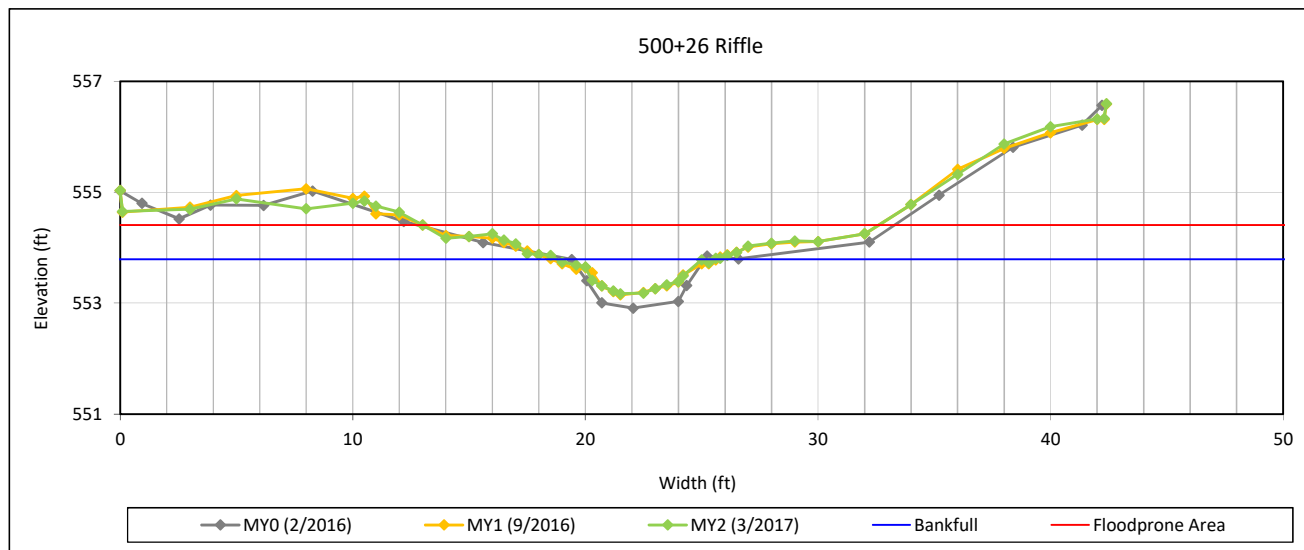
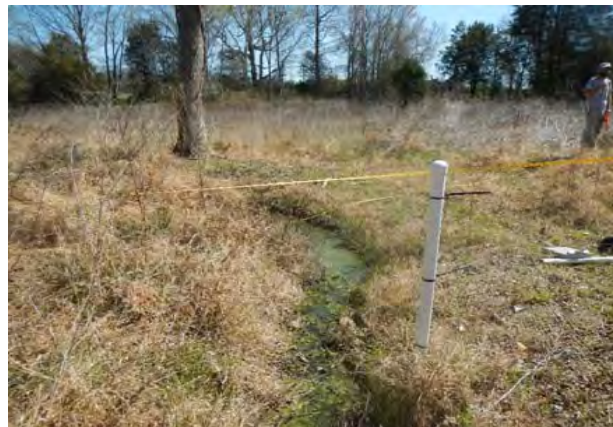
Cross Section 14, UT4B

2.4	x-section area (ft.sq.)
6.7	width (ft)
0.4	mean depth (ft)
0.6	max depth (ft)
7.0	wetted perimeter (ft)
0.3	hydraulic radius (ft)
19.2	width-depth ratio
25.0	W flood prone area (ft)
3.7	entrenchment ratio
1.0	low bank height ratio

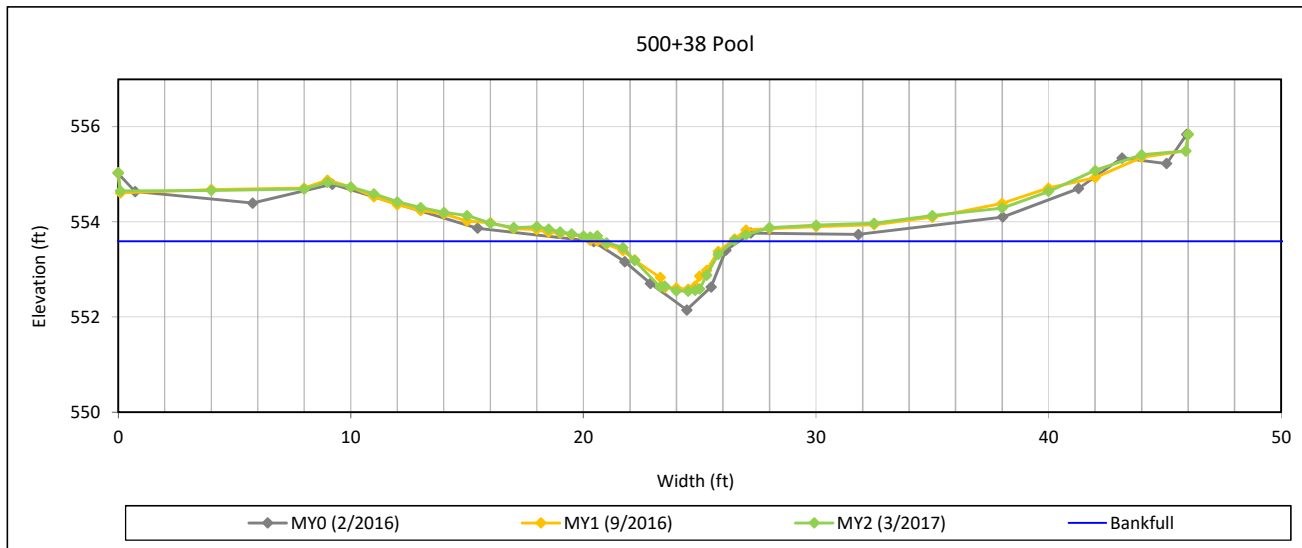
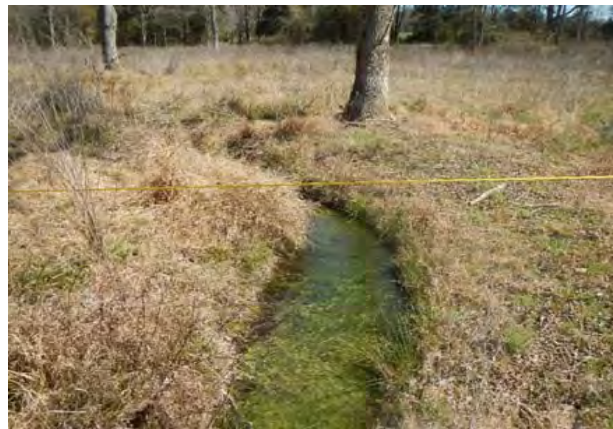
Cross Section 15, UT4B

3.2	x-section area (ft.sq.)
5.5	width (ft)
0.6	mean depth (ft)
1.1	max depth (ft)
6.1	wetted perimeter (ft)
0.5	hydraulic radius (ft)
9.4	width-depth ratio

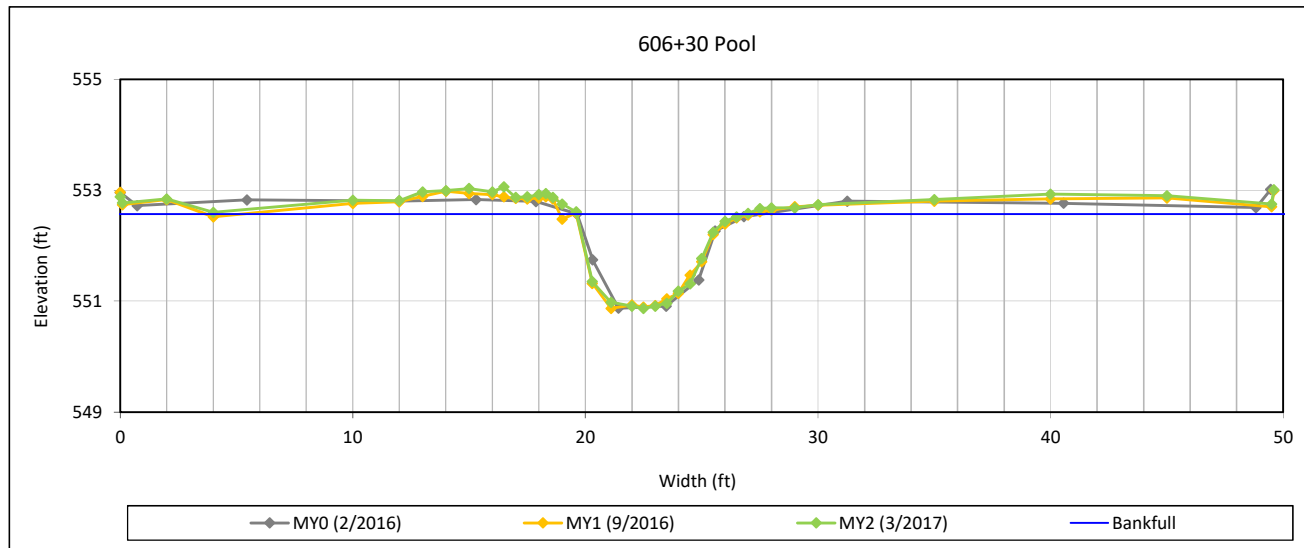
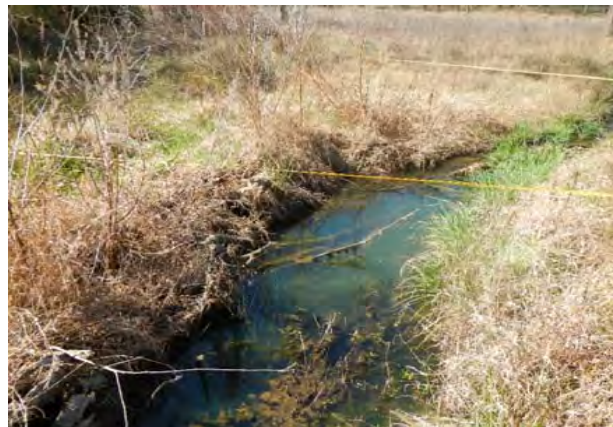
Cross Section 16, UT5

7.9	x-section area (ft.sq.)
7.3	width (ft)
1.1	mean depth (ft)
1.7	max depth (ft)
8.6	wetted perimeter (ft)
0.9	hydraulic radius (ft)
6.8	width-depth ratio

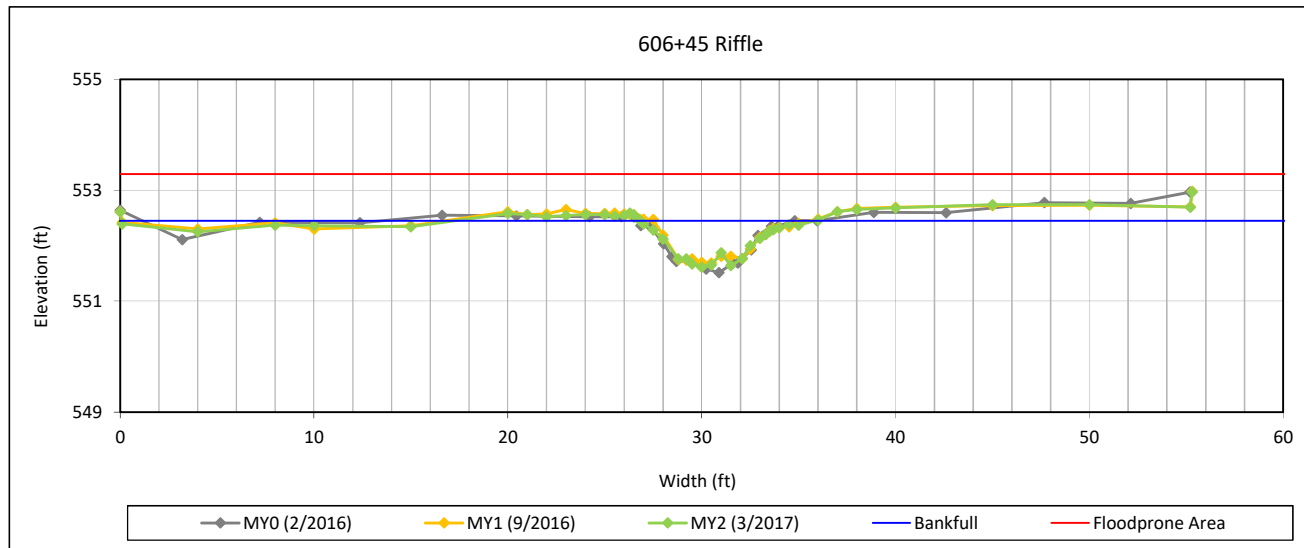
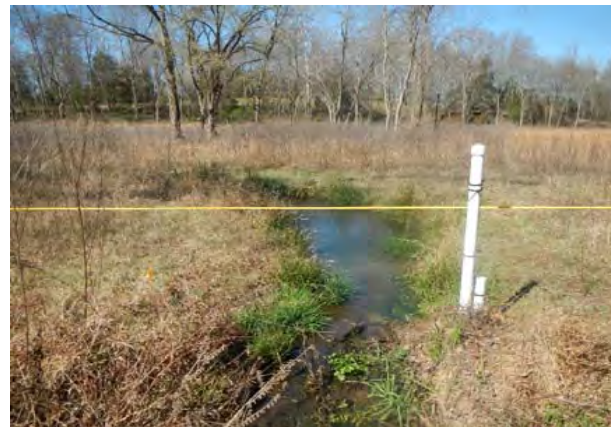
Cross Section 17, UT5

3.8	x-section area (ft.sq.)
8.2	width (ft)
0.5	mean depth (ft)
0.8	max depth (ft)
8.5	wetted perimeter (ft)
0.4	hydraulic radius (ft)
17.8	width-depth ratio
100.0	W flood prone area (ft)
12.2	entrenchment ratio
1.0	low bank height ratio
