MONITORING YEAR 3 ANNUAL REPORT

MANEY FARM MITIGATION PROJECT

Chatham County, NC
NCDEQ Contract 005793
DMS ID No. 96314

Data Collection Period: January - October 2018
Draft Submission Date: November 12, 2018
Final Submission Date: December 10, 2018

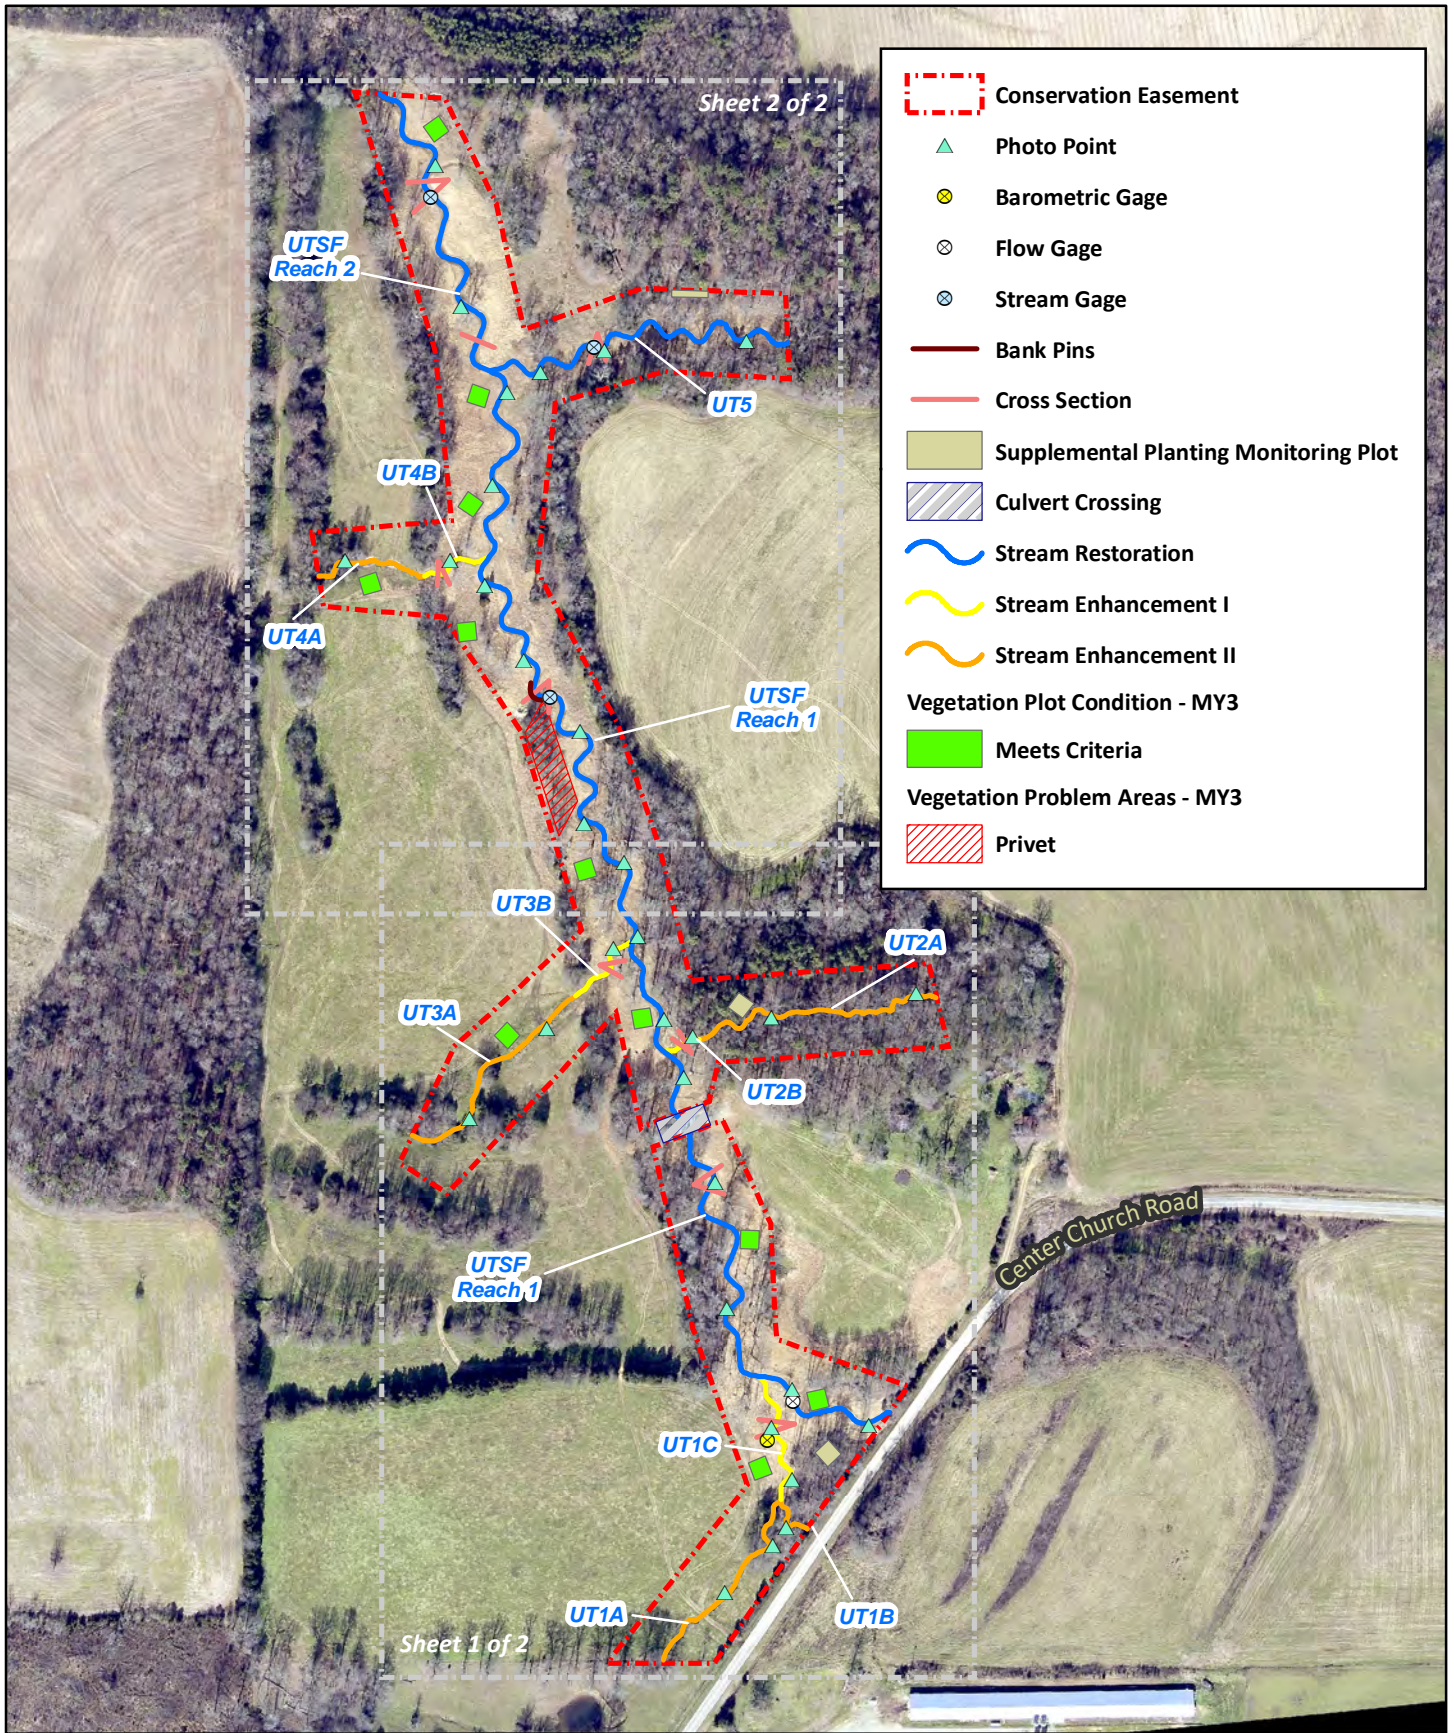
Figure 3.0 Integrated Current Condition Plan View (Key)
 Maney Farm Mitigation Project
 DMS Project No. 96314
 Monitoring Year 3 - 2018
 Chatham County, NC
 2017 Aerial Photography

easement was treated using glyphosate and triclopyr respectively. A dense population of Chinese privet along UTSF (Figure 3.0) will be retreated during MY4. Privet will continue to be monitored and treated in subsequent monitoring years.

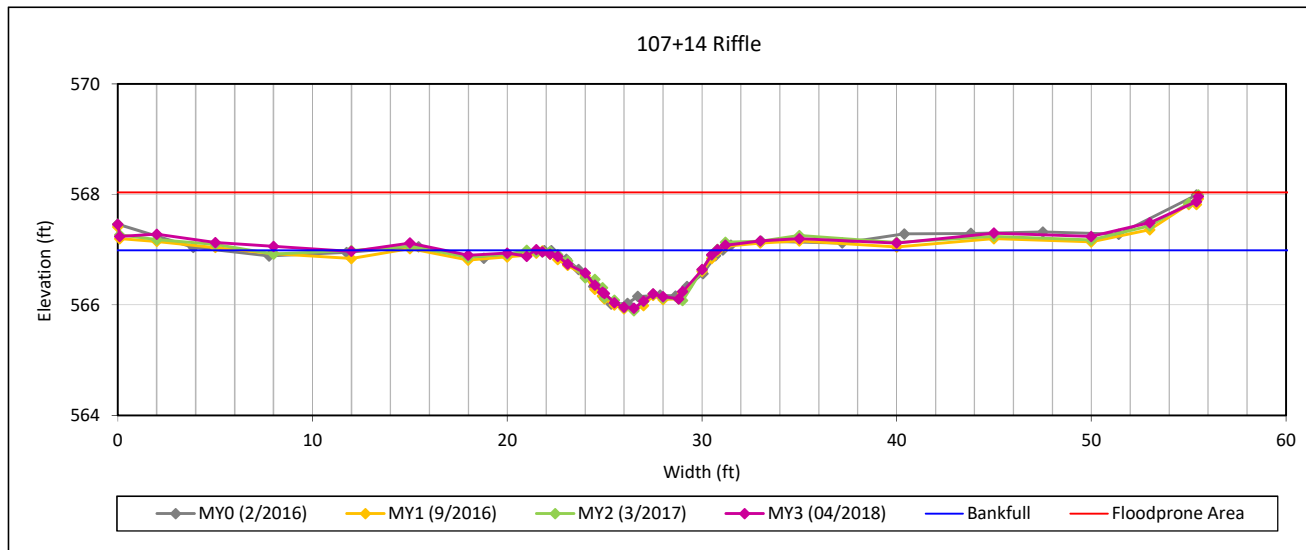
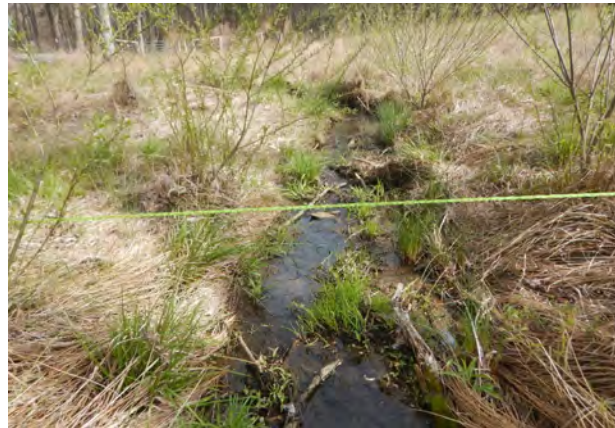
Cross Section 1, UTSF Reach 1

5.3	x-section area (ft.sq.)
8.6	width (ft)
0.6	mean depth (ft)
1.1	max depth (ft)
8.9	wetted perimeter (ft)
0.6	hydraulic radius (ft)
13.8	width-depth ratio
85.0	W flood prone area (ft)
9.9	entrenchment ratio
1.0	low bank height ratio

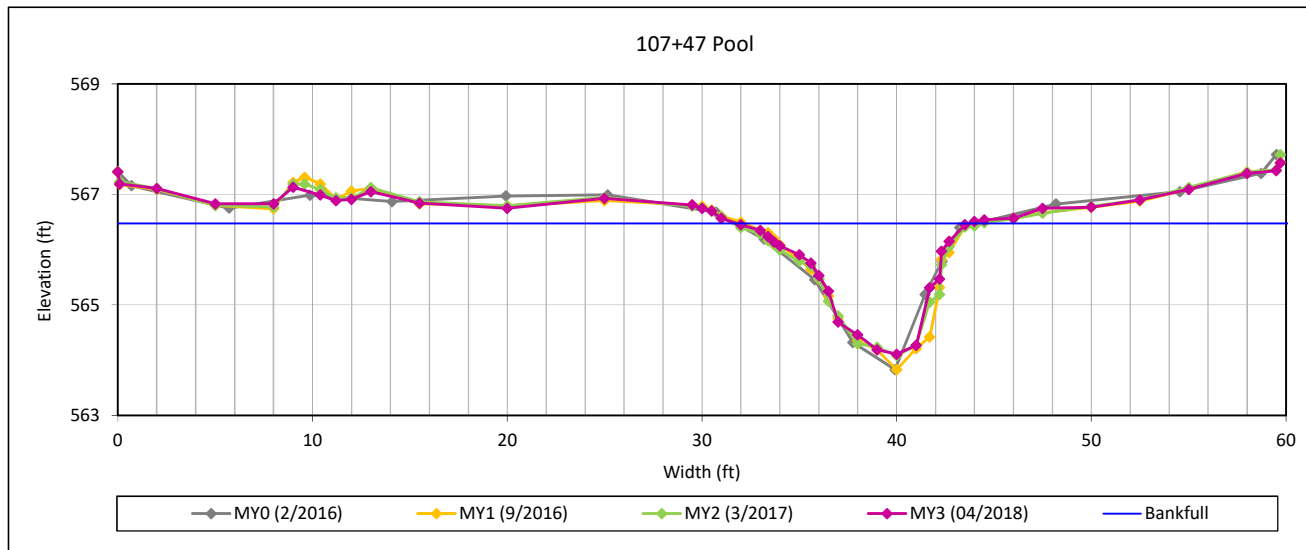
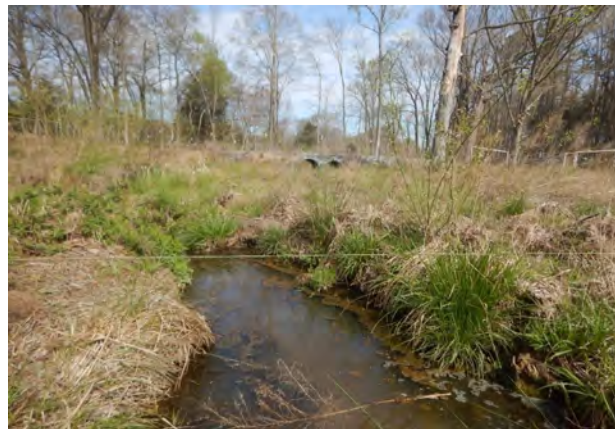
Cross Section 2, UTSF Reach 1

13.6	x-section area (ft.sq.)
11.9	width (ft)
1.1	mean depth (ft)
2.4	max depth (ft)
13.5	wetted perimeter (ft)
1.0	hydraulic radius (ft)
10.4	width-depth ratio

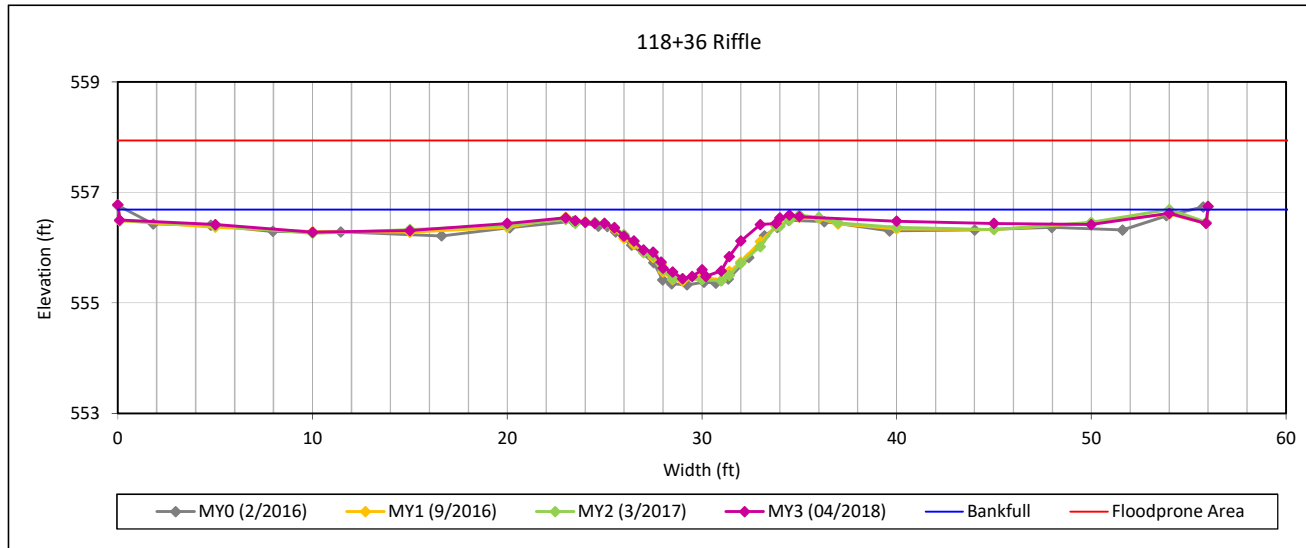
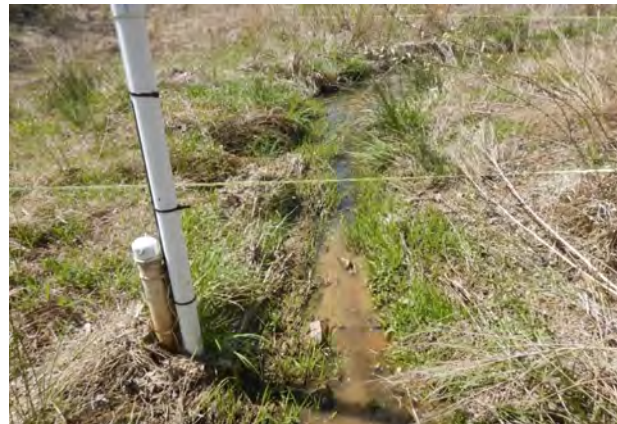
Cross Section 3, UTSF Reach 1

6.8	x-section area (ft.sq.)
9.5	width (ft)
0.7	mean depth (ft)
1.3	max depth (ft)
9.9	wetted perimeter (ft)
0.7	hydraulic radius (ft)
13.3	width-depth ratio
85.0	W flood prone area (ft)
8.9	entrenchment ratio
0.8	low bank height ratio

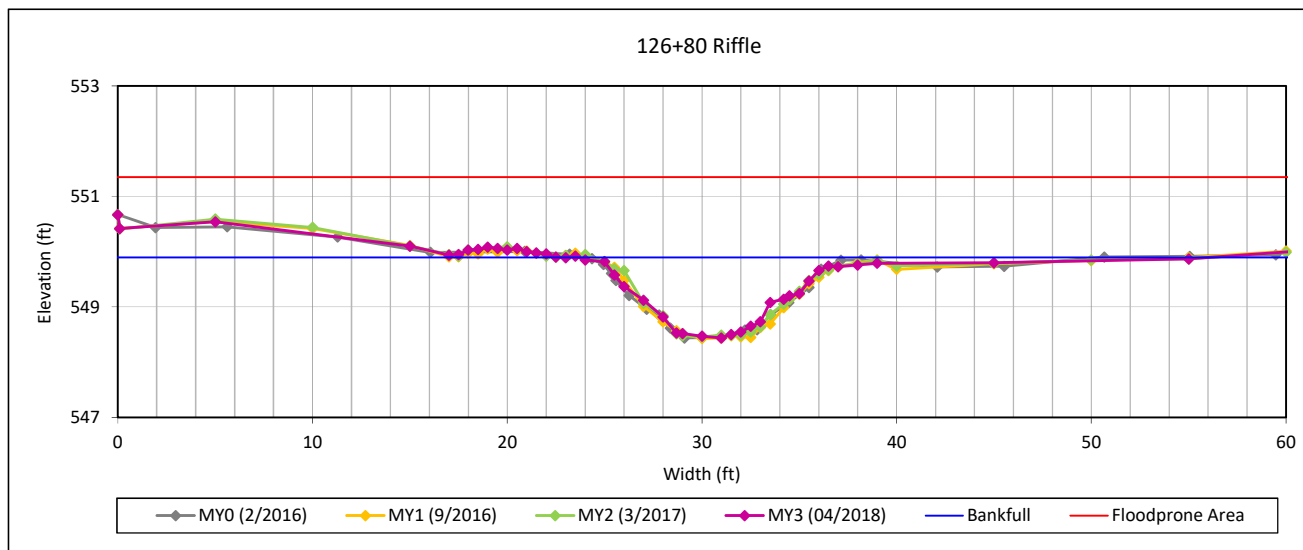
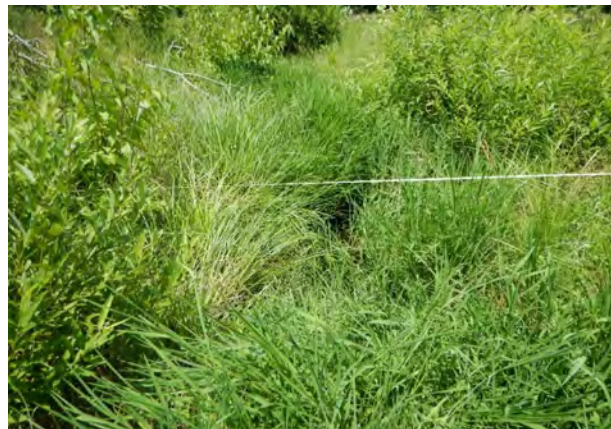
Cross Section 5, UTSF Reach 2

10.9	x-section area (ft.sq.)
13.6	width (ft)
0.8	mean depth (ft)
1.5	max depth (ft)
14.1	wetted perimeter (ft)
0.8	hydraulic radius (ft)
16.9	width-depth ratio
150.0	W flood prone area (ft)
11.0	entrenchment ratio
0.9	low bank height ratio

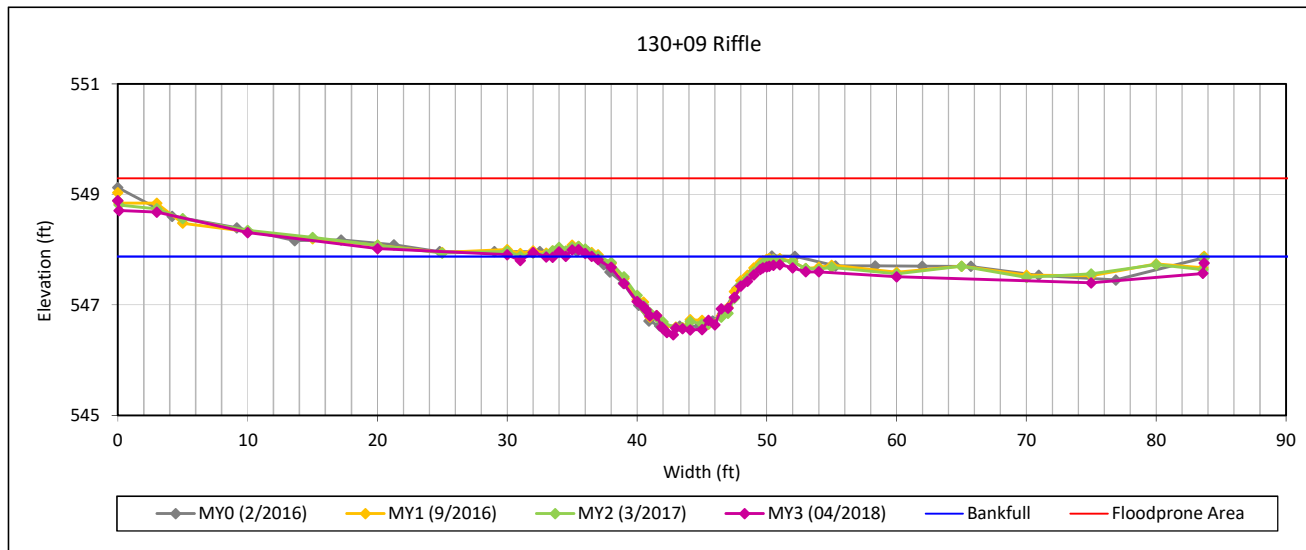
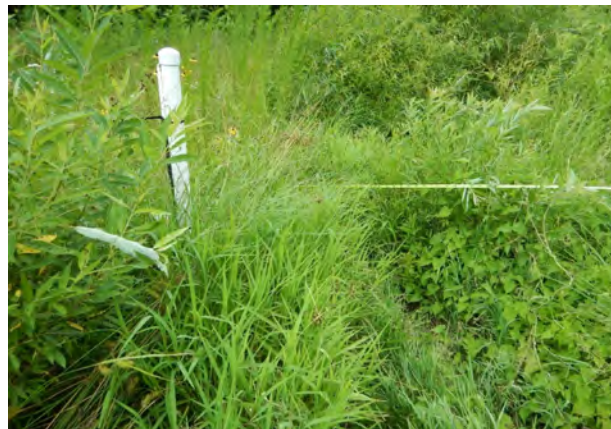
Cross Section 6, UTSF Reach 2

10.9	x-section area (ft.sq.)
15.3	width (ft)
0.7	mean depth (ft)
1.4	max depth (ft)
15.8	wetted perimeter (ft)
0.7	hydraulic radius (ft)
21.5	width-depth ratio
150.0	W flood prone area (ft)
9.8	entrenchment ratio
0.9	low bank height ratio

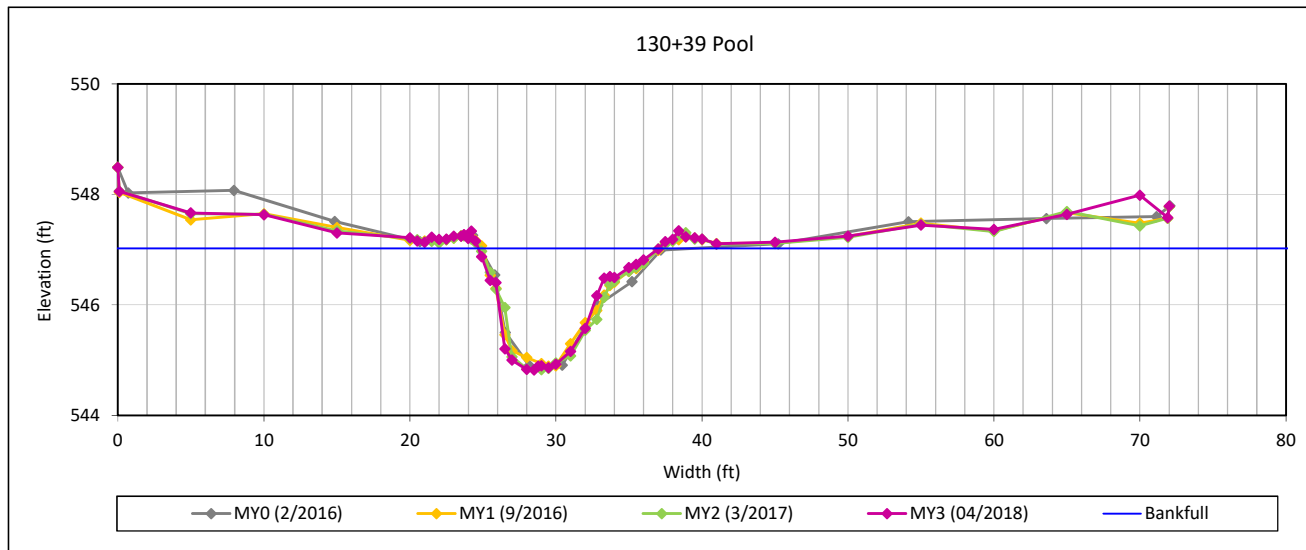
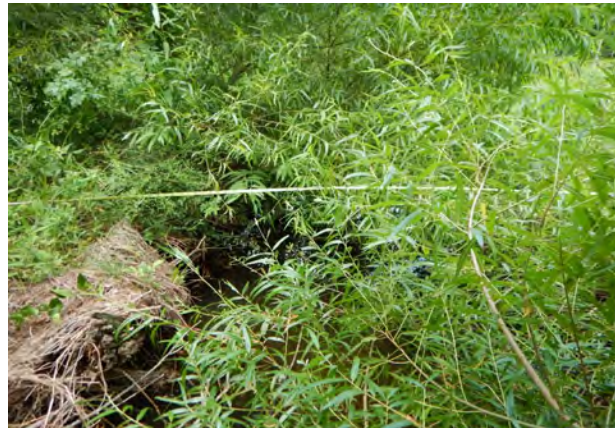
Cross Section 7, UTSF Reach 2

14.7	x-section area (ft.sq.)
12.4	width (ft)
1.2	mean depth (ft)
2.2	max depth (ft)
13.8	wetted perimeter (ft)
1.1	hydraulic radius (ft)
10.4	width-depth ratio

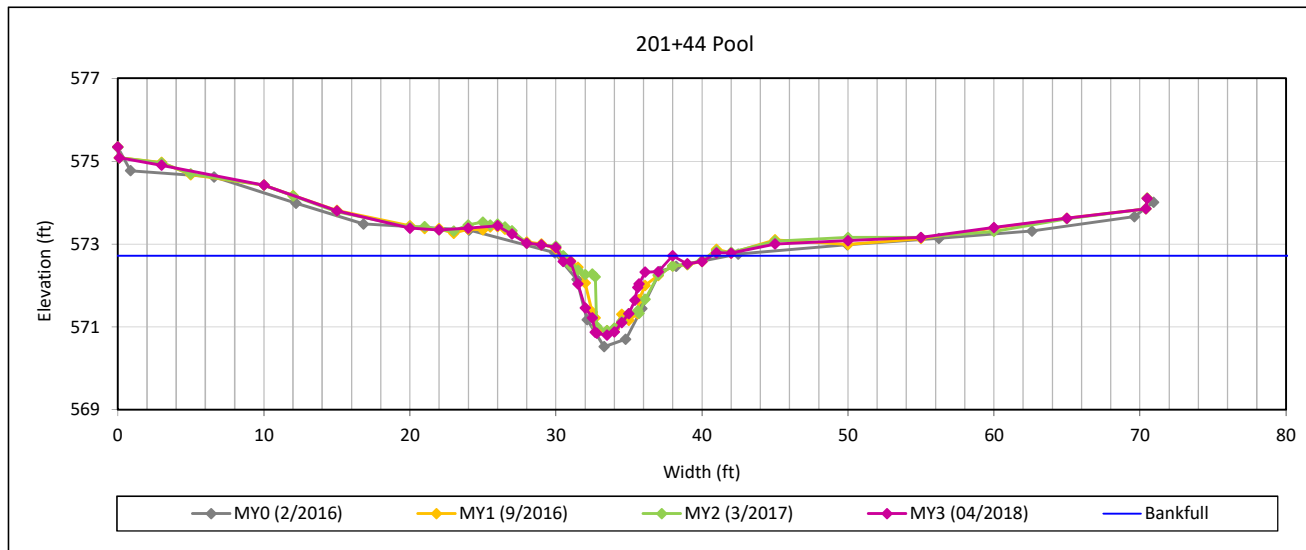
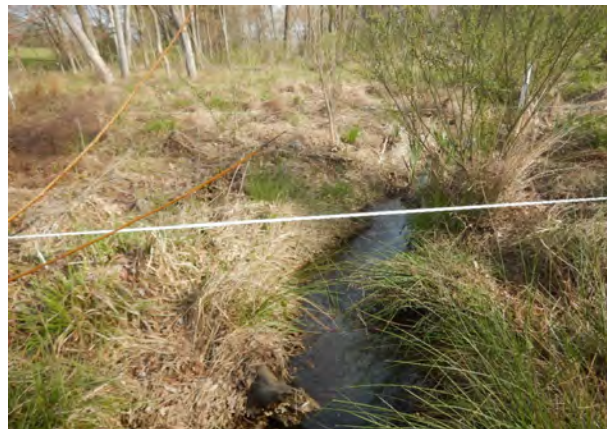
Cross Section 8, UT1C

7.7	x-section area (ft.sq.)
10.4	width (ft)
0.7	mean depth (ft)
1.9	max depth (ft)
11.8	wetted perimeter (ft)
0.7	hydraulic radius (ft)
13.9	width-depth ratio

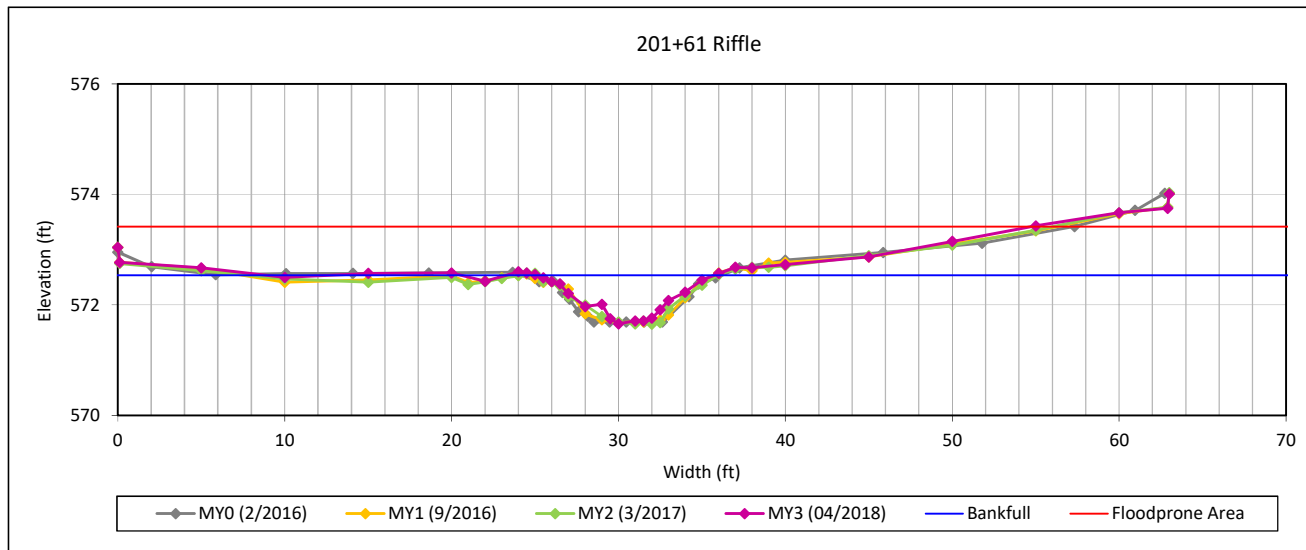
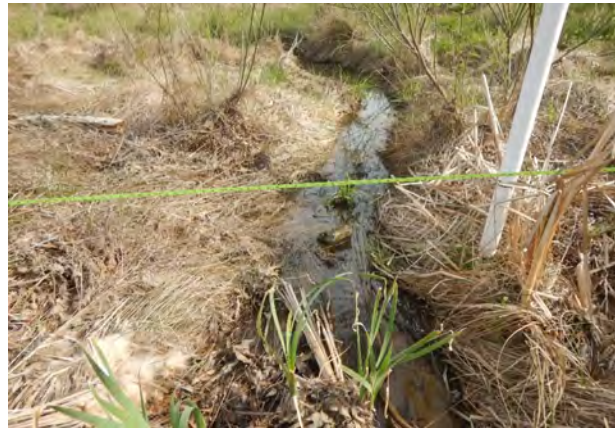
Cross Section 9, UT1C

4.9	x-section area (ft.sq.)
10.7	width (ft)
0.5	mean depth (ft)
0.9	max depth (ft)
10.9	wetted perimeter (ft)
0.5	hydraulic radius (ft)
23.2	width-depth ratio
60.0	W flood prone area (ft)
5.6	entrenchment ratio
0.9	low bank height ratio

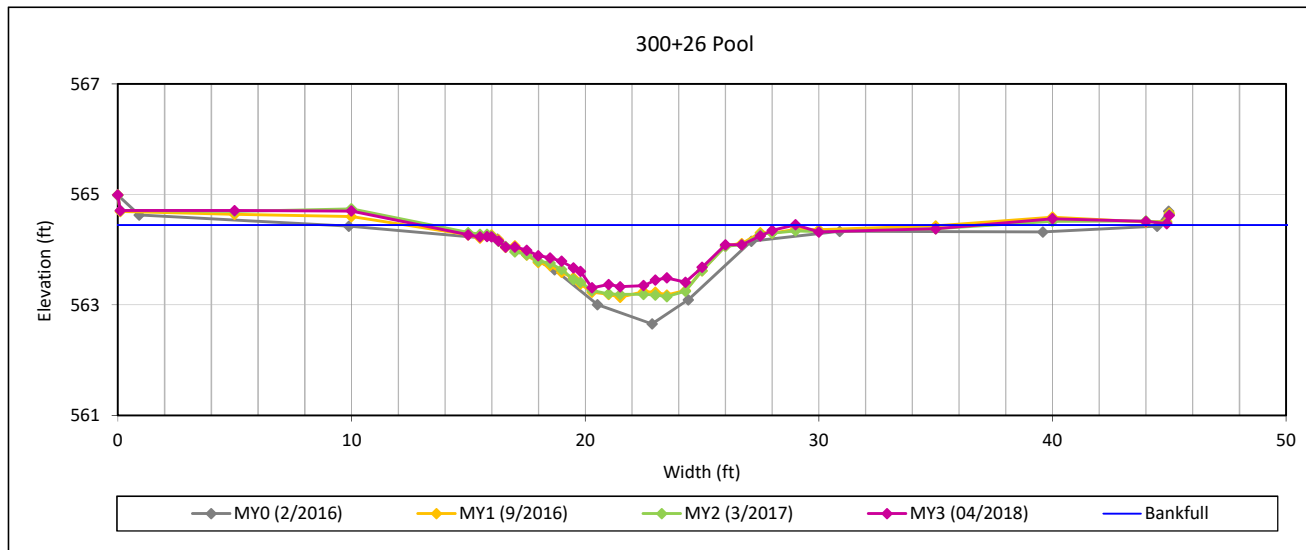
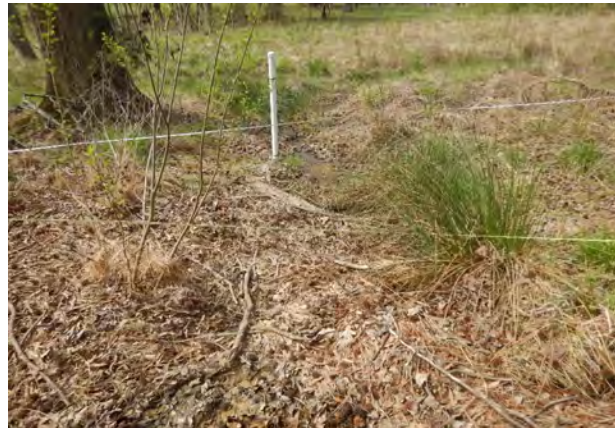
Cross Section 10, UT2B

8.6	x-section area (ft.sq.)
13.2	width (ft)
0.7	mean depth (ft)
1.1	max depth (ft)
13.5	wetted perimeter (ft)
0.6	hydraulic radius (ft)
20.2	width-depth ratio

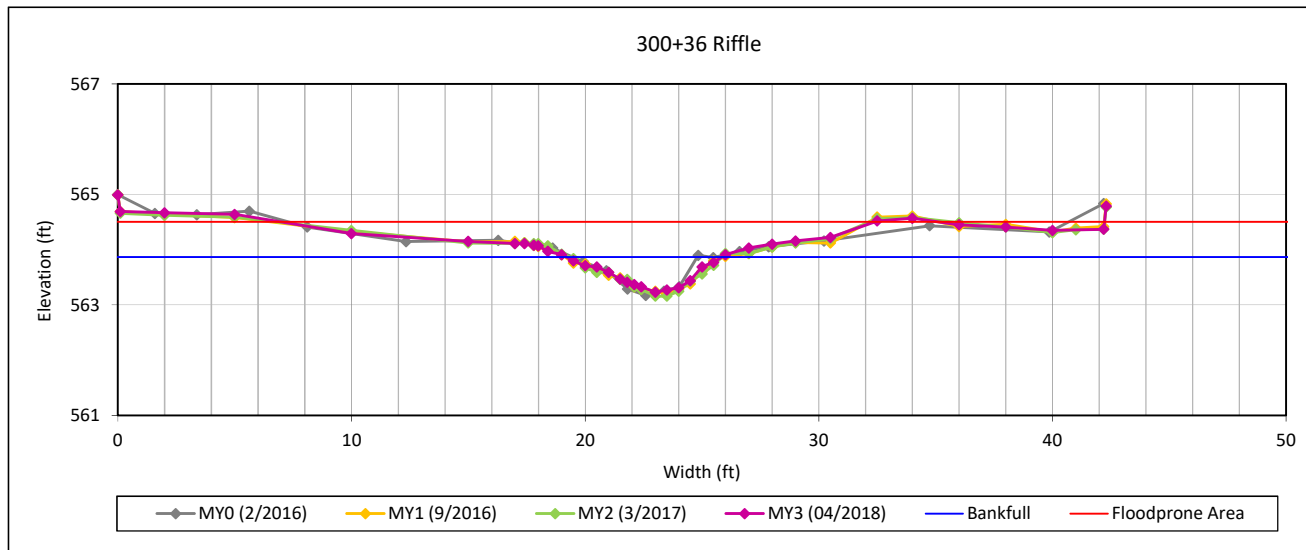
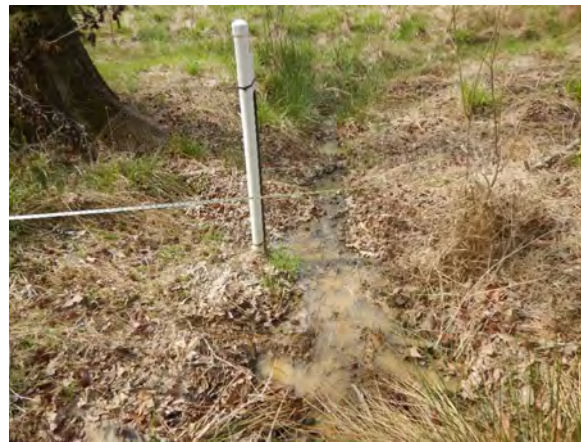
Cross Section 11, UT2B

2.3	x-section area (ft.sq.)
6.7	width (ft)
0.3	mean depth (ft)
0.6	max depth (ft)
6.8	wetted perimeter (ft)
0.3	hydraulic radius (ft)
19.3	width-depth ratio
60.0	W flood prone area (ft)
9.0	entrenchment ratio
1.1	low bank height ratio

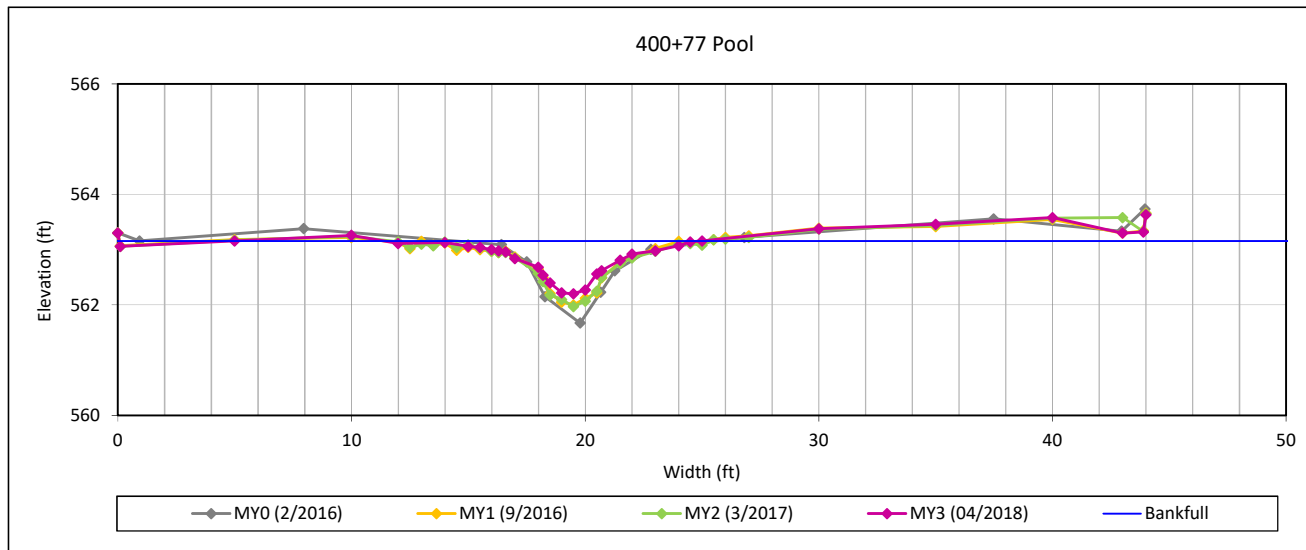
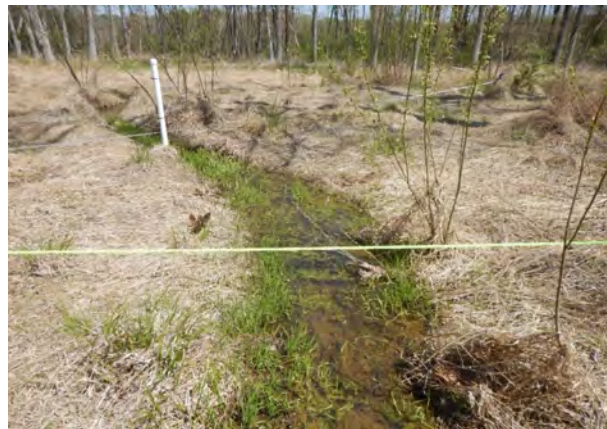
Cross Section 12, UT3B

3.8	x-section area (ft.sq.)
10.9	width (ft)
0.3	mean depth (ft)
1.0	max depth (ft)
11.2	wetted perimeter (ft)
0.3	hydraulic radius (ft)
31.2	width-depth ratio

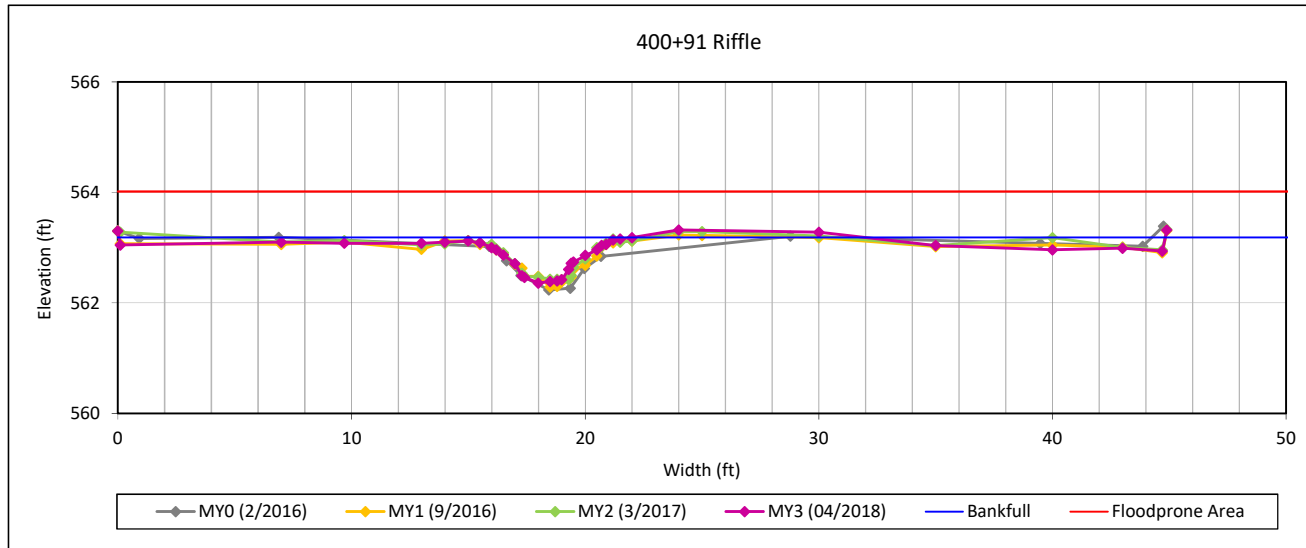
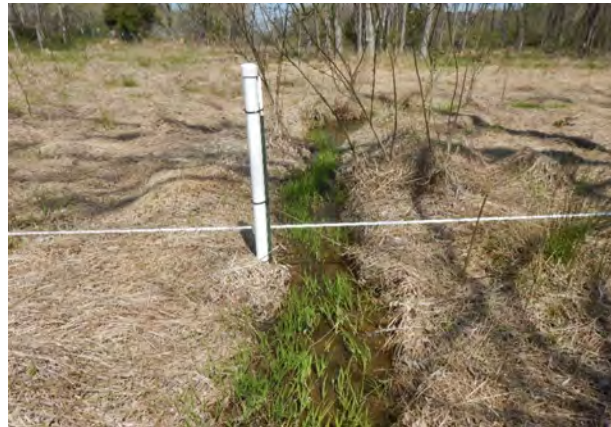
Cross Section 13, UT3B

2.7	x-section area (ft.sq.)
6.6	width (ft)
0.4	mean depth (ft)
0.8	max depth (ft)
6.9	wetted perimeter (ft)
0.4	hydraulic radius (ft)
16.5	width-depth ratio
60.0	W flood prone area (ft)
9.1	entrenchment ratio
0.9	low bank height ratio

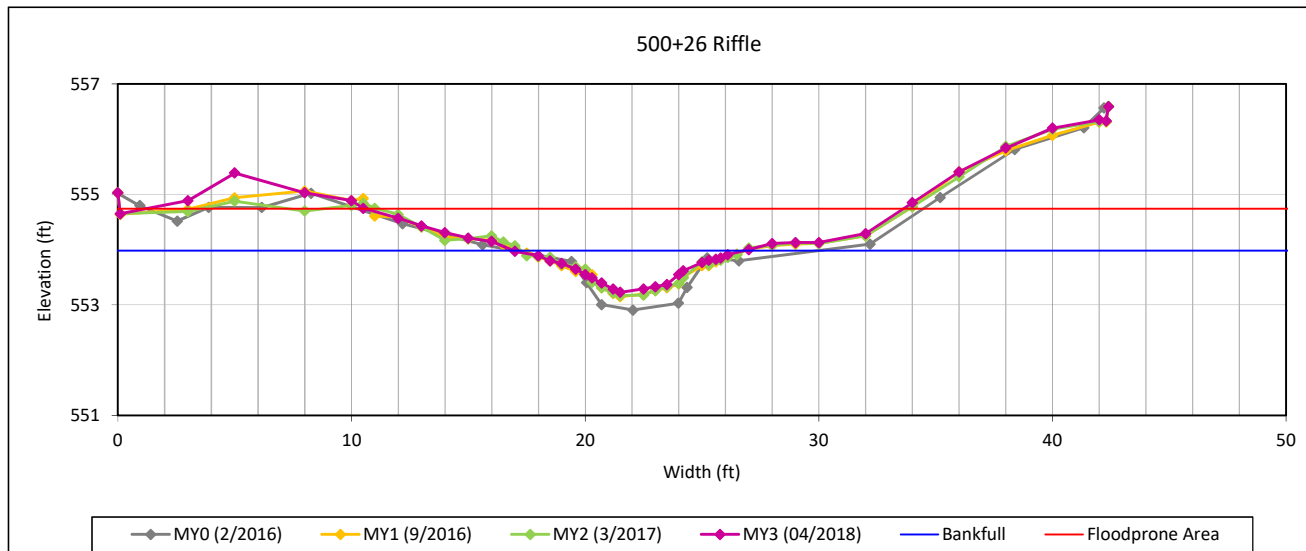
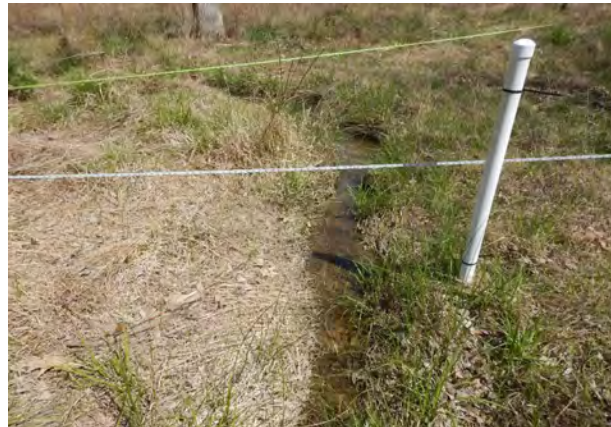
Cross Section 14, UT4B

3.6	x-section area (ft.sq.)
9.9	width (ft)
0.4	mean depth (ft)
0.8	max depth (ft)
10.1	wetted perimeter (ft)
0.4	hydraulic radius (ft)
27.4	width-depth ratio
25.0	W flood prone area (ft)
2.5	entrenchment ratio
0.7	low bank height ratio

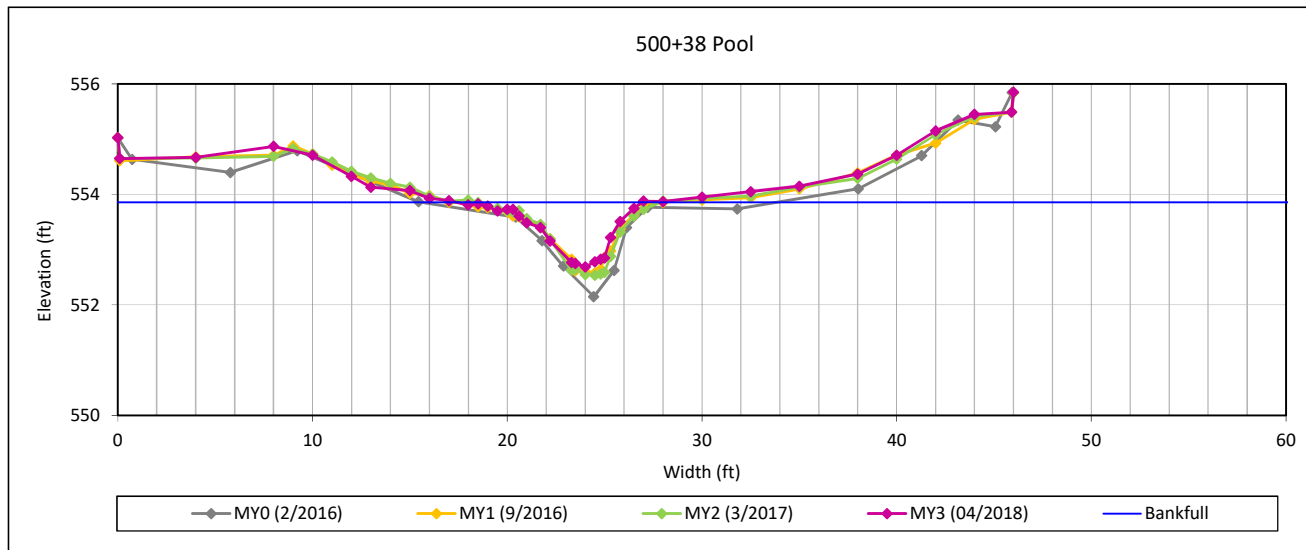
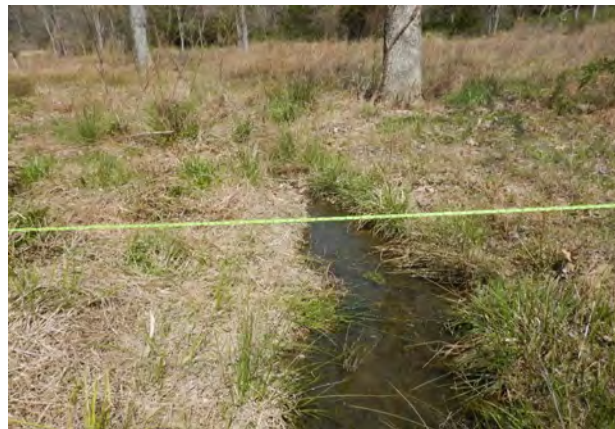
Cross Section 15, UT4B

4.3	x-section area (ft.sq.)
6.5	width (ft)
0.7	mean depth (ft)
1.2	max depth (ft)
7.0	wetted perimeter (ft)
0.6	hydraulic radius (ft)
9.8	width-depth ratio

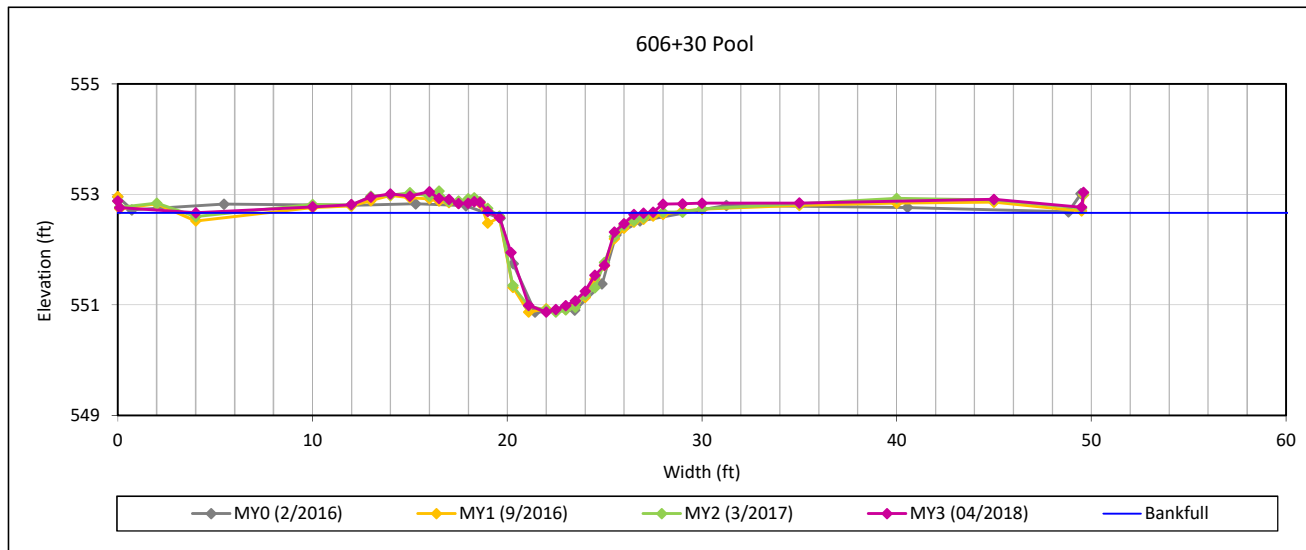
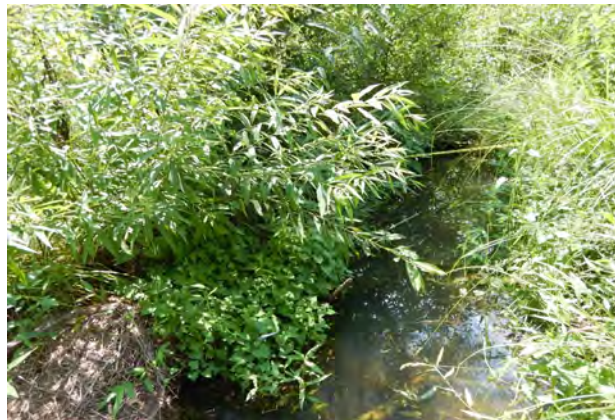
Cross Section 16, UT5

7.9	x-section area (ft.sq.)
8.1	width (ft)
1.0	mean depth (ft)
1.8	max depth (ft)
9.3	wetted perimeter (ft)
0.9	hydraulic radius (ft)
8.3	width-depth ratio

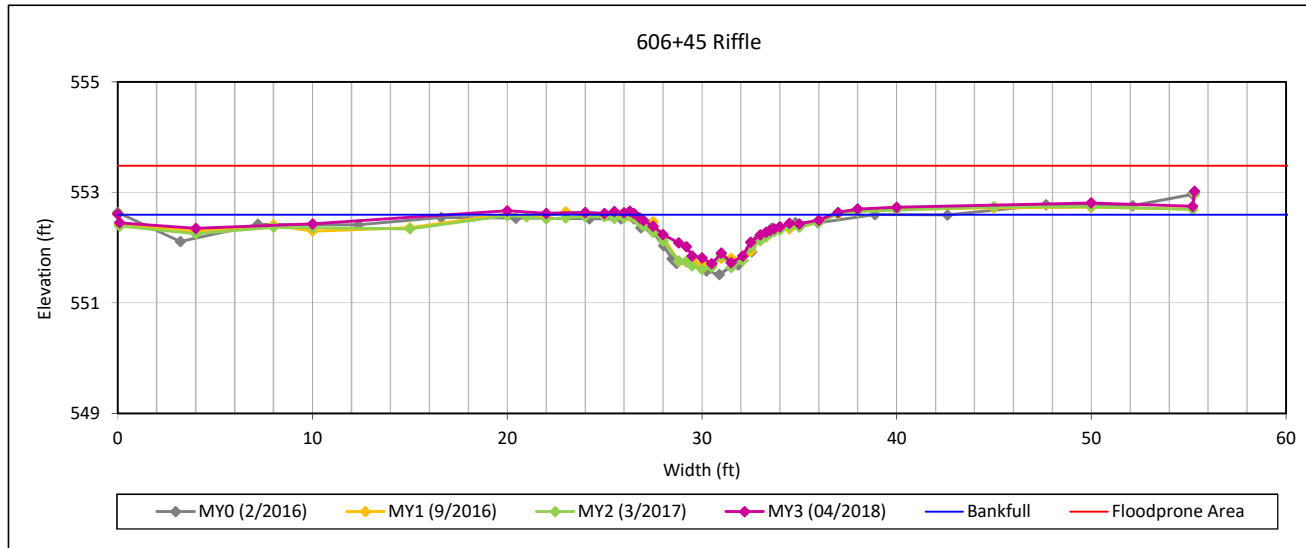
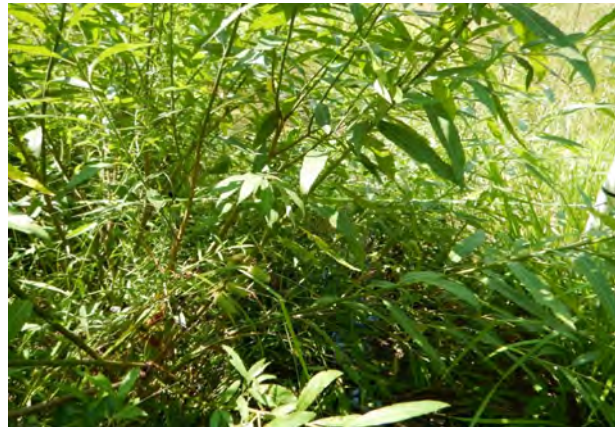
Cross Section 17, UT5

4.0	x-section area (ft.sq.)
8.4	width (ft)
0.5	mean depth (ft)
0.9	max depth (ft)
8.7	wetted perimeter (ft)
0.5	hydraulic radius (ft)
17.7	width-depth ratio
100.0	W flood prone area (ft)
11.9	entrenchment ratio
0.8	low bank height ratio
