# MONITORING YEAR 5 ANNUAL REPORT

## MANEY FARM MITIGATION PROJECT

Chatham County, NC

DMS ID No. 96314

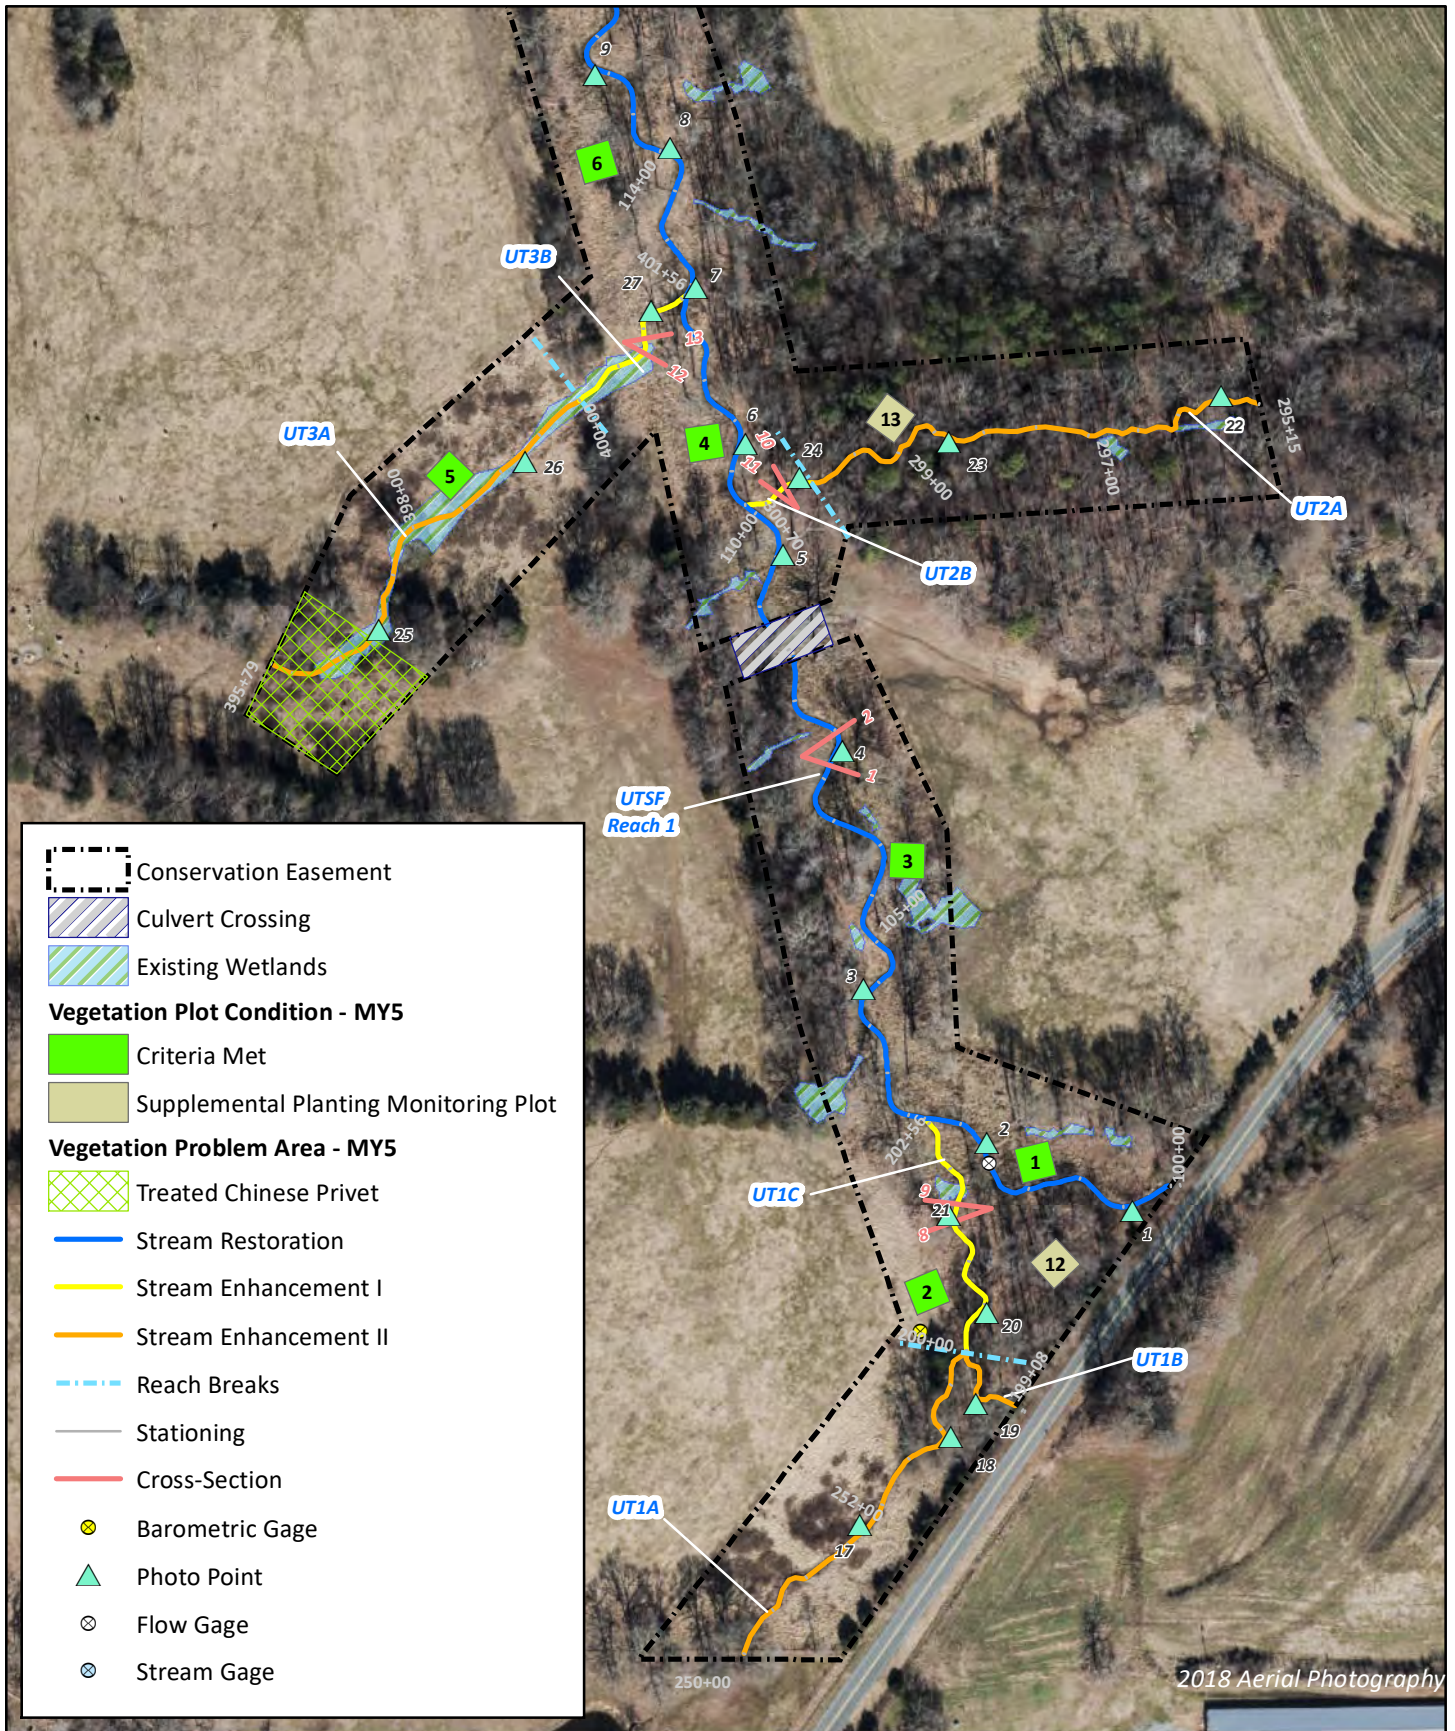
Figure 3.1 Integrated Current Condition Plan View  
 Maney Farm Mitigation Project  
 DMS Project No. 96314  
 Monitoring Year 5 - 2020

A 0.7 acre area of low vegetative growth was noted along UTSF Reach 2 (Figure 3.0). This area was replanted and soil amendments were added during MY5. Eighty, one gallon container trees were planted in February 2020 which included a mixture of willow oak (*Quercus phellos*), sycamore (*Platanus occidentalis*), and river birch (*Betula nigra*). Soil amendments including a mixture of dolomitic lime, fertilizer, humic acid, and a seed mix of herbaceous vegetation was applied to the low growth area in July 2020. Trees in the area look healthy with signs of new growth, and herbaceous vegetation has fully covered the ground.

Chinese privet (*Ligustrum sinense*) is located immediately adjacent to the project boundary; however, this farm is certified organic and prevents chemical treatments outside the easement boundary. As a result, scattered populations of Chinese privet have become established along the perimeter of the conservation easement. A 0.34 acre dense population of privet along UT3 (Figure 3.0) was treated in
