# MONITORING YEAR 7 ANNUAL REPORT

## MANEY FARM MITIGATION PROJECT

Chatham County, NC

DMS Project Number 96314

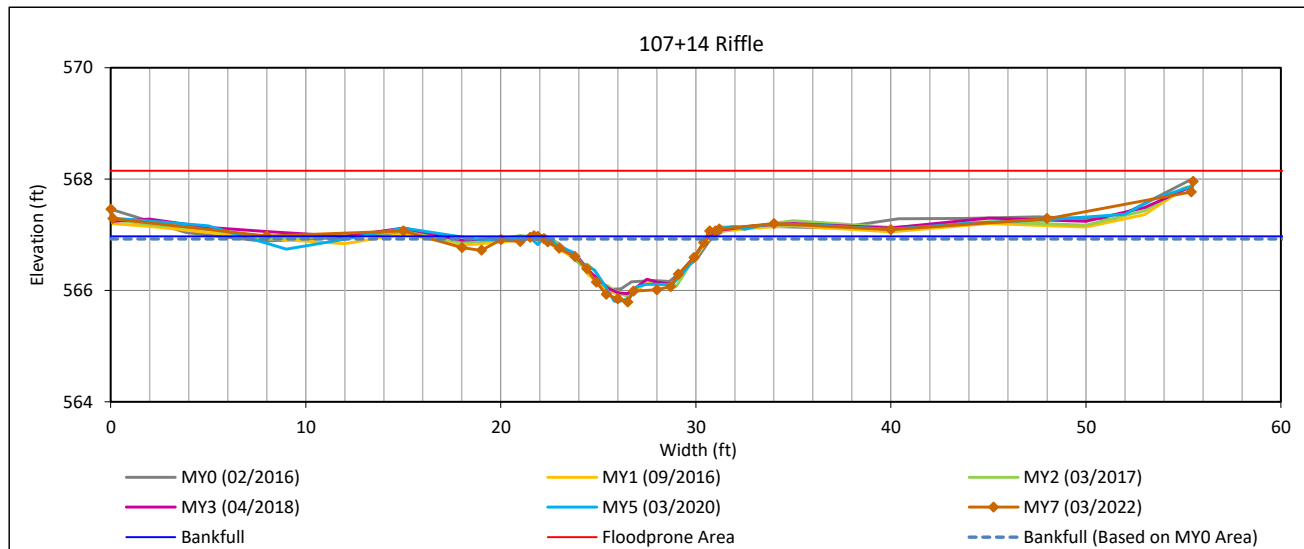
#### Cross-Section 1, UTSF Reach 1

5.7	x-section area (ft.sq.)
8.7	width (ft)
0.7	mean depth (ft)
1.2	max depth (ft)
9.1	wetted perimeter (ft)
0.6	hydraulic radius (ft)
13.2	width-depth ratio
85.0	W flood prone area (ft)
9.8	entrenchment ratio
1.0	low bank height ratio

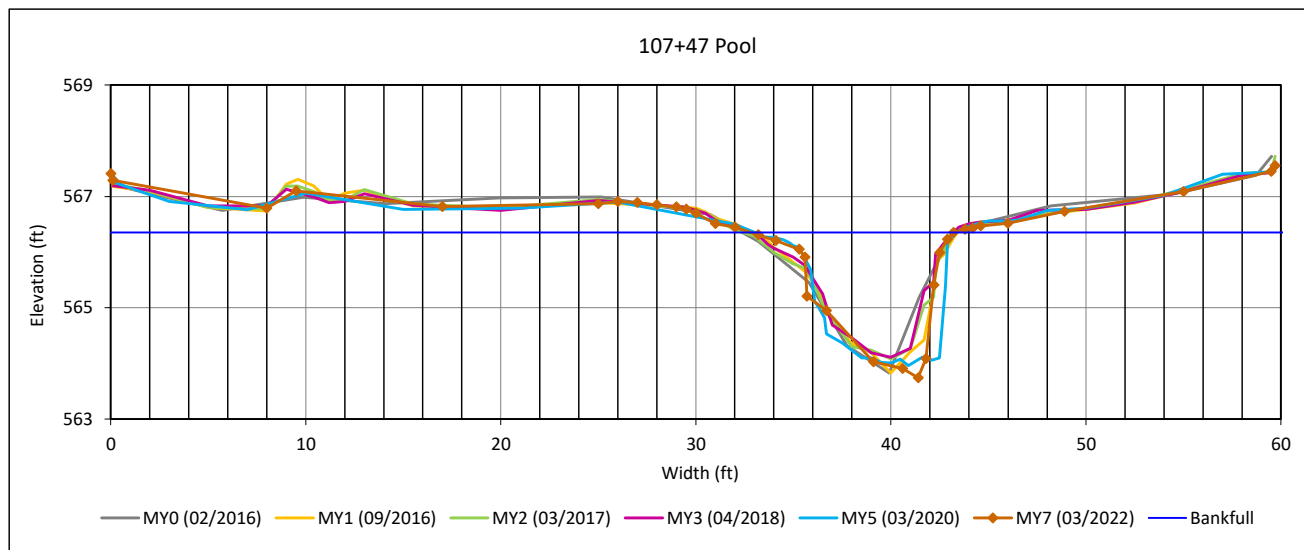
#### Cross-Section 2, UTSF Reach 1

13.8	x-section area (ft.sq.)
10.3	width (ft)
1.3	mean depth (ft)
2.6	max depth (ft)
12.8	wetted perimeter (ft)
1.1	hydraulic radius (ft)
7.8	width-depth ratio

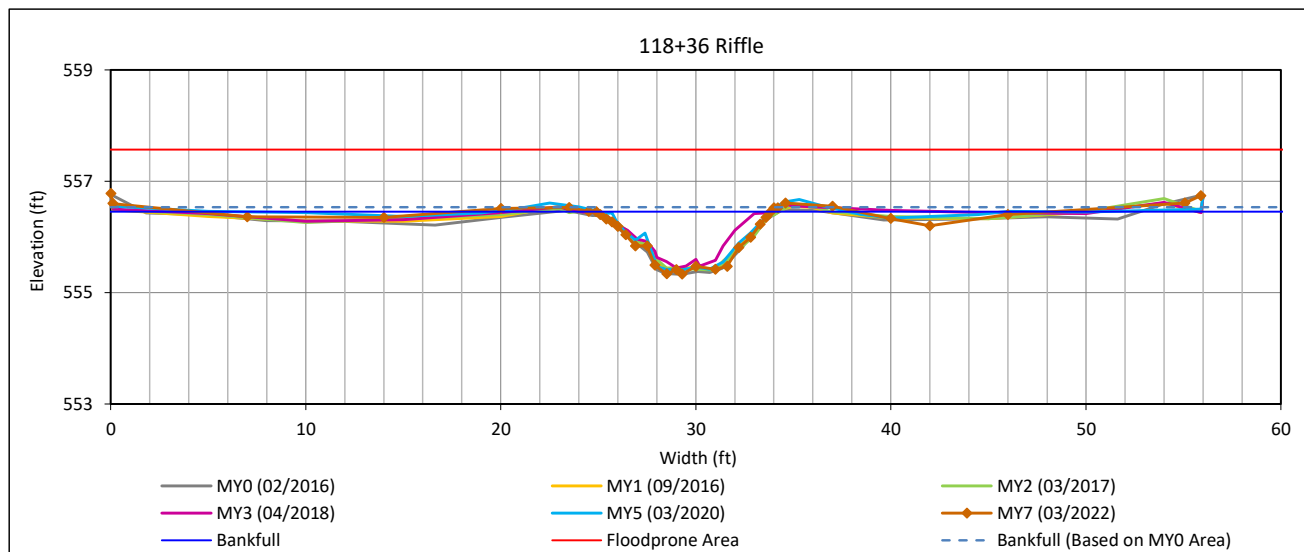
### Cross-Section 3, UTSF Reach 1

6.1	x-section area (ft.sq.)
8.9	width (ft)
0.7	mean depth (ft)
1.1	max depth (ft)
9.4	wetted perimeter (ft)
0.6	hydraulic radius (ft)
13.0	width-depth ratio
85.0	W flood prone area (ft)
9.6	entrenchment ratio
1.0	low bank height ratio

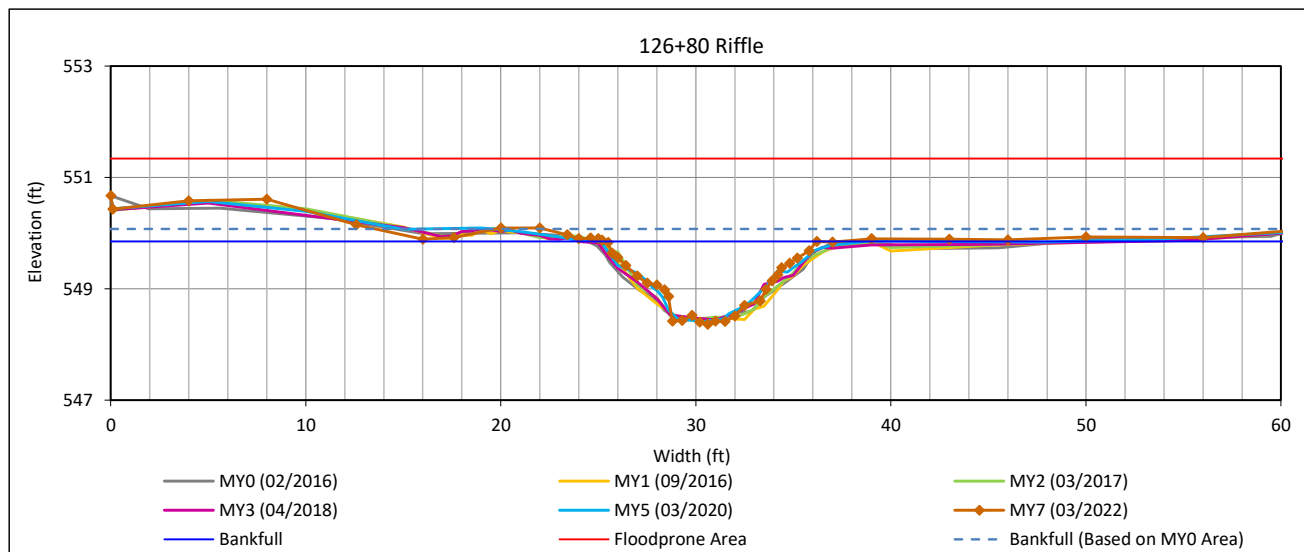
### Cross-Section 5, UTSF Reach 2

9.4	x-section area (ft.sq.)
10.9	width (ft)
0.9	mean depth (ft)
1.5	max depth (ft)
11.6	wetted perimeter (ft)
0.8	hydraulic radius (ft)
12.5	width-depth ratio
150.0	W flood prone area (ft)
13.8	entrenchment ratio
< 1.0	low bank height ratio

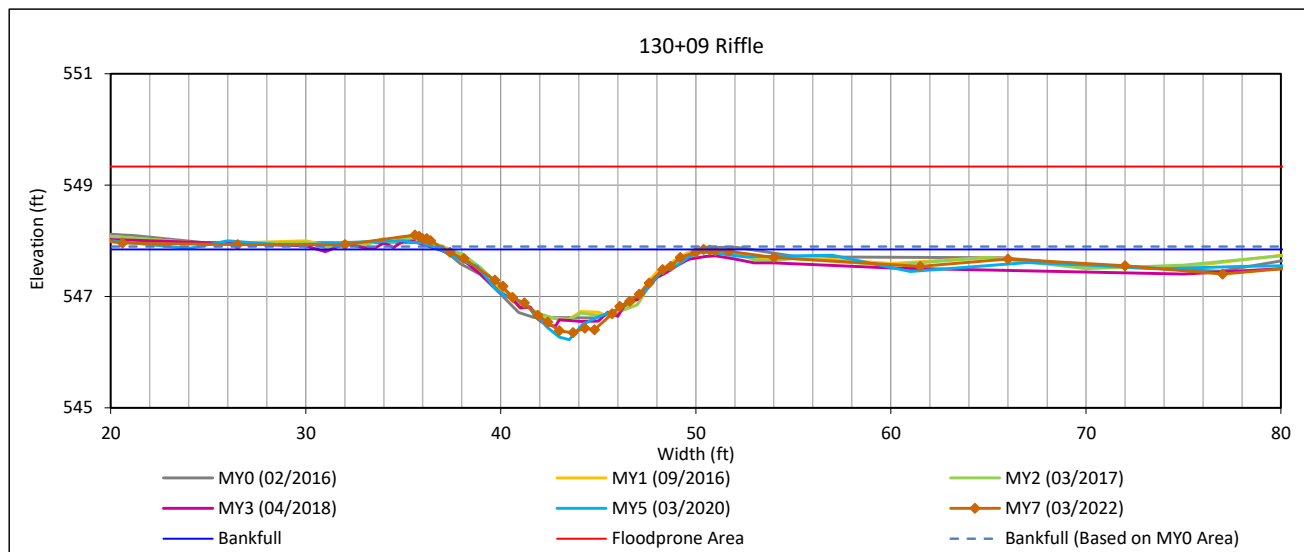
### Cross-Section 6, UTSF Reach 2

10.2	x-section area (ft.sq.)
13.2	width (ft)
0.8	mean depth (ft)
1.5	max depth (ft)
13.6	wetted perimeter (ft)
0.7	hydraulic radius (ft)
17.2	width-depth ratio
150.0	W flood prone area (ft)
11.3	entrenchment ratio
1.0	low bank height ratio

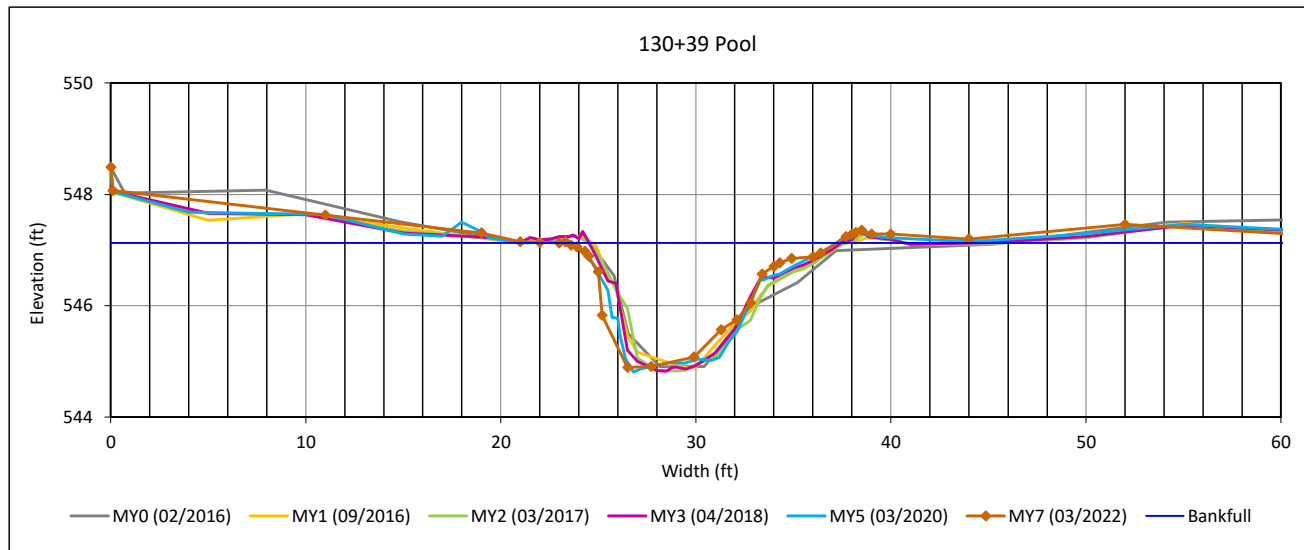
### Cross-Section 7, UTSF Reach 2

16.3	x-section area (ft.sq.)
13.8	width (ft)
1.2	mean depth (ft)
2.2	max depth (ft)
15.2	wetted perimeter (ft)
1.1	hydraulic radius (ft)
11.7	width-depth ratio

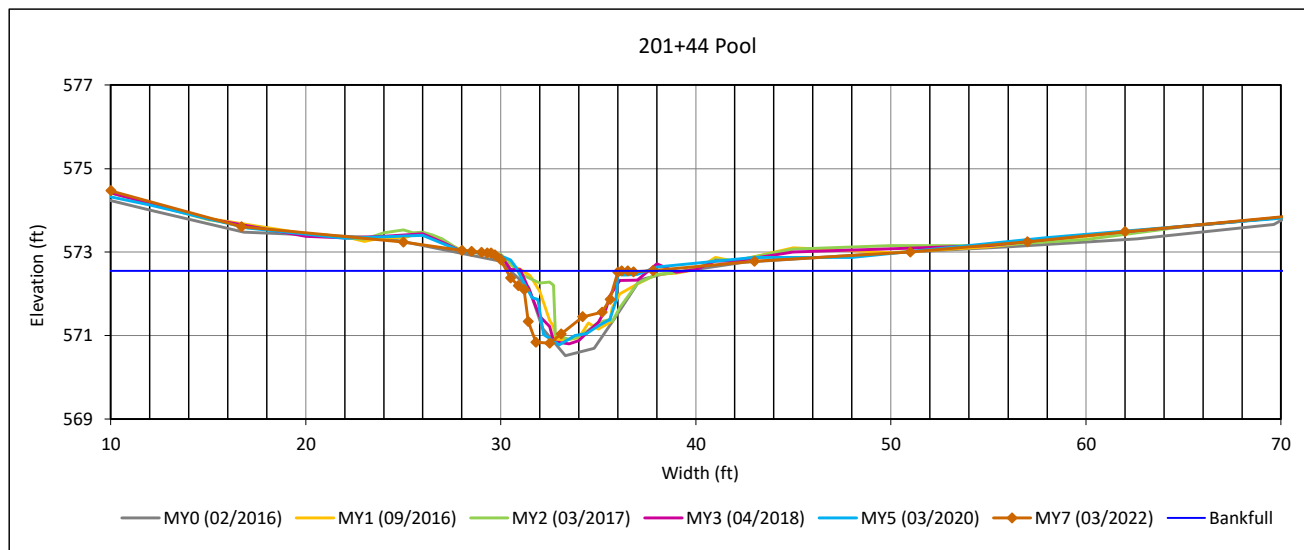
#### Cross-Section 8, UT1C

6.1	x-section area (ft.sq.)
5.9	width (ft)
1.0	mean depth (ft)
1.7	max depth (ft)
7.4	wetted perimeter (ft)
0.8	hydraulic radius (ft)
5.7	width-depth ratio

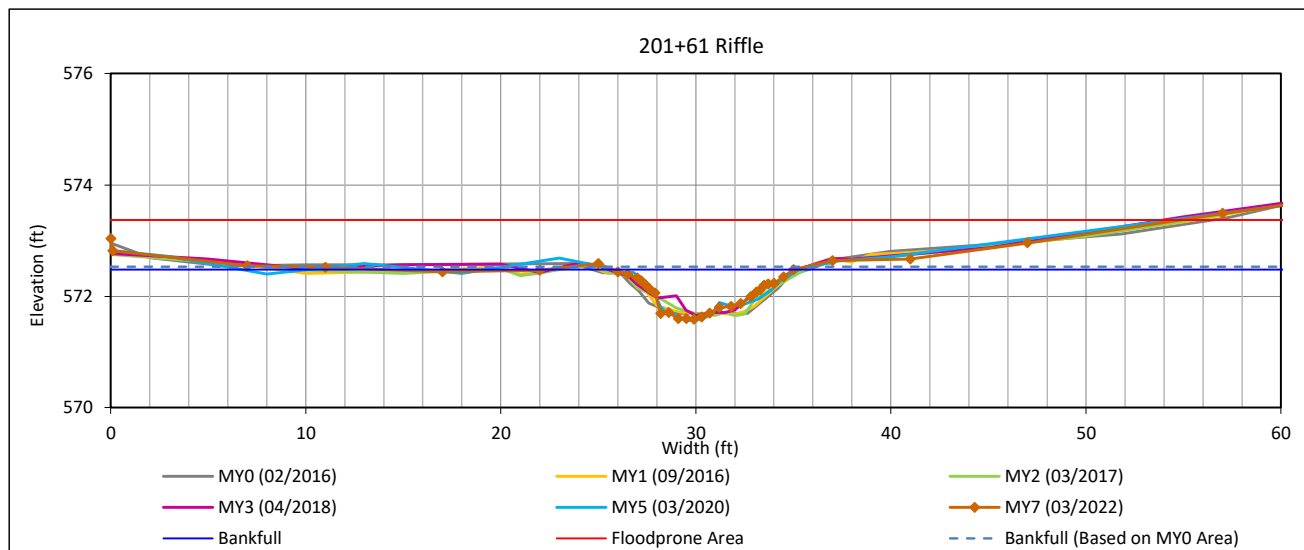
### Cross-Section 9, UT1C

4.5	x-section area (ft.sq.)
9.3	width (ft)
0.5	mean depth (ft)
0.9	max depth (ft)
9.6	wetted perimeter (ft)
0.5	hydraulic radius (ft)
19.0	width-depth ratio
60.0	W flood prone area (ft)
6.5	entrenchment ratio
<1.0	low bank height ratio

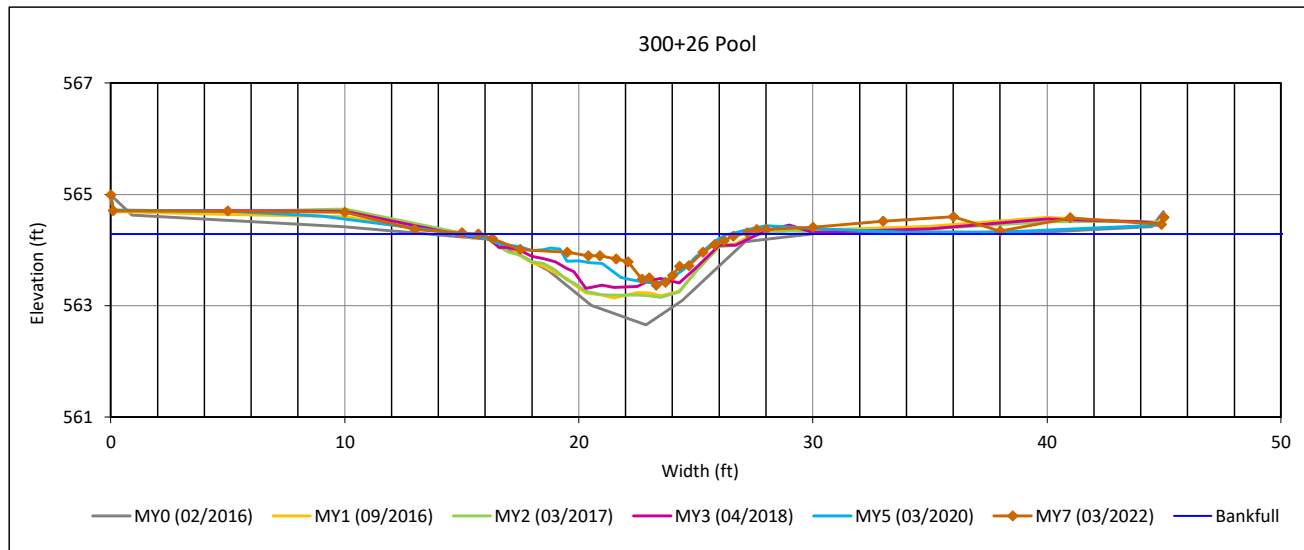
### Cross-Section 10, UT2B

4.3	x-section area (ft.sq.)
11.3	width (ft)
0.4	mean depth (ft)
0.9	max depth (ft)
11.6	wetted perimeter (ft)
0.4	hydraulic radius (ft)
29.5	width-depth ratio

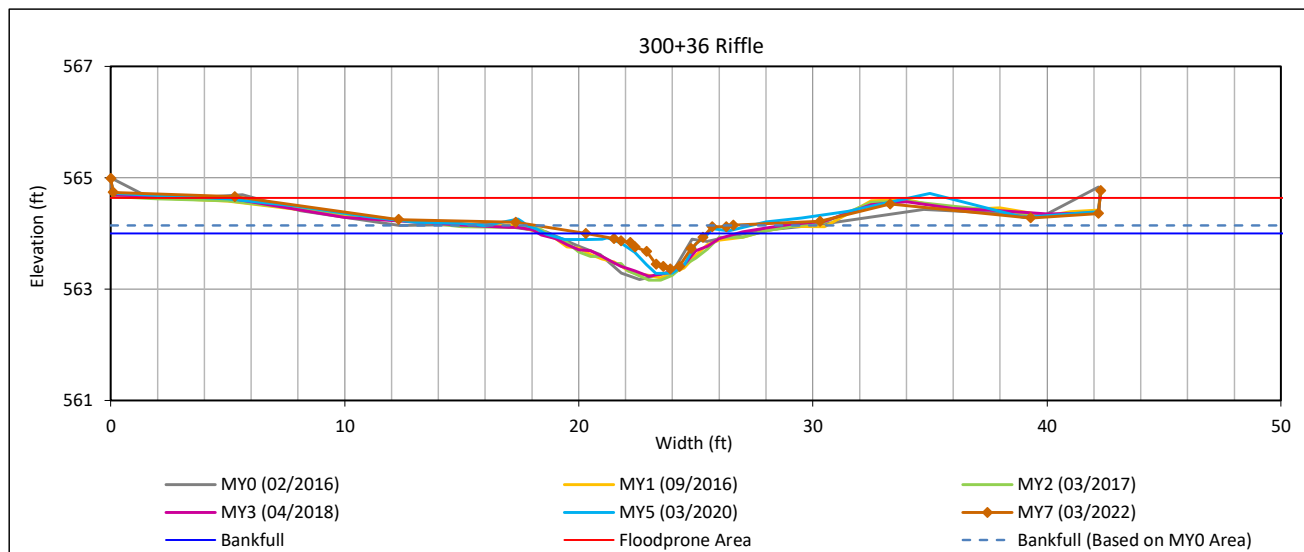
### Cross-Section 11, UT2B

1.4	x-section area (ft.sq.)
5.1	width (ft)
0.3	mean depth (ft)
0.6	max depth (ft)
5.4	wetted perimeter (ft)
0.3	hydraulic radius (ft)
18.8	width-depth ratio
60.0	W flood prone area (ft)
11.7	entrenchment ratio
<1.0	low bank height ratio

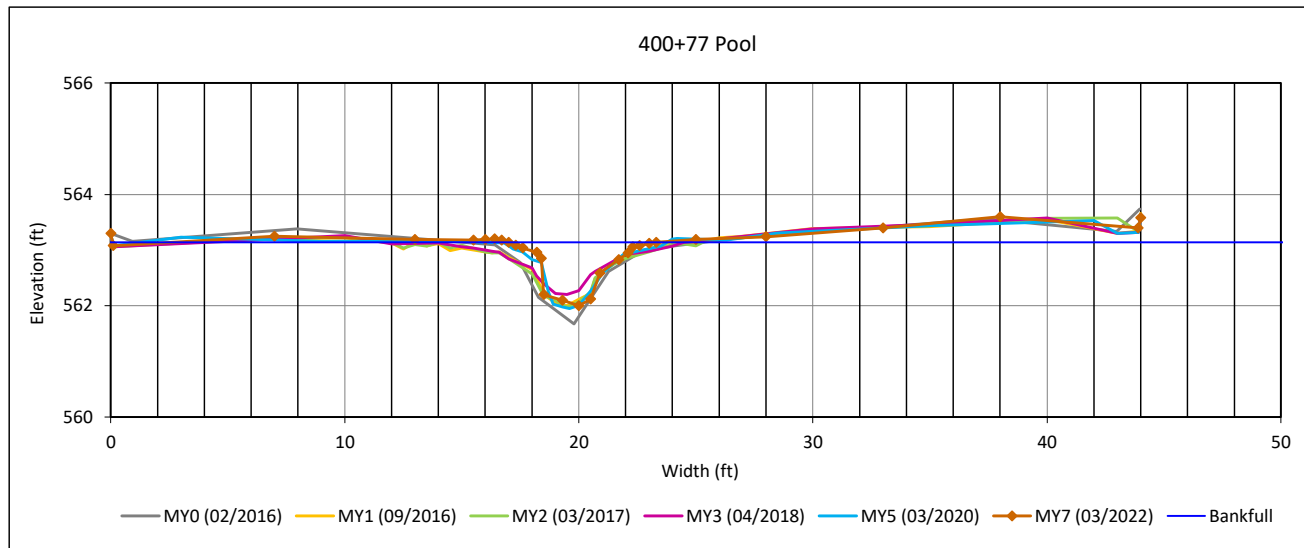
### Cross-Section 12, UT3B

3.1	x-section area (ft.sq.)
6.3	width (ft)
0.5	mean depth (ft)
1.1	max depth (ft)
7.2	wetted perimeter (ft)
0.4	hydraulic radius (ft)
12.6	width-depth ratio

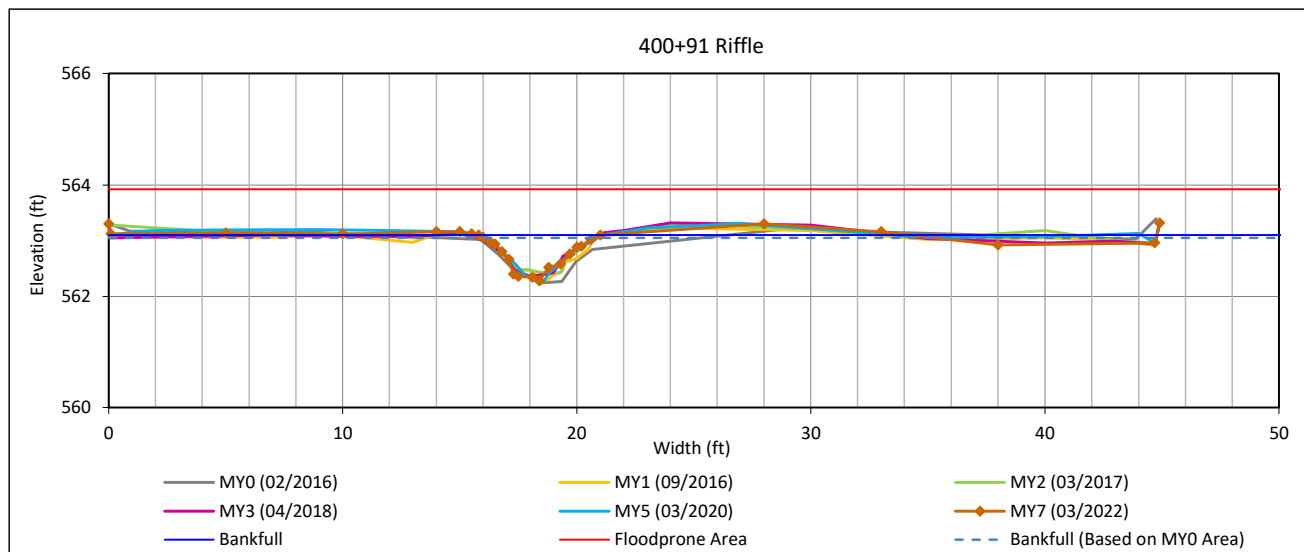
### Cross-Section 13, UT3B

2.1	x-section area (ft.sq.)
5.2	width (ft)
0.4	mean depth (ft)
0.8	max depth (ft)
5.6	wetted perimeter (ft)
0.4	hydraulic radius (ft)
12.8	width-depth ratio
60.0	W flood prone area (ft)
11.5	entrenchment ratio
1.1	low bank height ratio

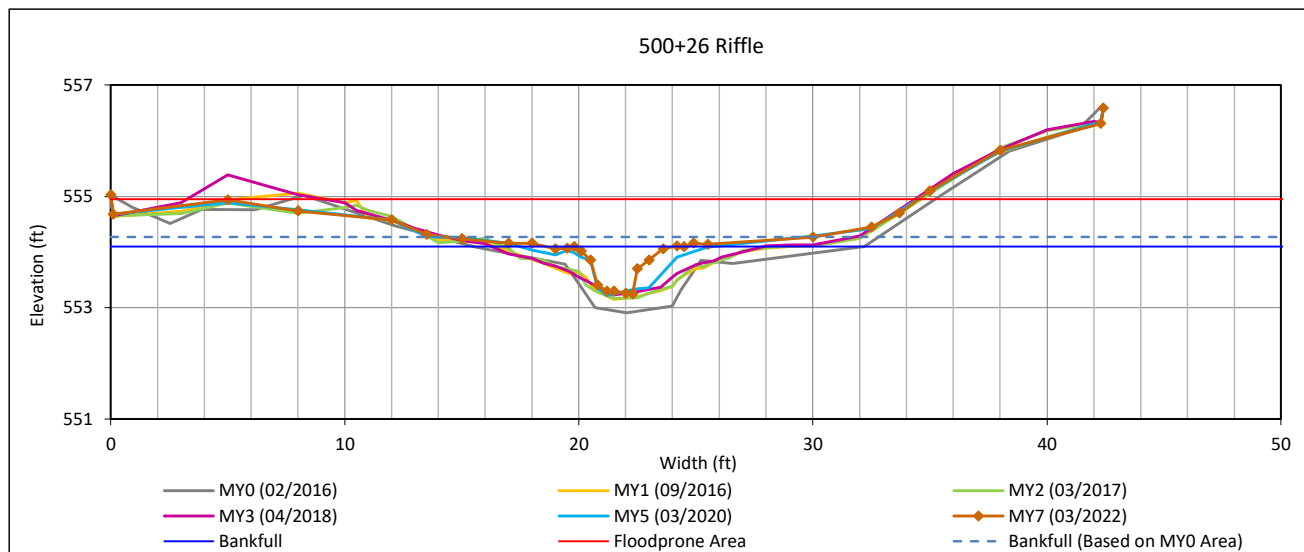
### Cross-Section 14, UT4B

1.8	x-section area (ft.sq.)
4.3	width (ft)
0.4	mean depth (ft)
0.9	max depth (ft)
4.9	wetted perimeter (ft)
0.4	hydraulic radius (ft)
10.2	width-depth ratio
25.0	W flood prone area (ft)
5.8	entrenchment ratio
< 1.0	low bank height ratio

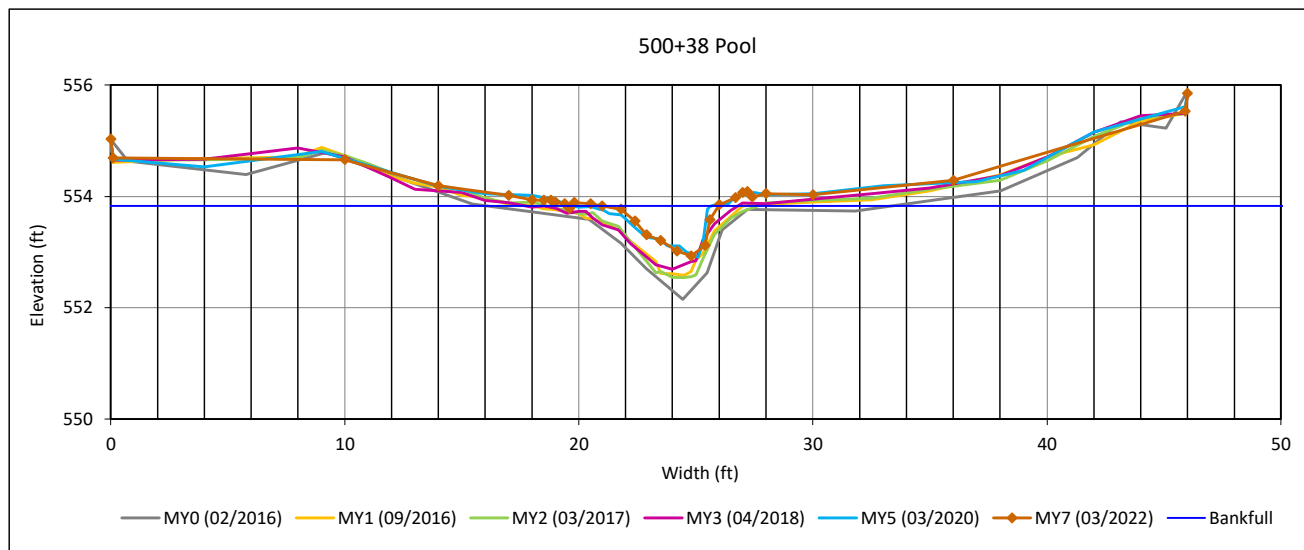
### Cross-Section 15, UT4B

2.3	x-section area (ft.sq.)
5.0	width (ft)
0.5	mean depth (ft)
0.9	max depth (ft)
5.5	wetted perimeter (ft)
0.4	hydraulic radius (ft)
10.7	width-depth ratio

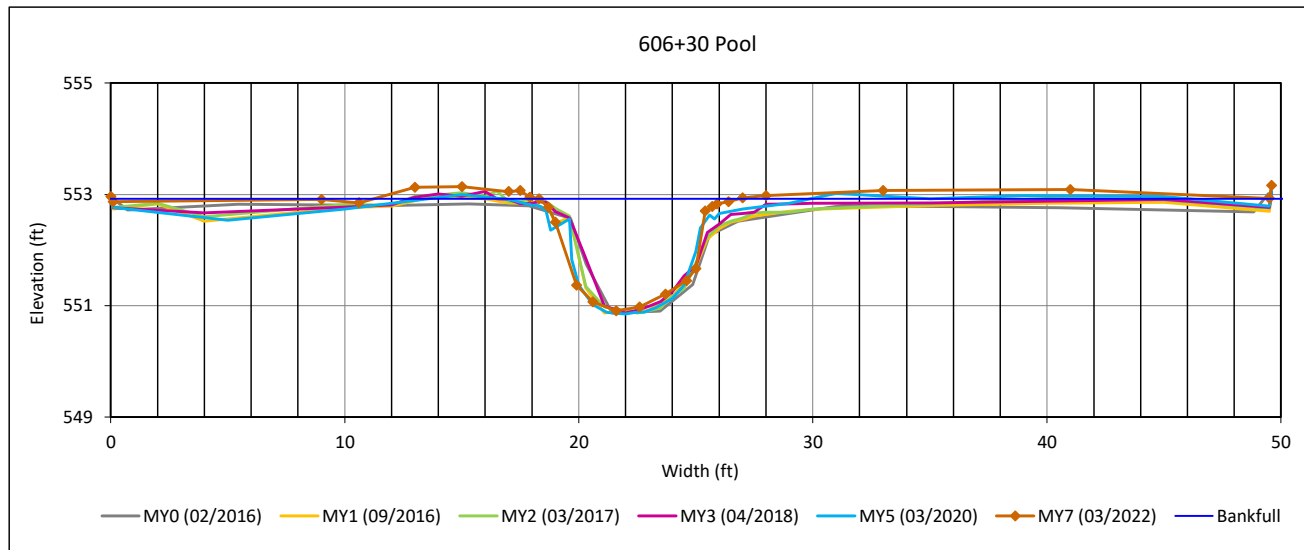
### Cross-Section 16, UT5

10.5	x-section area (ft.sq.)
8.1	width (ft)
1.3	mean depth (ft)
2.0	max depth (ft)
9.7	wetted perimeter (ft)
1.1	hydraulic radius (ft)
6.3	width-depth ratio

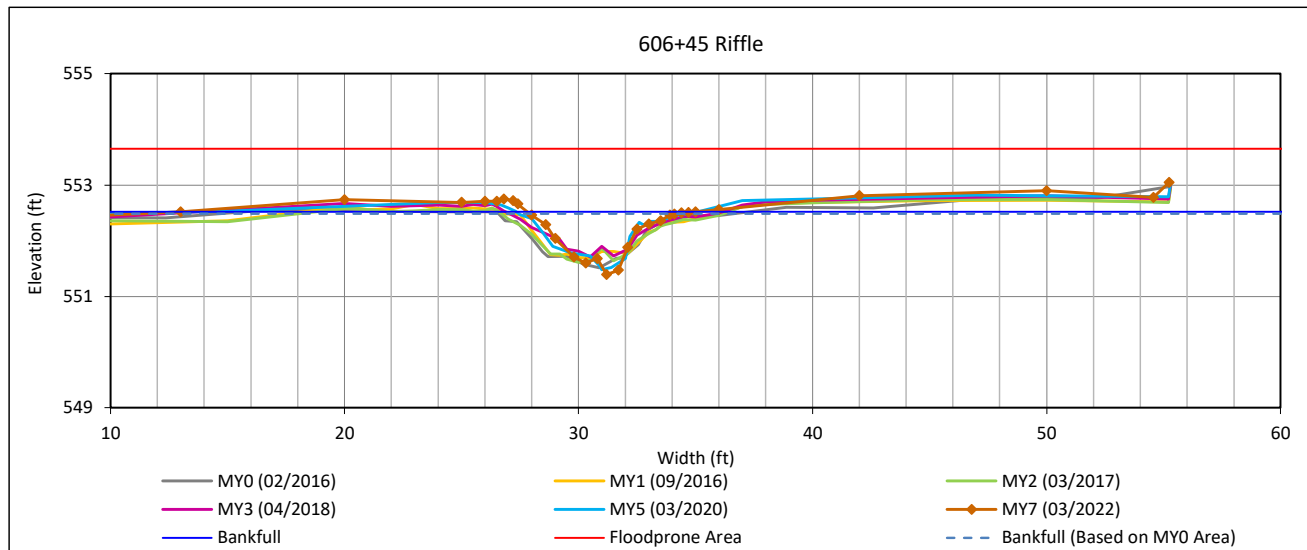
### Cross-Section 17, UT5

3.4	x-section area (ft.sq.)
7.0	width (ft)
0.5	mean depth (ft)
1.1	max depth (ft)
7.6	wetted perimeter (ft)
0.4	hydraulic radius (ft)
14.5	width-depth ratio
100.0	W flood prone area (ft)
14.3	entrenchment ratio
1.0	low bank height ratio
