**BASELINE MONITORING
DOCUMENT AND AS-BUILT
BASELINE REPORT
FINAL**

MARTIN DAIRY MITIGATION SITE

Orange County, NC

DMS Project Number 97087

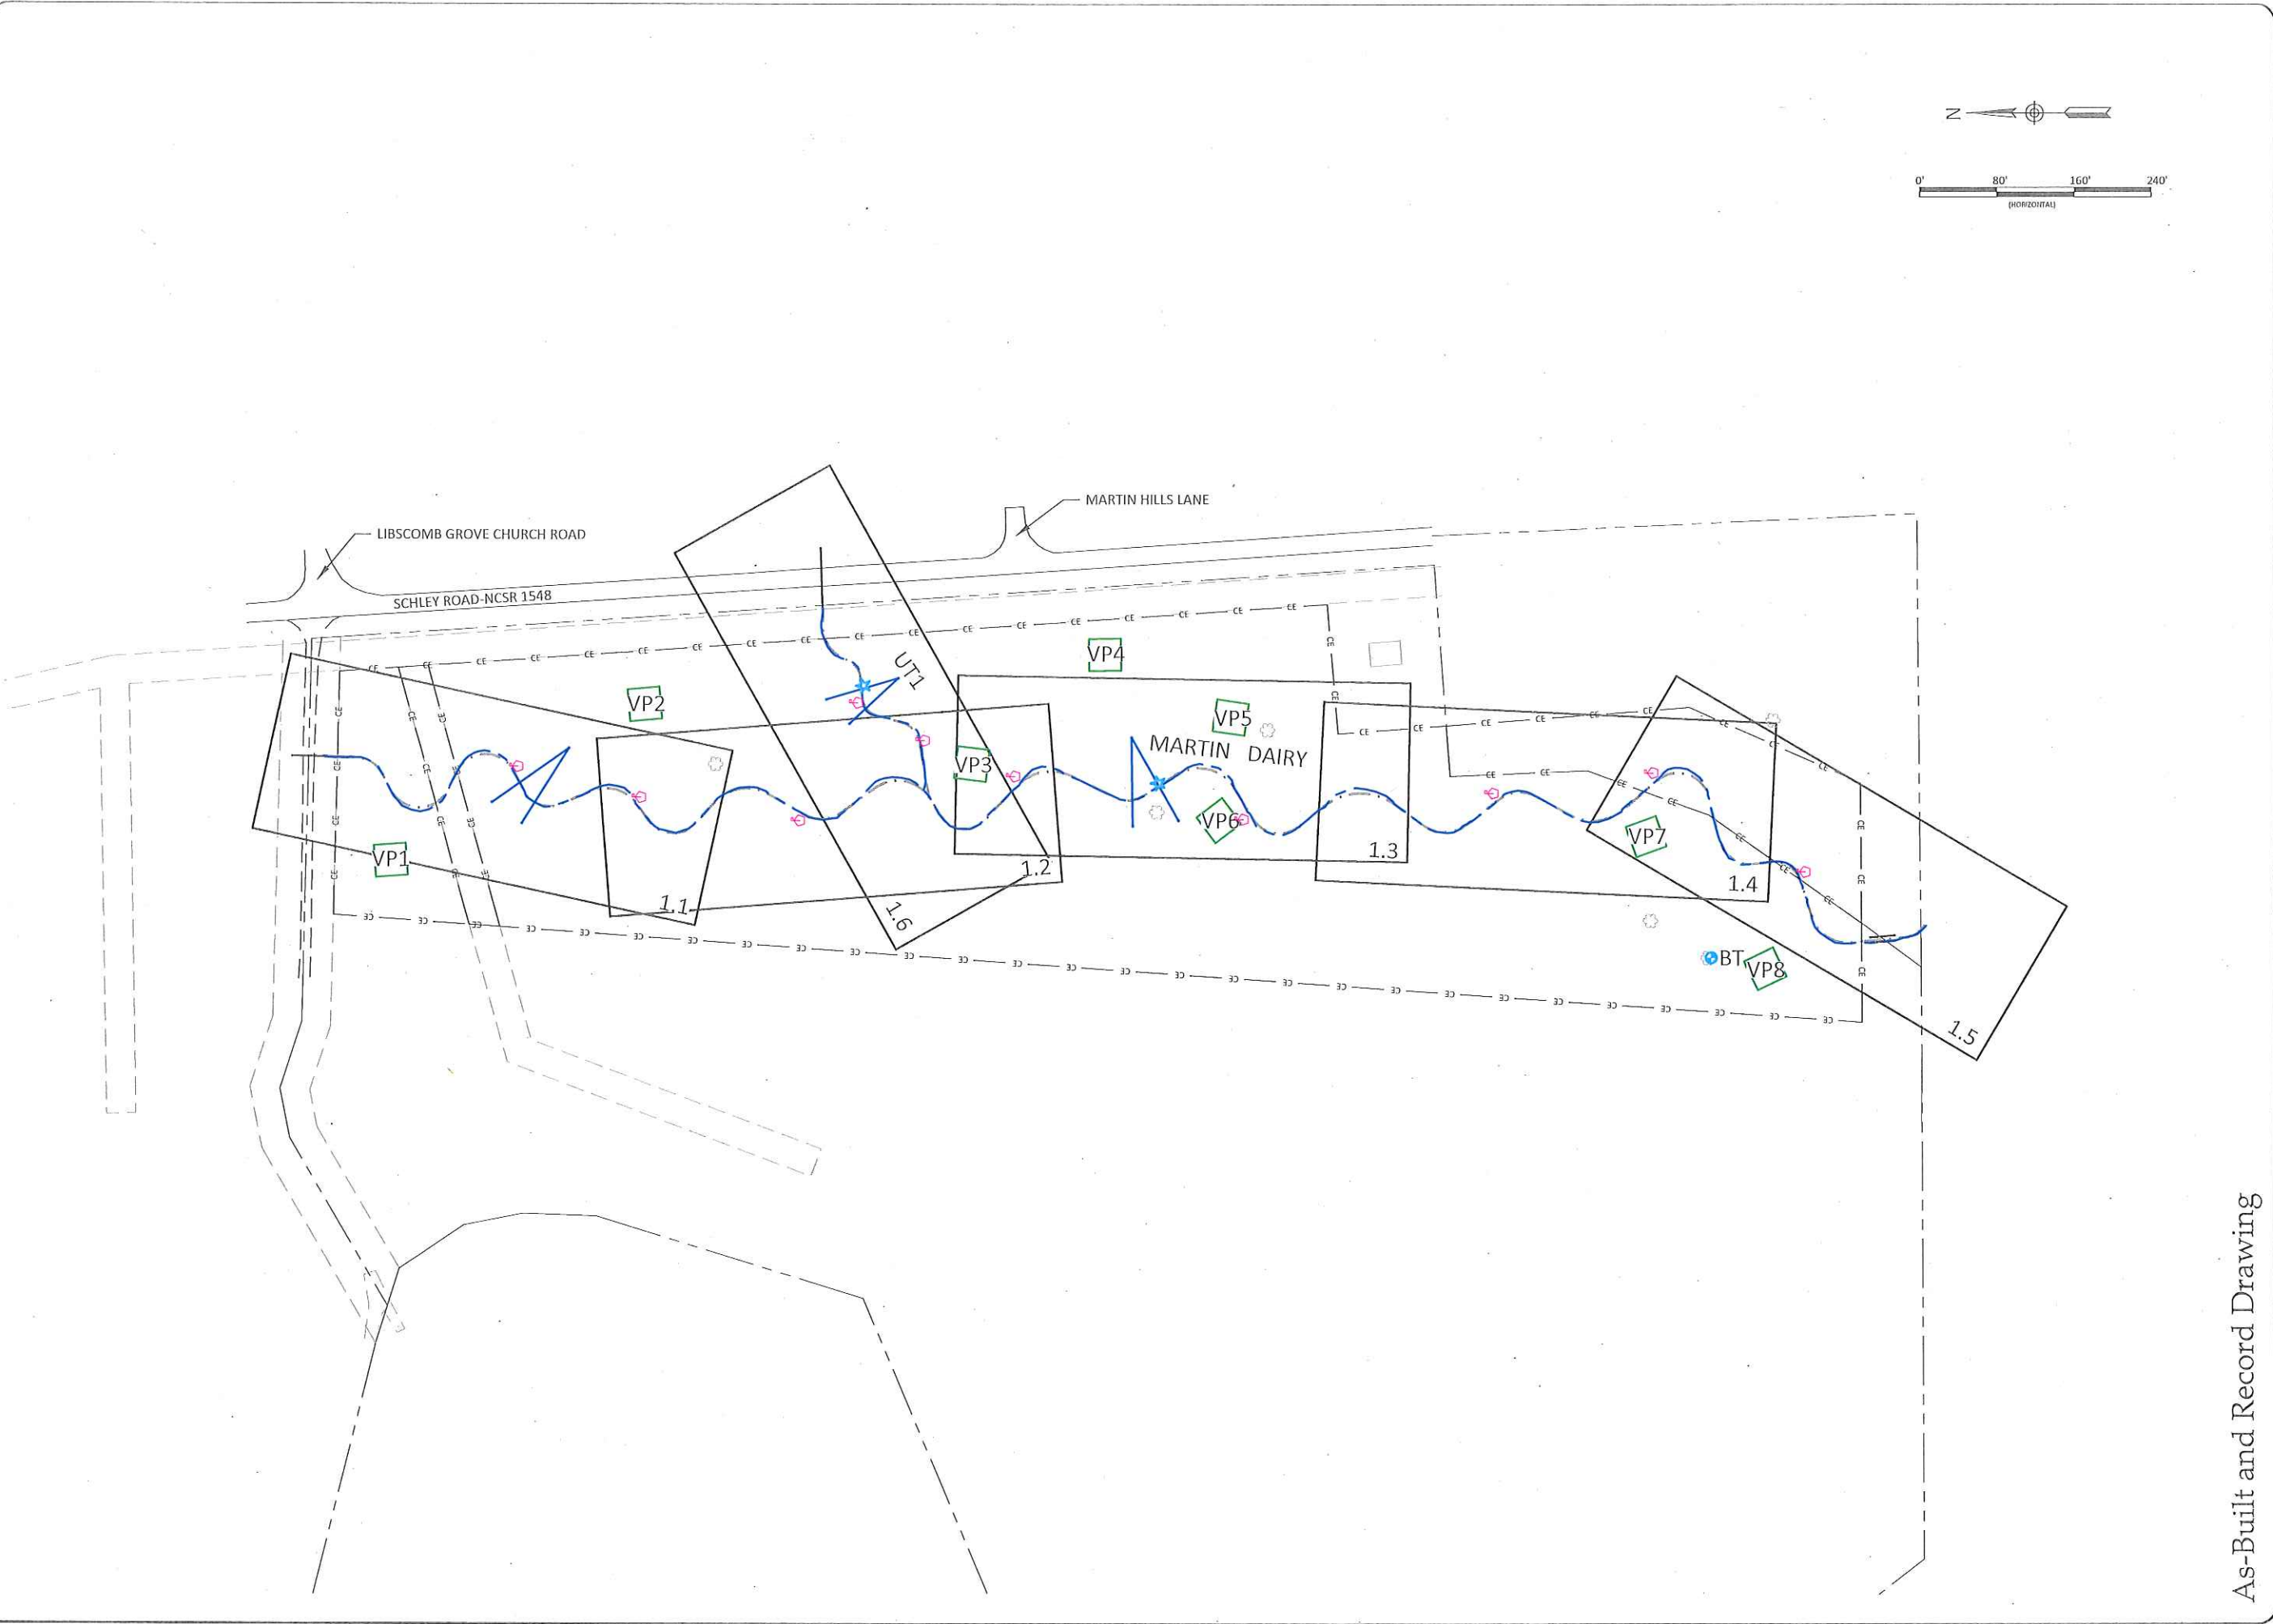
NOTE: AT MARTIN DAIRY STA. 100+34, BOULDER SILL WAS REPLACED WITH LOG SILL DUE TO FIELD CONDITIONS AND AVAILABILITY OF ONSITE MATERIAL.

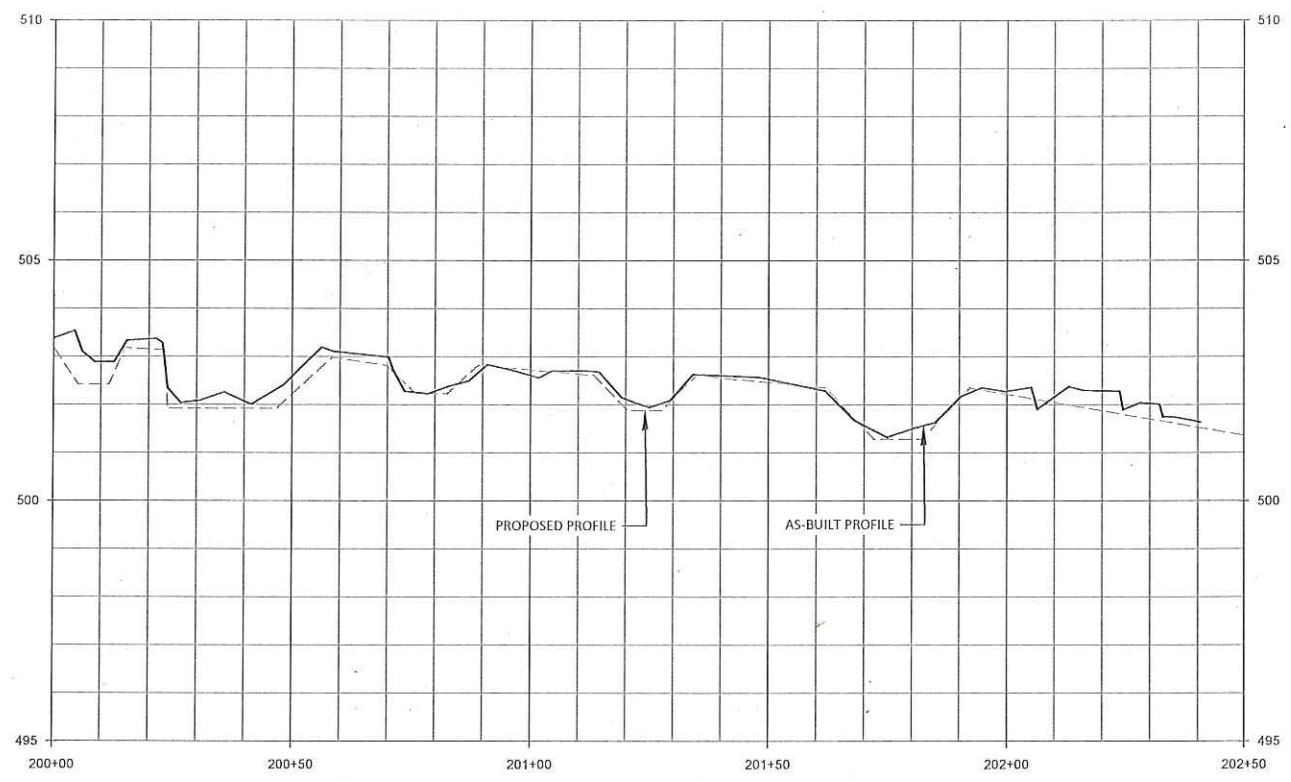
NOTE: AT UT1 STA. 200+23, BOULDER SILL WAS REPLACED WITH LOG SILL DUE TO FIELD CONDITIONS AND AVAILABILITY OF ONSITE MATERIAL.
