MONITORING YEAR 2 ANNUAL REPORT

MARTIN DAIRY MITIGATION SITE

Orange County, NC

DMS Project Number 97087

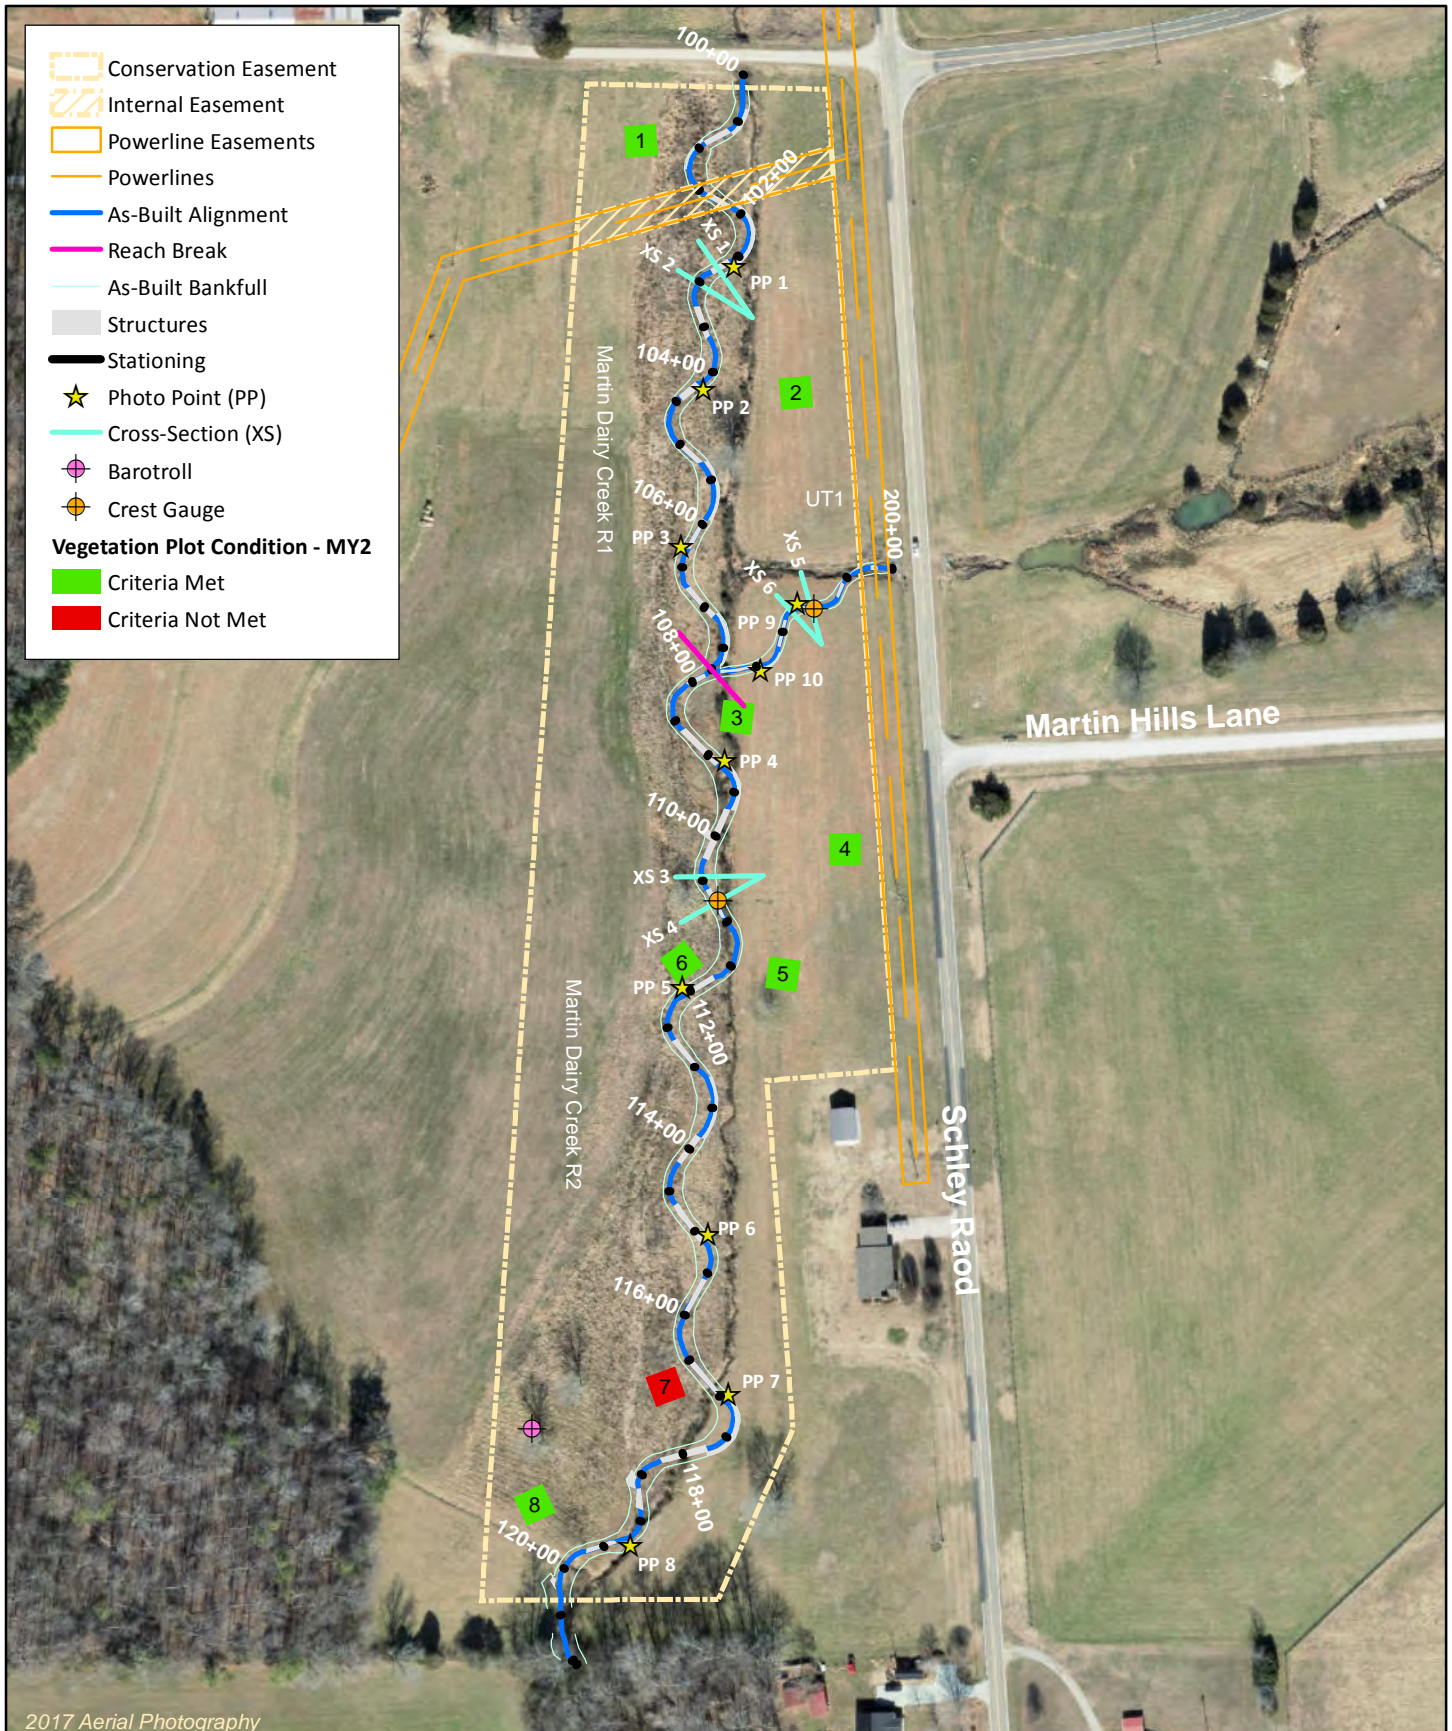
Table 5a. Visual Stream Morphology Stability Assessment Table

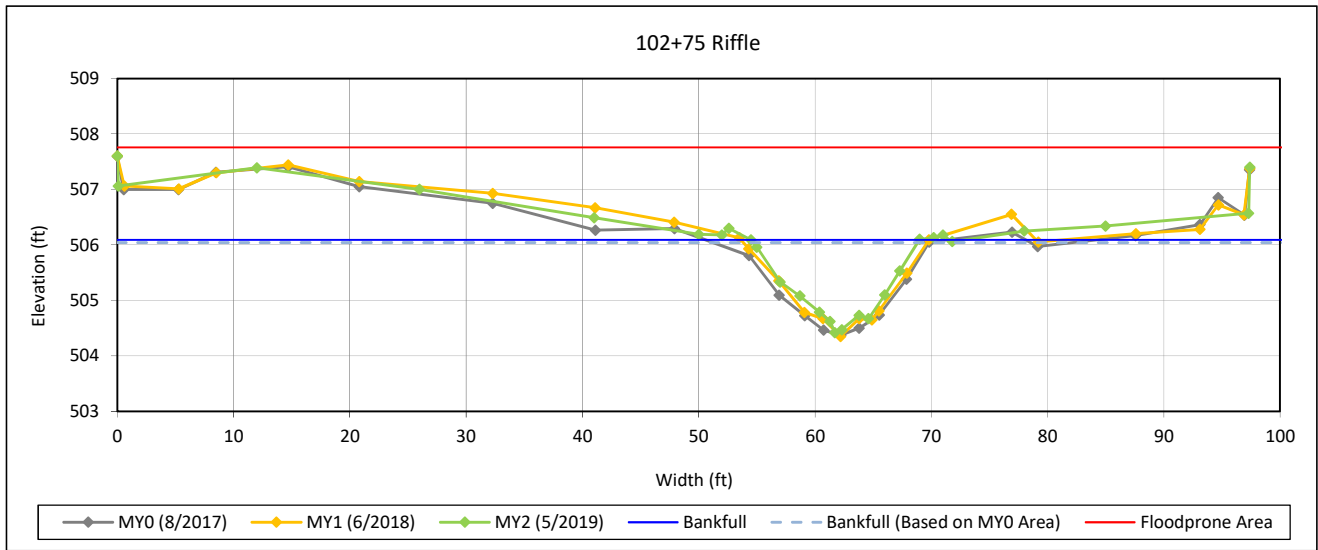
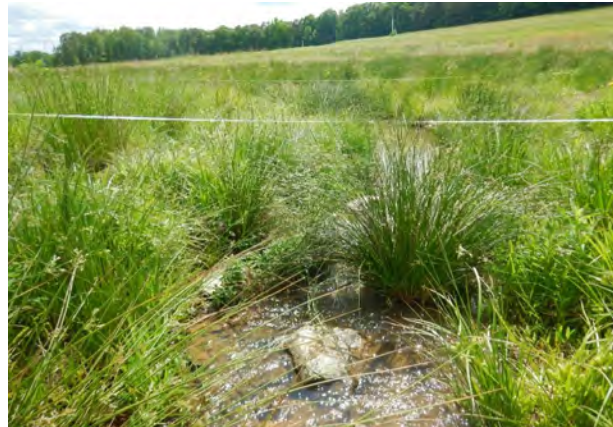
Cross-Section 1 Martin Dairy Reach 1

13.8	x-section area (ft.sq.)
14.5	width (ft)
1.0	mean depth (ft)
1.7	max depth (ft)
14.9	wetted perimeter (ft)
0.9	hydraulic radius (ft)
15.2	width-depth ratio
150.0	W flood prone area (ft)
10.4	entrenchment ratio
1.0	low bank height ratio

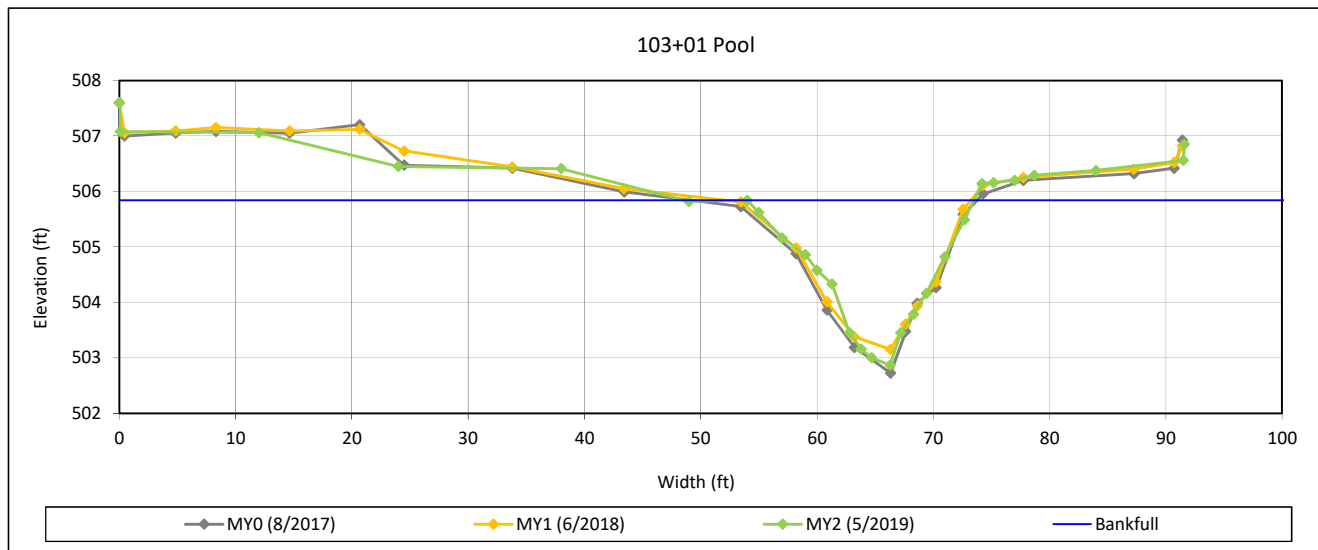
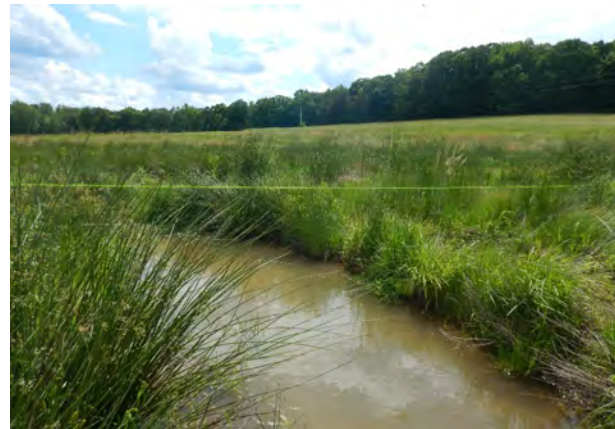
Cross-Section 2 Martin Dairy Reach 1

28.6	x-section area (ft.sq.)
19.5	width (ft)
1.5	mean depth (ft)
3.0	max depth (ft)
20.6	wetted perimeter (ft)
1.4	hydraulic radius (ft)
13.3	width-depth ratio

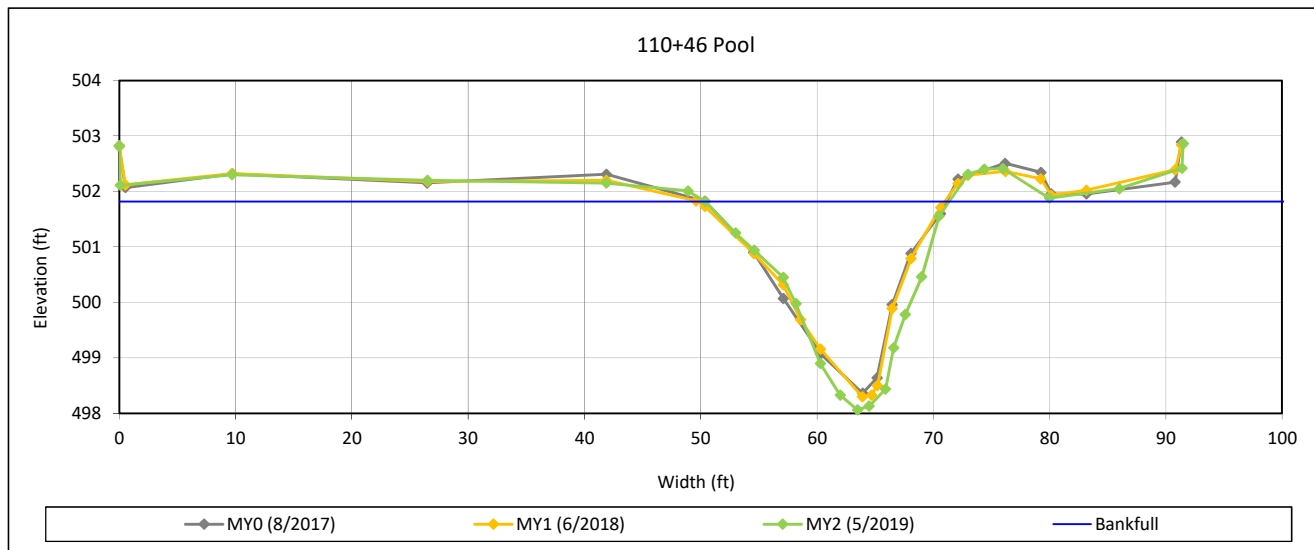
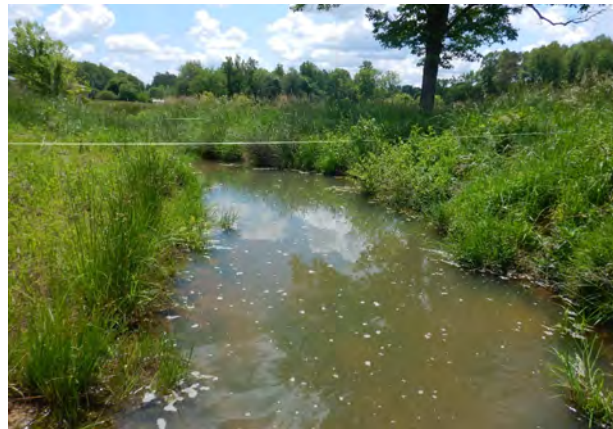
Cross-Section 3 Martin Dairy Reach 2

39.2	x-section area (ft.sq.)
21.0	width (ft)
1.9	mean depth (ft)
3.8	max depth (ft)
22.7	wetted perimeter (ft)
1.7	hydraulic radius (ft)
11.2	width-depth ratio

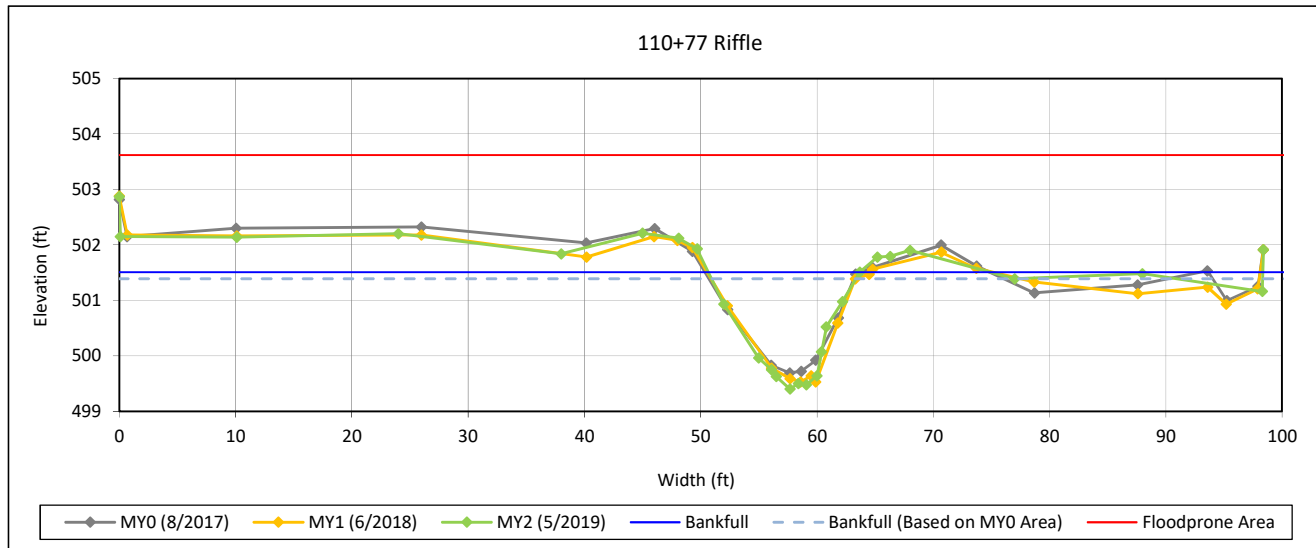
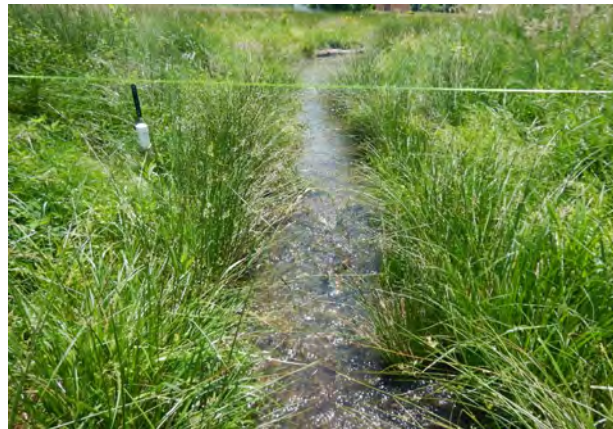
Cross-Section 4 Martin Dairy Reach 2

15.7	x-section area (ft.sq.)
13.0	width (ft)
1.2	mean depth (ft)
2.1	max depth (ft)
13.9	wetted perimeter (ft)
1.1	hydraulic radius (ft)
10.8	width-depth ratio
200.0	W flood prone area (ft)
15.3	entrenchment ratio
1.1	low bank height ratio

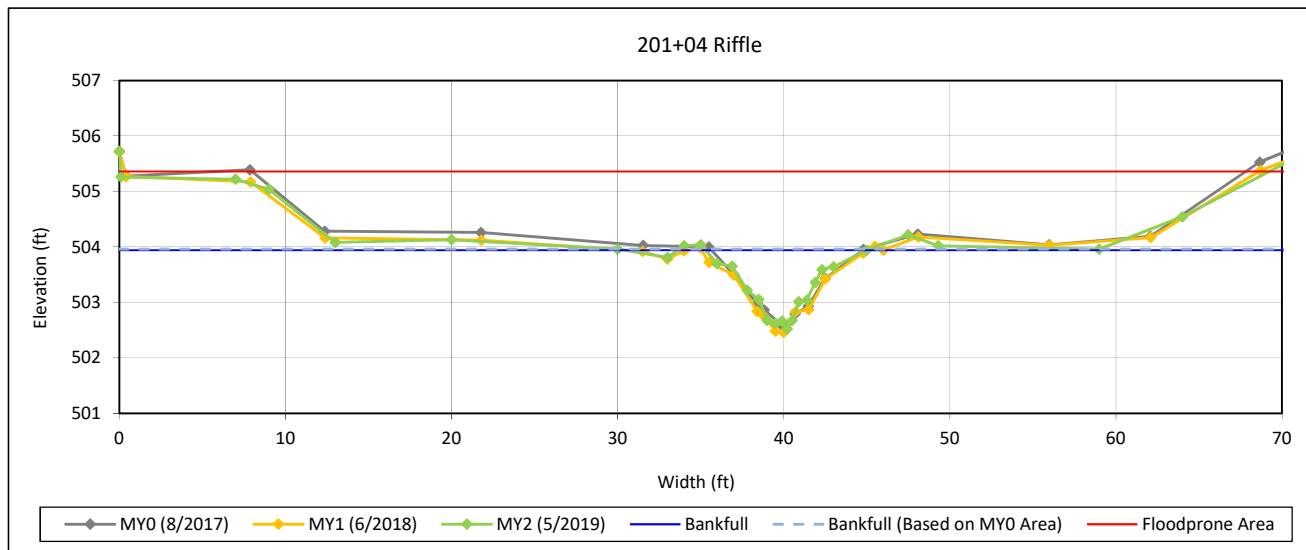
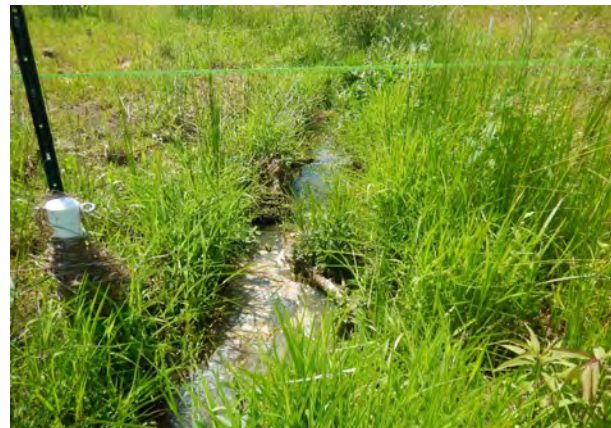
Cross-Section 5 UT1

5.8	x-section area (ft.sq.)
9.7	width (ft)
0.6	mean depth (ft)
1.4	max depth (ft)
10.4	wetted perimeter (ft)
0.6	hydraulic radius (ft)
16.1	width-depth ratio
65.0	W flood prone area (ft)
6.7	entrenchment ratio
< 1.0	low bank height ratio

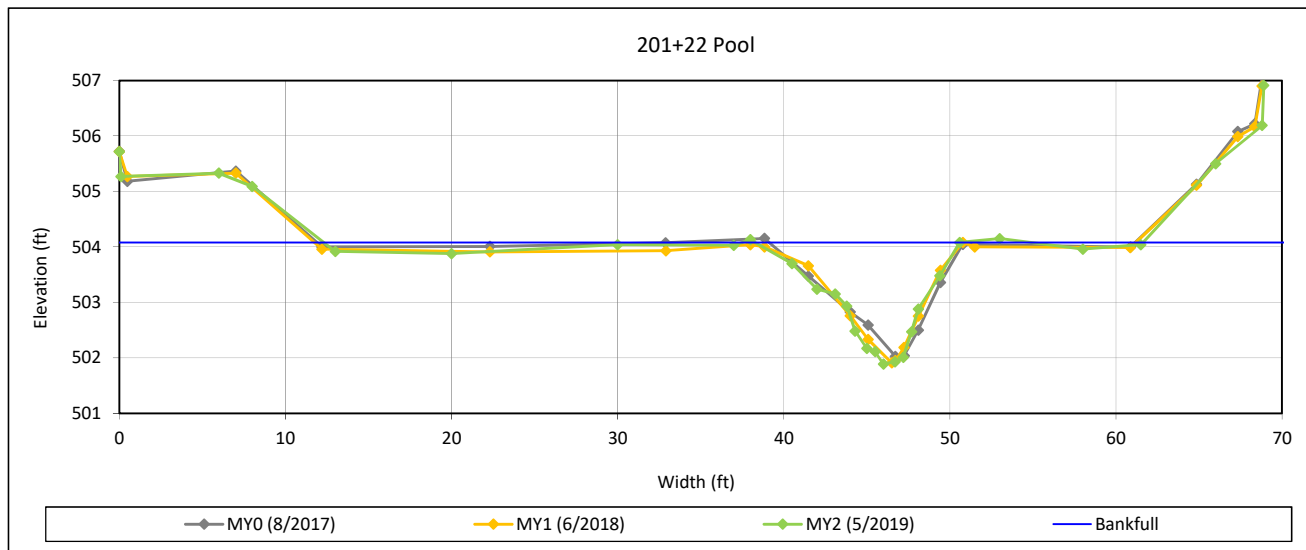
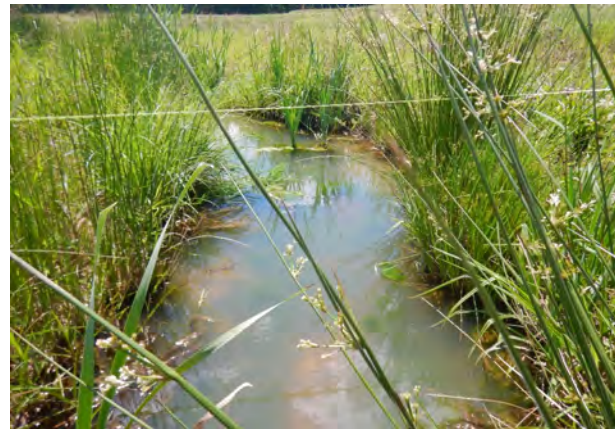
Cross-Section 6 UT1

12.5	x-section area (ft.sq.)
12.3	width (ft)
1.0	mean depth (ft)
2.2	max depth (ft)
13.4	wetted perimeter (ft)
0.9	hydraulic radius (ft)
12.1	width-depth ratio
