# **MONITORING YEAR 5 ANNUAL REPORT**

## **MARTIN DAIRY MITIGATION SITE**

DMS Project No. 97087

Data Collection Period: January – October 2022

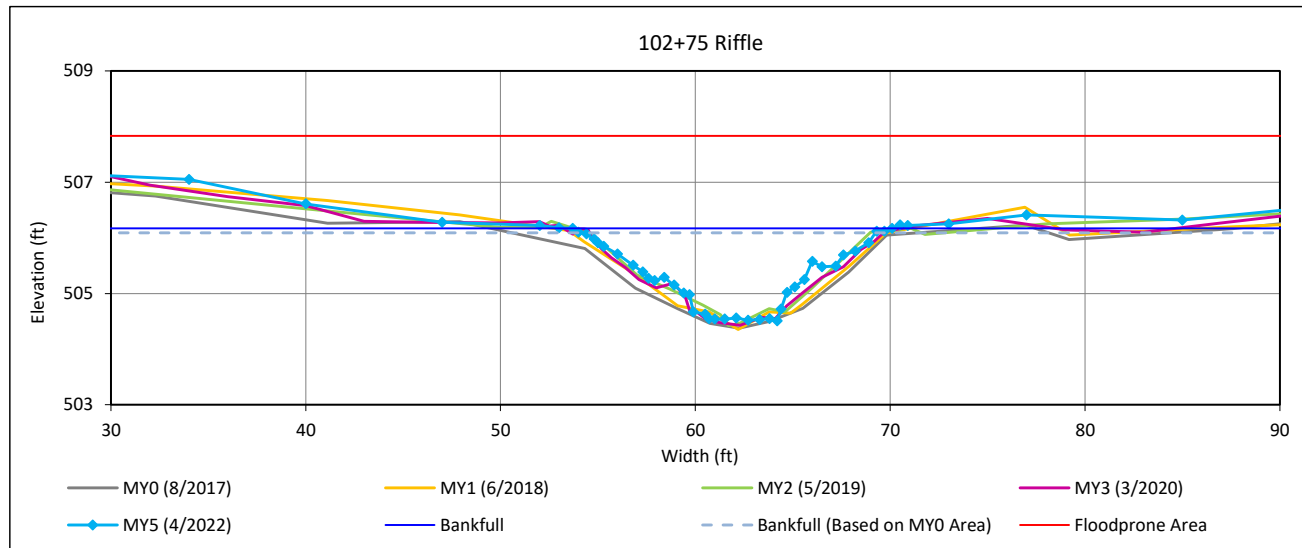
**Cross-Section 1 Martin Dairy Reach 1**

14.3	x-section area (ft.sq.)
15.3	width (ft)
0.9	mean depth (ft)
1.7	max depth (ft)
16.1	wetted perimeter (ft)
0.9	hydraulic radius (ft)
16.3	width-depth ratio
150.0	W flood prone area (ft)
9.8	entrenchment ratio
1.0	low bank height ratio

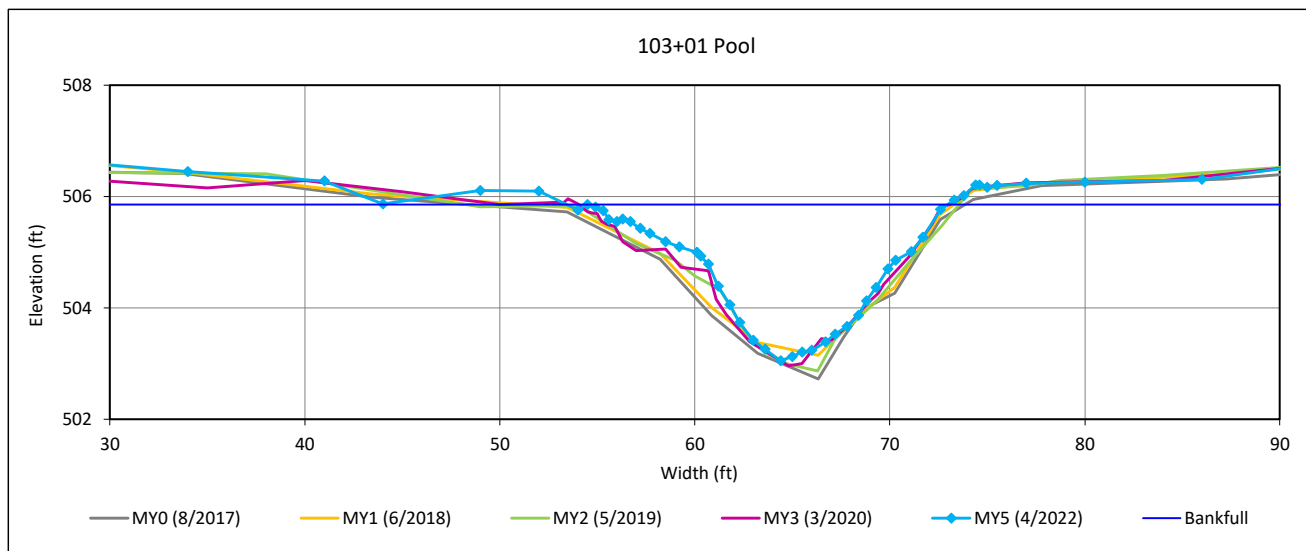
#### Cross-Section 2 Martin Dairy Reach 1

25.2	x-section area (ft.sq.)
18.5	width (ft)
1.4	mean depth (ft)
2.8	max depth (ft)
19.6	wetted perimeter (ft)
1.3	hydraulic radius (ft)
13.6	width-depth ratio

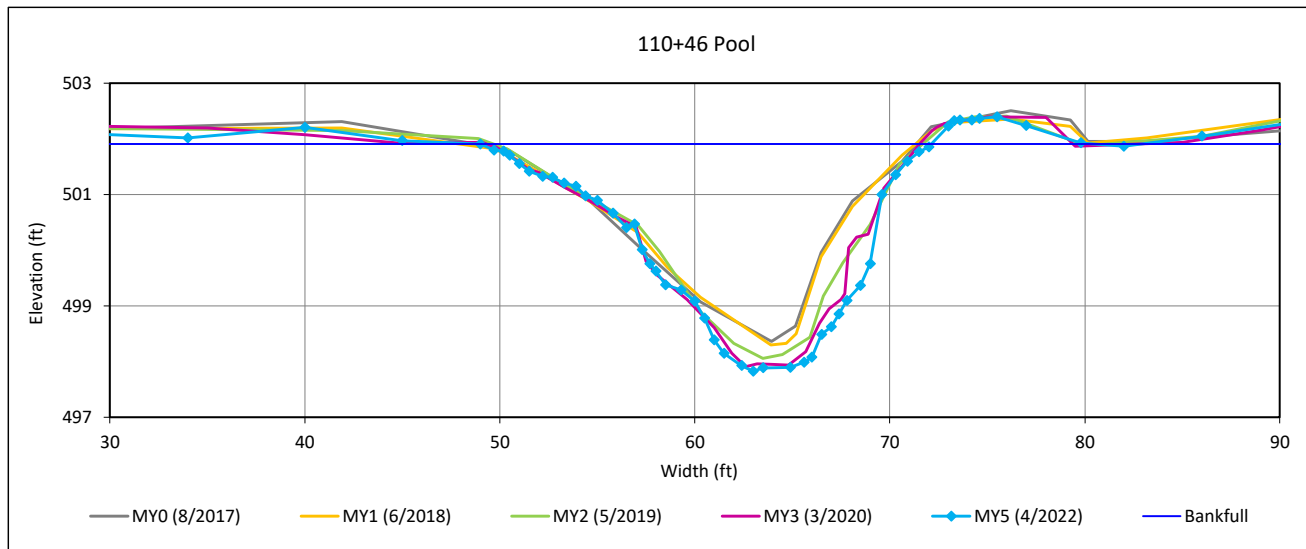
#### Cross-Section 3 Martin Dairy Reach 2

46.4	x-section area (ft.sq.)
23.1	width (ft)
2.0	mean depth (ft)
4.1	max depth (ft)
25.5	wetted perimeter (ft)
1.8	hydraulic radius (ft)
11.5	width-depth ratio

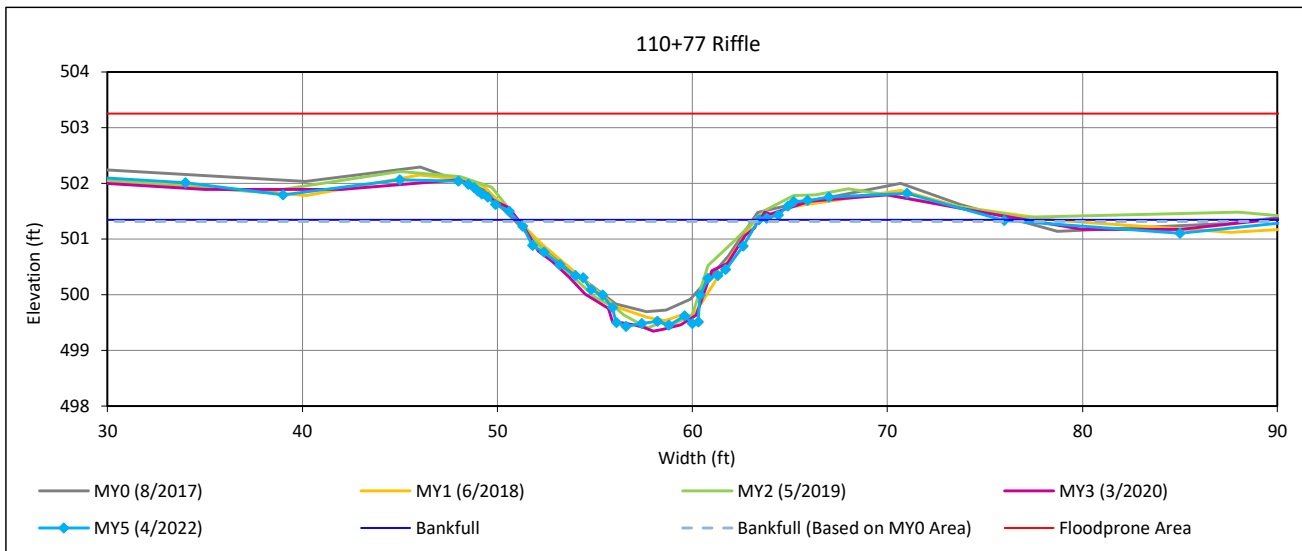
**Cross-Section 4 Martin Dairy Reach 2**

14.5	x-section area (ft.sq.)
12.4	width (ft)
1.2	mean depth (ft)
1.9	max depth (ft)
13.6	wetted perimeter (ft)
1.1	hydraulic radius (ft)
10.6	width-depth ratio
200.0	W flood prone area (ft)
16.1	entrenchment ratio
1.0	low bank height ratio

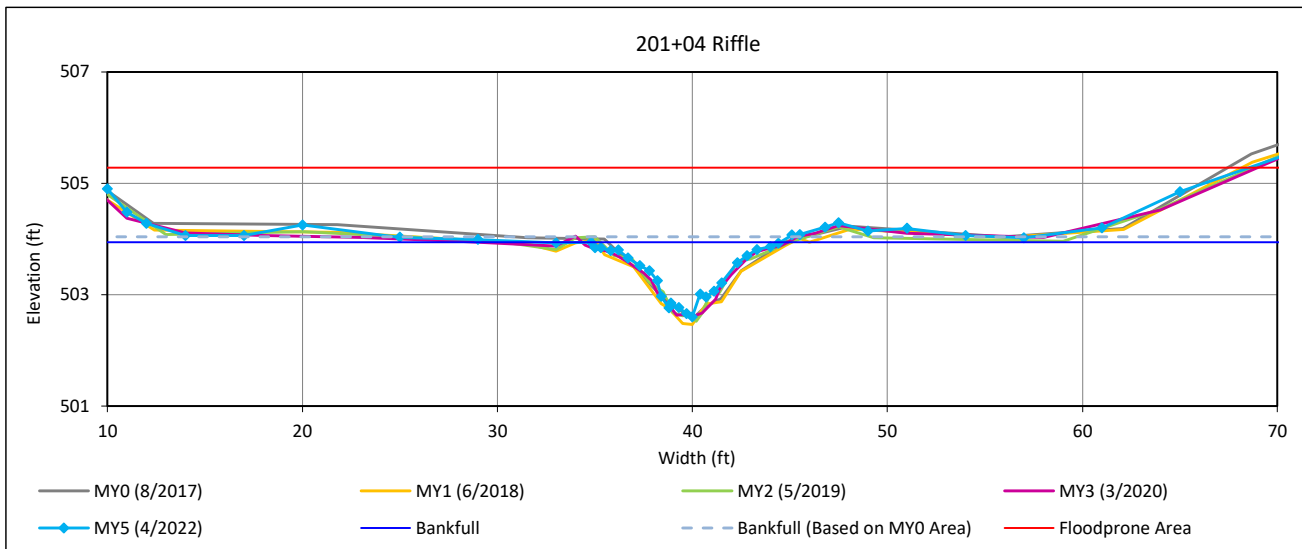
#### Cross-Section 5 UT1

5.2	x-section area (ft.sq.)
9.7	width (ft)
0.5	mean depth (ft)
1.3	max depth (ft)
10.4	wetted perimeter (ft)
0.5	hydraulic radius (ft)
18.0	width-depth ratio
65.0	W flood prone area (ft)
6.7	entrenchment ratio
< 1.0	low bank height ratio

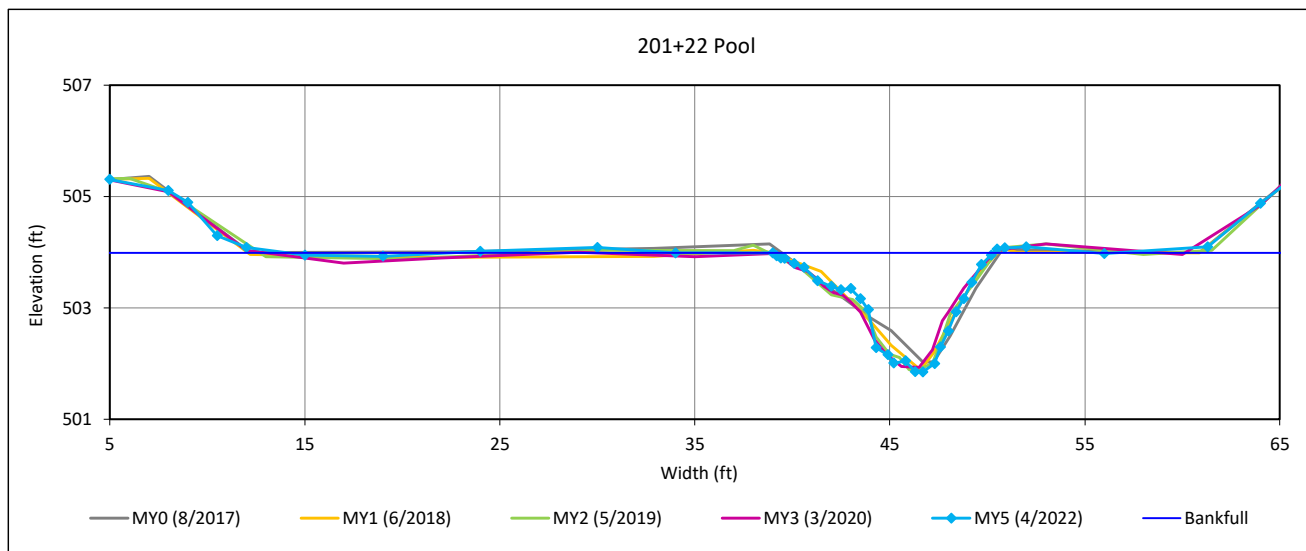
#### Cross-Section 6 UT1

11.3	x-section area (ft.sq.)
11.3	width (ft)
1.0	mean depth (ft)
2.1	max depth (ft)
12.6	wetted perimeter (ft)
0.9	hydraulic radius (ft)
11.4	width-depth ratio
