FINAL
YEAR 2 (2015) ANNUAL MONITORING REPORT
MARTIN'S CREEK II MITIGATION PROJECT

Cherokee County, North Carolina
DMS Project No. 92633 (Contract No. 005717)
USACE Action ID No. SAW – 2009-00209/DWR Project No. 10-0952
SCO No. 08-07251-01

Data Collection – March-November 2015

December 2015

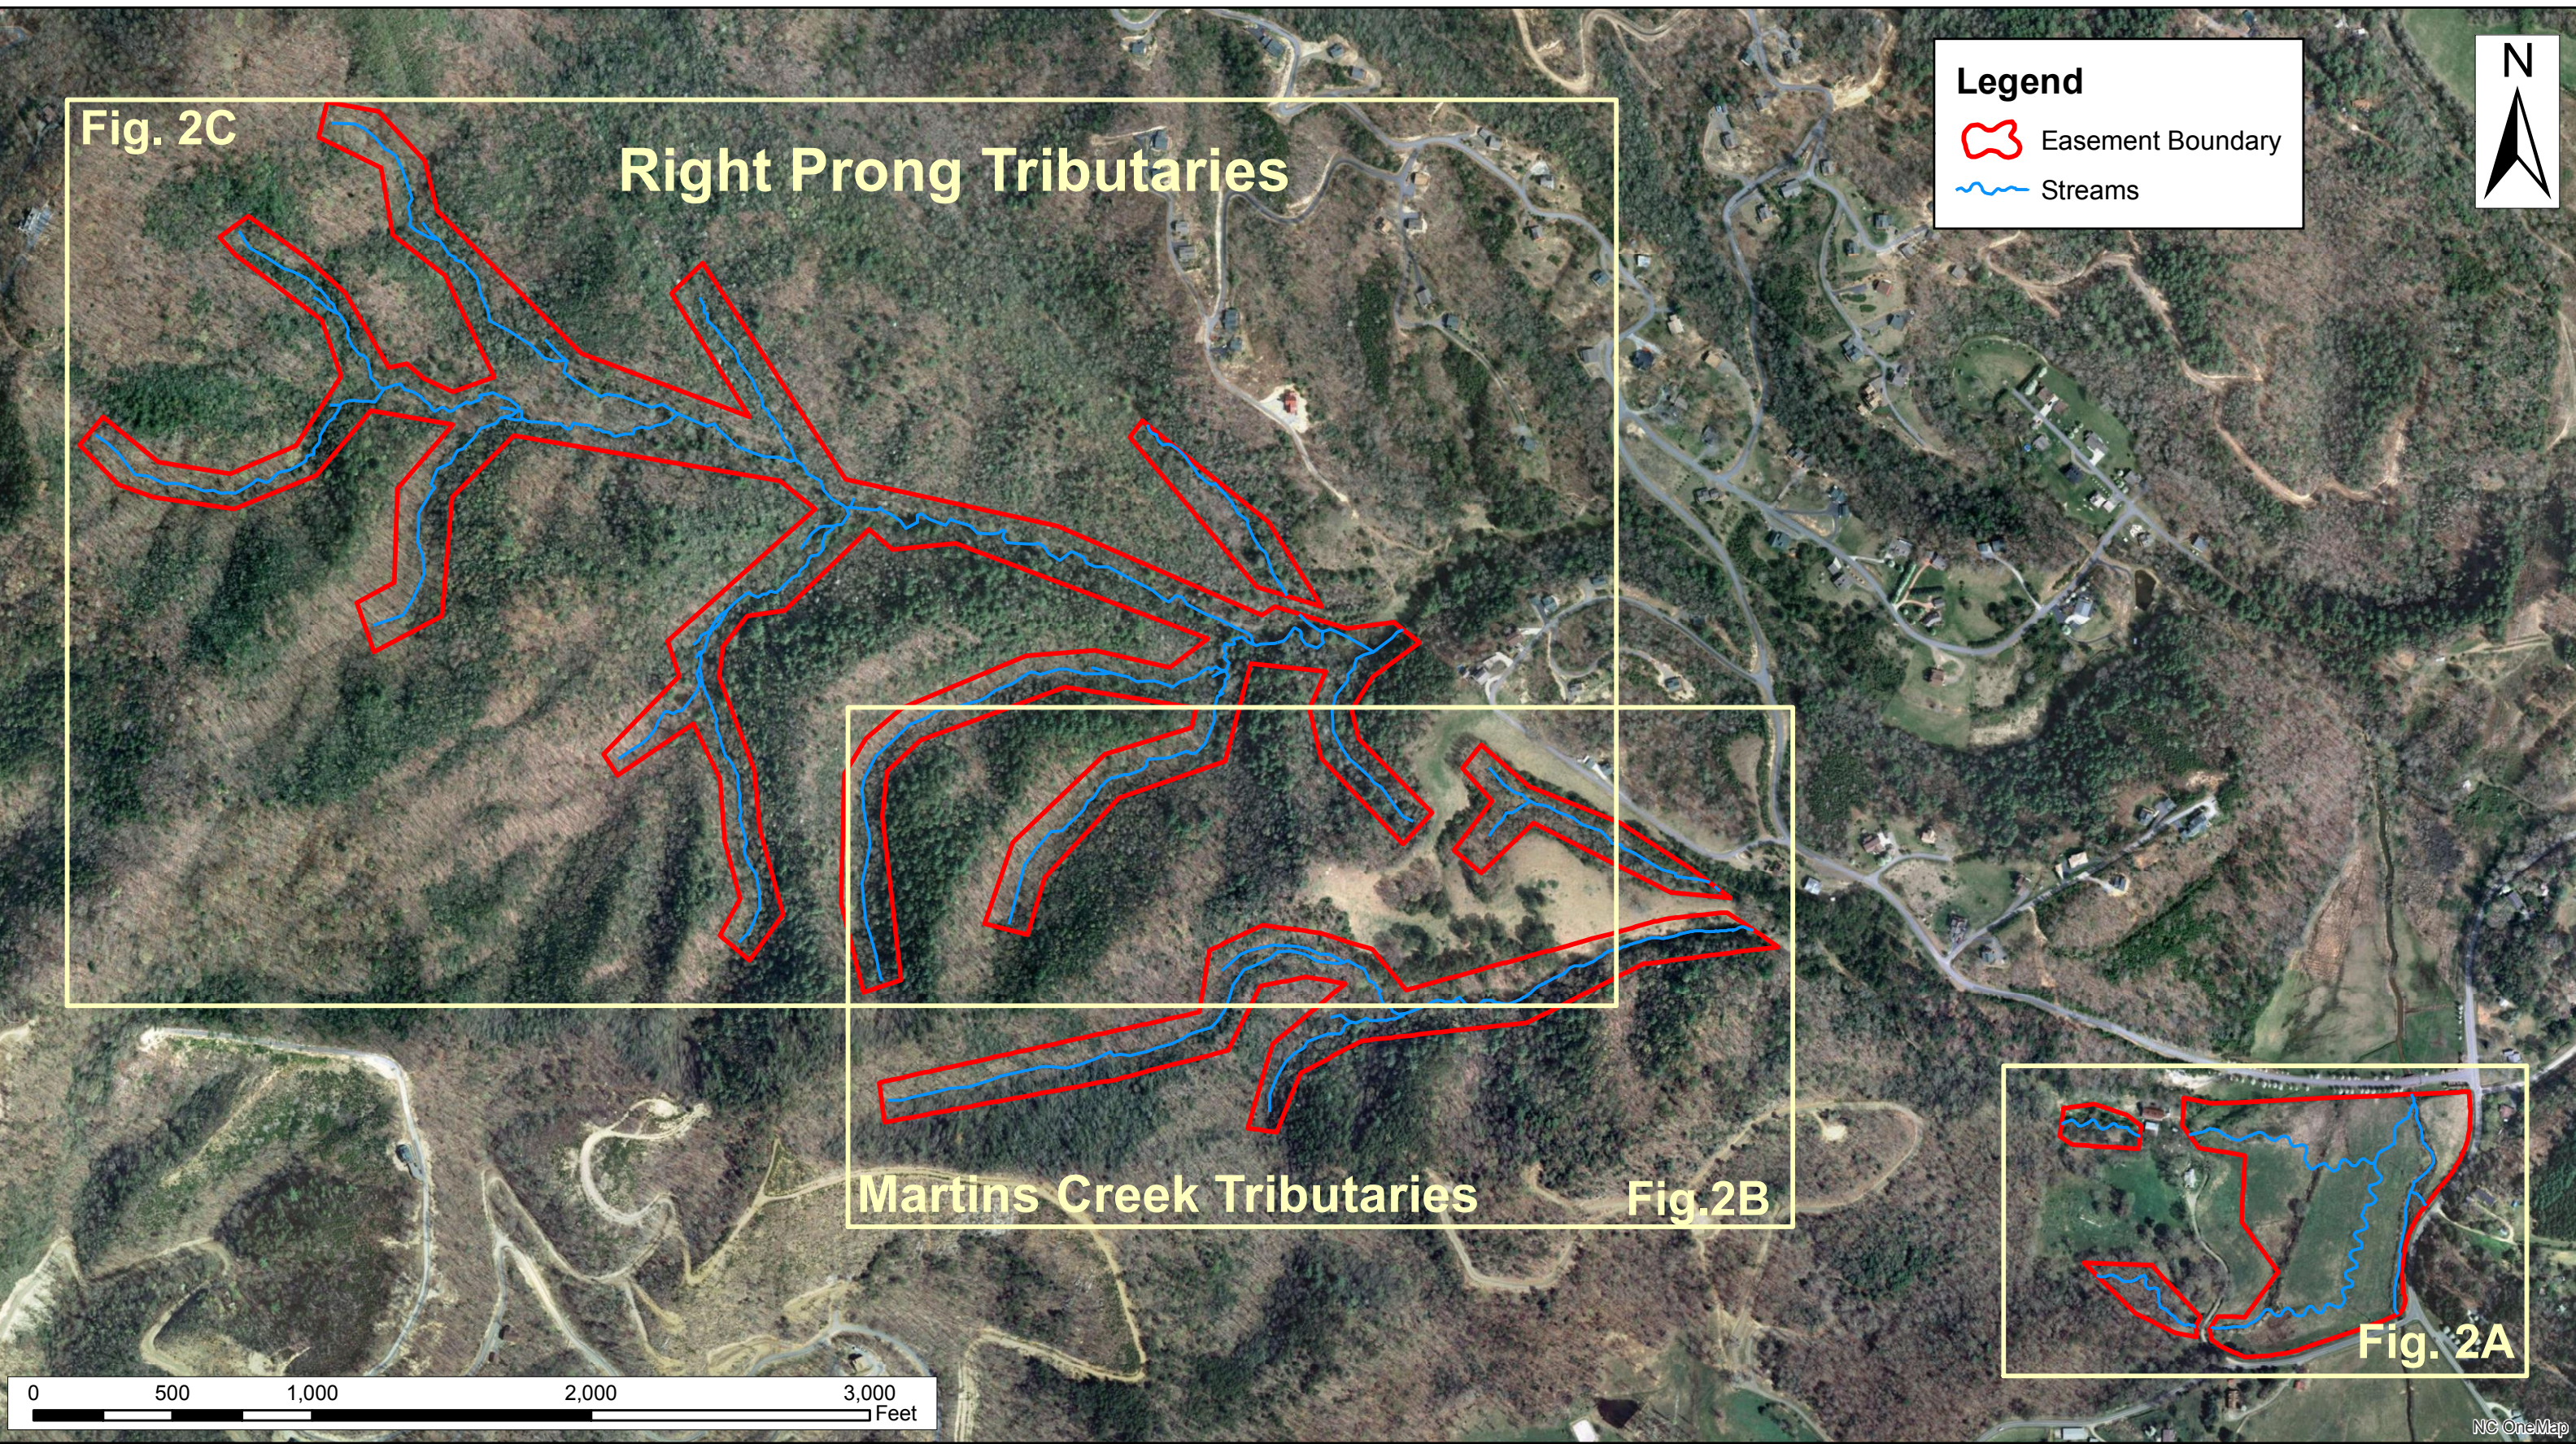
FIGURE
2

No areas of concern or indicators of instability were observed during year 2 (2015) monitoring; therefore, stream dimension measurements are currently meeting success criteria.

No areas of concern or indicators of bedform instability were observed during year 2 (2015) monitoring; therefore, stream longitudinal profile measurements are currently meeting success criteria.

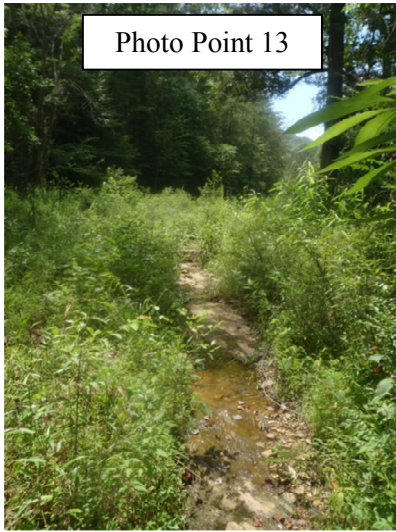
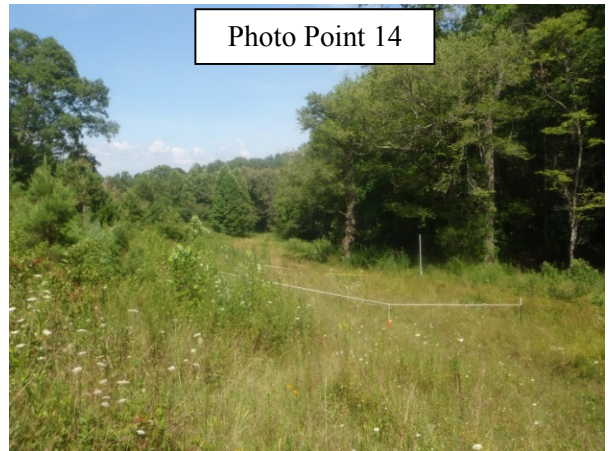
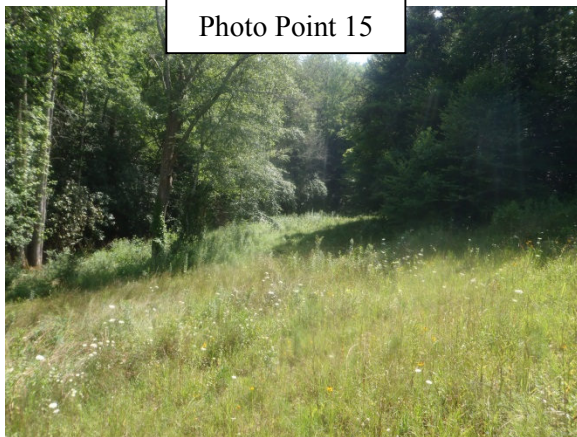
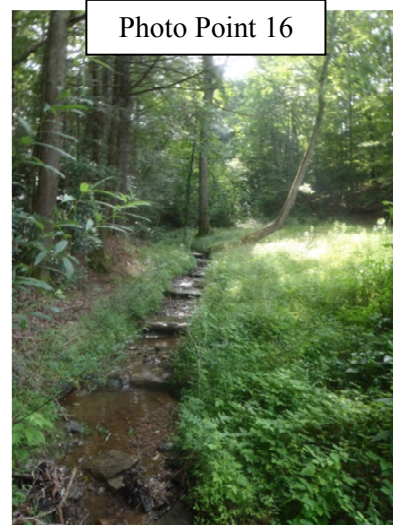
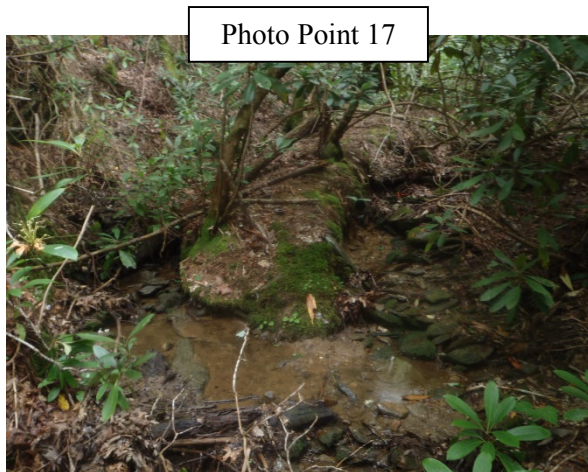
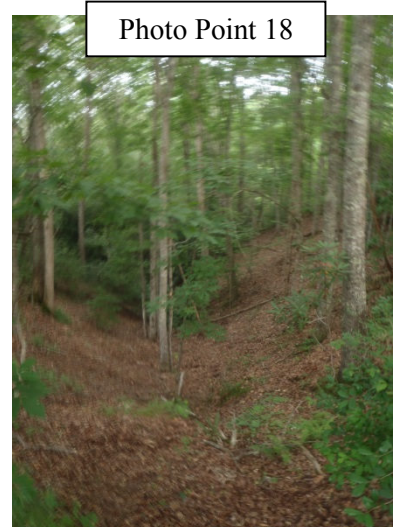
Martin's Creek II
Year 2 Fixed Station Photographs (continued)
Taken July 2015

Year 2 (2015) photo reference sites show no channel aggradation or degradation, or bank erosion. In addition, riparian vegetation is meeting success criteria based on stem counts across the Site; however, it is too early in the monitoring period to show successive maturation of riparian vegetation.
