FINAL
YEAR 4 (2017) ANNUAL MONITORING REPORT
MARTIN'S CREEK II MITIGATION PROJECT

Cherokee County, North Carolina
DMS Project No. 92633 (Contract No. 005717)
USACE Action ID No. SAW – 2009-00209/DWR Project No. 10-0952
SCO No. 08-07251-01

RE: Martin's Creek II Monitoring (DMS Project # 92633, Contract # 005717)
Final MY4 (2017) Annual Monitoring Report

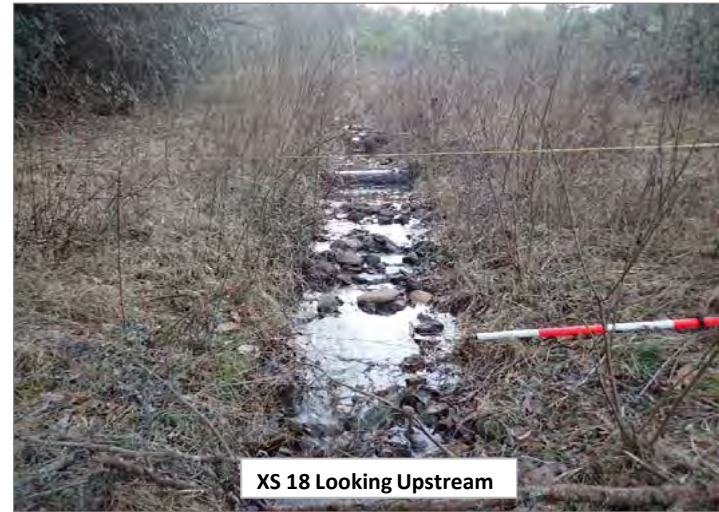
Site	Martins Creek II
Project Number:	92633
XS ID	XS - 18, Riffle
Reach	MC UT 1, Reach 2
Date:	3/7/2017
Field Crew:	Perkinson, Jernigan

SUMMARY DATA	
Bankfull Elevation:	75.2
Bankfull Cross-Sectional Area:	4.5
Bankfull Width:	8.0
Flood Prone Area Elevation:	76.1
Flood Prone Width:	25.0
Max Depth at Bankfull:	0.9
Mean Depth at Bankfull:	0.6
W / D Ratio:	14.2
Entrenchment Ratio:	3.1
Bank Height Ratio:	1.0

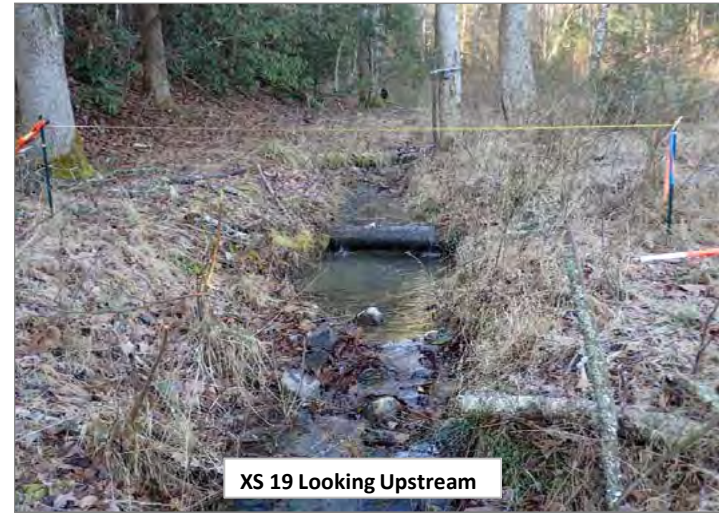
Site	Martins Creek II
Project Number:	92633
XS ID	XS - 19, Riffle
Reach	MC UT 1, Reach 2
Date:	3/7/2017
Field Crew:	Perkinson, Jernigan

SUMMARY DATA	
Bankfull Elevation:	102.5
Bankfull Cross-Sectional Area:	6.2
Bankfull Width:	7.5
Flood Prone Area Elevation:	103.9
Flood Prone Width:	25.0
Max Depth at Bankfull:	1.4
Mean Depth at Bankfull:	0.8
W / D Ratio:	9.1
Entrenchment Ratio:	3.3
Bank Height Ratio:	1.1

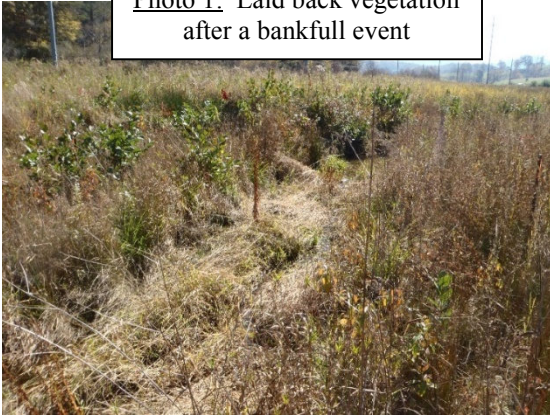
August 22, 2016	June 5, 2016	Crest gauge data, floodplain scour, and laid back vegetation indicate a bankfull event after approximately 2.28 inches of rain was documented over two days at an onsite rain gauge.	2
August 29, 2017	June 23, 2017	Crest gauge data indicates a bankfull event after approximately 1.85 inches of rain was documented in one day at an onsite rain gauge.	--
November 8, 2017	October 8, 2017	Crest gauge data indicates a bankfull event after approximately 1.97 inches of rain was documented in one day at an onsite rain gauge.	--

Photo 1: Laid back vegetation after a bankfull event

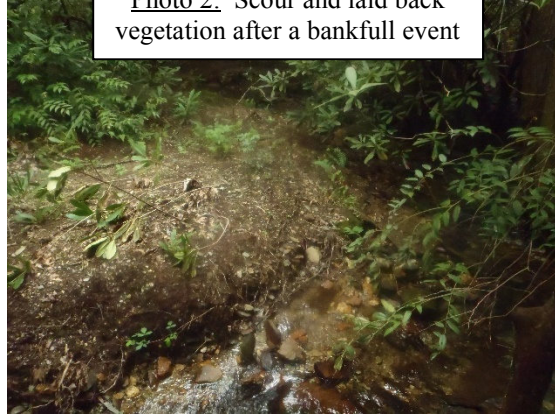
Photo 2: Scour and laid back vegetation after a bankfull event

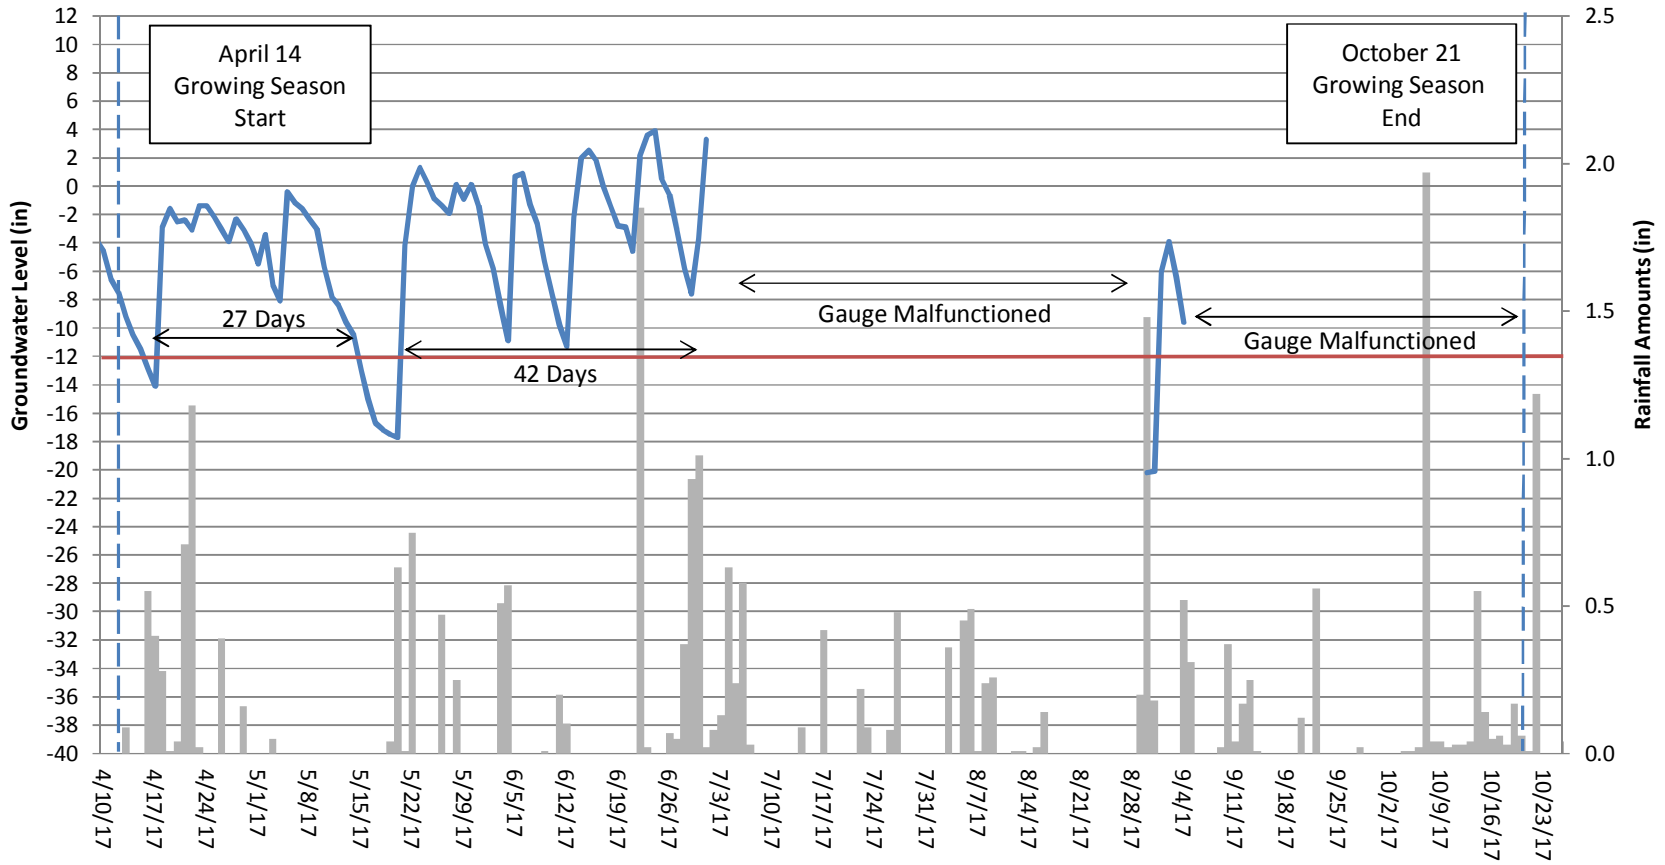
Martins Creek II Groundwater Gauge 2 Year 4 (2017 Data)

The following was added to the wetland hydrology discussion: "Gauge 2 malfunctioned on July 1, 2017 and was replaced on August 30, 2017. The new gauge collected data for just 6 days before malfunctioning again for the remainder of the growing season; however, it was saturated/inundated for 42 days prior to its malfunction. Gauge 11 malfunctioned on August 29, 2017 resulting in loss of data for the remainder of the growing season. The gauge had not met success criteria prior to its malfunction, and it is not expected to have met success criteria during the period of its malfunction. Both gauges were replaced with functioning gauges, and, as of November 8, 2017, were functioning properly." Axiom keeps several DMS-owned gauges in stock and brings them to every site visit in anticipation of gauge malfunction. We will request additional replacement gauges from DMS if the need arises.

*This gauge malfunctioned on July 1, 2017 and was replaced on August 30, 2017. The new gauge collected data for just 6 days before malfunctioning again for the remainder of the growing season; however, it was saturated/inundated for 42 days prior to its malfunction.
