FINAL
YEAR 5 (2018) ANNUAL MONITORING REPORT
MARTIN'S CREEK II MITIGATION PROJECT

Cherokee County, North Carolina
DMS Project No. 92633 (Contract No. 005717)
USACE Action ID No. SAW – 2009-00209/DWR Project No. 10-0952
SCO No. 08-07251-01

December 2018

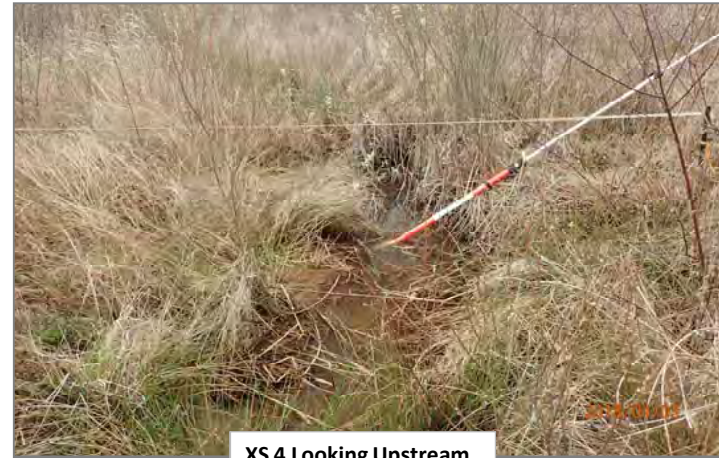
XS 4 Looking Upstream

SUMMARY DATA	
Bankfull Elevation:	96.7
Bankfull Cross-Sectional Area:	5.9
Bankfull Width:	7.7
Flood Prone Area Elevation:	NA
Flood Prone Width:	NA
Max Depth at Bankfull:	1.6
Mean Depth at Bankfull:	0.8
W / D Ratio:	NA
Entrenchment Ratio:	NA
Bank Height Ratio:	1.0

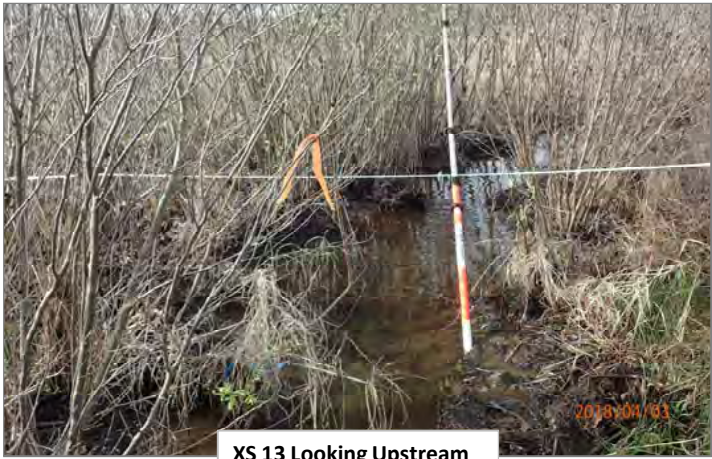
XS 13 Looking Upstream

SUMMARY DATA	
Bankfull Elevation:	99.0
Bankfull Cross-Sectional Area:	2.2
Bankfull Width:	4.5
Flood Prone Area Elevation:	99.9
Flood Prone Width:	25.0
Max Depth at Bankfull:	0.9
Mean Depth at Bankfull:	0.5
W / D Ratio:	9.2
Entrenchment Ratio:	5.6
Bank Height Ratio:	1.4

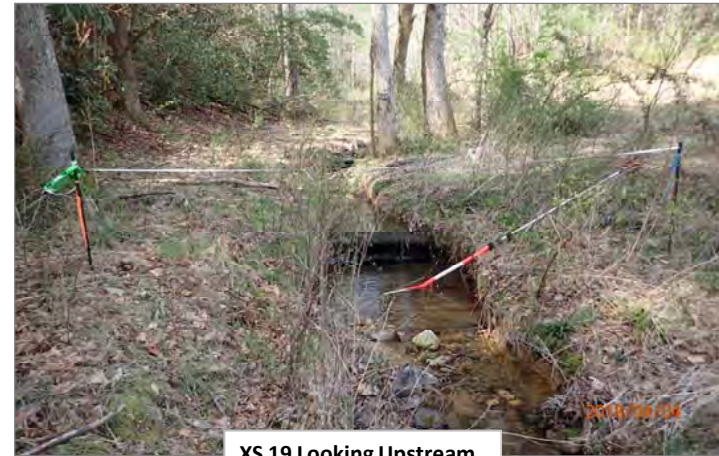
XS 19 Looking Upstream

SUMMARY DATA	
Bankfull Elevation:	102.5
Bankfull Cross-Sectional Area:	7.3
Bankfull Width:	8.9
Flood Prone Area Elevation:	104.1
Flood Prone Width:	25.0
Max Depth at Bankfull:	1.6
Mean Depth at Bankfull:	0.8
W / D Ratio:	10.9
Entrenchment Ratio:	2.8
Bank Height Ratio:	1.0

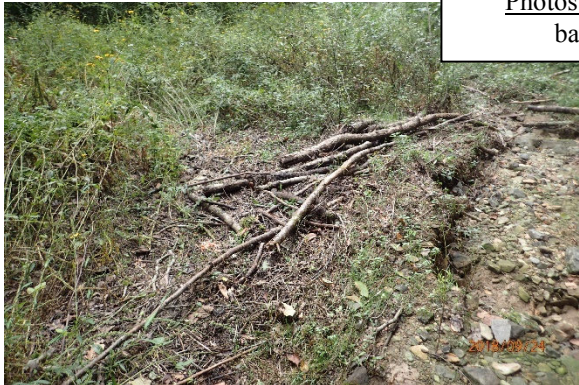
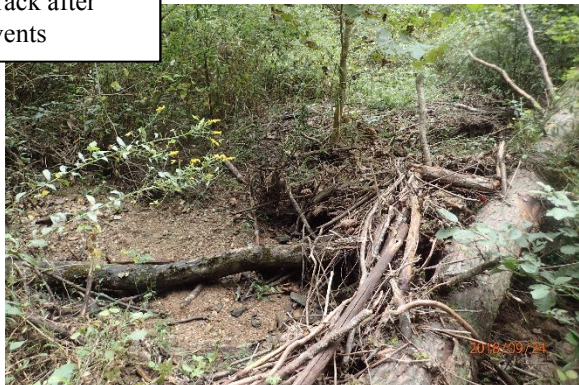
Photos 3-4: Wrack after bankfull events
