Mason Property Wetland Mitigation Project

Hyde County, NC

2008 Annual Monitoring Report
Year 1, Baseline

NCEEP Project Number D06001
Tar-Pamlico River Basin

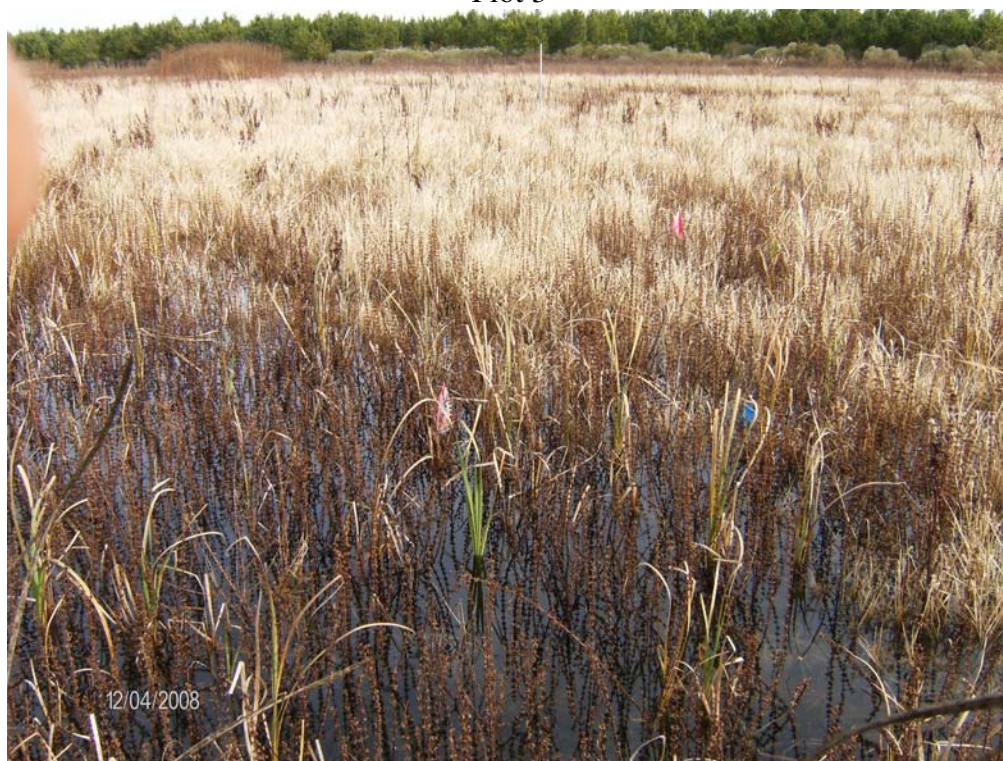
Plot 3

Two of the four monitoring plots met the Year 3 success criterion of a minimum of 320 stems per acre after the first growing season. Over the entire project, the survival rate averaged 243 live stems per acre, a survival rate of 54%. Those stems that were planted in 2007 and did not survive were replaced in 2008. In addition, the stocking level was raised to 450 stems per acre across the entire site, but due to almost constant inundation, survival was poor. Water oak (*Q. phellos*) and Bald Cypress (*T. distichum*) proved to be the hardiest species. Replacement and supplemental planting is planned for the winter of 2009. Dead stems will be replaced and the overall stocking level will be increased to approximately 600 stems per acre. There are few options for site maintenance beyond herbaceous competition control to improve tree survival and herbaceous competition is thought to be a secondary problem. Selecting the most hydric species

Table 6. Vegetation Problem Areas			
Feature/Issue	Plot	Probable Cause	Photo #
Poor Survival	3, 4	Excessivley Wet	VPA 1
Poor Health and Growth	All	Excessively Wet	VPA 2, VPA 3

for replanting appears to be the best approach to achieving the required stocking levels, because although there is a cumulative rainfall deficit for the year, the site has remained inundated for all but approximately 2 of the 8 months in the 2008 growing season. The site was under an average of 6 inches of water when planting was done in 2008. Water levels on site began to recede in June, which allowed the herbaceous cover to expand and cause some competition. If it is possible and if deemed necessary, maintenance of herbaceous competition will take place during the 2009 growing season
