Year 2 Monitoring Report

MATTHEW SITE

NCDMS Project #100043 (Contract #7419)
USACE Action ID: SAW-2017-00055
DWR Project #2017-0624

January 2023

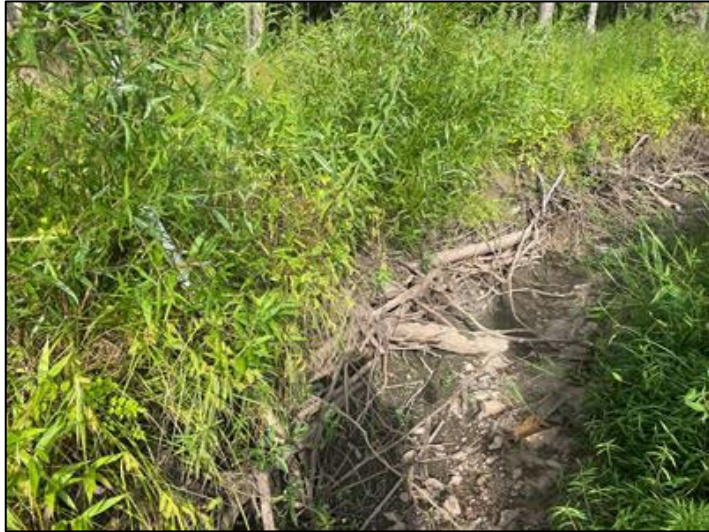
Stage Recorder RL1-A

Two stage recorders are currently recording bankfull events on reaches RL1-A and RL2. The stage recorder on RL1-A recorded 6 bankfull events in MY2 with the highest reading being 1.28 feet above the top of bank. The stage recorder on RL2 recorded 11 bankfull events in MY2 with the highest reading being 2.64 feet above the top of bank. Stage recorder locations can be found on **Figure 2**, photos are in **Appendix B**, and hydrology data are in **Appendix E**.

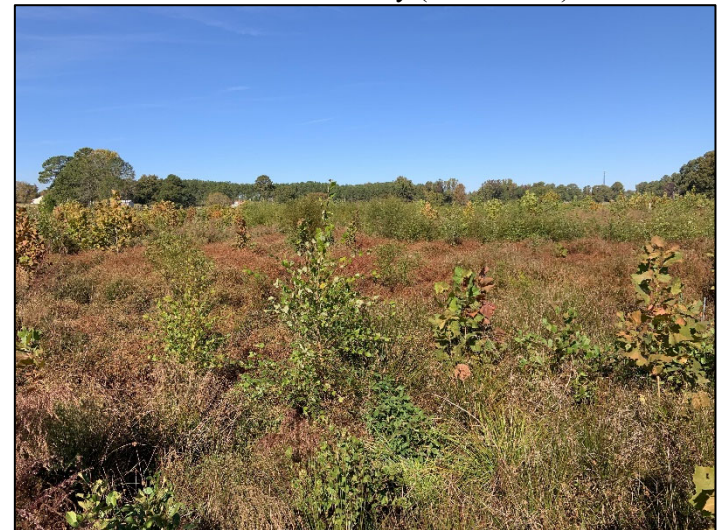
Looking upstream from GW5 (10/20/2022)
