FINAL
ANNUAL MONITORING REPORT
YEAR 4 (2012)
McCain Stream Restoration Site
RANDOLPH COUNTY, NORTH CAROLINA
(EEP Project No. 443, Contract No. 004807)
Construction Completed March 2009

December 2012

Prepared by:
Axiom Environmental, Inc.
218 Snow Avenue
Raleigh, North Carolina 27603

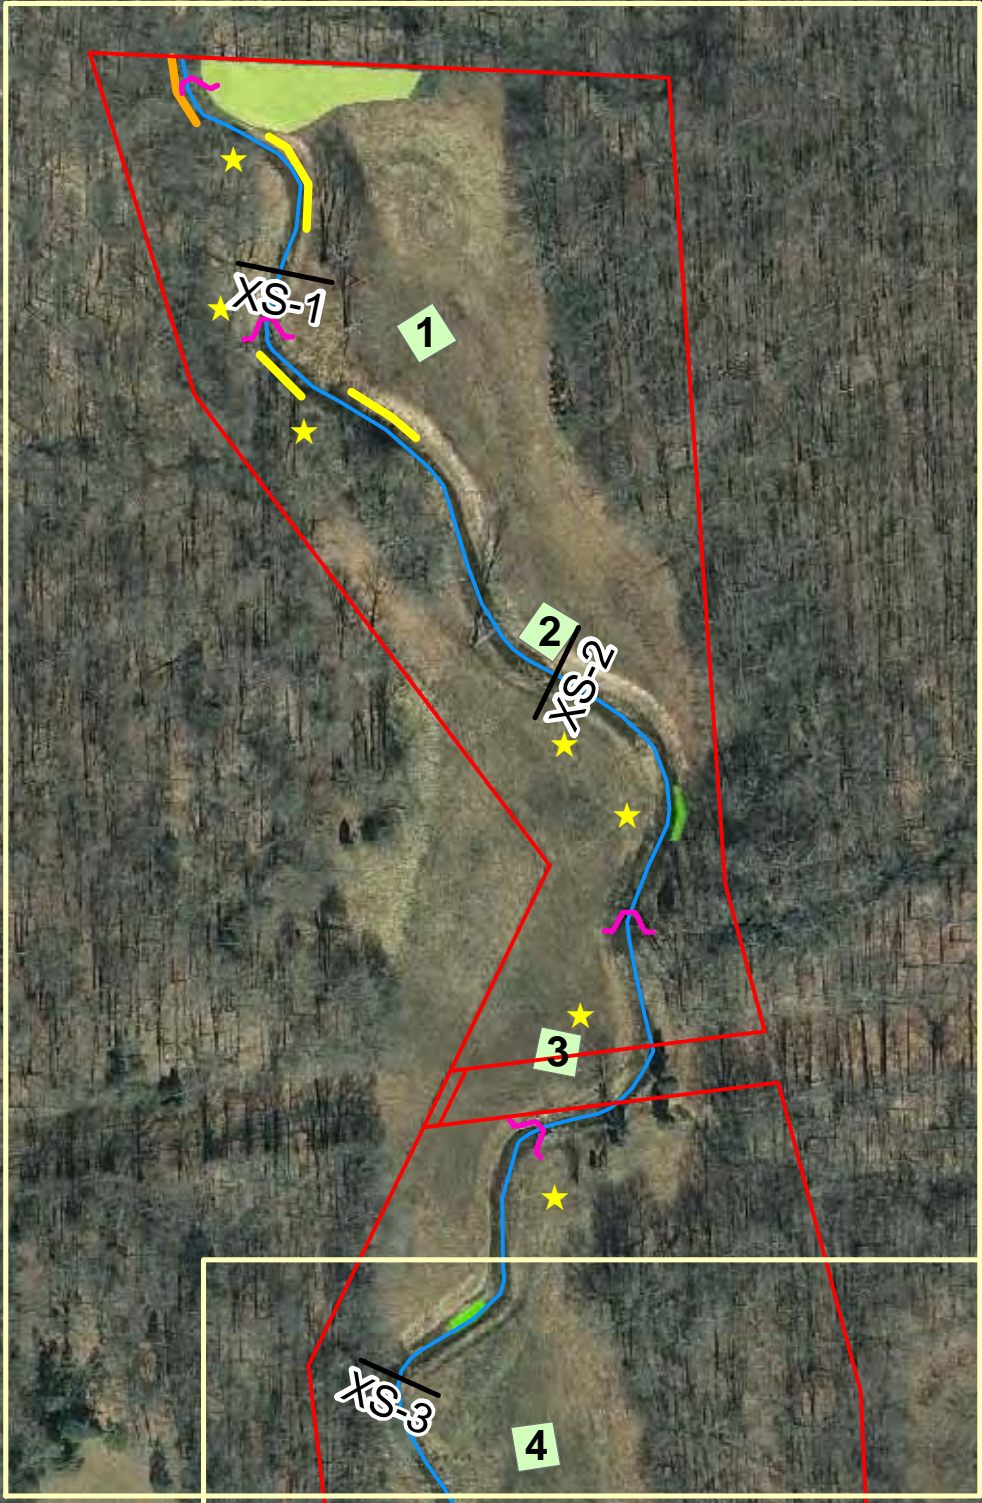
Fig. 2A

The dominant herbaceous vegetation throughout the Site is mainly comprised of planted grasses such as fescue and Japanese stiltgrass (*Microstegium vimineum*). Although fescue occurs throughout the Site, the northernmost end of the Site is characterized by dense fescue resulting in planted stem mortality (depicted on Figures 2A-2B, Appendix B). Additional vegetation problem areas include two small Japanese stiltgrass populations on stream banks located at stations 17+50 and 22+10. On the right bank of the southernmost end of the Site, a small population of Chinese privet (*Ligustrum sinense*) has established; however, the area is small enough to not be problematic. Chinese privet will be assessed during future Site monitoring. For additional information relating to vegetation, see Appendix C.

Stream problem areas include areas of minor bank erosion/scour in the upstream 300 linear feet of the Site (Reach 1). Stream problem areas do not appear to be worsening and no immediate maintenance actions are recommended at this time. Many areas considered problems during previous monitoring years have recovered and vegetation has established; therefore, these areas are no longer considered problems. Stream problem areas are depicted on Figures 2A-2B (Appendix B) and include the following.
