**FINAL
ANNUAL MONITORING REPORT
YEAR 5 (2013)
McCain Stream Restoration Site
Randolph County, North Carolina
(EEP Project No. 443, Contract No. 004807)
Construction Completed March 2009**

October 2013

Prepared by:
Axiom Environmental, Inc.
218 Snow Avenue
Raleigh, North Carolina 27603

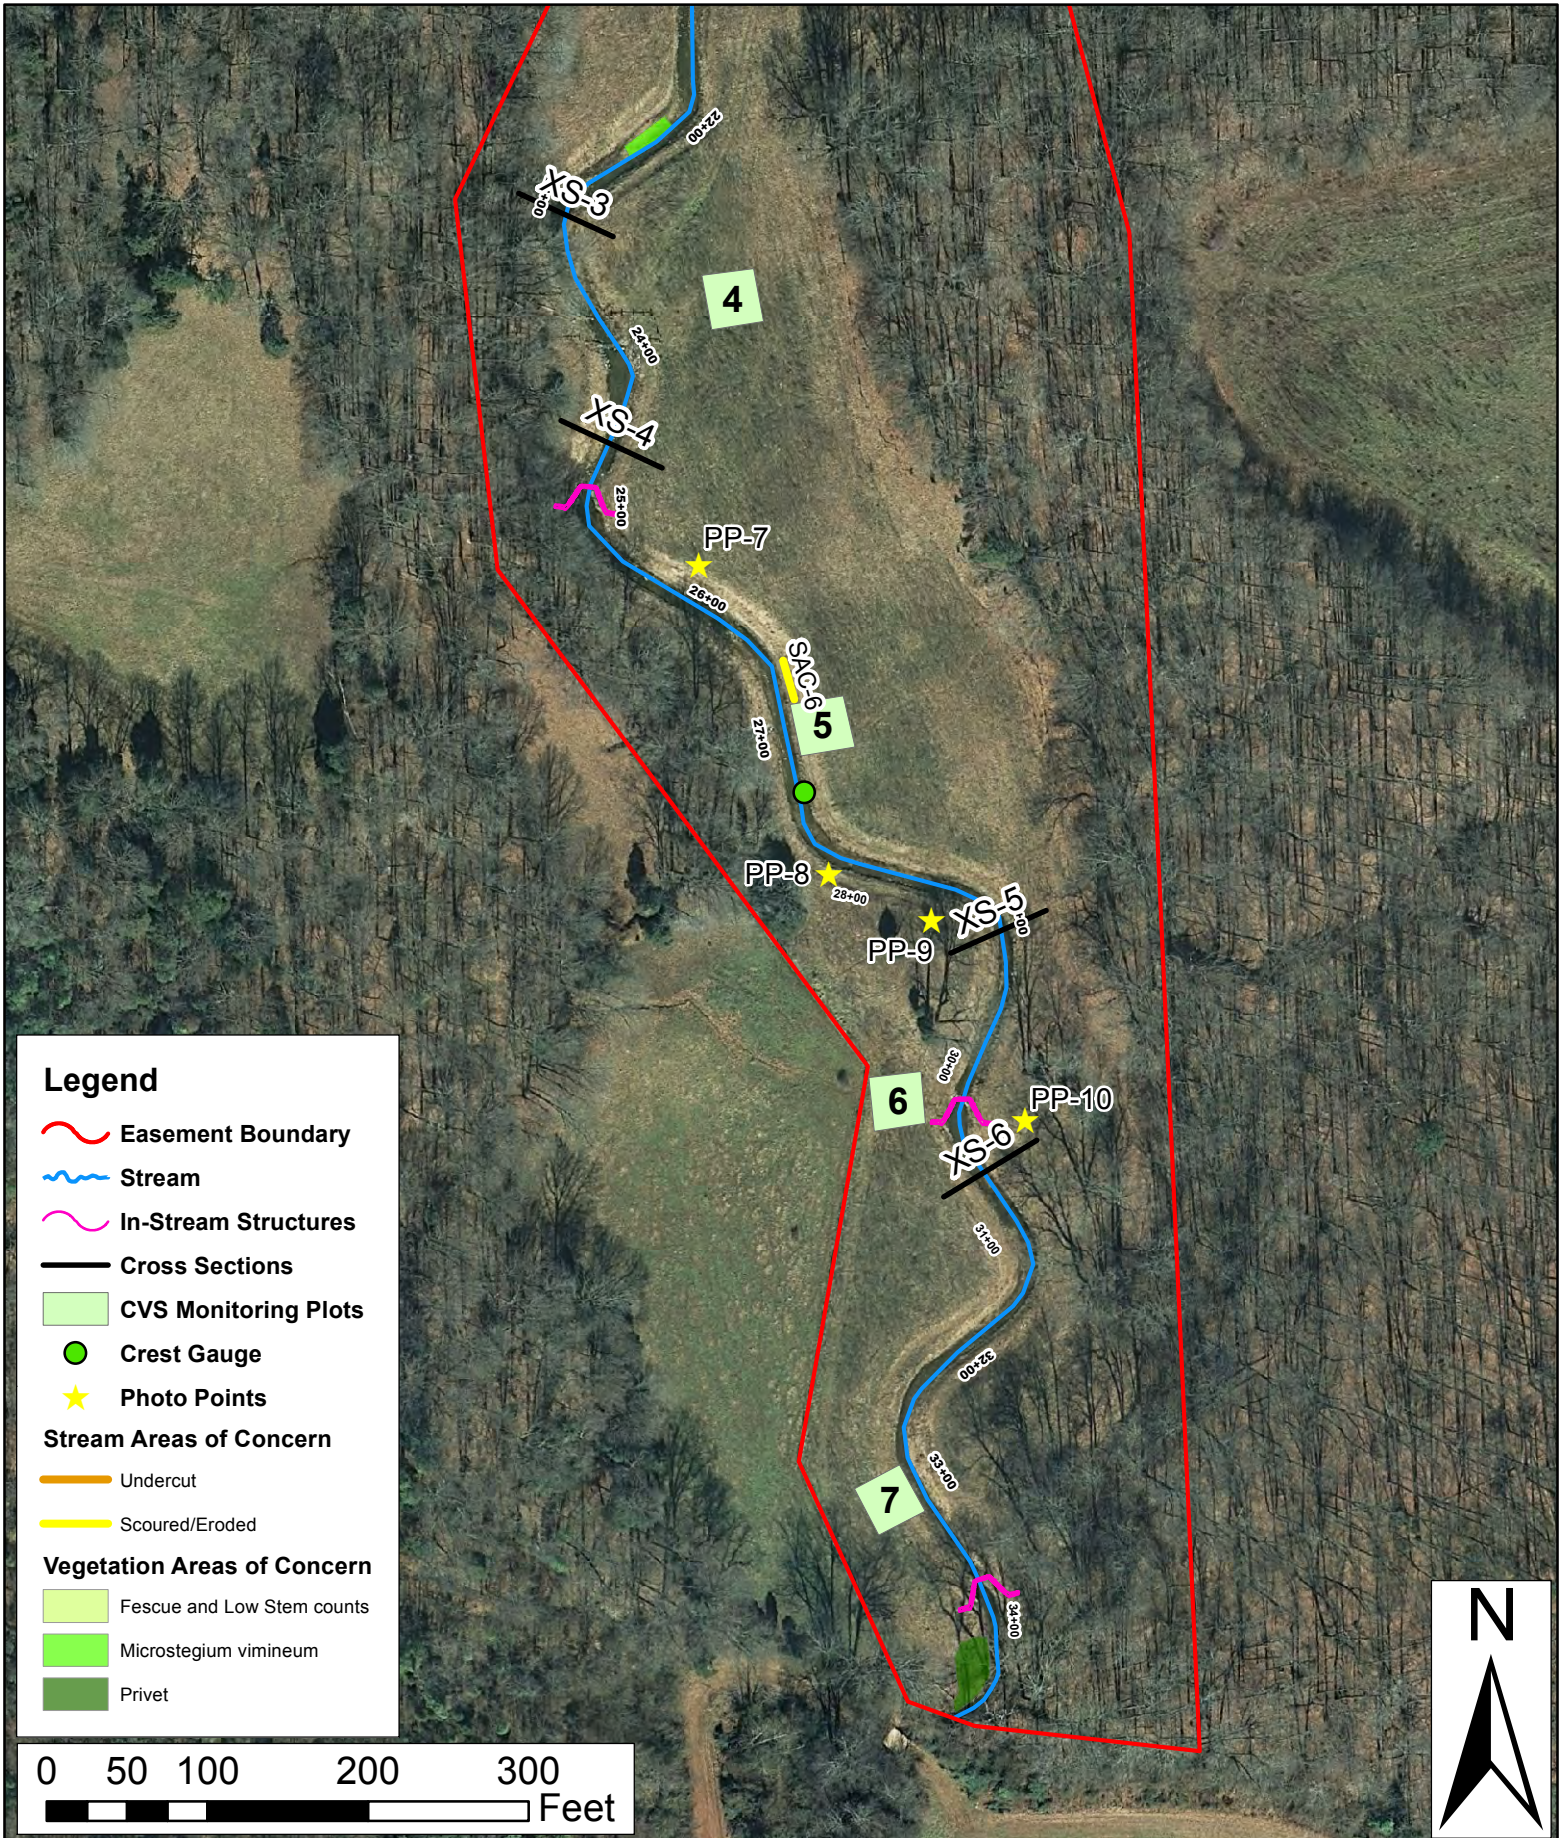
FIGURE
2A

Stream areas of concern include areas of minor bank erosion/scour in the upstream 300 linear feet of the Site (Reach 1). Stream areas of concern do not appear to be worsening and no immediate maintenance actions are recommended at this time. Many areas considered areas of concern during previous monitoring years have recovered and vegetation has established. Current stream areas of concern are depicted on Figures 2A-2B (Appendix B) and include the following.
