MONITORING YEAR 2 ANNUAL REPORT FINAL

MCLENNY ACRES MITIGATION SITE

Wayne County, NC
Neuse River Basin
HUC 03020201

DMS Project No. 100038
NCDEQ Contract No. 7423
DWR Project No. 2018-0197
USACE Action ID No. 2018-02042

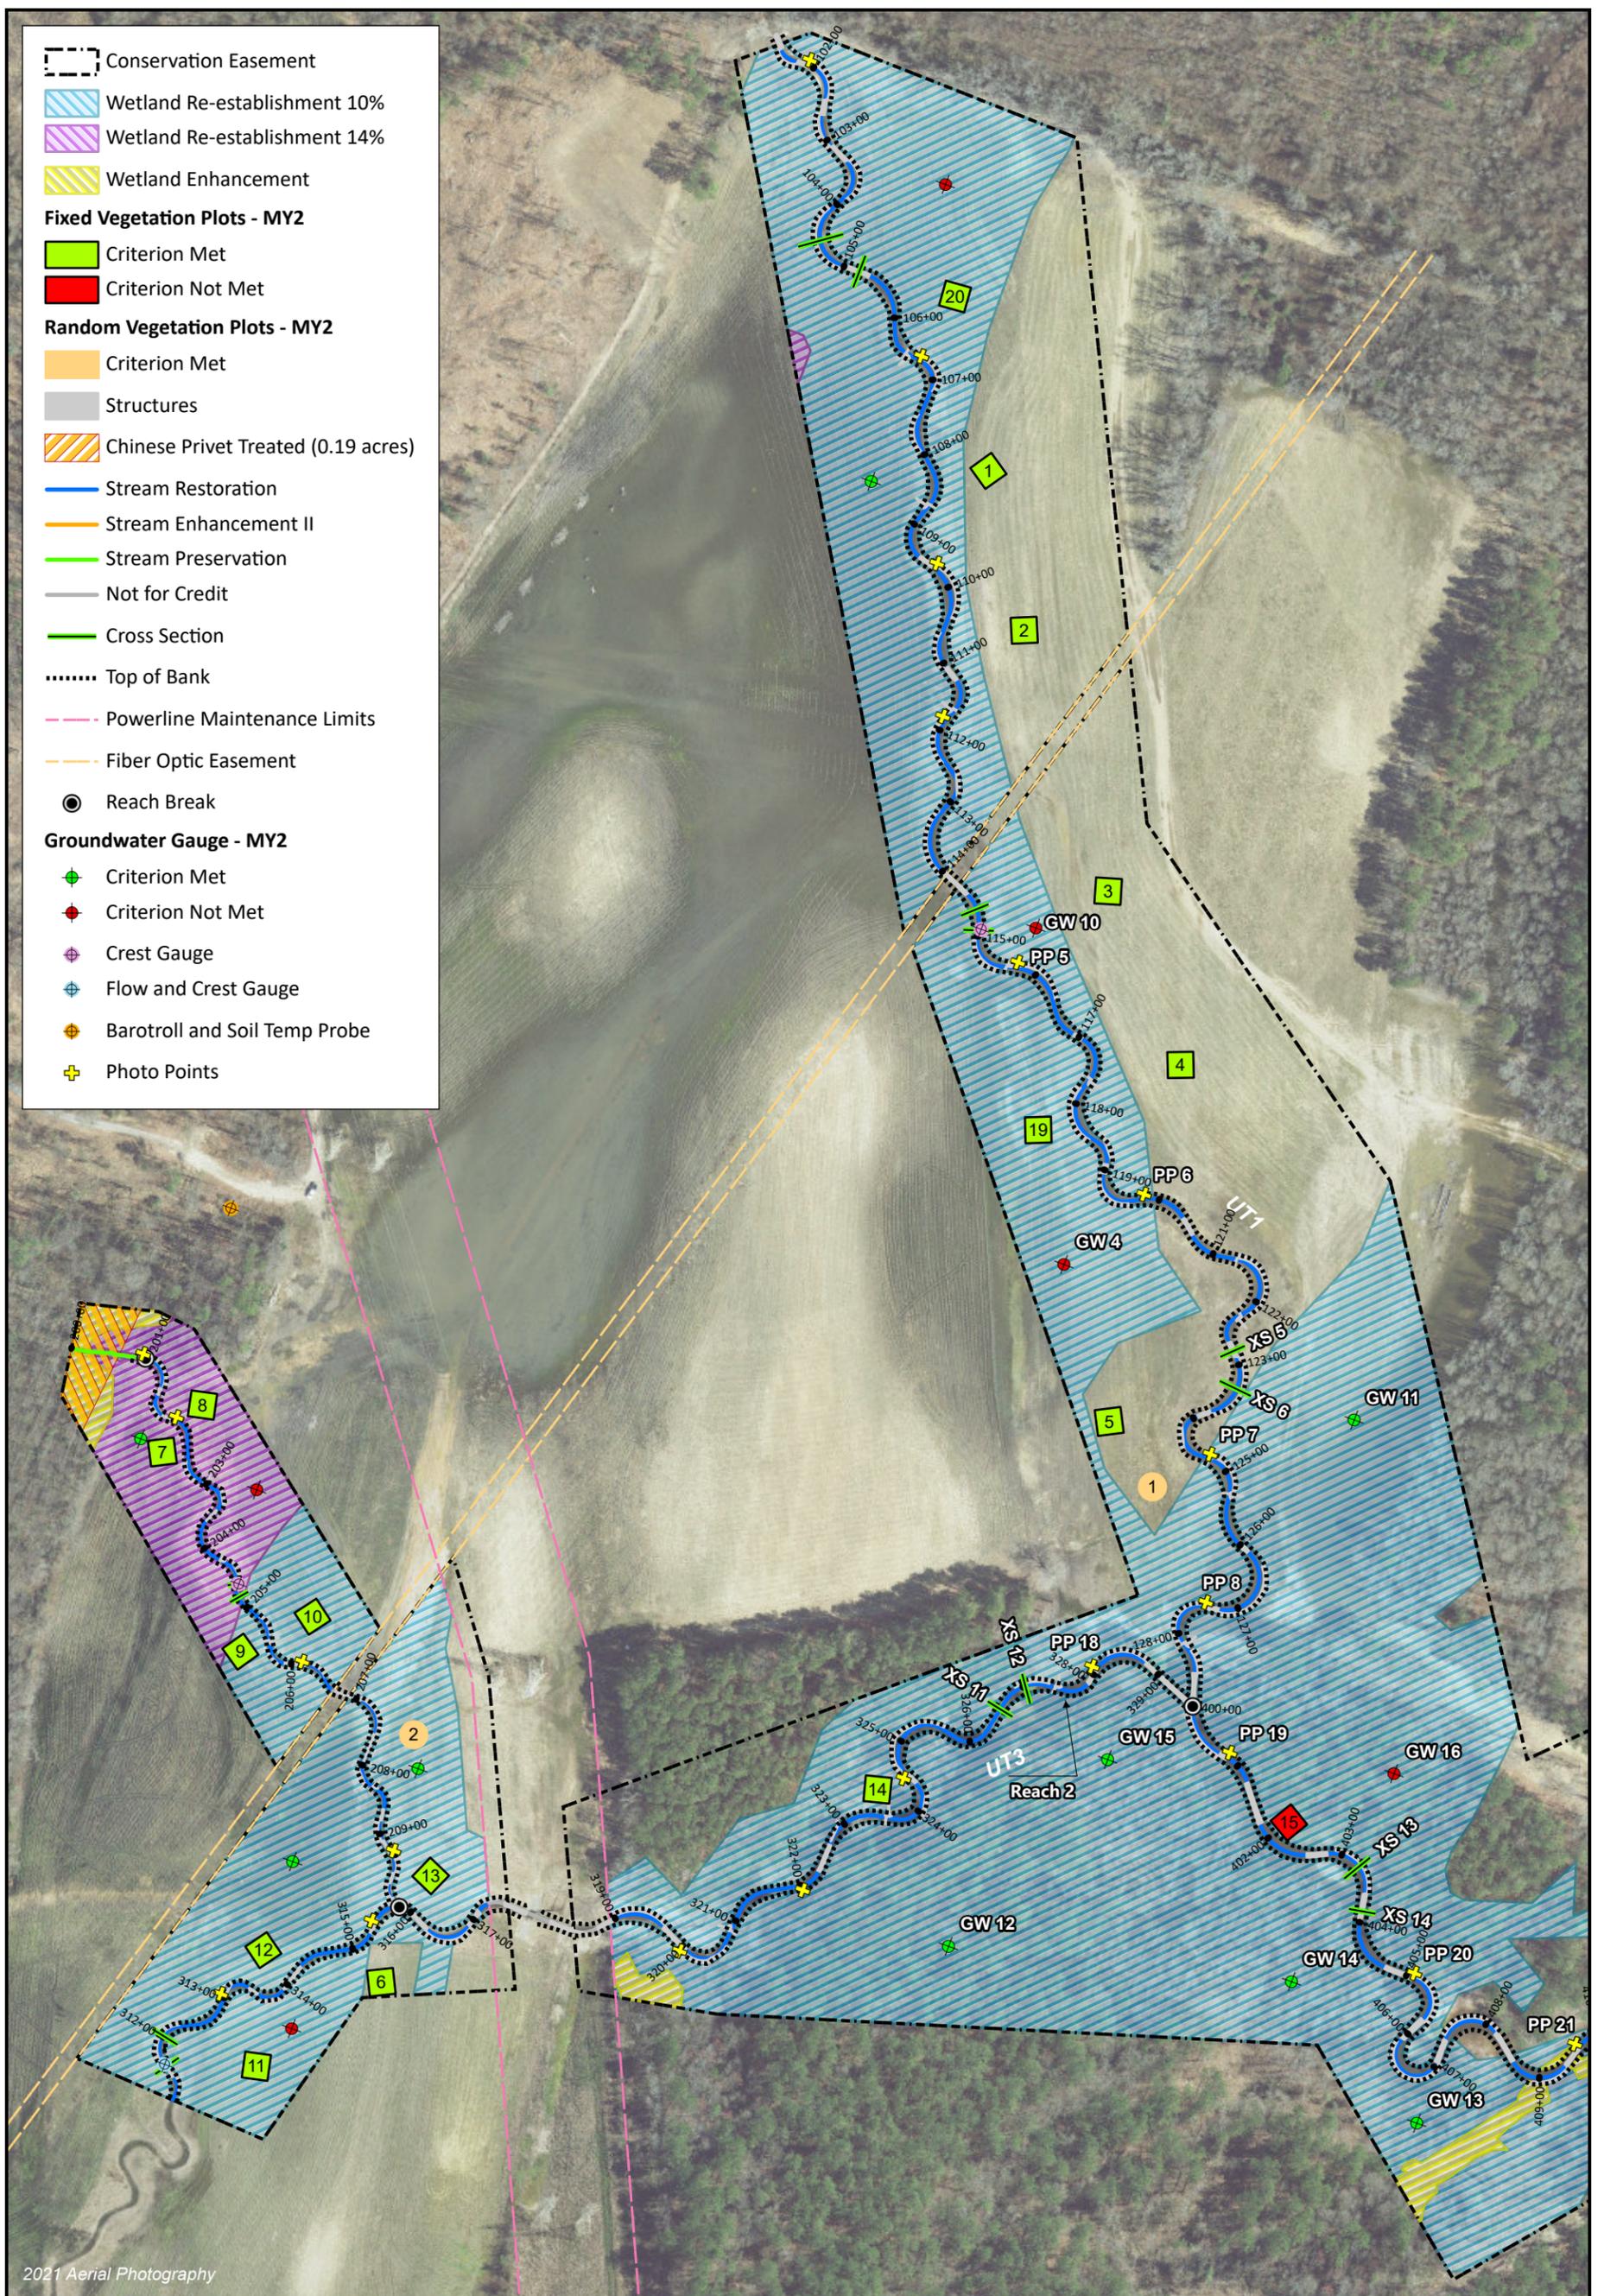
Chinese privet (*Ligustrum sinense*) was treated during December 2022 using the cut-stump method within a 0.19 acre area at the upstream extent of UT2 (Figure 1a). No other vegetation areas of concern have been identified during MY2.

Follow up treatment of the area treated for Chinese privet may be required during future monitoring years (Figure 1a). No other adaptive management practices are currently necessary.
