**FINAL**  
**ANNUAL MONITORING REPORT**  
**MCINTYRE CREEK RESTORTION SITE**  
**AT HORNETS NEST PARK**  
**MECKLENBURG COUNTY, NORTH CAROLINA**  
**(EEP Project No. 243)**

February 2011

Prepared by:  
Axiom Environmental, Inc.  
218 Snow Avenue  
Raleigh, North Carolina 27603

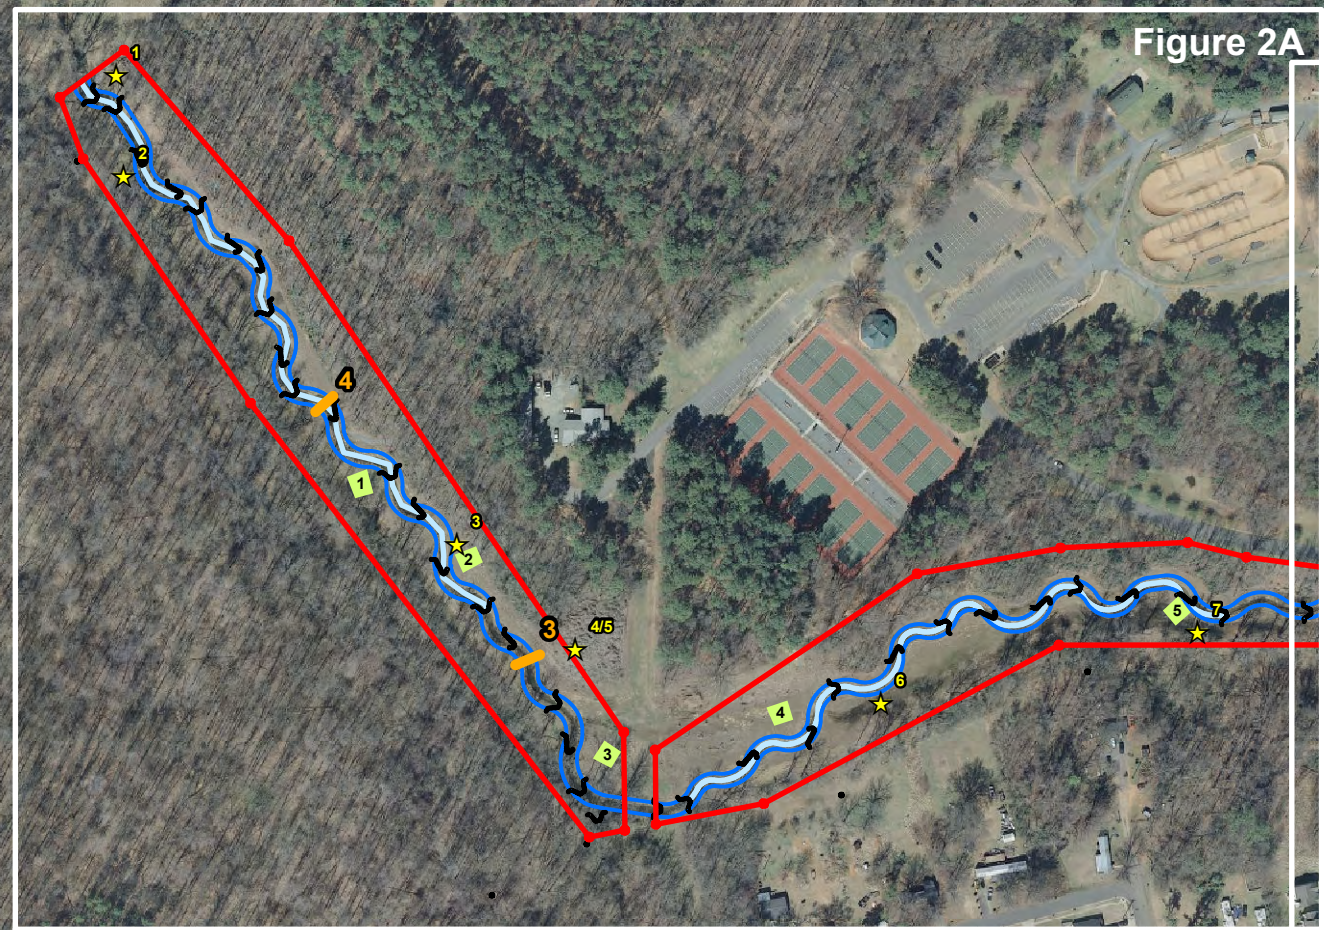
Figure 2A

Several areas of bank erosion are located throughout the project as the result of high stream flows, vertical banks, urbanized watershed, flashy flows, and tight radius of curvatures. These areas are depicted on Figures 2 and 2A-2B (Appendix B) and should continue to be monitored closely. Currently, the stream channel is considered to be within an acceptable range of variation compared to the as-built construction channel. However, due to the extensive impervious surfaces located within the upstream watershed the Site has periods of flashy flood flows even during smaller rain events. Flashy flood flows, compiled with minor bank instability has resulted in some degradation of the channel including eroding outer bends and slumping banks with loss of planted vegetation and reduced integrity of several structures. The loss of planted stems due to sloughing banks will most likely make the banks, particularly outer bends, more vulnerable to erosive flows and continued bank loss. Degradation is anticipated to continue to occur due to the characteristics of the watershed.

Vegetation problem areas within the Site include a small patch of multiflora rose (*Rosa multiflora*) north of the stream near cross-section 3 and a patch of kudzu (*Pueraria lobata*) north of the stream near cross-section 2 (depicted on Figure 2, Appendix B). The kudzu is located on a filled area spreading from outside of the easement towards the stream channel.
