FINAL
ANNUAL MONITORING REPORT
YEAR 2 (2011)
MCINTYRE CREEK RESTORTION SITE
AT HORNETS NEST PARK
MECKLENBURG COUNTY, NORTH CAROLINA
(EEP Project No. 243)

December 2011

Prepared by:
Axiom Environmental, Inc.
218 Snow Avenue
Raleigh, North Carolina 27603

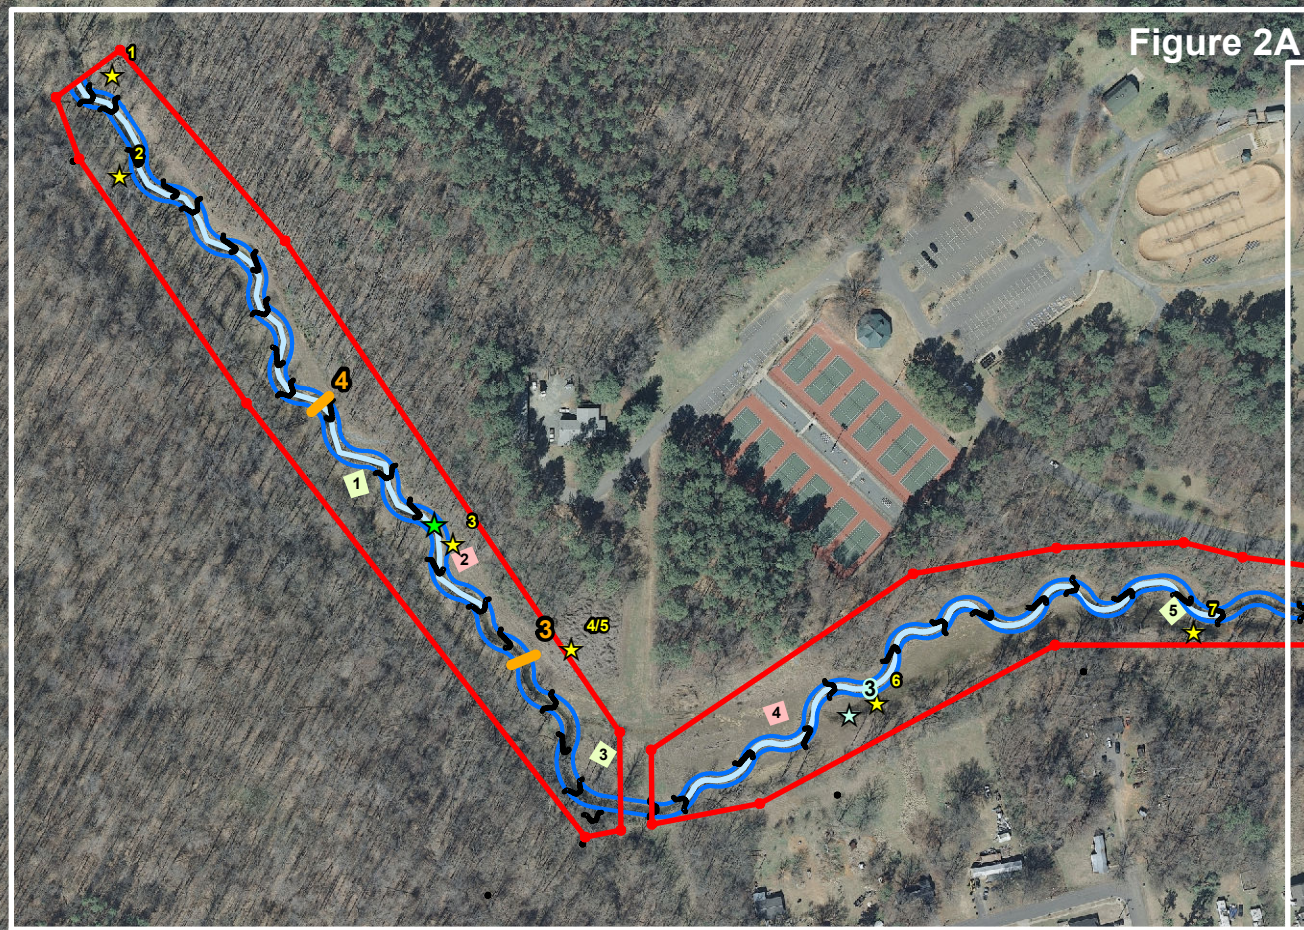
Figure 2A

Several areas of bank erosion are located throughout the project as the result of high stream flows, vertical banks, urbanized watershed, flashy flows, and tight radius of curvatures. These areas are depicted on Figures 2 and 2A-2B (Appendix B) and should continue to be monitored closely. Currently, the stream channel is considered to be within an acceptable range of variation compared to the as-built construction channel. However, due to the extensive impervious surfaces located within the upstream watershed the Site has periods of flashy flood flows even during smaller rain events. Flashy flood flows, compiled with minor bank instability has resulted in some degradation of the channel including eroding outer bends and slumping banks with loss of planted vegetation and reduced integrity of several structures. The loss of planted stems due to sloughing banks will most likely make the banks, particularly outer bends, more vulnerable to erosive flows and continued bank loss. Degradation is anticipated to continue to occur due to the characteristics of the watershed.

Vegetation problem areas within the Site include a large patch of multiflora rose (*Rosa multiflora*) and Chinese privet (*Ligustrum sinense*) north of the stream near cross-section 3, a large of kudzu (*Pueraria lobata*) north of the stream near cross-section 2, and scattered smaller patches of multiflora rose, Chinese privet, and kudzu (depicted on Figures 2A-2B, Appendix B).

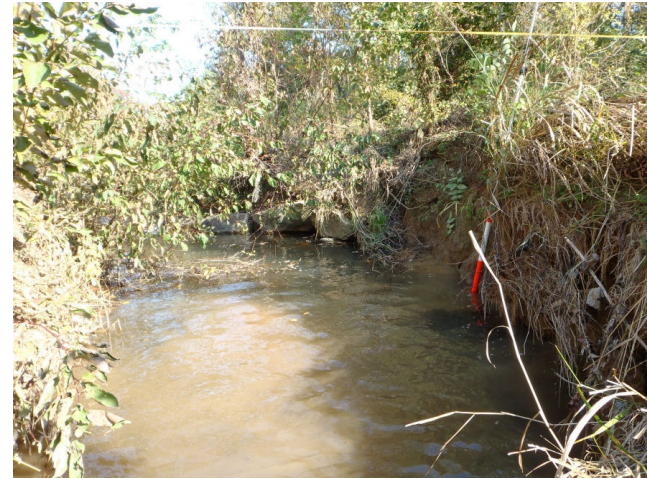
River Basin:	Catawba
Watershed:	McIntyre Creek
XS ID	XS - 1, Pool
Feature	Pool
Date:	10/28/2011
Field Crew:	Thomas, Perkinson

SUMMARY DATA	
Bankfull Elevation:	96.3
Bankfull Cross-Sectional Area:	61.3
Bankfull Width:	19.4
Flood Prone Area Elevation:	NA
Flood Prone Width:	NA
Max Depth at Bankfull:	6.1
Mean Depth at Bankfull:	3.2
W / D Ratio:	NA
Entrenchment Ratio:	NA
Bank Height Ratio:	1.0

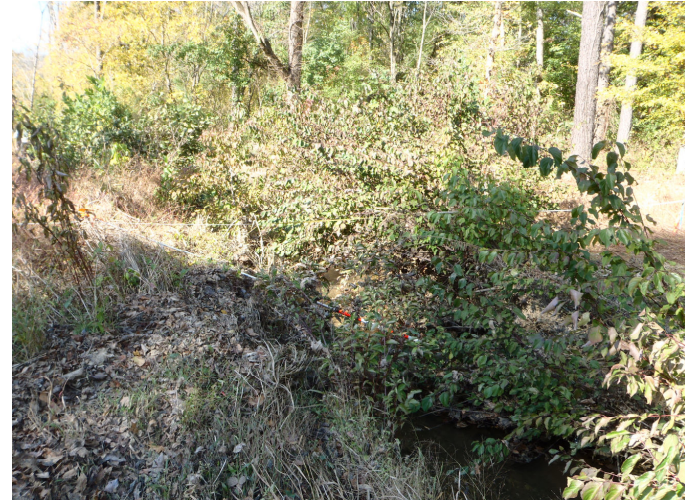
River Basin:	Catawba
Watershed:	McIntyre Creek
XS ID	XS - 2, Riffle
Feature	Riffle
Date:	10/28/2011
Field Crew:	Thomas, Perkinson

SUMMARY DATA	
Bankfull Elevation:	98.0
Bankfull Cross-Sectional Area:	33.5
Bankfull Width:	15.9
Flood Prone Area Elevation:	101.2
Flood Prone Width:	150.0
Max Depth at Bankfull:	3.2
Mean Depth at Bankfull:	2.1
W / D Ratio:	7.5
Entrenchment Ratio:	9.4
Bank Height Ratio:	1.0

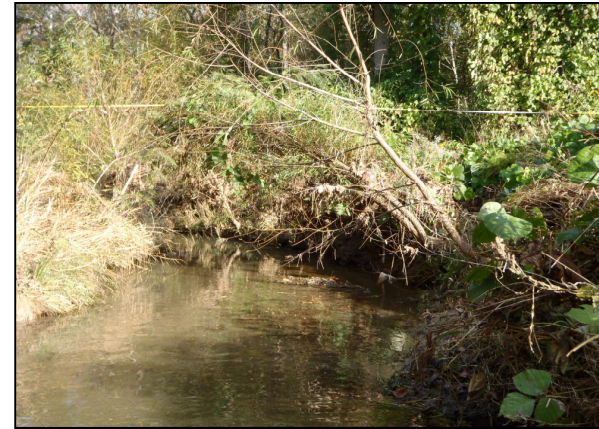
River Basin:	Catawba
Watershed:	McIntyre Creek
XS ID	XS - 3, Riffle
Feature	Riffle
Date:	10/28/2011
Field Crew:	Thomas, Perkinson

SUMMARY DATA	
Bankfull Elevation:	107.2
Bankfull Cross-Sectional Area:	23.8
Bankfull Width:	11.1
Flood Prone Area Elevation:	109.8
Flood Prone Width:	150.0
Max Depth at Bankfull:	2.6
Mean Depth at Bankfull:	2.1
W / D Ratio:	5.2
Entrenchment Ratio:	13.5
Bank Height Ratio:	1.0

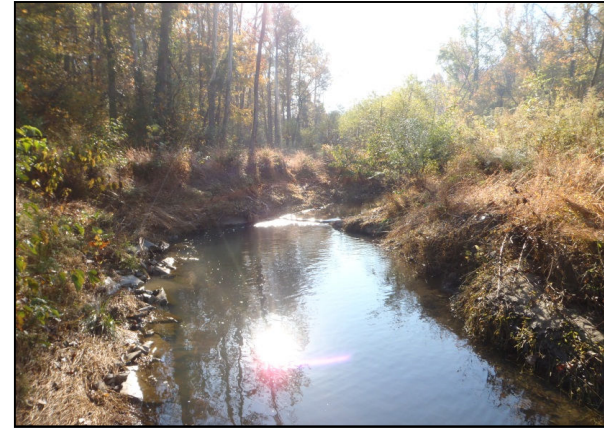
River Basin:	Catawba
Watershed:	McIntyre Creek
XS ID	XS - 4, Pool
Feature	Pool
Date:	10/28/2011
Field Crew:	Thomas, Perkinson

SUMMARY DATA	
Bankfull Elevation:	109.3
Bankfull Cross-Sectional Area:	45.2
Bankfull Width:	13.7
Flood Prone Area Elevation:	NA
Flood Prone Width:	NA
Max Depth at Bankfull:	4.1
Mean Depth at Bankfull:	3.3
W / D Ratio:	NA
Entrenchment Ratio:	NA
Bank Height Ratio:	1.0
