FINAL
ANNUAL MONITORING REPORT
YEAR 3 (2012)
MCINTYRE CREEK RESTORTION SITE
AT HORNETS NEST PARK
MECKLENBURG COUNTY, NORTH CAROLINA
(EEP Project No. 243, Contract No. 004499)

November 2012

Prepared by:
Axiom Environmental, Inc.
218 Snow Avenue
Raleigh, North Carolina 27603

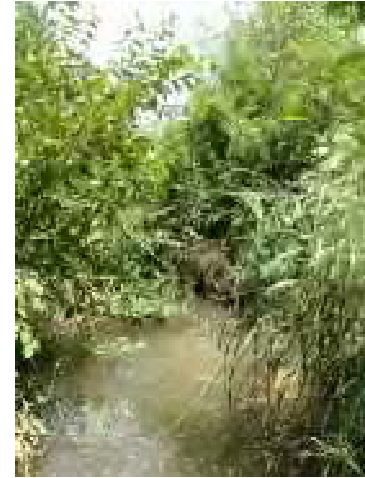
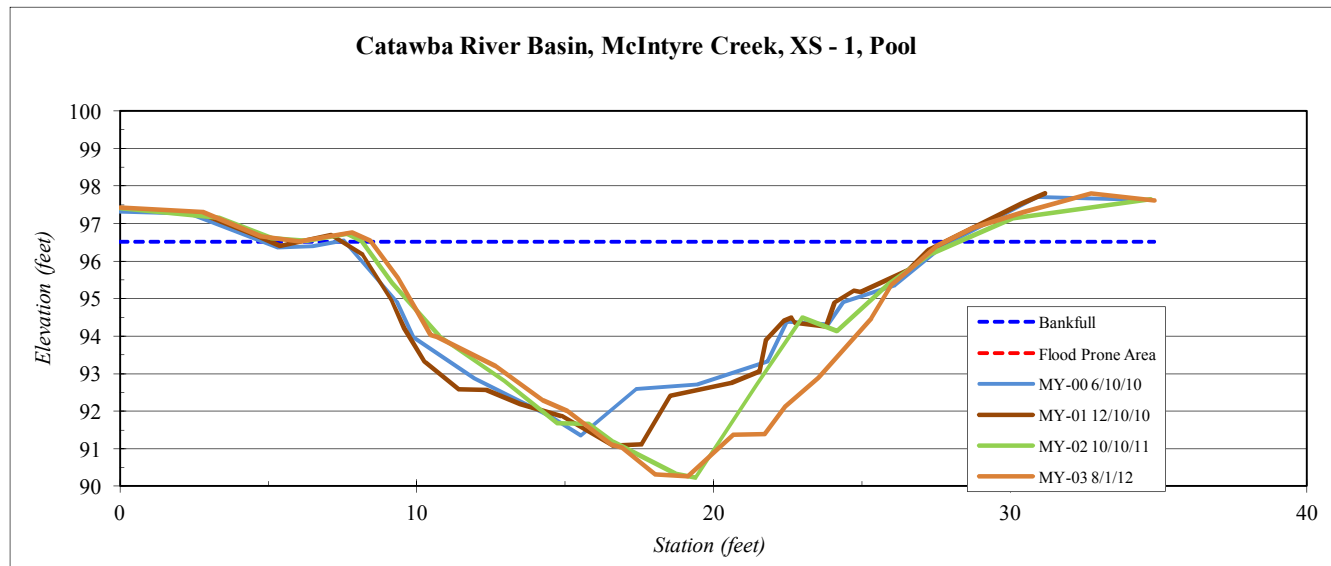
River Basin:	Catawba
Watershed:	McIntyre Creek
XS ID	XS - 1, Pool
Feature	Pool
Date:	8/1/2012
Field Crew:	Perkinson, Dean, Jernigan

SUMMARY DATA	
Bankfull Elevation:	96.5
Bankfull Cross-Sectional Area:	70.0
Bankfull Width:	19.4
Flood Prone Area Elevation:	NA
Flood Prone Width:	NA
Max Depth at Bankfull:	6.3
Mean Depth at Bankfull:	3.6
W / D Ratio:	NA
Entrenchment Ratio:	NA
Bank Height Ratio:	1.0

Stream Type	E
--------------------	---

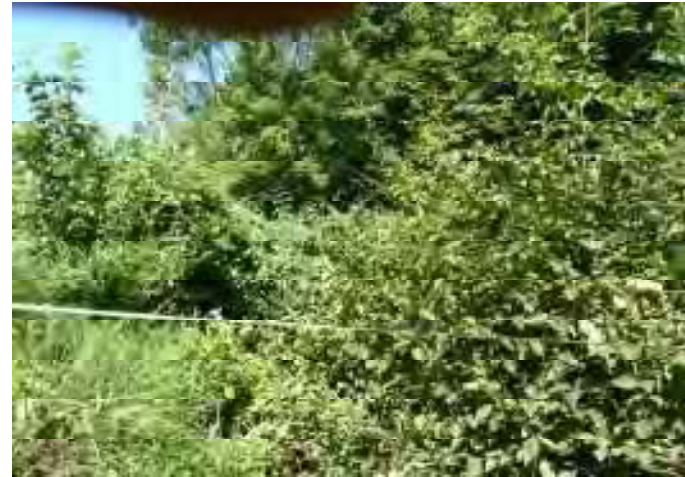
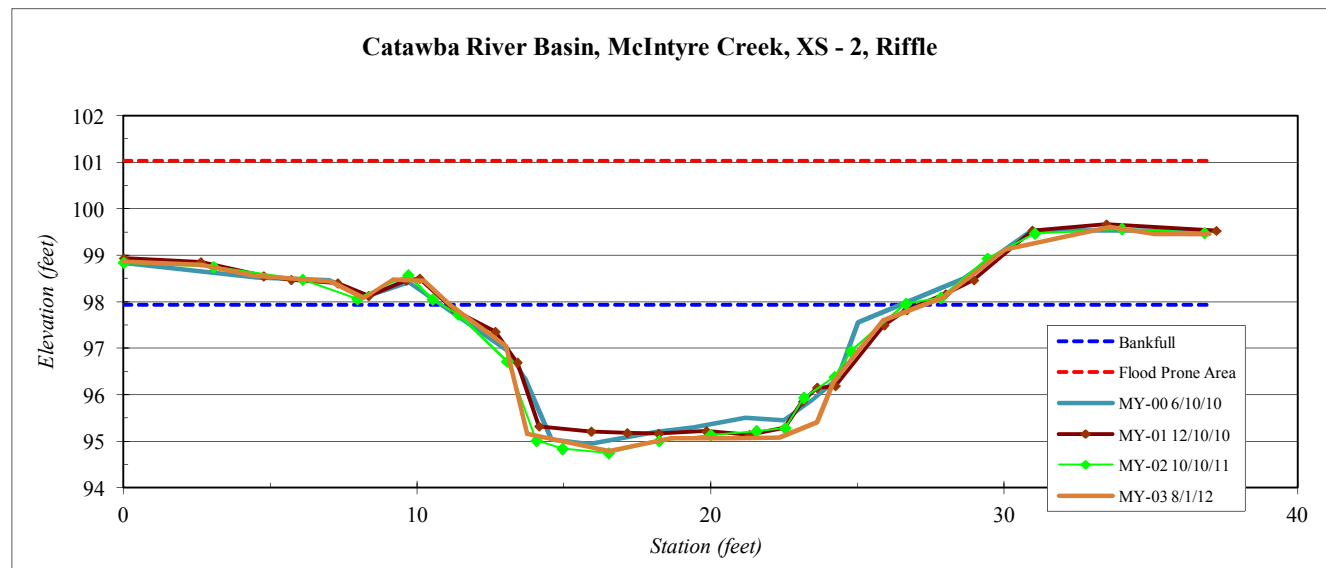
River Basin:	Catawba
Watershed:	McIntyre Creek
XS ID	XS - 2, Riffle
Feature	Riffle
Date:	8/1/2012
Field Crew:	Perkinson, Dean, Jernigan

SUMMARY DATA	
Bankfull Elevation:	97.9
Bankfull Cross-Sectional Area:	33.8
Bankfull Width:	16.1
Flood Prone Area Elevation:	101.0
Flood Prone Width:	150.0
Max Depth at Bankfull:	3.1
Mean Depth at Bankfull:	2.1
W / D Ratio:	7.7
Entrenchment Ratio:	9.3
Bank Height Ratio:	1.0

Stream Type	E
--------------------	---

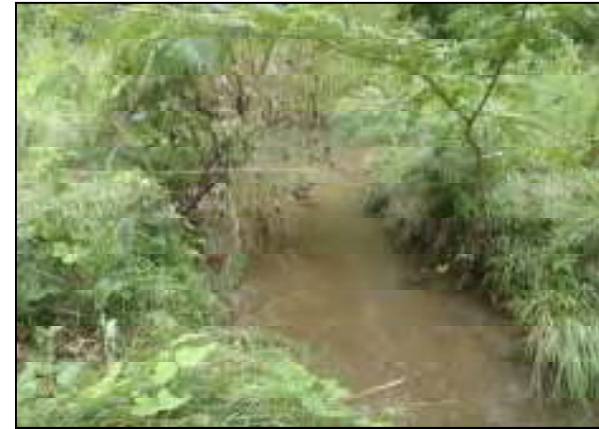
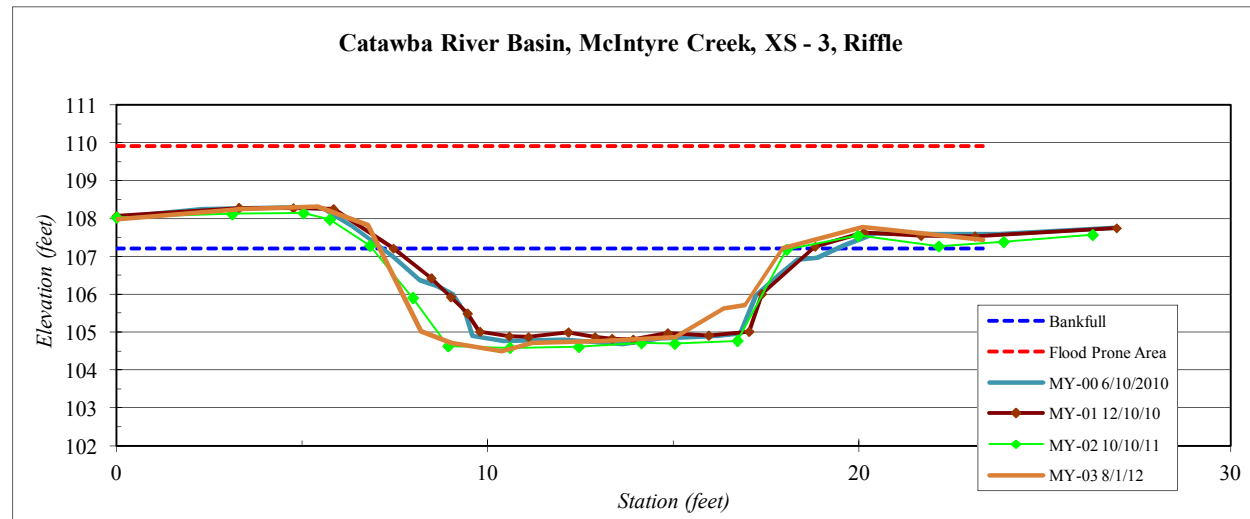
River Basin:	Catawba
Watershed:	McIntyre Creek
XS ID	XS - 3, Riffle
Feature	Riffle
Date:	8/1/2012
Field Crew:	Perkinson, Dean, Jernigan

SUMMARY DATA	
Bankfull Elevation:	107.2
Bankfull Cross-Sectional Area:	22.4
Bankfull Width:	10.9
Flood Prone Area Elevation:	109.9
Flood Prone Width:	150.0
Max Depth at Bankfull:	2.7
Mean Depth at Bankfull:	2.1
W / D Ratio:	5.3
Entrenchment Ratio:	13.8
Bank Height Ratio:	1.0

Stream Type	E
--------------------	---

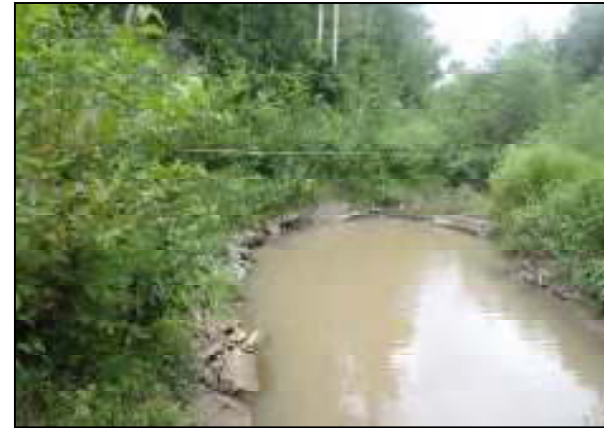
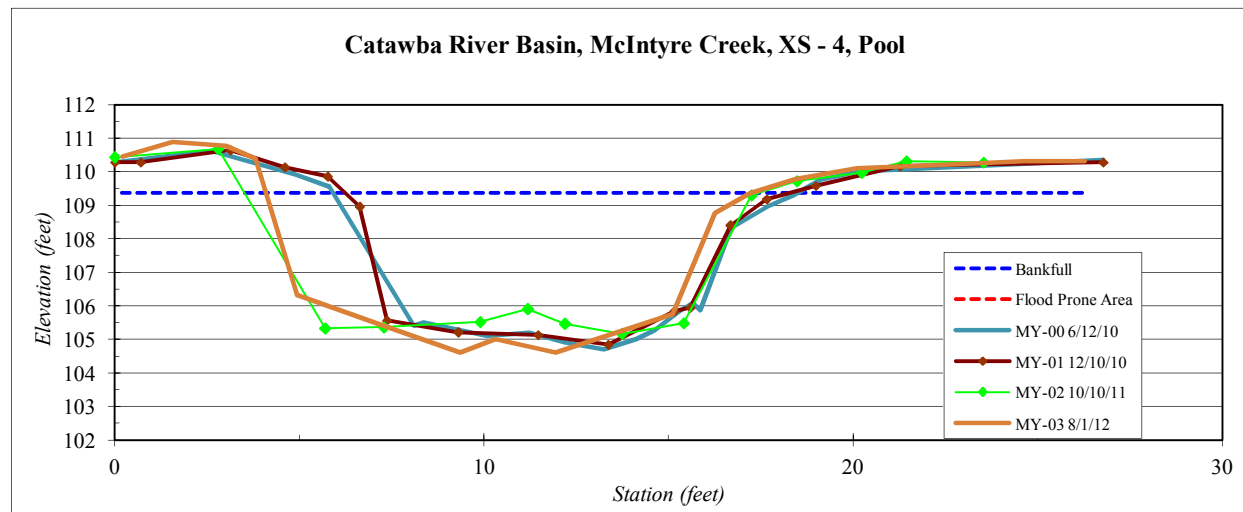
River Basin:	Catawba
Watershed:	McIntyre Creek
XS ID	XS - 4, Pool
Feature	Pool
Date:	8/1/2012
Field Crew:	Perkinson, Dean, Jernigan

SUMMARY DATA	
Bankfull Elevation:	109.4
Bankfull Cross-Sectional Area:	46.2
Bankfull Width:	13.1
Flood Prone Area Elevation:	NA
Flood Prone Width:	NA
Max Depth at Bankfull:	4.8
Mean Depth at Bankfull:	3.5
W / D Ratio:	NA
Entrenchment Ratio:	NA
Bank Height Ratio:	1.0

Stream Type	C/E
--------------------	-----

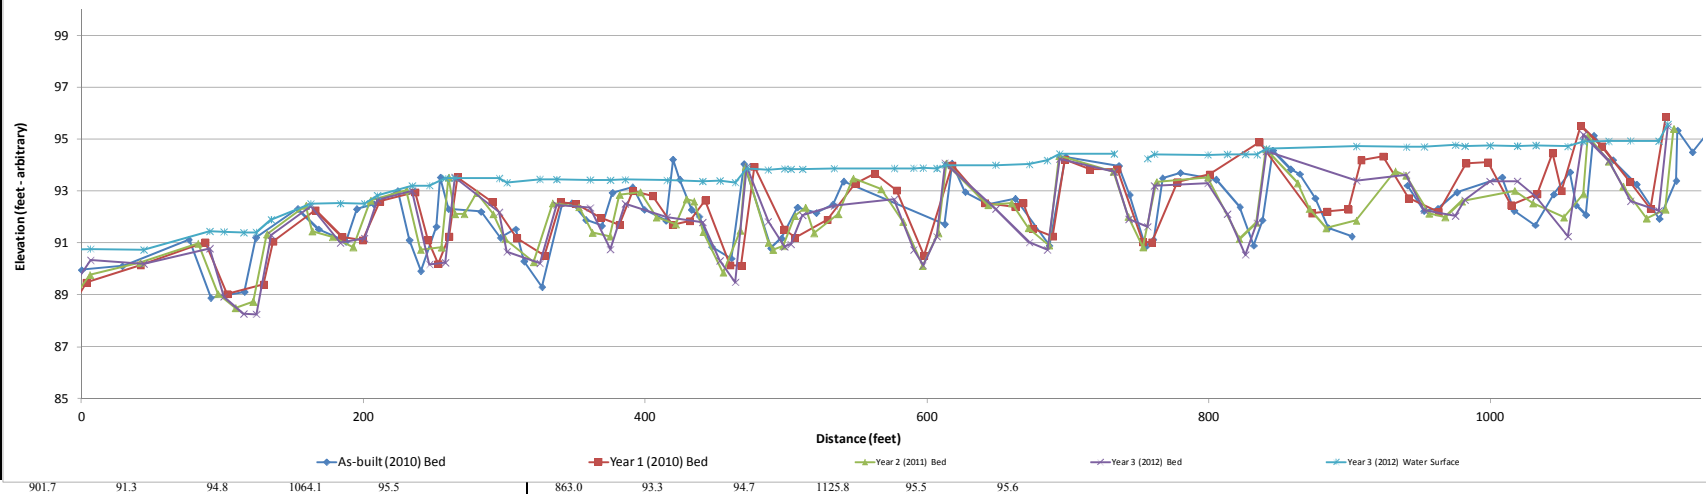
McIntyre Creek Year 3 (2012) Profile - Reach 00+00 to 11+50

As-built	2010	2011	2012
Avg. Water Surface Slope	0.0035	0.0042	0.0041	0.0043
Riffle Length	32	26	27	34
Avg. Riffle Slope	0.0042	0.0047	0.0023	0.0034
Pool Length	16	19	20	18
Avg. Pool Slope	76	76	0.0023	0.0033

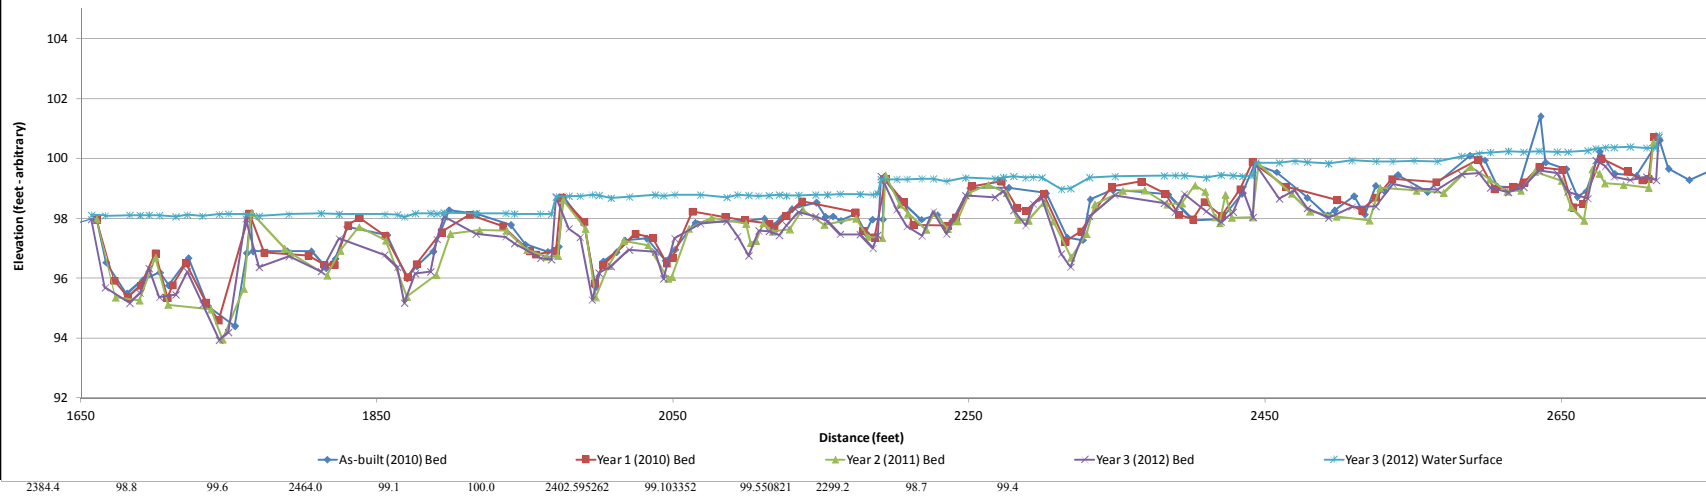
McIntyre Creek Year 3 (2012) Profile - Reach 16+50 to 27+50

As-built	2010	2011	2012
Avg. Water Surface Slope	0.0035	0.0022	0.0020	0.0026
Riffle Length	32	30	25	28
Avg. Riffle Slope	0.0042	0.0010	0.0010	0.0012
Pool Length	16	15	10	15
Avg. Pool Slope	76	76	0.0000	0.0011

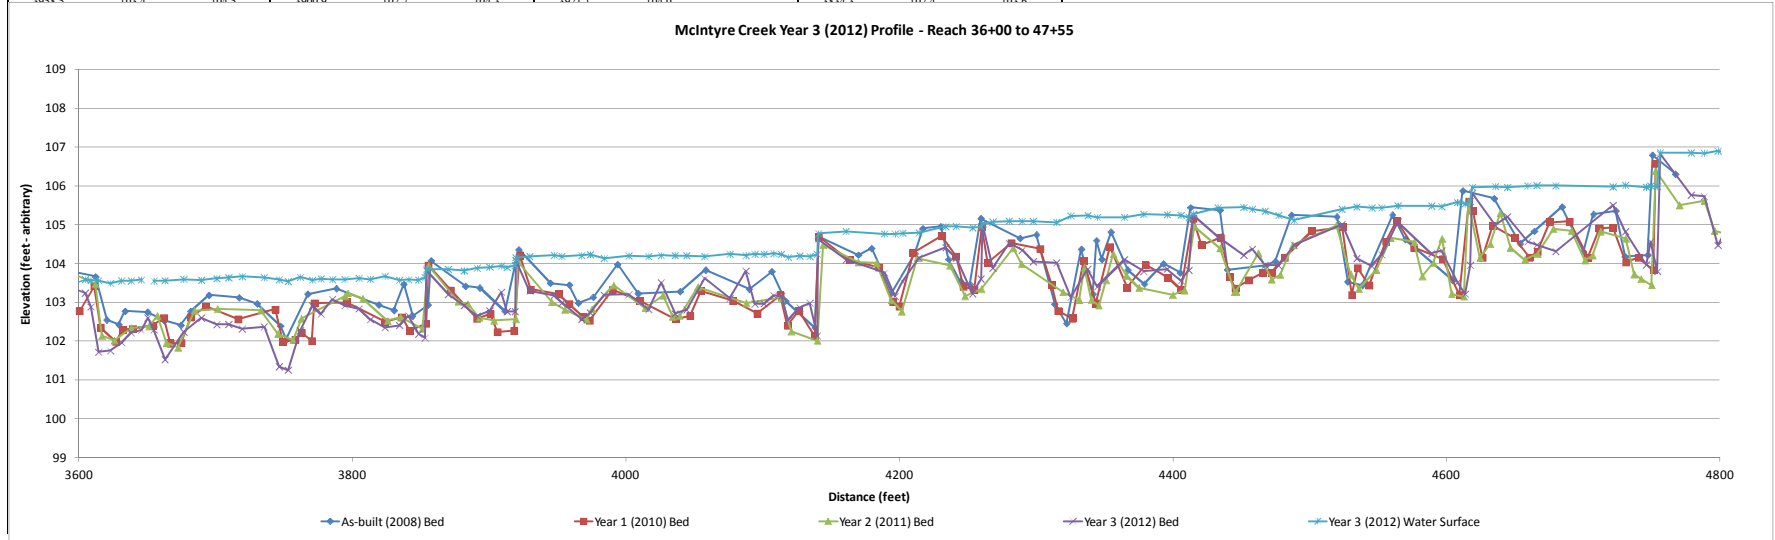
Project Name McIntyre Creek - Year 3 (2012) Profile
Reach Reach 3 (36+00 - 47+55)
Feature Profile
Date 8/1/12
Crew Perkinson, Dean, Jernigan

As-built	2010	2011	2012
Avg. Water Surface Slope	0.0035	0.0020	0.0025	0.0029
Riffle Length	32	35	28	29
Avg. Riffle Slope	0.0042	0.0027	0.0003	0.0022
Pool Length	16	12	16	16
Pool to Pool Spacing	76	76	0.0005	0.0018

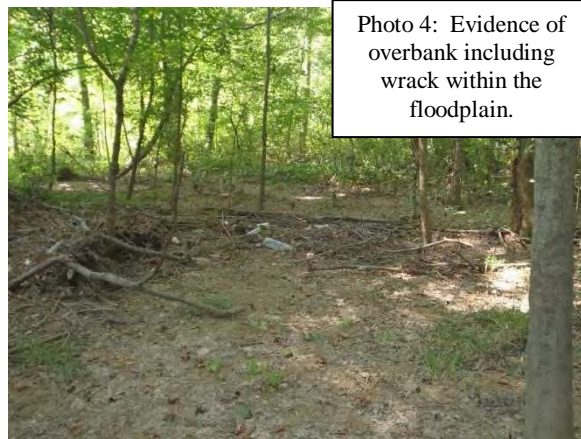
Photo 4: Evidence of overbank including wrack within the floodplain.

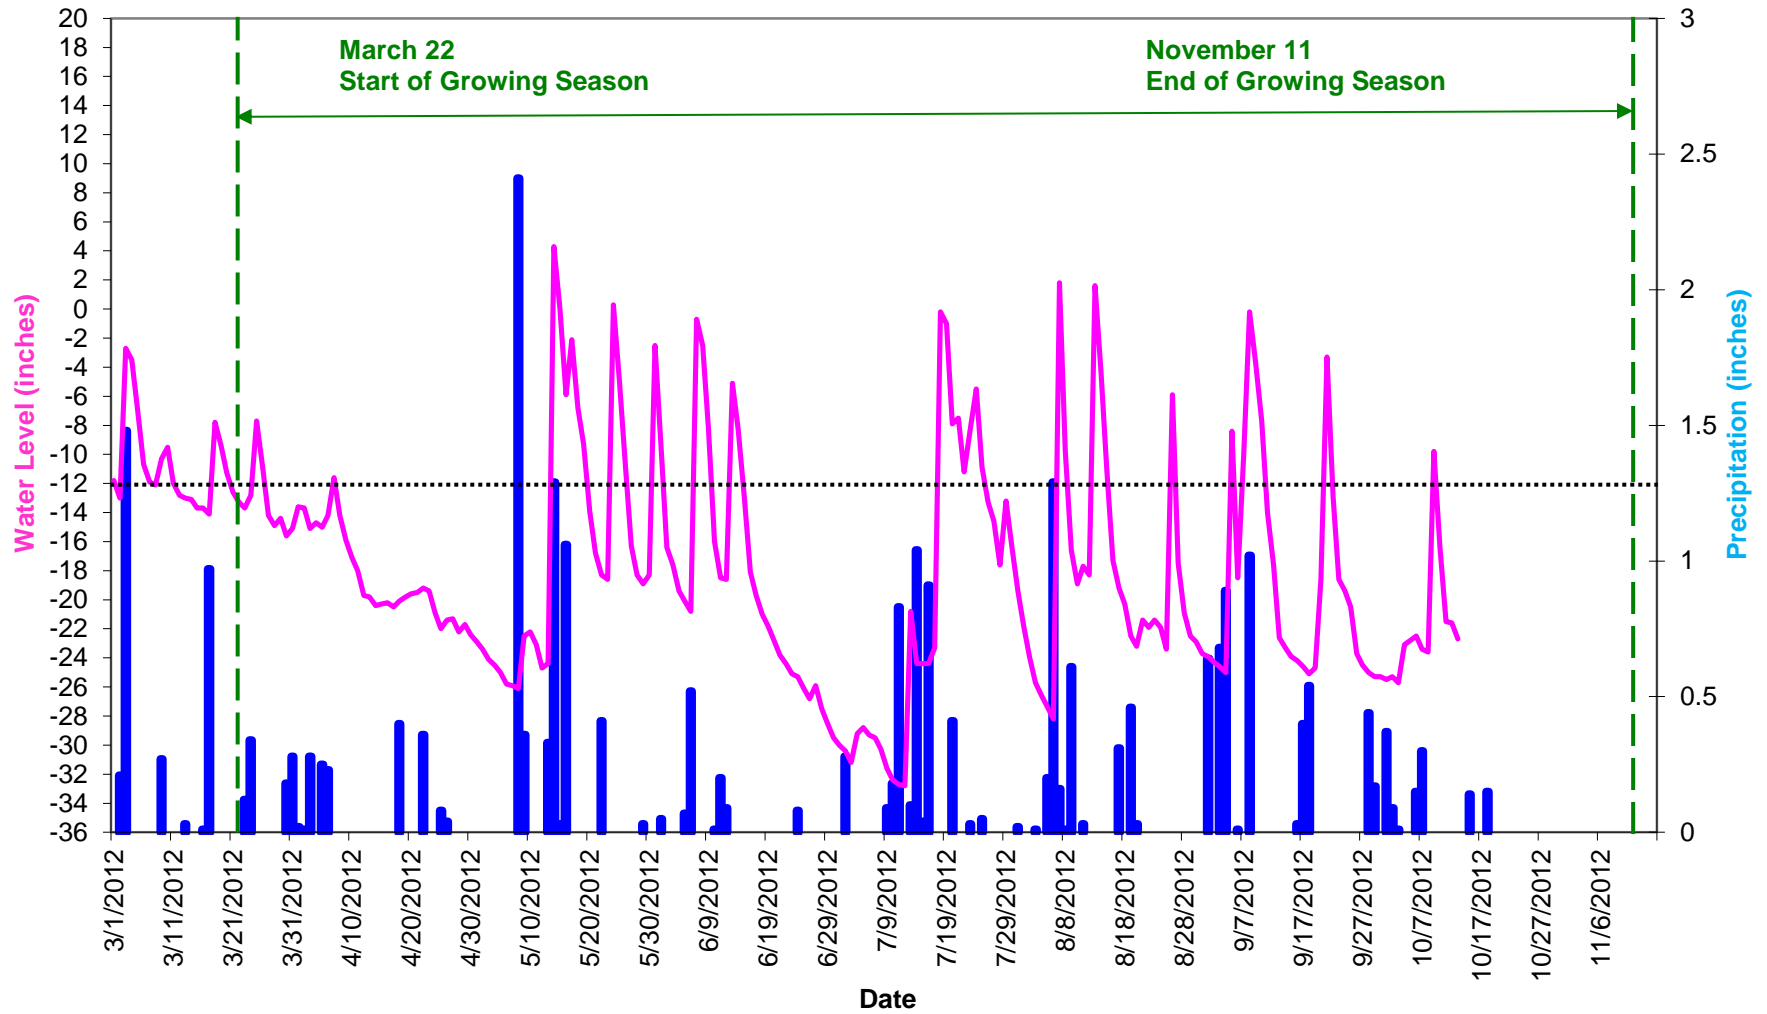
McIntyre Creek Gauge 1 Year 3 (2012 Data)

Gauge	Success Criteria Achieved/Max Consecutive Days During Growing Season (Percentage)				
	Year 1 (2010)*	Year 2 (2011)*	Year 3 (2012)*	Year 4 (2013)	Year 5 (2014)
1	--	No/7 day (3.0 %)	No/8 day (3.4 %)		
2	--	Yes/38 day (16.3 %)	Yes/23 day (10 %)		
3	--	Yes/41 day (17.6 %)	No/22 day (9.4 %)
